Photographs
-Chisapani-

His Majesty's Government of Nepal
 Ministry of Forest and Soil Conservation/Department of Soil Conservation
THE STUDY ON THE DISASTER PREVENTION PLAN FOR SEVERELY AFFECTED AREAS BY 1993 DISASTER IN THE CENTRAL DEVELOPMENT REGION OF NEPAL
 JAPAN INTERNATIONAL COOPERATION AGENCY

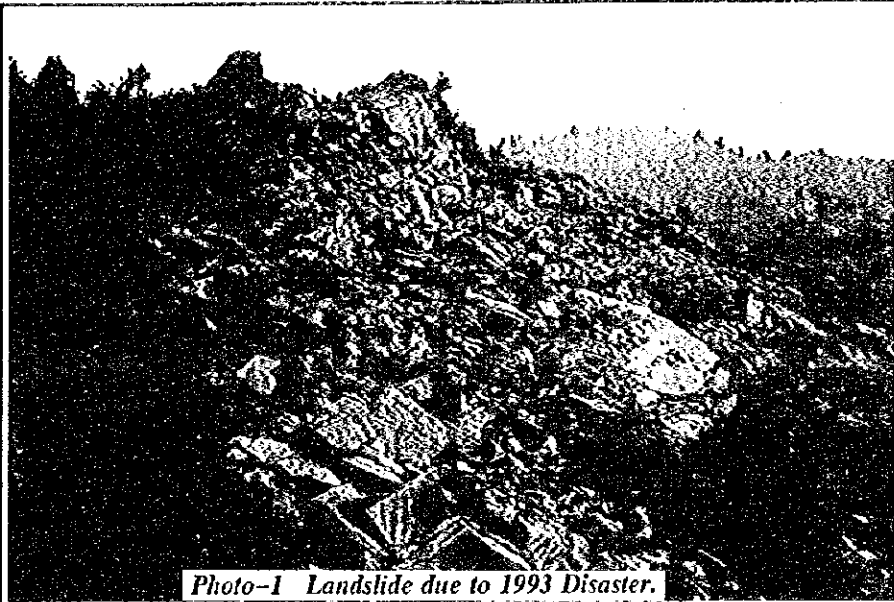
Photo-1 Landslide due to 1993 Disaster.

The slided rocks in form of broken rock layers shows the characteristic of "plane slide".

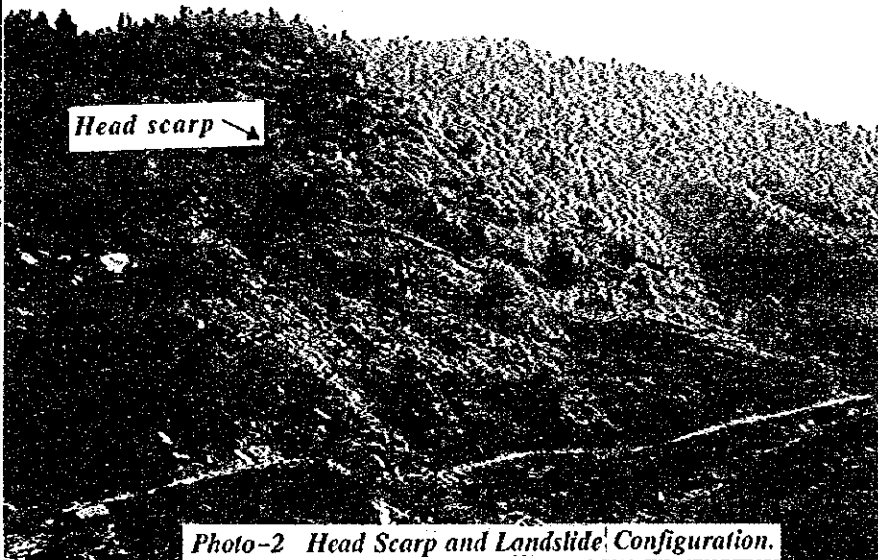
Photo-2 Head Scarp and Landslide Configuration.

The head scarp of landslide are observed between the vegetation steps.

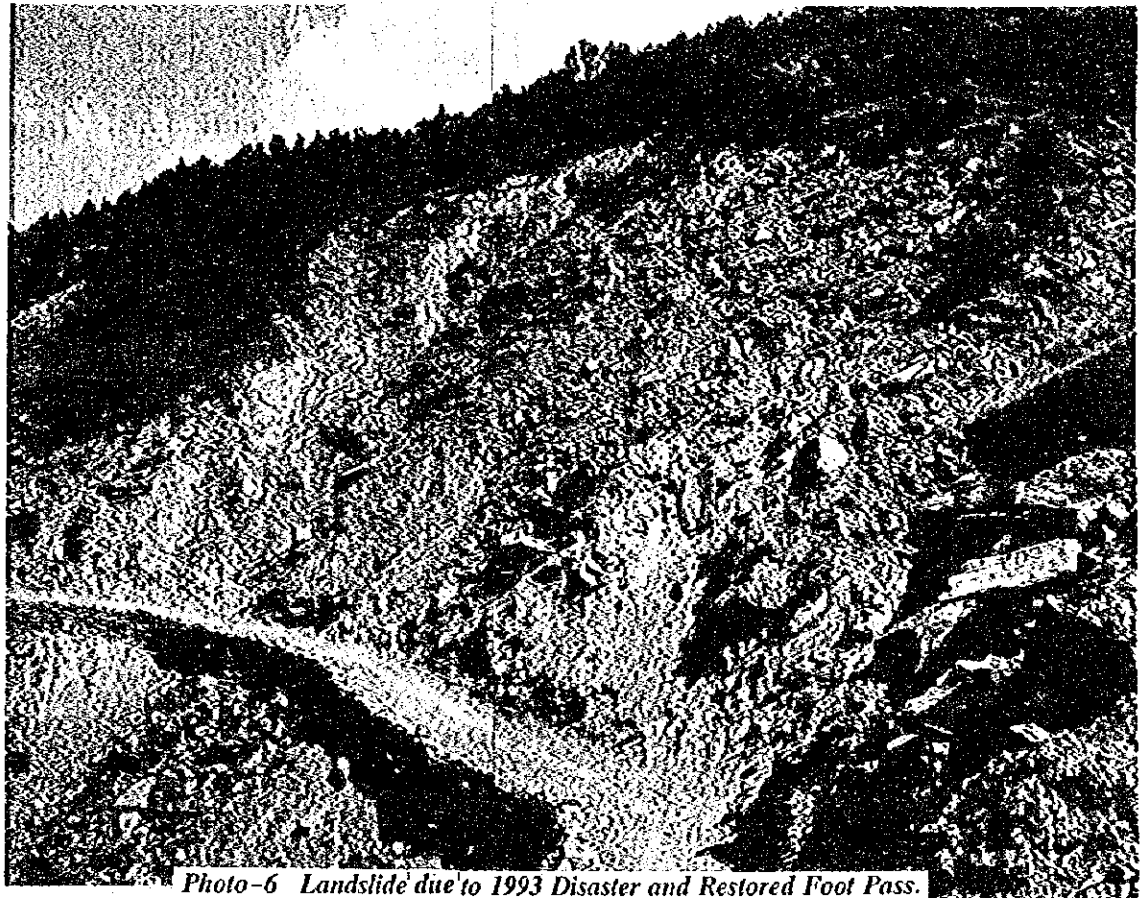
Photo-6 *Landslide due to 1993 Disaster and Restored Foot Pass.*

Landslide along the foot pass. The top soil on the slope is very thin, the average is less than 1 m thick. the landslide was about 2-3 m thick. The damaged road is now tentatively rehabilitated.

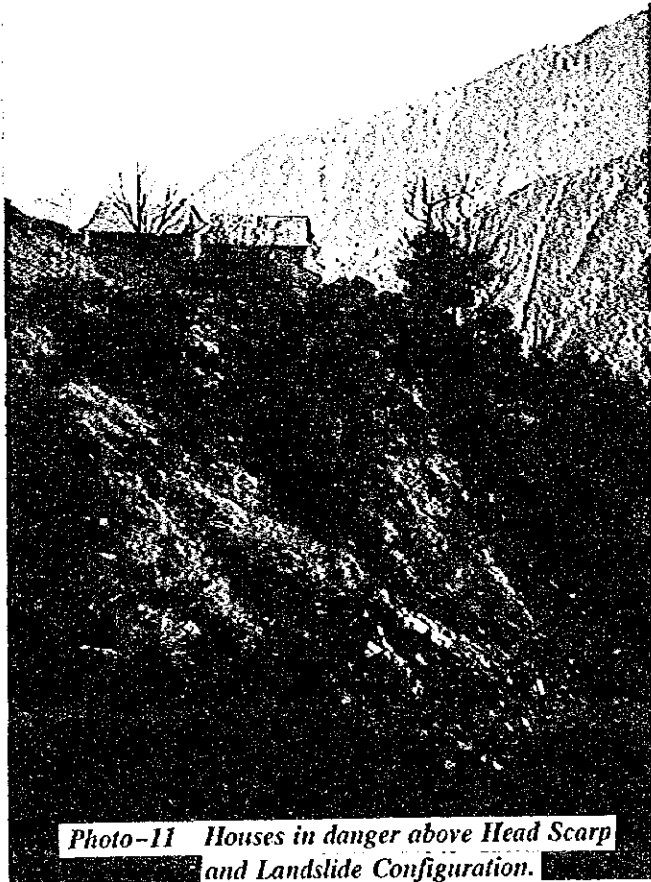
Photo-11 Houses in danger above Head Scarp and Landslide Configuration.

Many houses are found on such a top of scarp in Chisapani.

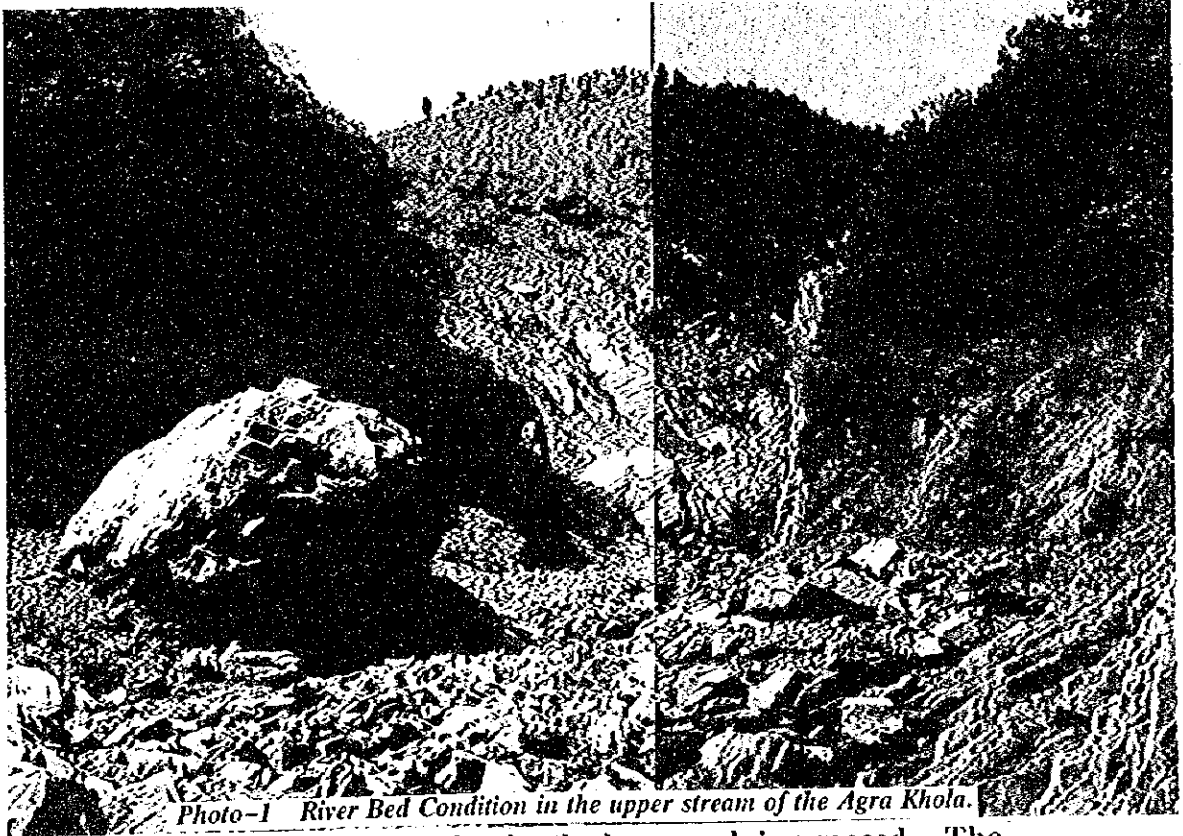
Photo-1 River Bed Condition in the upper stream of the Agra Khola.

Along the river bank, the base rock is exposed. The sediment on the riverbed is comparatively thin.

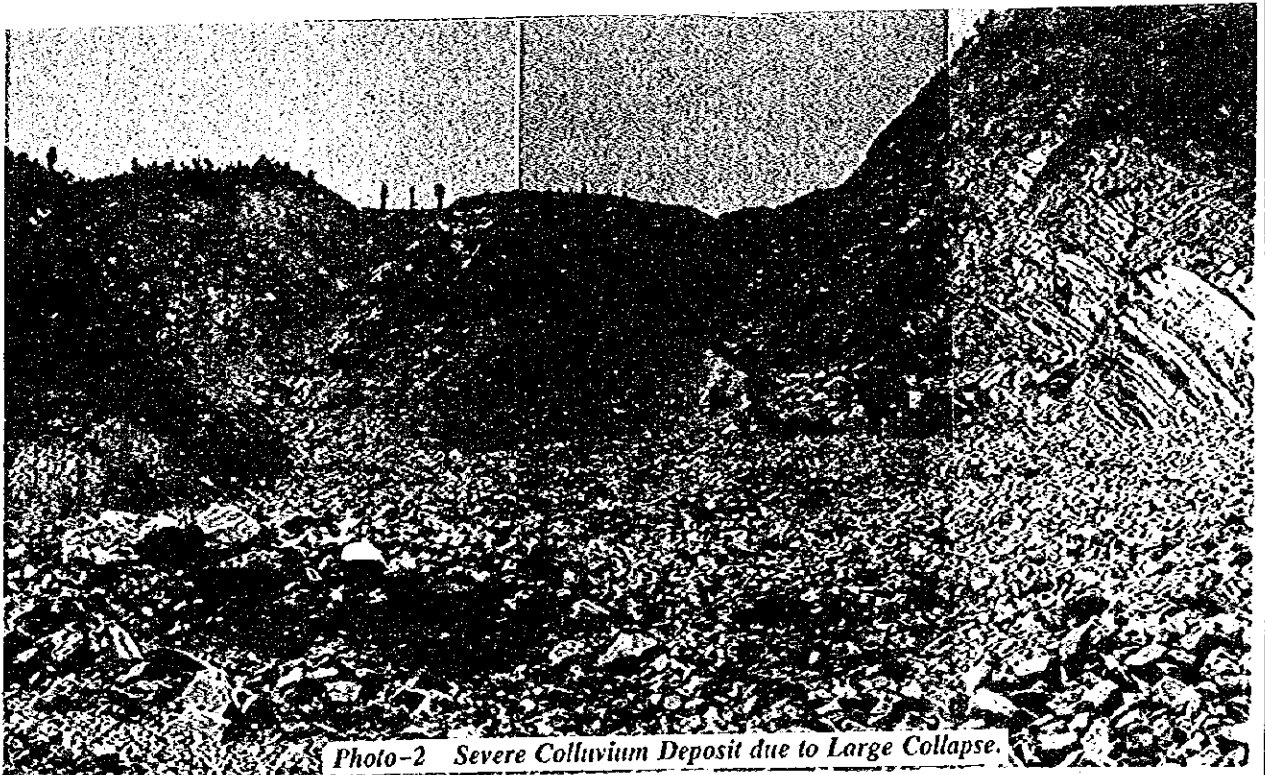
Photo-2 Severe Colluvium Deposit due to Large Collapse.

In the underground of landslide, the small gravels are thickly accumulated.

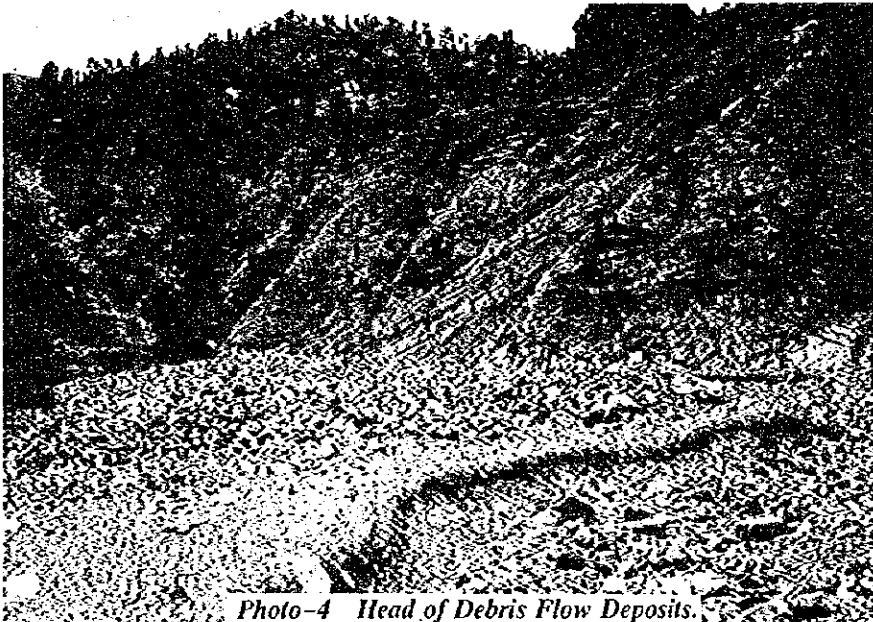
The head of debris fan. Such geographical features are often observed.

Photo-4 Head of Debris Flow Deposits.

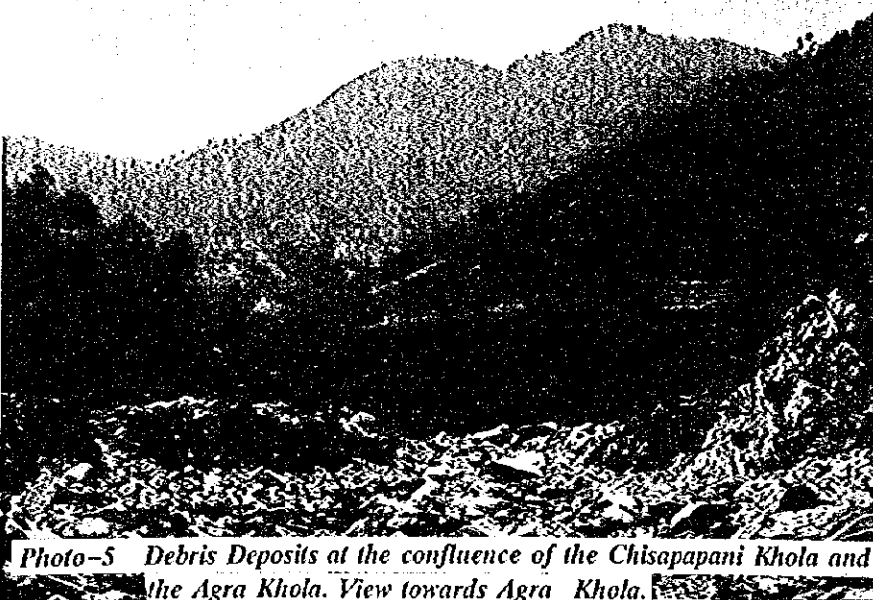
Photo-5 Debris Deposits at the confluence of the Chisapapani Khola and the Agra Khola. View towards Agra Khola.

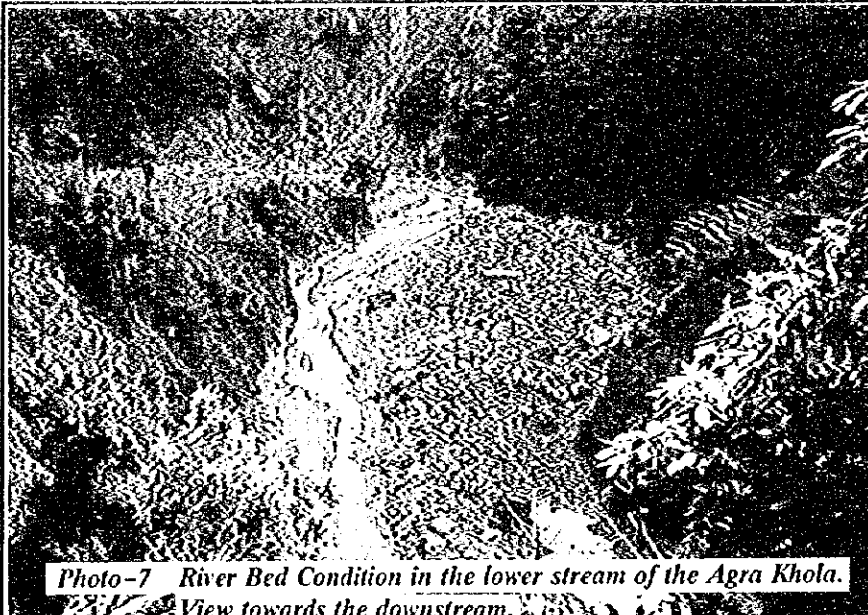
The river course remarkably meander, the boulders are accumulated in the right bank.

Photo-7 River Bed Condition in the lower stream of the Agra Khola. View towards the downstream.

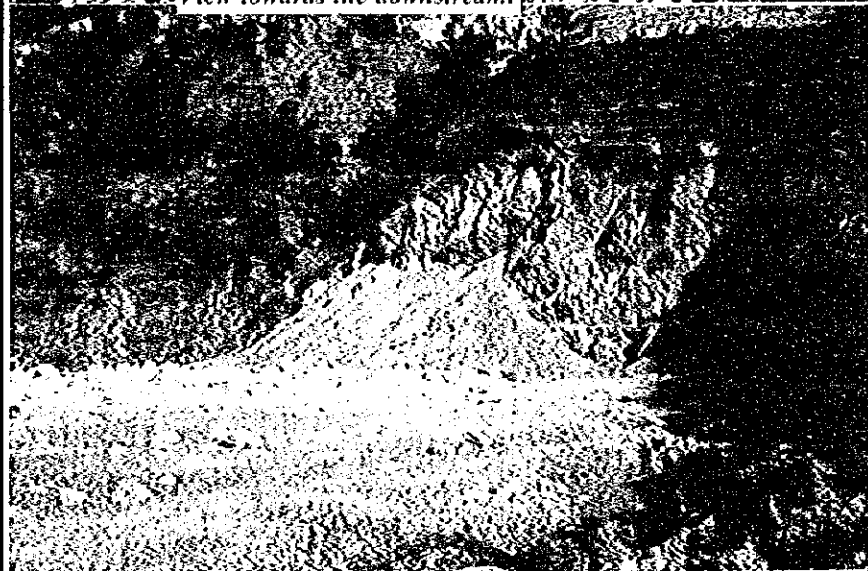
This is the source of debris to downstream.

Photo-8 Severe River Bank Failure and these Colluvium Deposits in the lower stream of The Agra Khola.

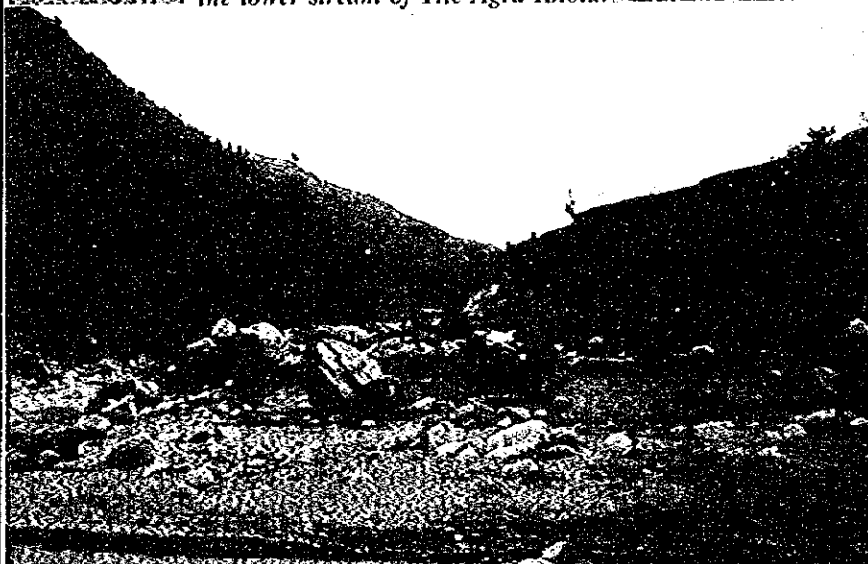
This is the source of large boulders to downstream.

Photo-9 Terrace Gravel Deposits in the lower stream of the Agra Khola.

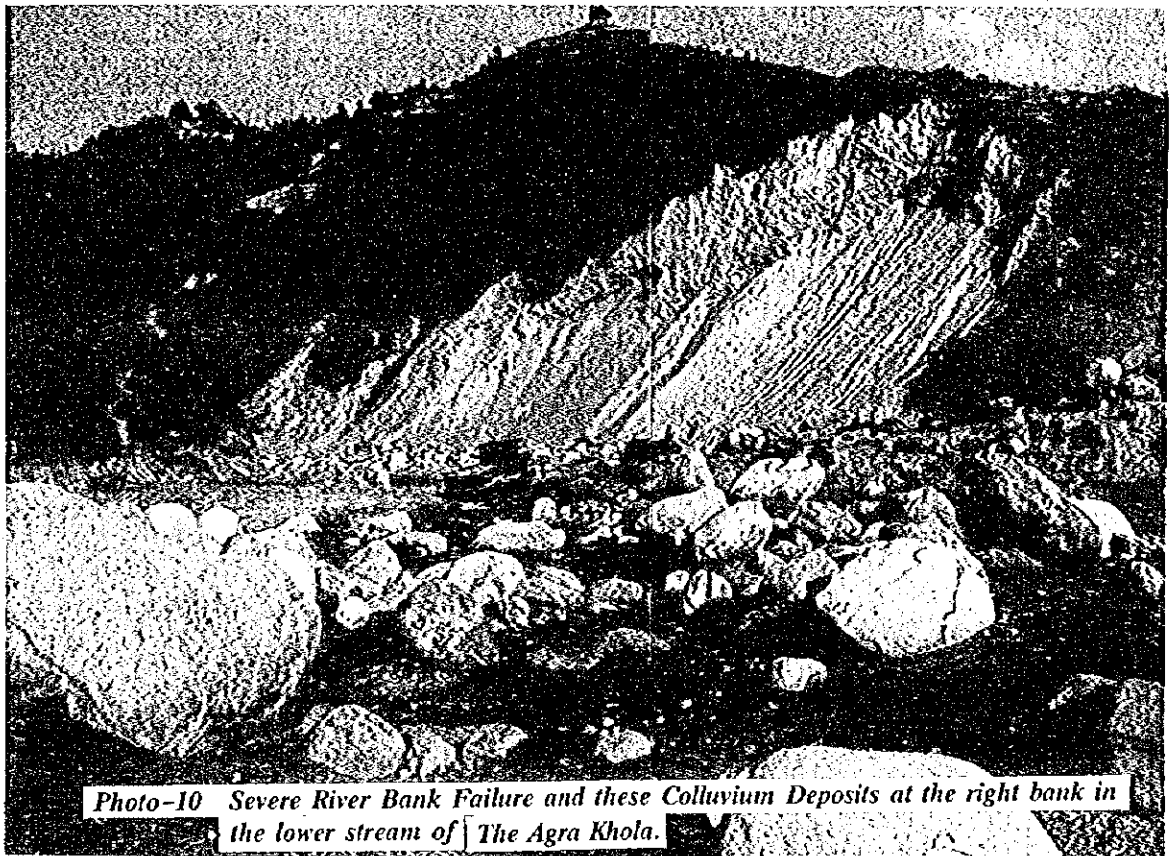
Photo-10 Severe River Bank Failure and these Colluvium Deposits at the right bank in the lower stream of The Agra Khola.

The failure debris and big boulders on the riverbed flow to around Mahadevbesi Bridge.

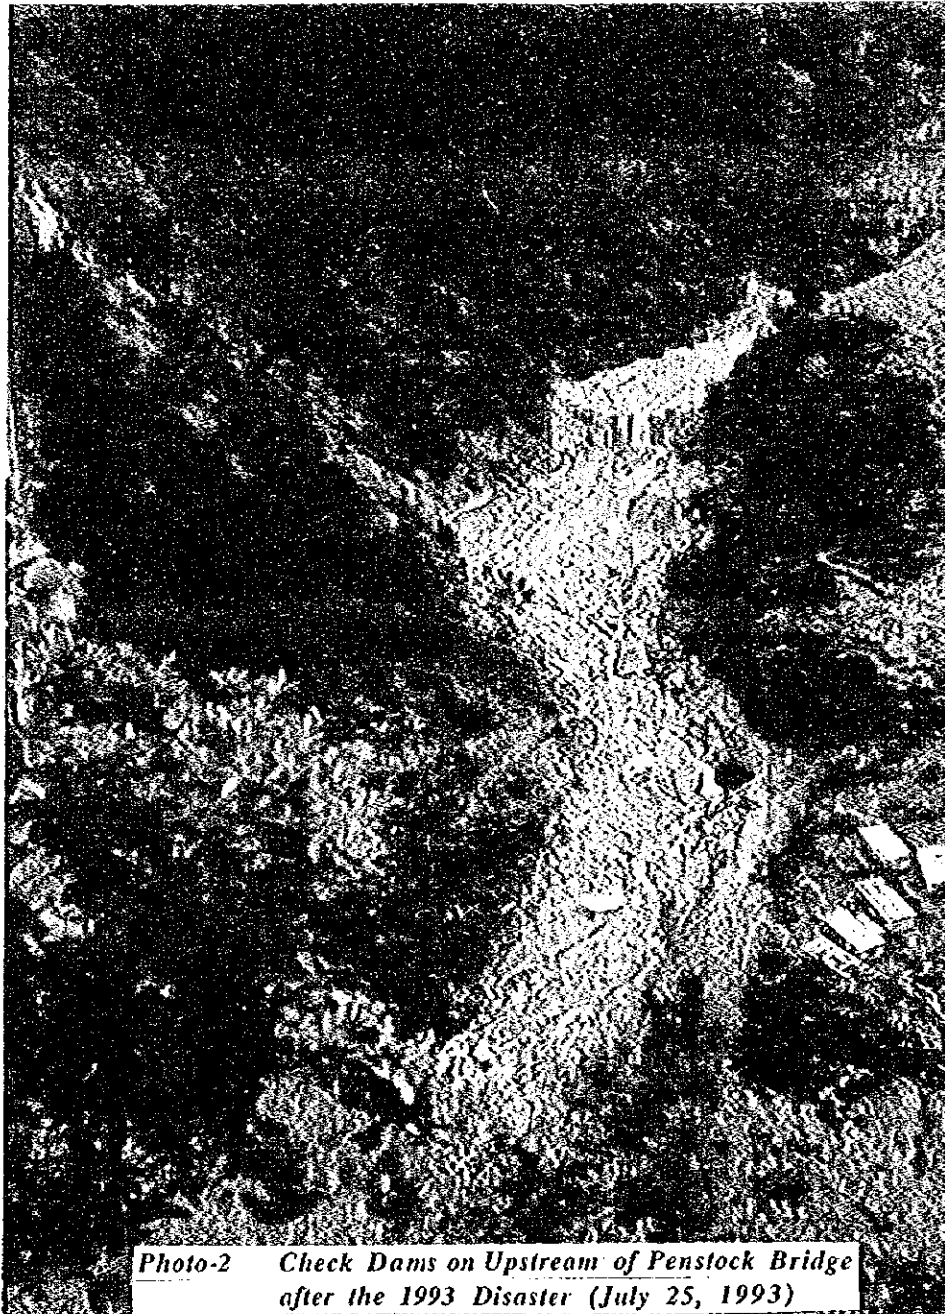
*Photo-2 Check Dams on Upstream of Penstock Bridge
after the 1993 Disaster (July 25, 1993)*

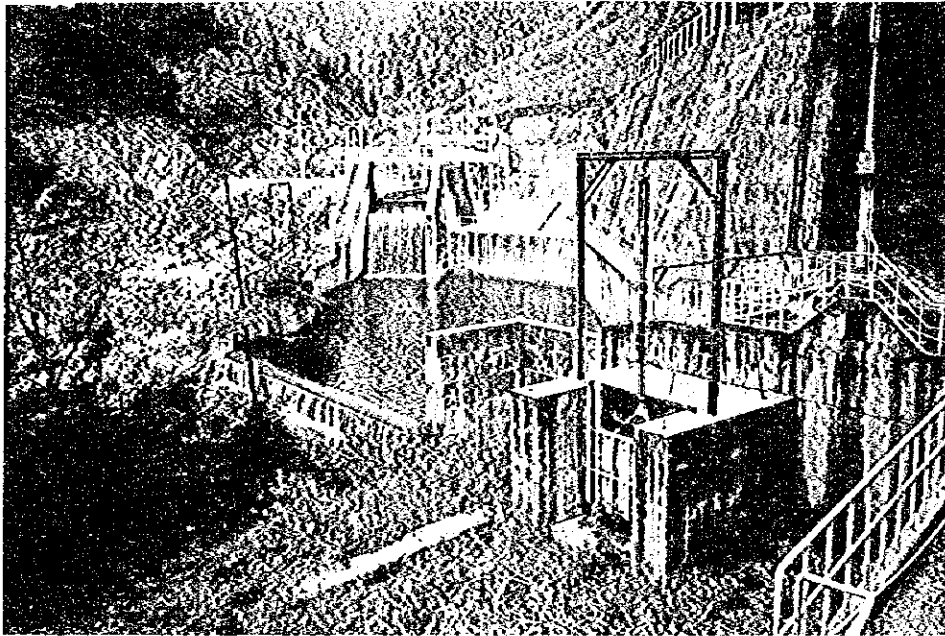
*Photo-4
Mandu Headpond and Outlet of No. 1 Tailrace*

**Apr. 29, '93 Before the flood of July 1993
Viewed from downstream to upstream
Water spilled out from spillway of headpond
The flow of Mandu river was taken to headpond**

**Aug. 28, '93 After the flood of July 1993
Viewed from downstream to upstream
Headpond and Tailrace outlet were completely buried by debris flow**
