DETAILED ENGINEERING DESIGN STUDY
ON
PAN-PHILIPPINE HIGHWAY IMPROVEMENT PROJECT
(MINDANAO SECTION)

FINAL REPORT
MAIN TEXT

MARCH 1997

KATAHIRA & ENGINEERS INTERNATIONAL
NIPPON ENGINEERING CONSULTANTS CO., LTD.

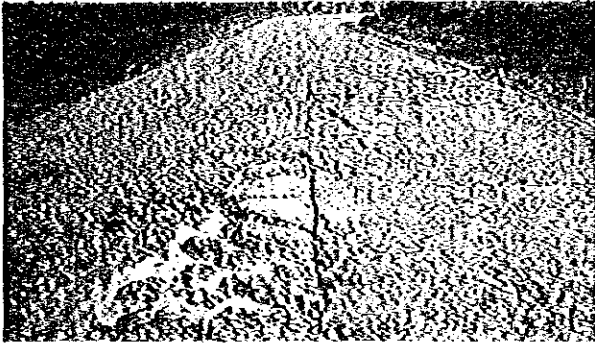
CONCRETE PAVEMENT IN VERY BAD CONDITION. TOTAL RECONSTRUCTION WITH CONCRETE PAVEMENT.

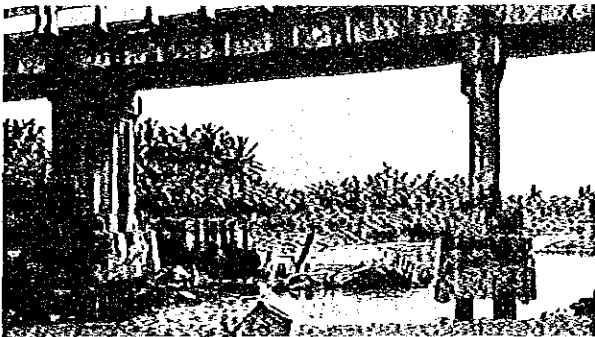
ANDANAN BRIDGE. SERIOUSLY DETERIORATED SUPERSTRUCTURE WITH DEEP LOCAL SCOURING AT PIERS. TOTAL RECONSTRUCTION.

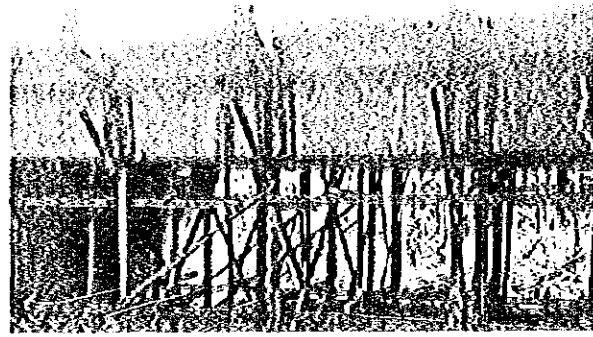
BAYUGAN BRIDGE. SERIOUSLY DETERIORATED SUPERSTRUCTURE. REPLACEMENT OF SUPERSTRUCTURE.

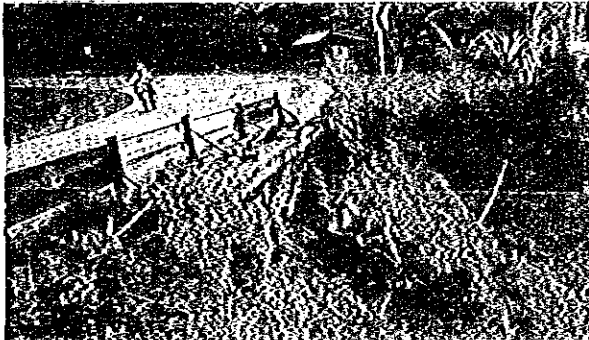
EMBANKMENT SLOPE FAILURE. ONE LANE AFFECTED. SLOPE PROTECTION WITH SURFACE AND SUBSURFACE WATER CONTROL.

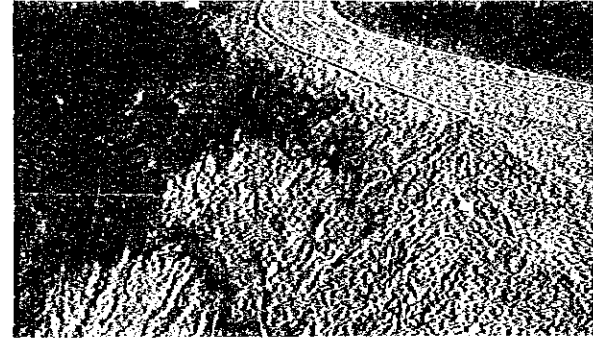
EMBANKMENT SLOPE FAILURE. SHOULDER AFFECTED. SLOPE PROTECTION.

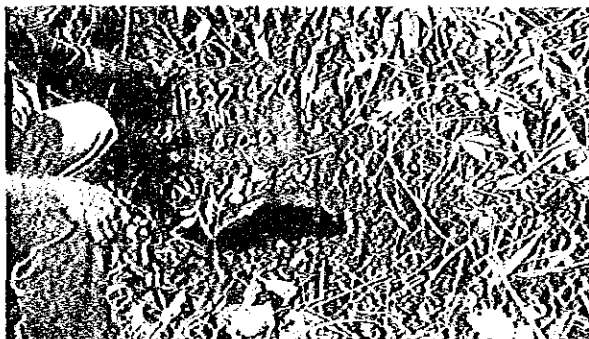
BURIED PIPE CULVERT WITHOUT INLET FACILITY. REPLACEMENT WITH NEW PIPE CULVERT.

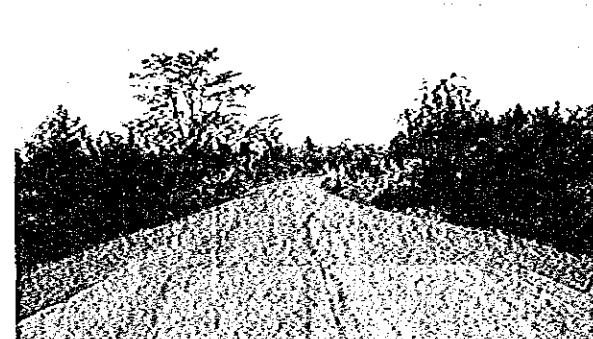
GRAVEL SECTION AT SOFT GROUND AREA. AC PAVEMENT AFTER PRE-LOADING.

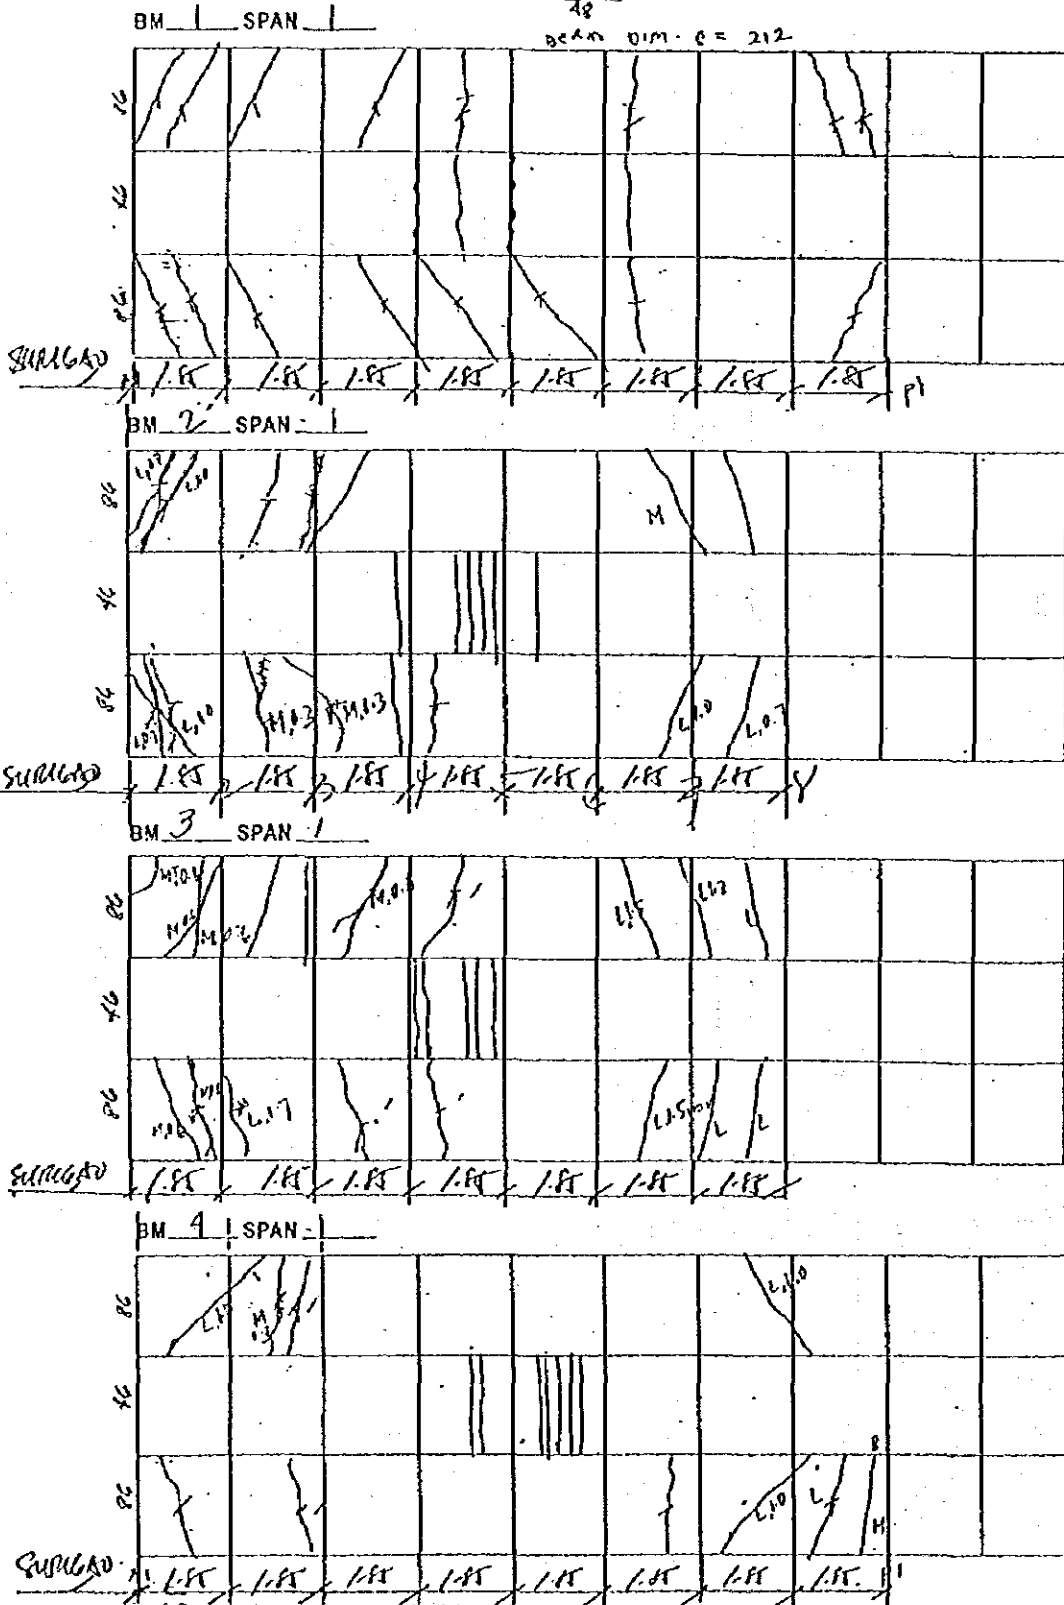
FIGURE 2.3-2 AN EXAMPLE OF CRACK SURVEY

BRIDGE NO. : 5-02
 BRIDGE NAME : GARAJAN
 INVENTORY DATE : 12-18

BEAM DIM. C = 212
