INVENTORY OF PAVEMENT SURFACE CONDITION

PAN-PHILIPPINE HIGHWAY IMPROVEMENT PROJECT
(MINDANAO SECTION)

PAVEMENT DISTRESS SURVEY
PACKAGE II
Km. 1349+000 - Km. 1364+000

DECEMBER , 1996

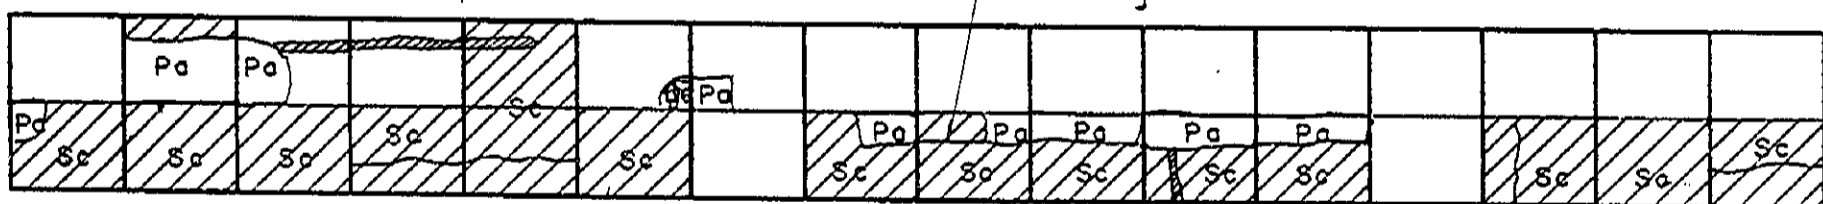
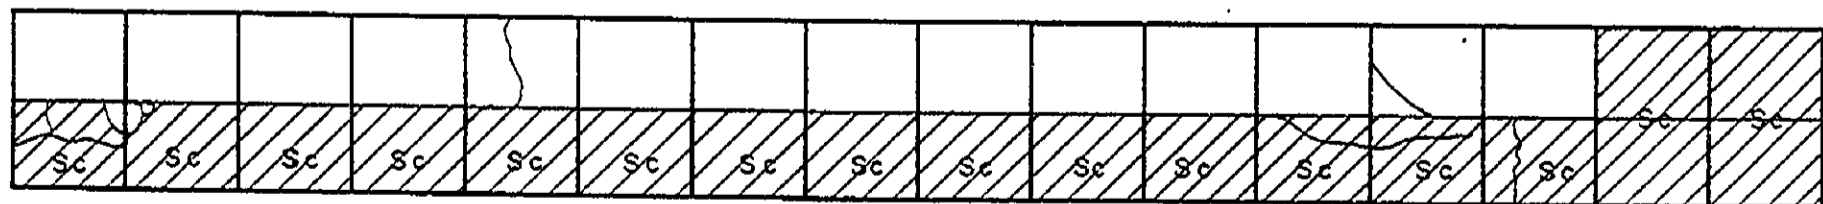
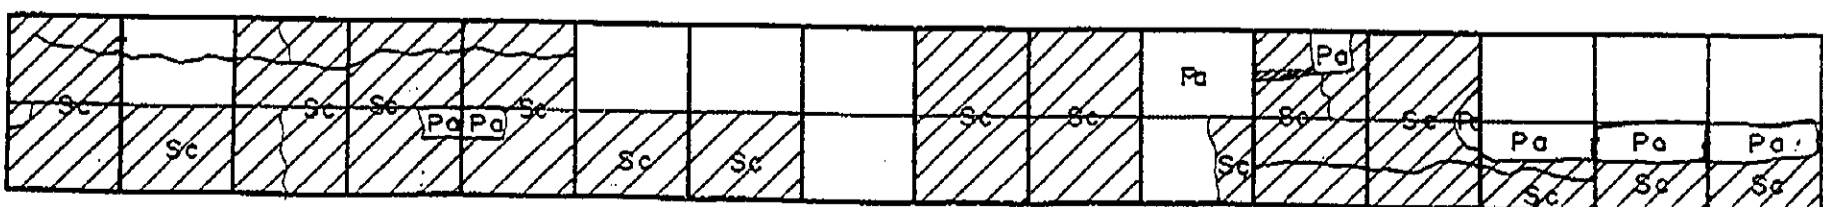
Undulating Pavement

Crack
