PAN-PHILIPPINE HIGHWAY IMPROVEMENT PROJECT
(MINDANAO SECTION)

PAVEMENT DISTRESS SURVEY
PACKAGE 13
End of Lankilaan Br. - Km.1396+000

DECEMBER , 1996

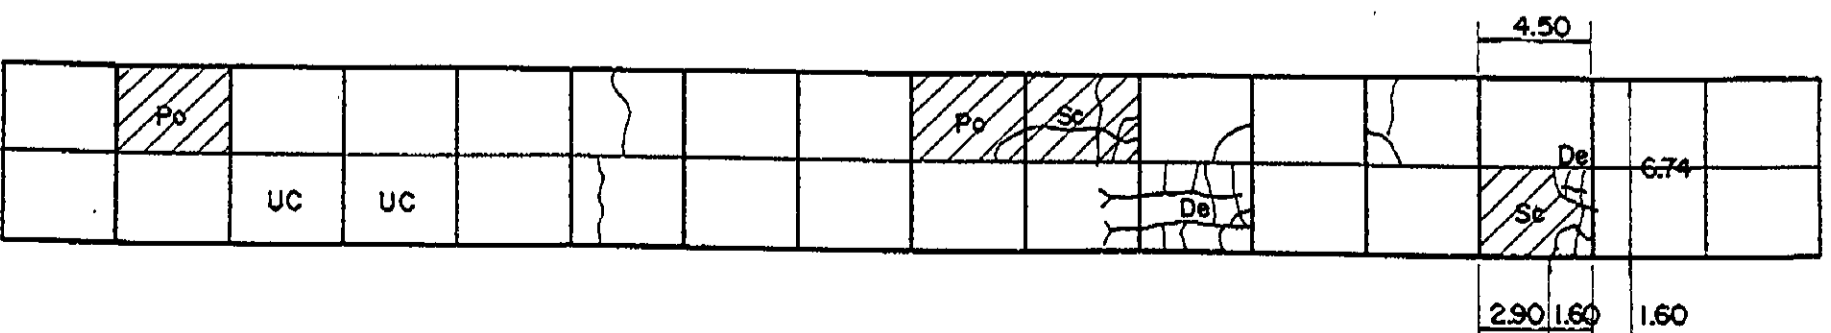
Under construction slope & embankment side

Under const'n. slope & emb. side
