INVENTORY OF PAVEMENT SURFACE CONDITION

PAN-PHILIPPINE HIGHWAY IMPROVEMENT PROJECT
(MINDANAO SECTION)

PAVEMENT DISTRESS SURVEY
PACKAGE 16
Km.1425+000 - Km.1456+000

DECEMBER, 1996

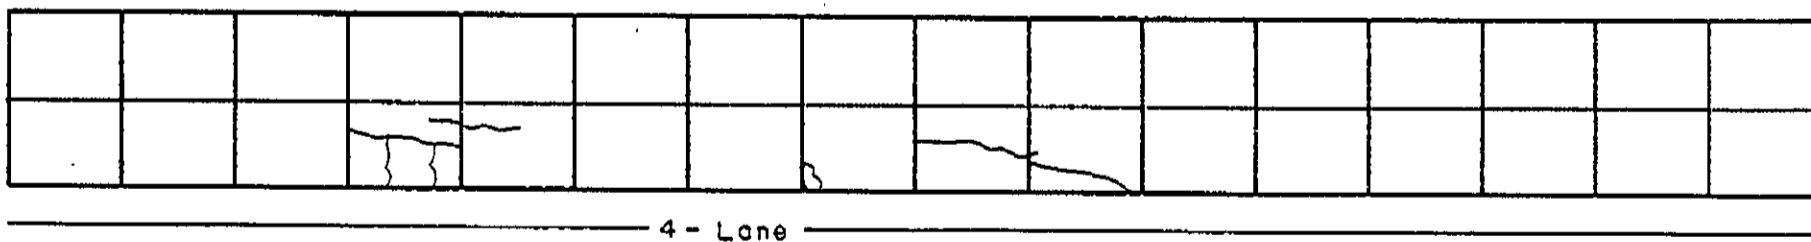
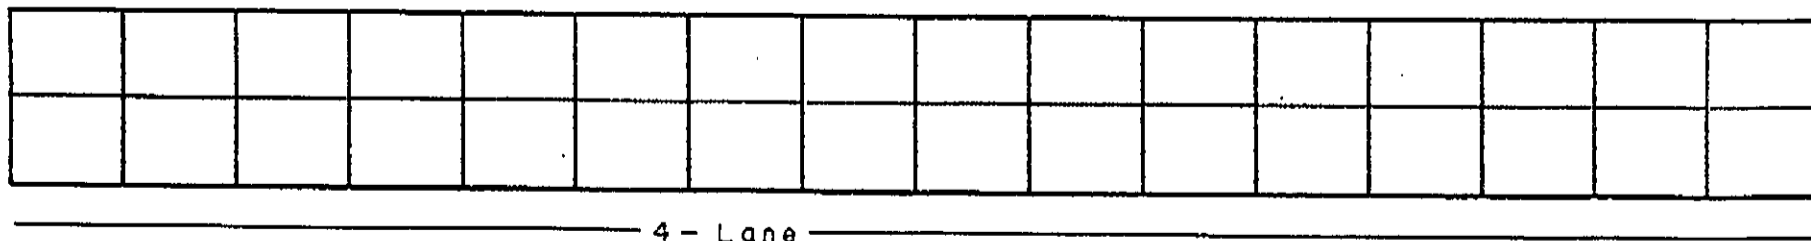
Fc through center line Joint

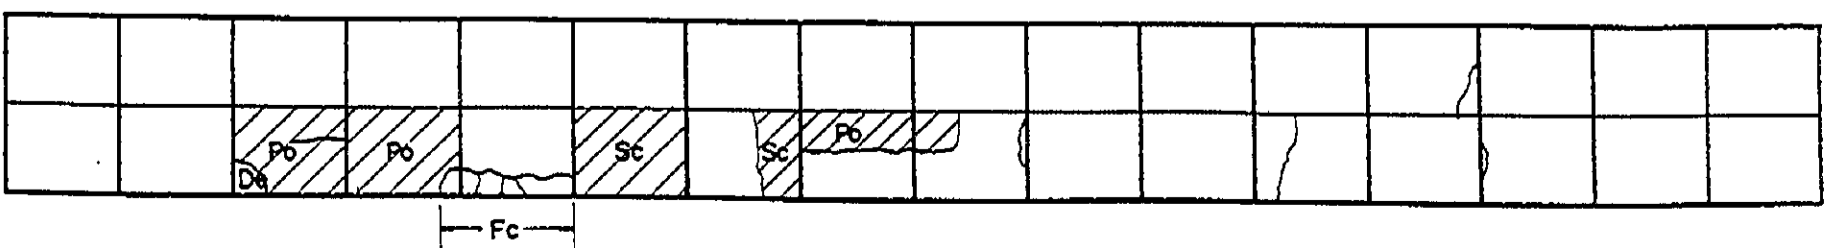
Fc through center line joint
chip off

Fc through center line Joint

Pa w/ cracks & De
