INVENTORY OF PAVEMENT SURFACE CONDITION

Km. 1472+000

To Carmen
Proper

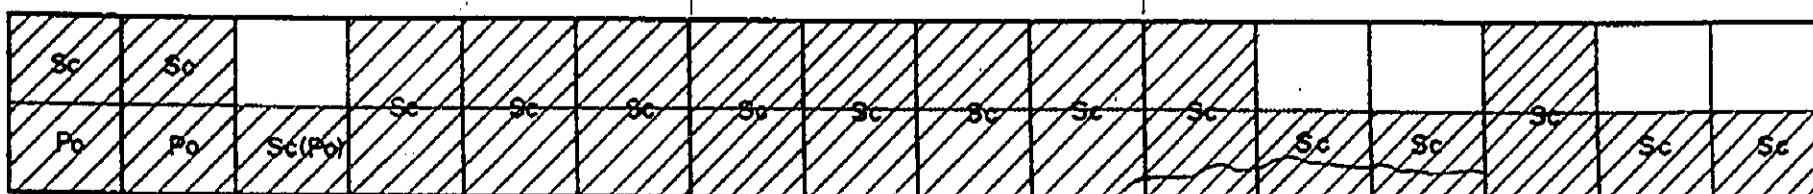
Undulating Pavt.
