PAN-PHILIPPINE HIGHWAY IMPROVEMENT PROJECT
(MINDANAO SECTION)

PAVEMENT DISTRESS SURVEY RESULT

PAVEMENT DISTRESS SURVEY
PACKAGE 1
Km.1113+397 - Km.1167+000

INVENTORY OF PAVEMENT SURFACE CONDITION

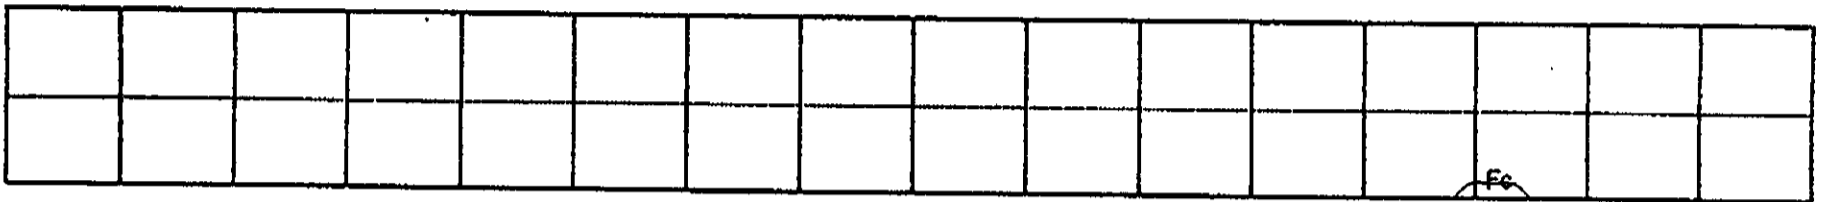
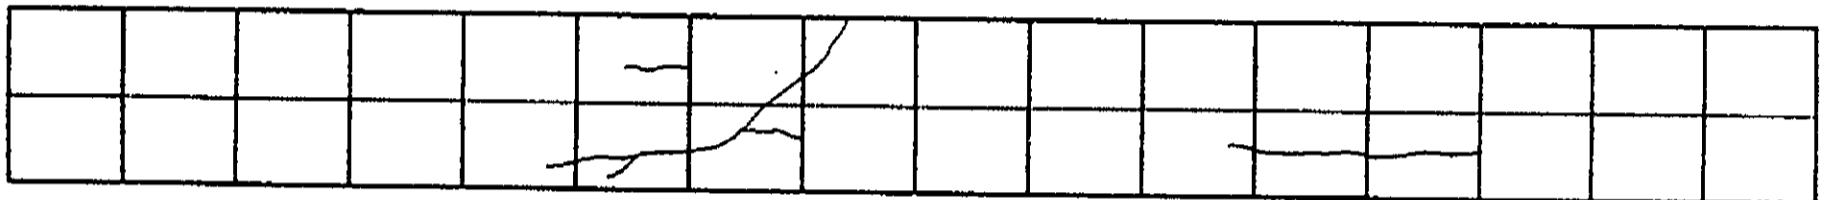
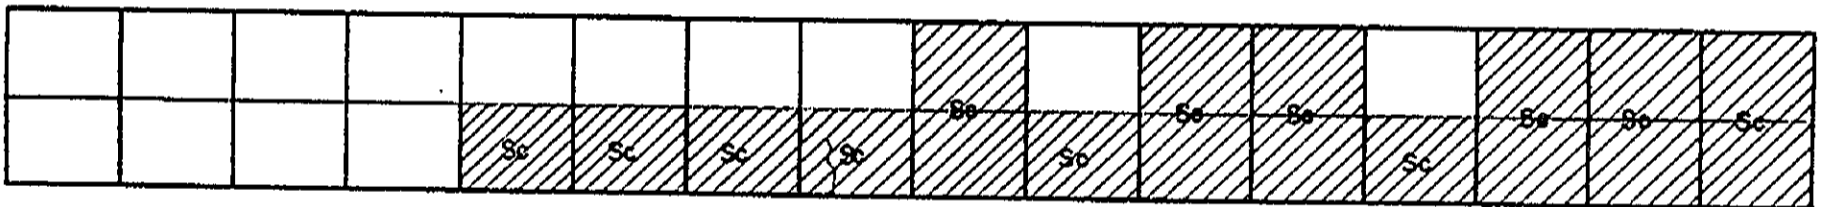
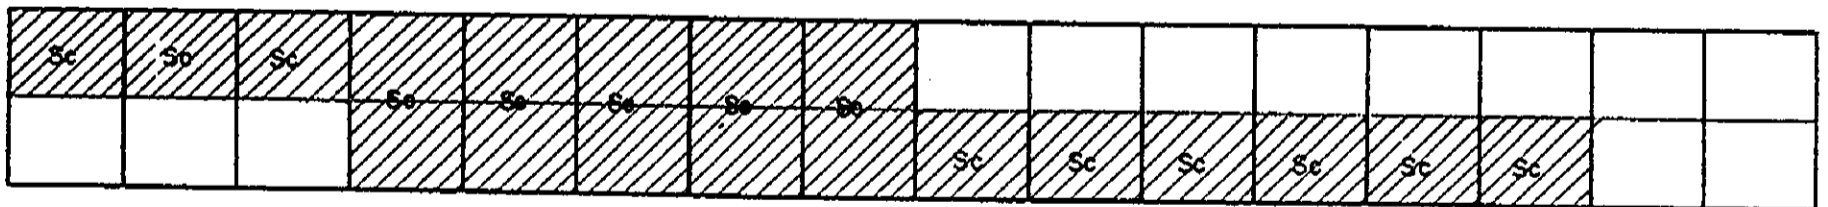
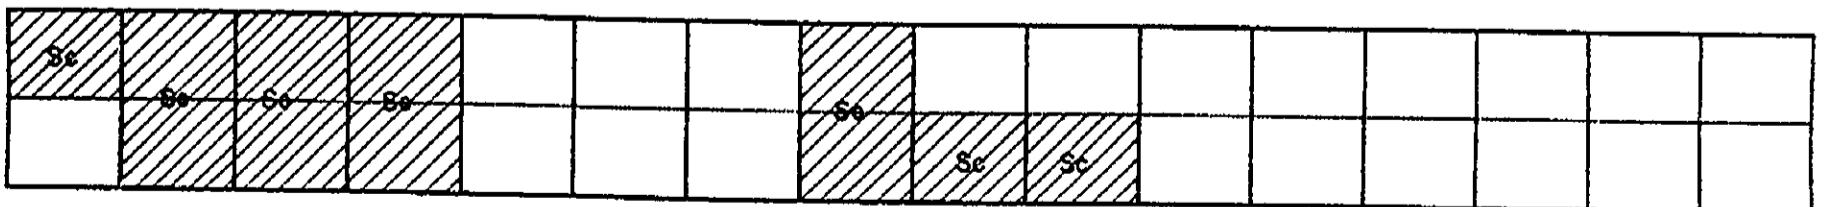
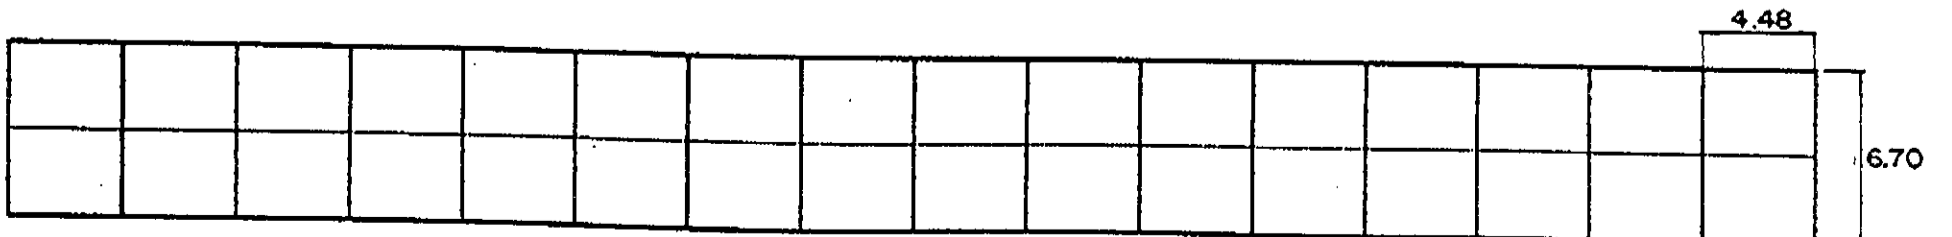
Km. 1118+000

Water pipe line leaking
																					Sc
