INVENTORY OF PAVEMENT SURFACE CONDITION

Date : 11-15-95

Km. 1132+000

Sheet No : 1/2

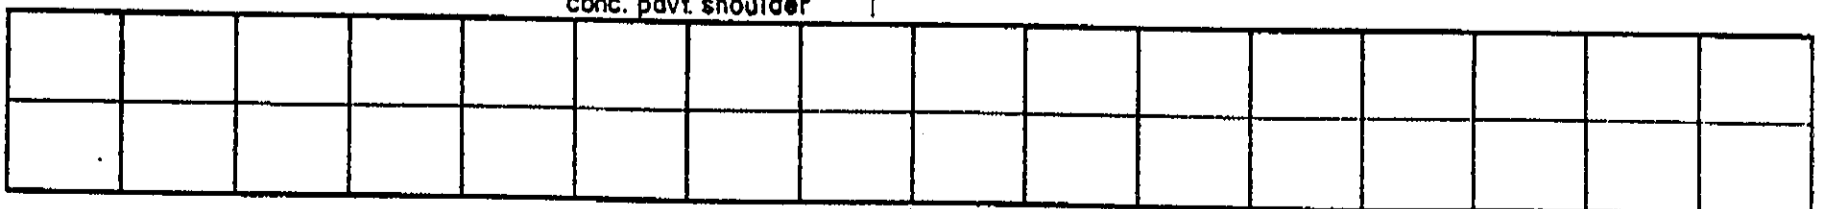
— South bound lane utilized as stockpile area for the on-going construction of slope protection.

End of stockpile area

— Start of conc. pavement shoulder, (w=2.00)

End of conc. pavt. shoulder

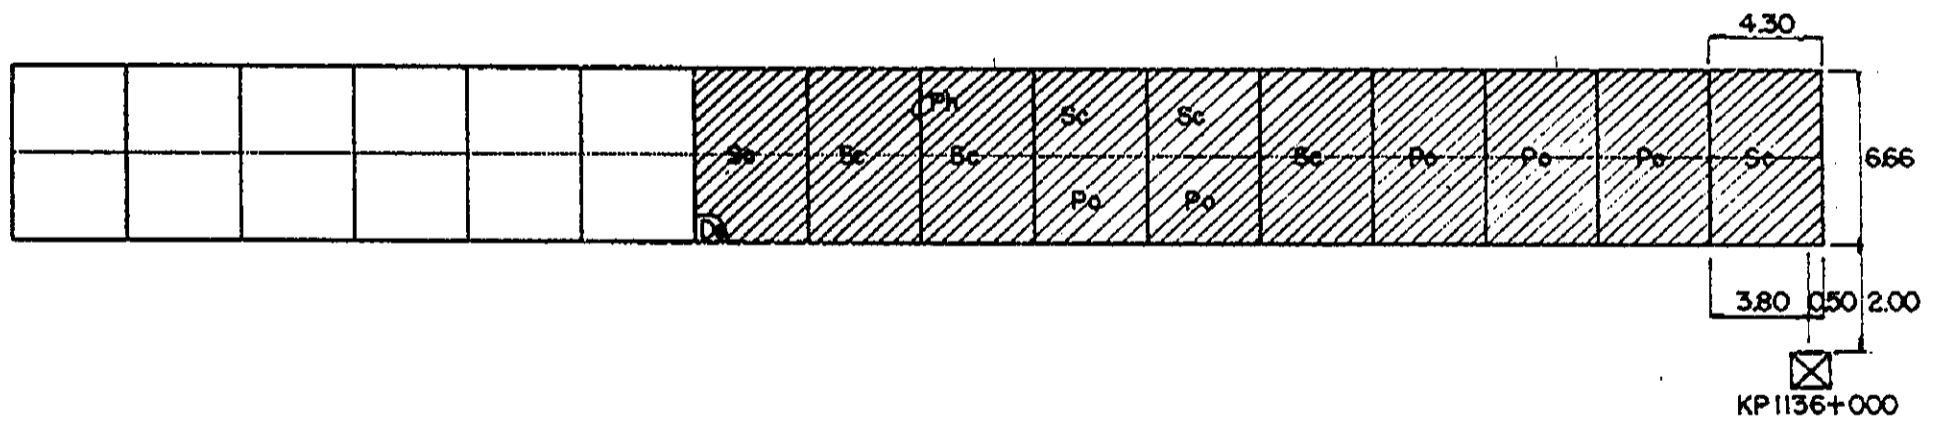
Open crack

1.30
Start of conc. pavement
shoulder, (w=2.00)

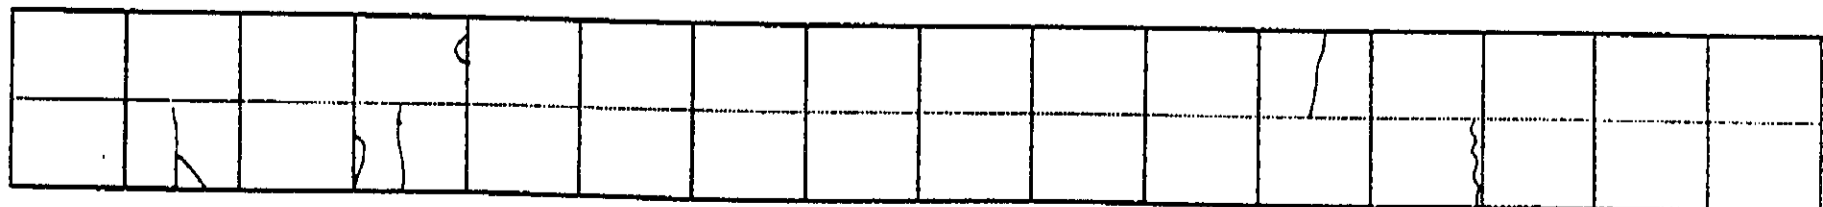
Deflection of center line

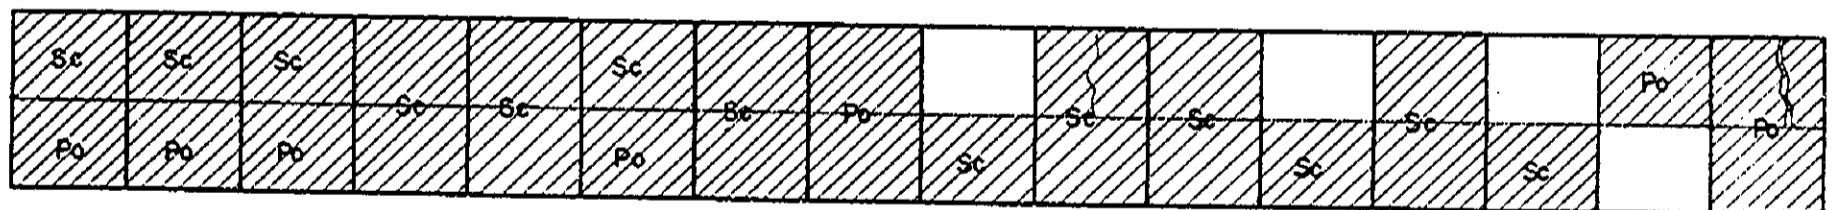
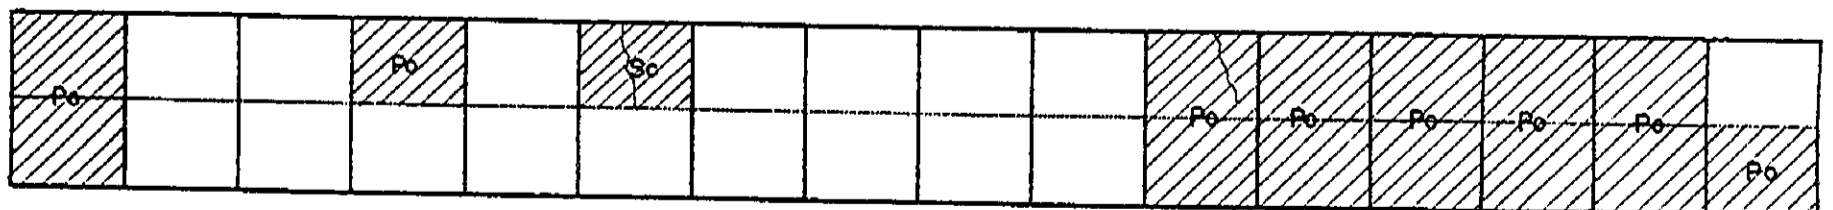
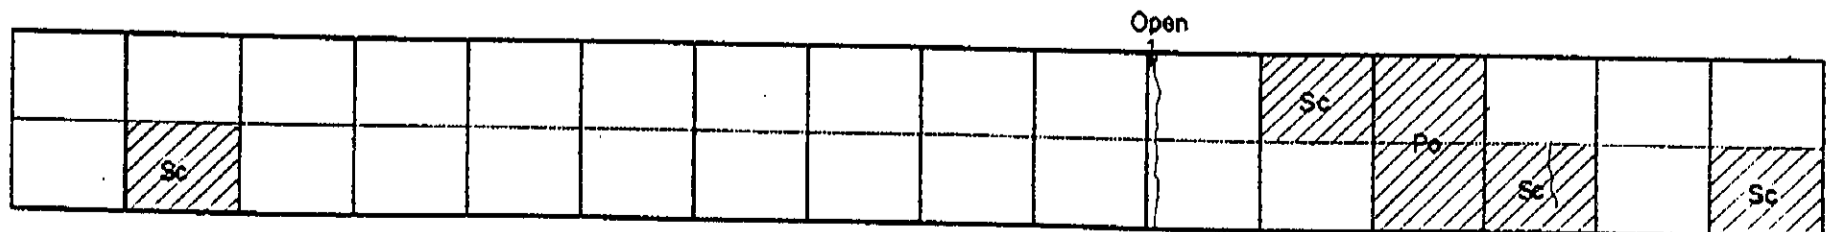
-Start conc. shoulder
0.85 (Both Sides)

Open use as
water G.I. pipeline

Open
