APPENDIX G

LEAKAGE RECORD OF DISTRIBUTION MAINS

JAPAN INTERNATIONAL COOPERATION AGENCY (JICA)
THE STUDY ON THE DEVELOPMENT OF WATER SUPPLY SYSTEM FOR THE DAMASCUS CITY
Figure G- 2.1 Administrative area of Damascus City
NIPPON KOEI CO., LTD

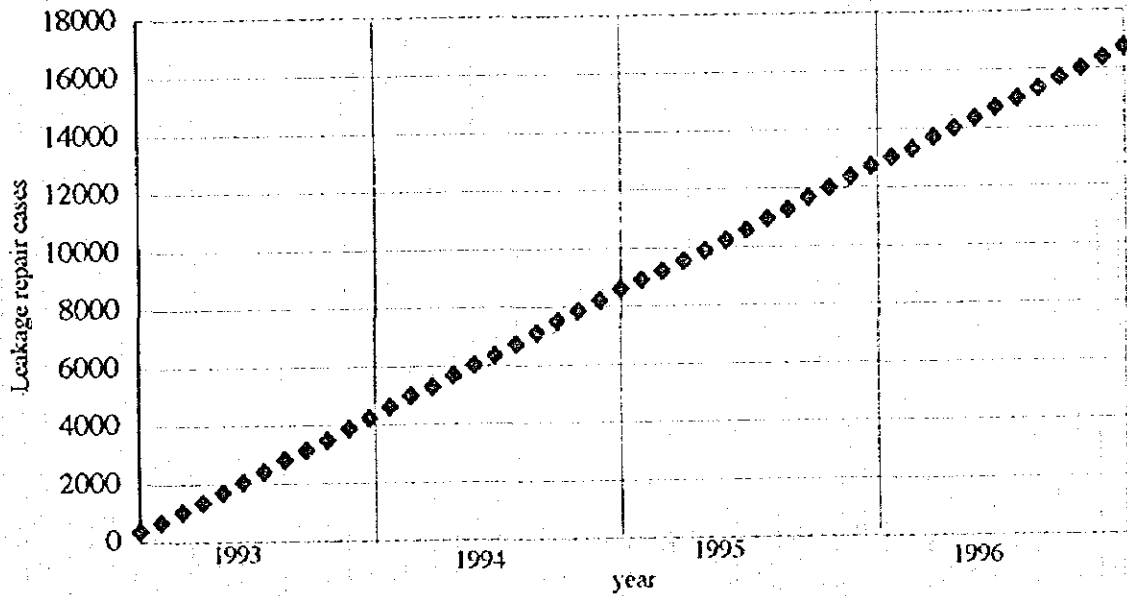
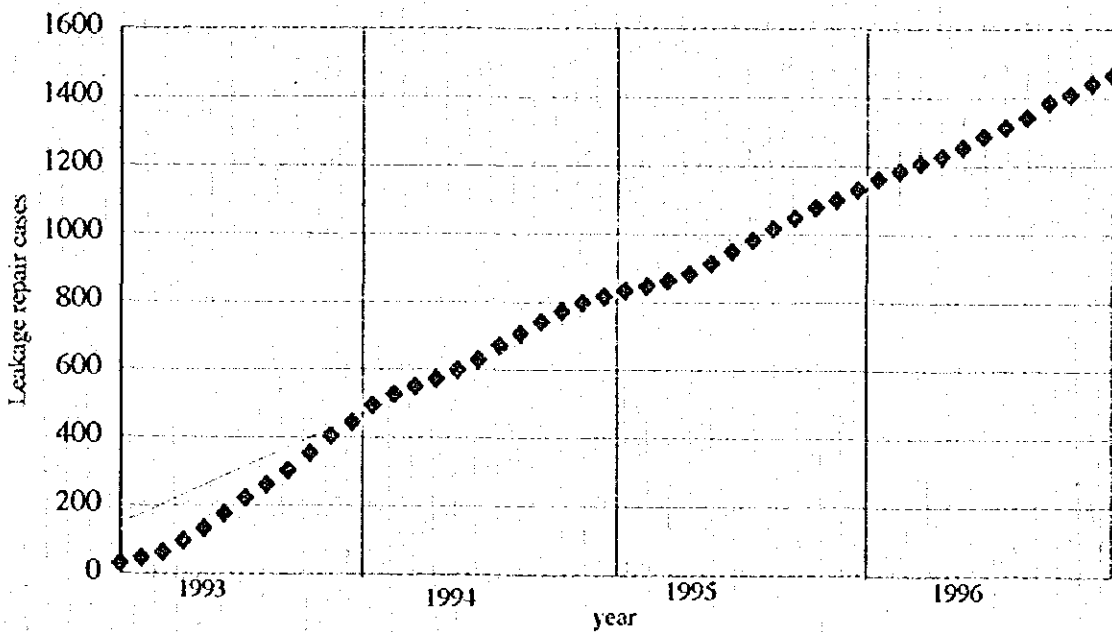
Figure G-2.2

The frequency of repair works on distribution pipes and service pipes has recorded about unchanged for the last 4 years, see Figure G-2.2. This indicates that, the condition of leakage on the cast iron pipes has not been improved in spite of continuous repair effects. It

is also an indication that most of the cast iron pipes are too old and have too many weak points for repairs to be effective. Therefore, the cast iron pipes must be replaced.

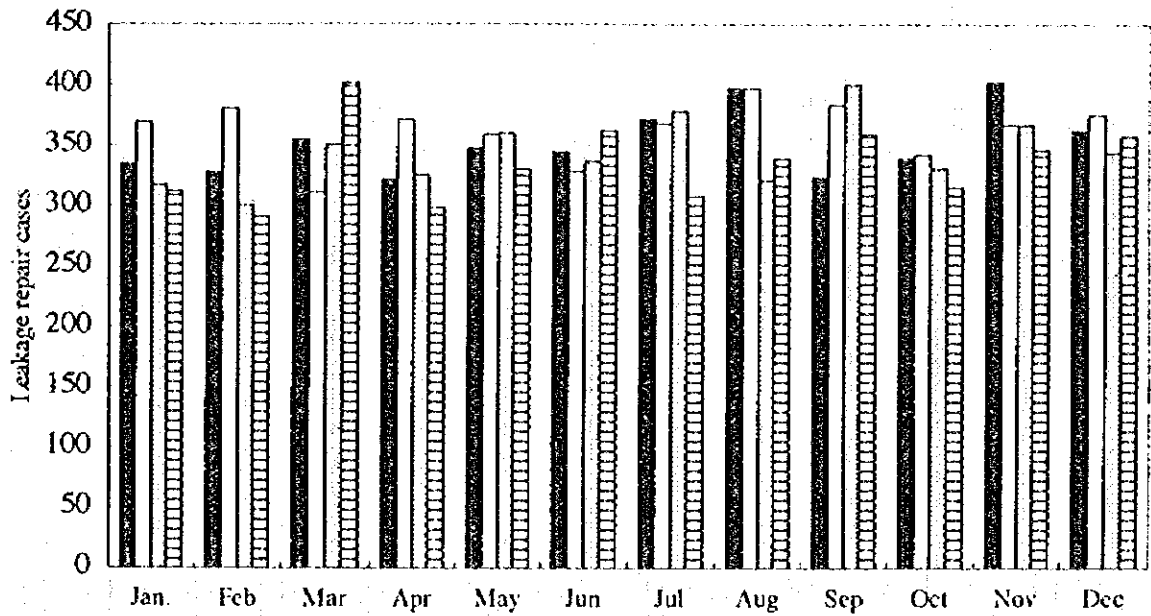
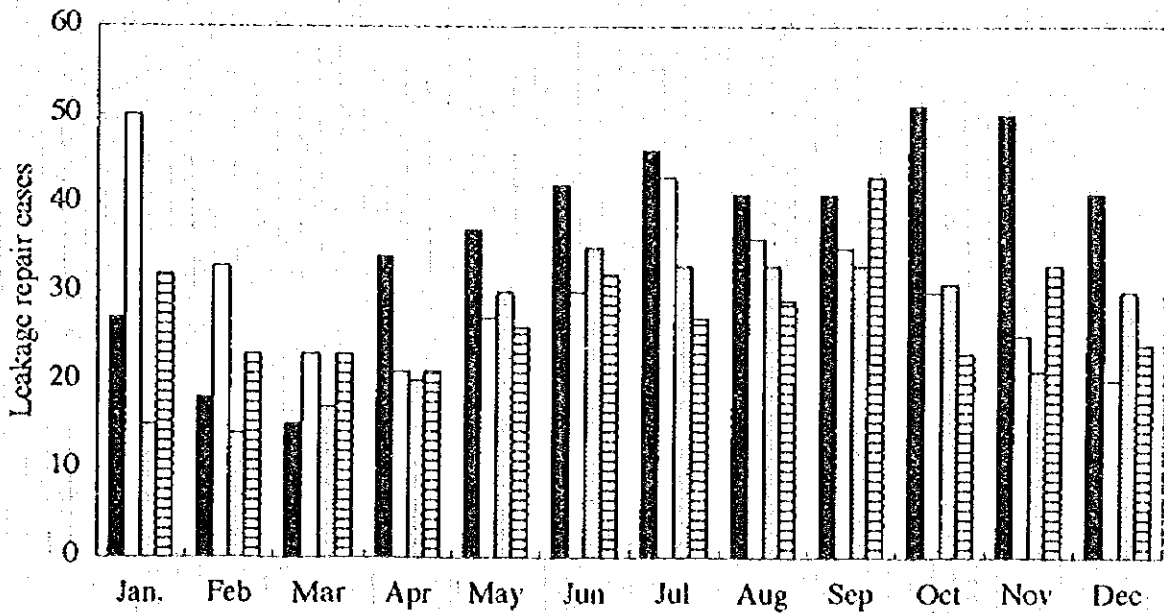
JAPAN INTERNATIONAL COOPERATION AGENCY (JICA)
 THE STUDY ON THE DEVELOPMENT OF
 WATER SUPPLY SYSTEM FOR THE DAMASCUS CITY
 Figure G-2.3
 Monthly Leakage Repair Record
 NIPPON KOEI CO., LTD.

It is observed from, Figure G-2.3, that the frequency of repairing works during the dry season are higher than the frequency during the rainy season. This is likely due to the fluctuation of water pressure caused by water rationing during dry season which stresses the weak cast iron pipe. Table G-2.2 indicates the frequency of repair on large diameter pipes tends to be higher than that of small diameter pipes, and the frequency of repair on cast iron pipes do not correlate with the age of the pipes.

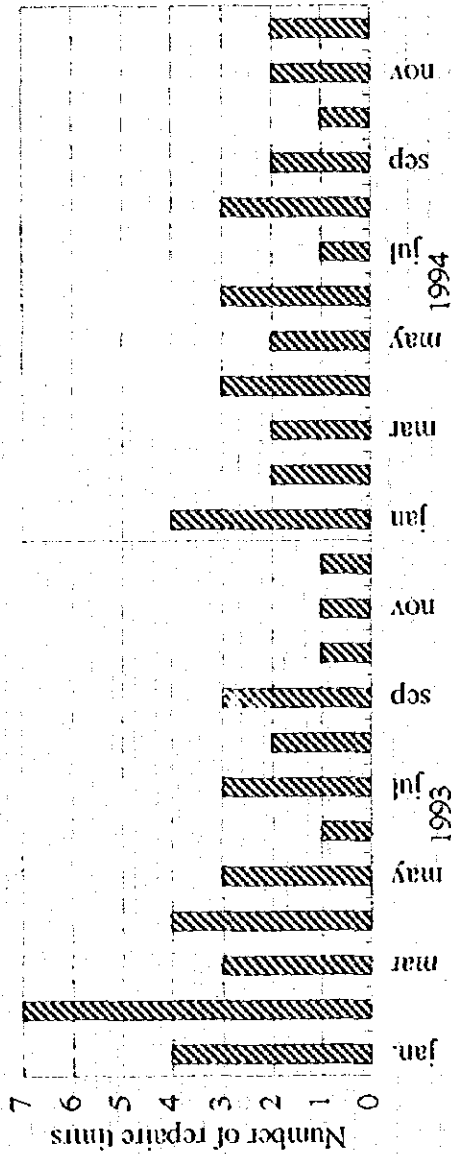
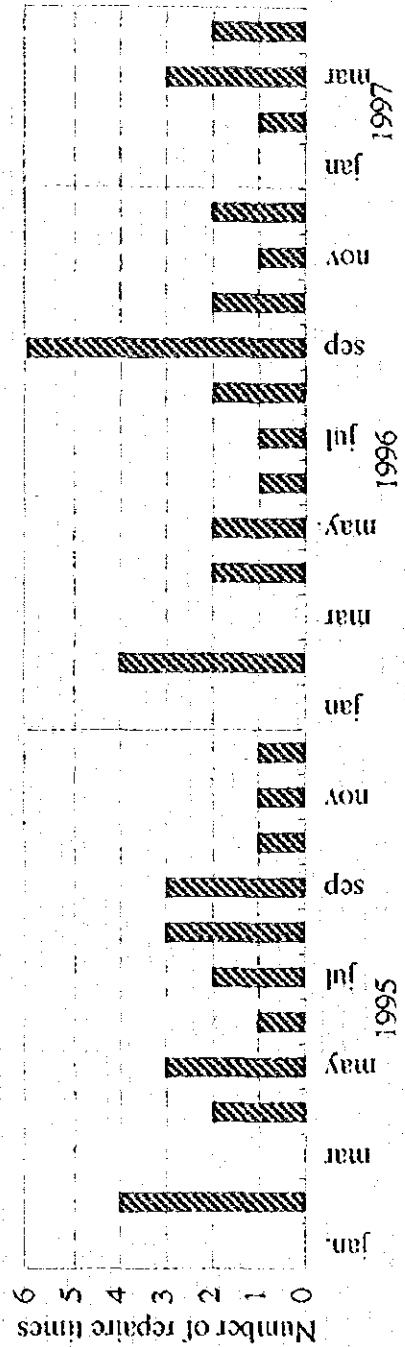
JAPAN INTERNATIONAL COOPERATION AGENCY (JICA)
 THE STUDY ON THE DEVELOPMENT OF
 WATER SUPPLY SYSTEM FOR THE DAMASCUS CITY
 Figure G-2.5 Monthly Repair Records of
 Water Main of Damas Center Medium 1
 NIPPON KOEI CO., LTD.

The frequency of repair for this pipe line 0.6 /km/month, is higher than the average frequency in Damascus City of 0.23 /km/month, because all of detected leakage points on this line were repaired immediately, see Figure G-2.5. The work load of continuously repairing the line (Length: 3.3 km) has not changed as shown on Figure G-2.6 and takes estimated 10 % of the total capacity of repair team of the Periodical Maintenance Department. The repair rate on this line is 100%, however the condition of leakage was not improved until the pipes were replaced with ductile iron.
