CHAPTER 8

CIVIL ENGINEERING WORKS PLAN

8 - 1 Existing Conditions and Problems

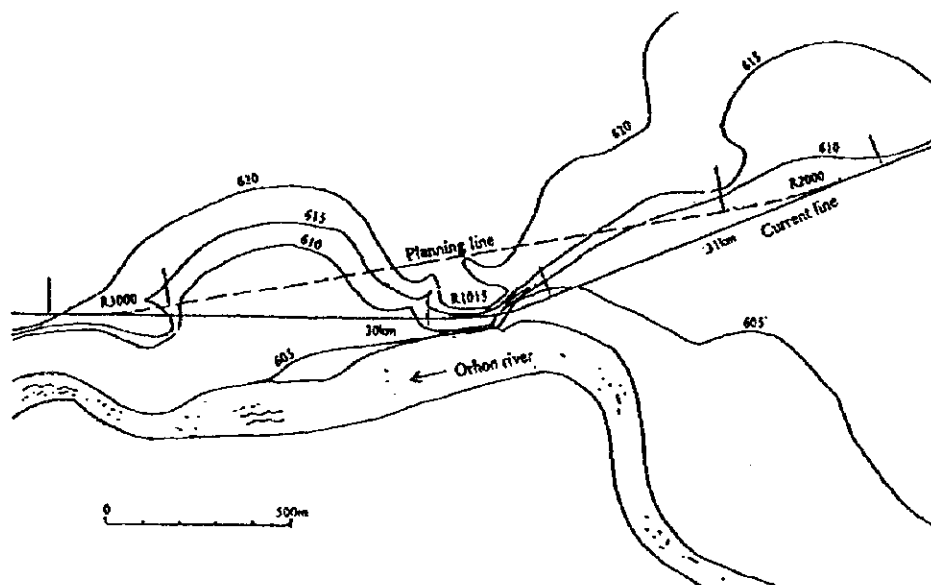
Fig.8-2-4 Plan of 31km Spot

It is difficult to provide permanent measures for control of erosion damage to the railway embankment caused by the meandering flow of rivers until national flood control and water utilization plans have been established by the government. In order to secure safe operation of trains, it is considered necessary to immediately provide groyne in river beds to correct the meandering flow, with stone blocks cast in river banks to prevent washing of soil and erosion by floodwater. In order to withstand the traction force of the river flow and to prevent scouring, it may be important to increase the weight of the protection blocks.

River bank protection is closely related to flood controls. Where river channels are properly maintained, share of cost for the railway can be reduced. These measures are provided as a part of river improvement projects in Japan with investment of national funds. In Mongolia, it is difficult to expect for action by the government because they do not have systematic river improvement plan. Funds may have to be provided by the railway for necessary measures to secure safe operation of trains without delay.
