添付資料 - ガーナ国側負担費用

2. 既存施設の補修費用

THE PROJECT FOR RENOVATION AND EXPANSION OF NOGUCHI MEMORIAL INSTITUTE FOR MEDICAL RESEARCH IN GHANA
TRIAL CALCULATION OF ANNUAL MAINTENANCE COST

8. 現場状況写真

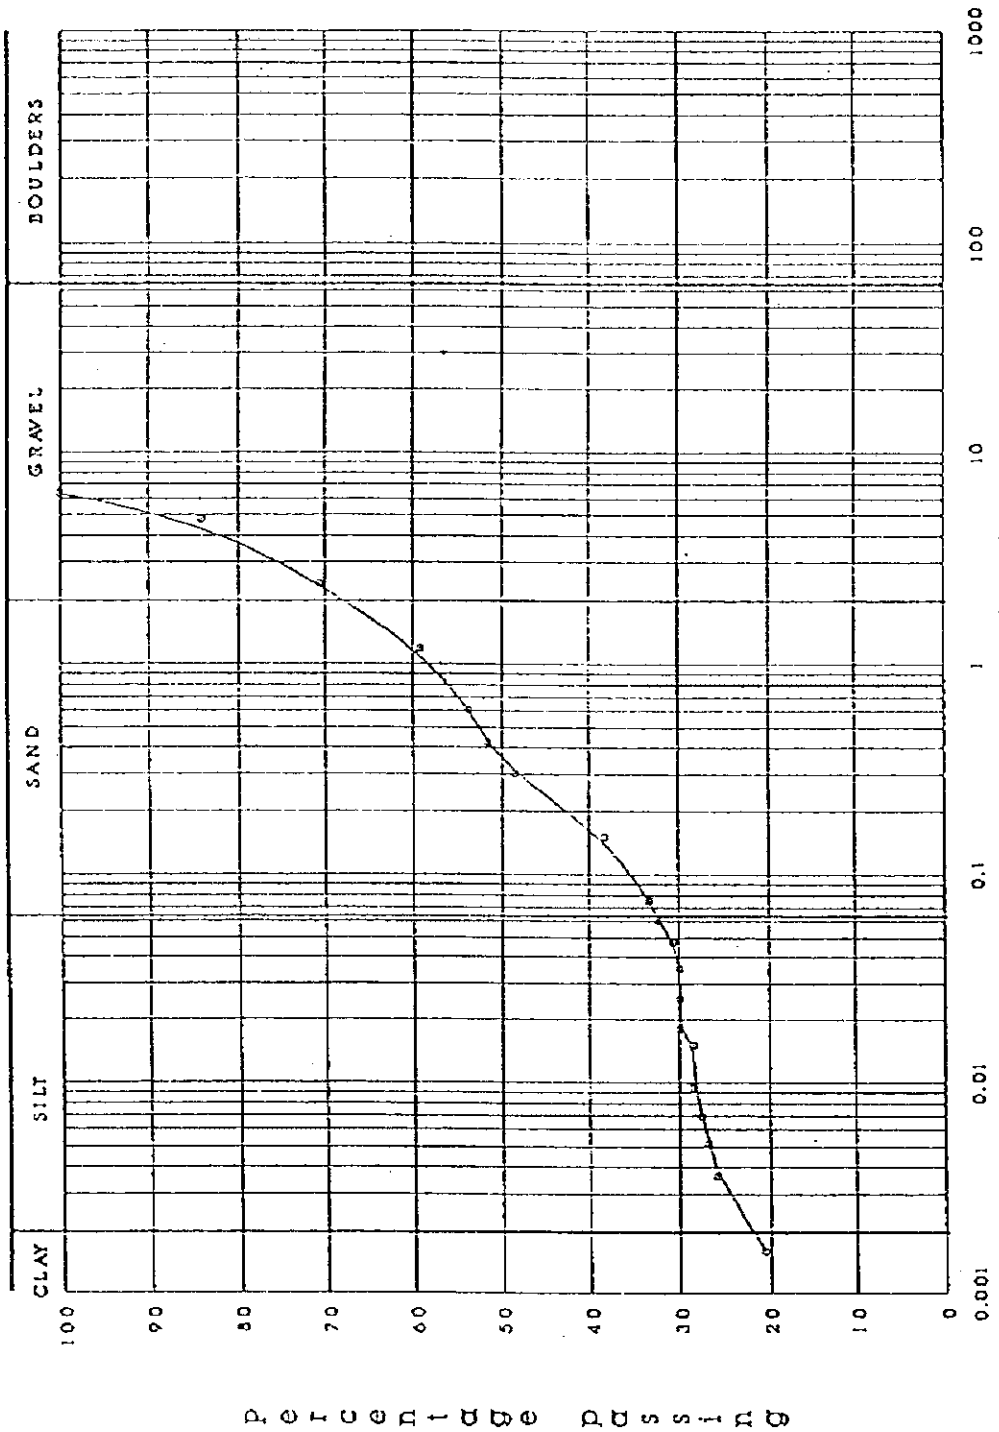
FIG. B-21

GRADING CURVE FOR BH10 (2.0m)

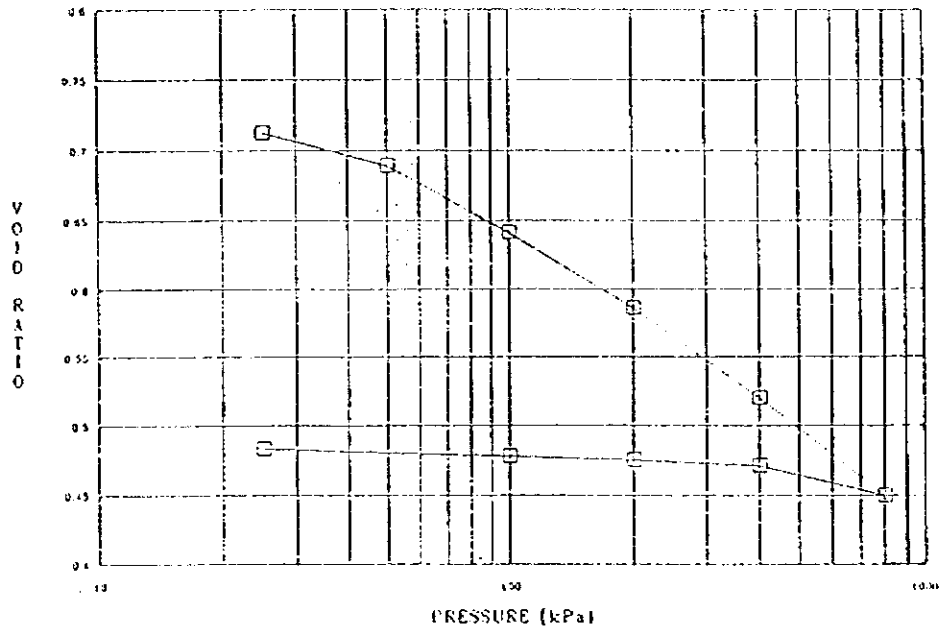
FIG. B-22 CONSOLIDATION TEST RESULTS FOR BH9 (1.4m)

BOREHOLE #		9
DEPTH (m)		1.4
MOISTURE CONTENT	%	16
BULK UNIT WEIGHT	kN/m ³	19.8
DRY UNIT WEIGHT	kN/m ³	17.1
SPECIFIC GRAVITY	-	3.13
INITIAL VOID RATIO	-	0.736
INITIAL DEGREE OF SAT.	%	76
SWELL PRESSURE	-	-

Pressure kPa	Coefficient of Consolidation $C_v \cdot 10^{-2} \text{ m}^2/\text{hr}$	Coefficient of Volume Compressibility $M_v \cdot 10^{-4}$ m^2/kN
0 - 25	9.0	5.8
25 - 50	6.8	5.6
50 - 100	5.0	5.5
100 - 200	4.7	3.4
200 - 400	4.1	2.1
400 - 800	3.9	1.2

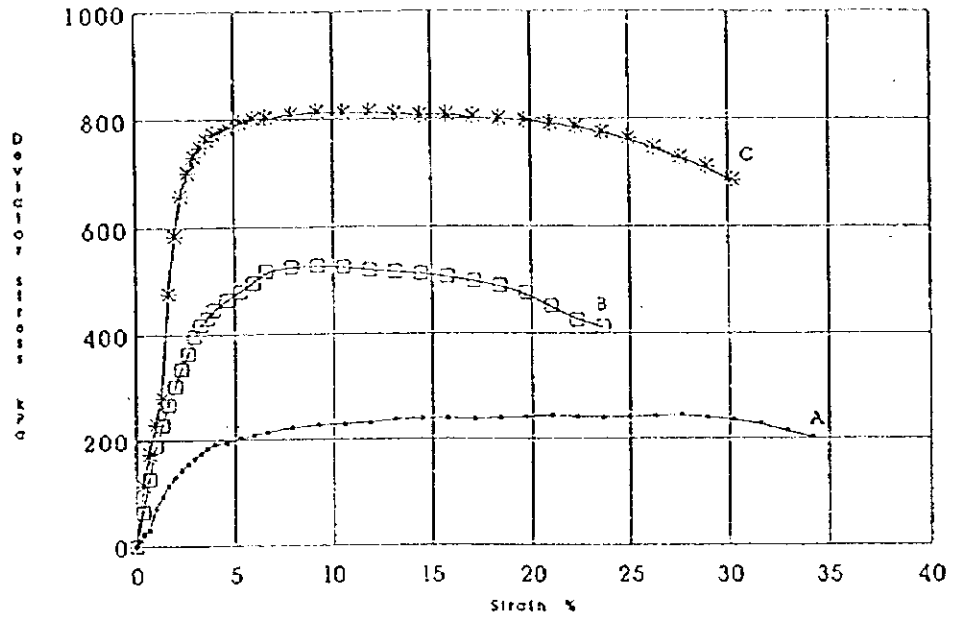
FIG. B-23 STRESS - STRAIN CURVES FOR BH9 (1.4m)

TEST DESIGNATION		A	B	C
	Moisture Content %	15.5	15.5	15.5
	Dry Unit Weight kN/m ³	16.6	16.8	16.1
	Moisture Content %	16.4	16.8	18.5
	Cell Pressure kPa	200	300	500
	Deviator Stress kPa	244	528	813
