1. Result of Natural Condition Survey

2. Present Condition of the Existing Facilities

APPENDIX--5-1 (1)
General Plot Plan of Quelimane Dry Dock

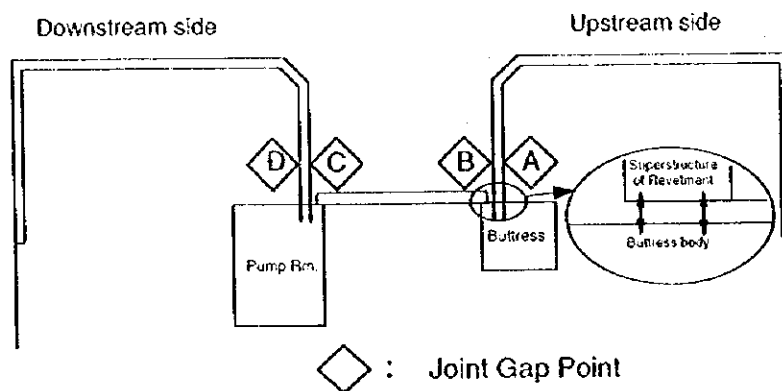
Figure 2.1 Measuring Locations

Increased joint separation in the upper concrete sections was first reported at the end of June, 1997. In an effort to measure the changes in the degree of separation from June until December, observation and measuring locations were set up at Point A on the upstream side and Point C on the downstream. These locations are shown in Figures 2.1 and 2.2.

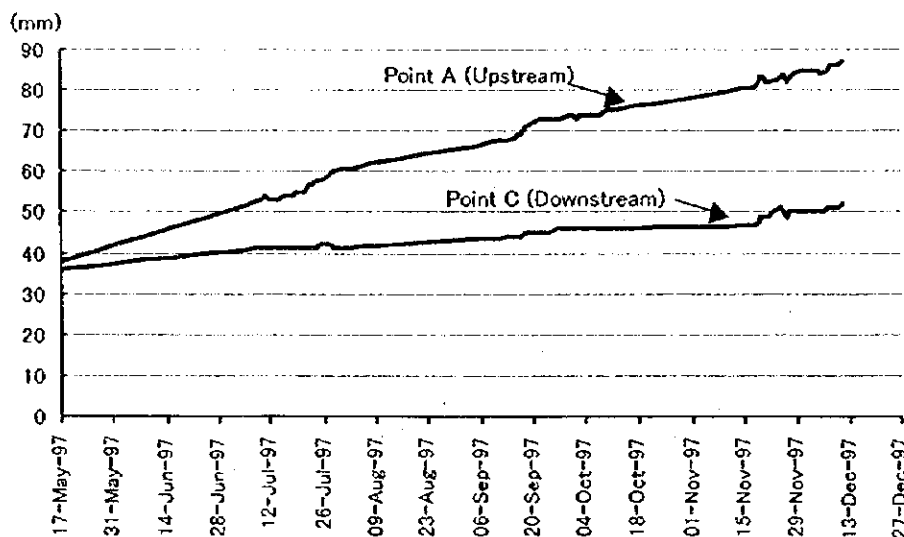
Figure 2.2 Development of Joint Separations

Measurements of joint separations in the buttress and upper concrete sections of the revetment were made at Points A and B on the upstream side, while those at the pump room and upper concrete sections were taken at Points C and D on the downstream side. The measurement values represent conversions of measurement data, based on the assumption that the concrete joint sections had been touching at the time the facilities were completed.

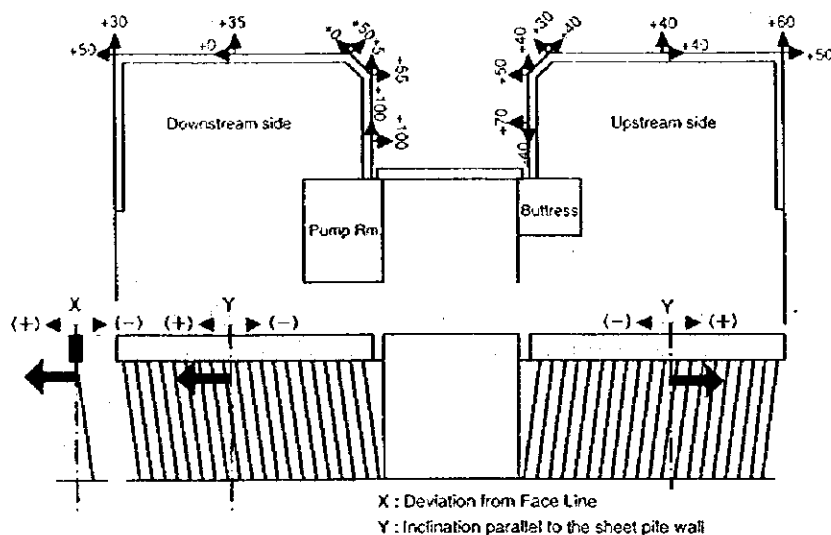
Figure 2.3 Measuring Record of Inclination of Steel Sheet Pile Wall

With respect to the baseline direction, as viewed from the offshore side in front of the dock, a inclination toward the outside from the dock center has been confirmed on both the upstream and downstream sides, with the upstream displacement larger than that on the downstream side. Generally speaking, the steel piles evidence a inclination in the pile-driving direction, owing to the frictional force generate at coupling between the sheet piles during pile driving operation. It is believed, therefore, that these differences resulted from the fact that the respective piles had been driven toward the outside from the center of the dock. However, since this was the first time that slope measurements were taken, changes and displacement in pile inclination since facility completion are not definitive.

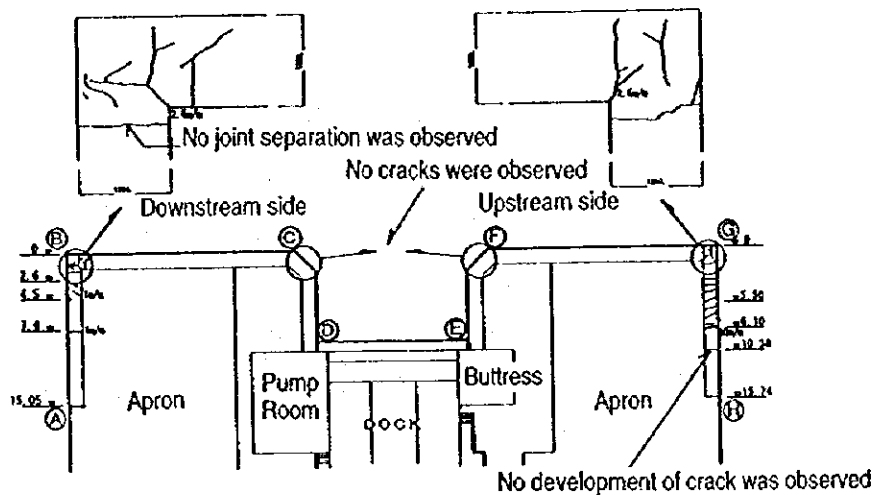
Figure 2.4 Crack Locations in the Coping Concrete Sections in the Upriver Revetment.

While the comparison with the findings of the July, 1997 survey revealed no increase in the number of cracks, since the concrete in the upper section of the revetment on the upstream side showed an enlarged displacement toward the outside in almost the center of the G-H section, the crack width in the center had advanced 5 mm → 30 mm.

It has been determined that, as this section is a self supporting revetment, in view of the progressive scouring action in the front, the pressure toward the outside on the side wall becomes relatively large, causing the cracks in the central portion to develop. Because of this, as the G portion is a corner section and thus subject to considerable bending distortion, the cracks have progressed to a substantial degree. The cracks in this portion and in the center of the G - H portion have penetrated the coping concrete.

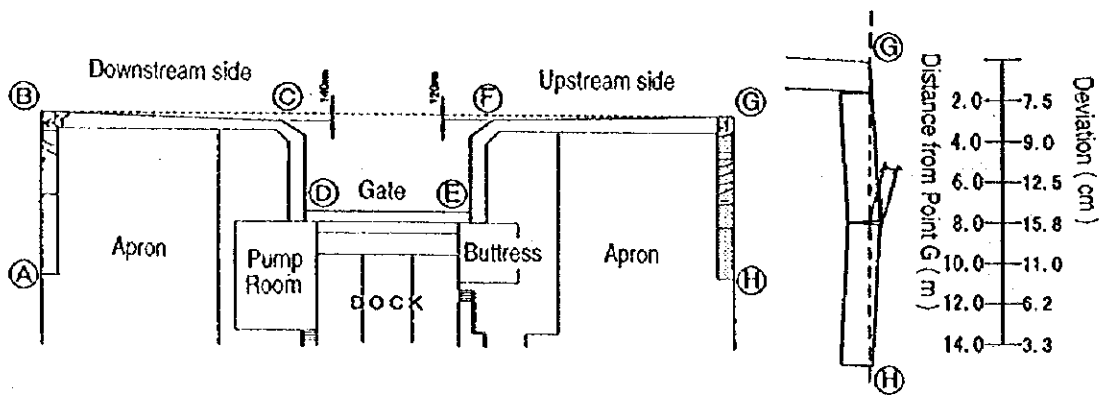
Figure 2.5 Displacement of the Coping Concrete

No cracks were observed in the C or F portions, as was also the case at the time of the July, 1997 survey. Nor was there any conspicuous cracking between Points A -B on the downstream side. With respect to the revetment baseline, a line was spread to Points B-G to measure relative displacement. A 14 mm difference was observed at Point C, and 120 mm at Point F.

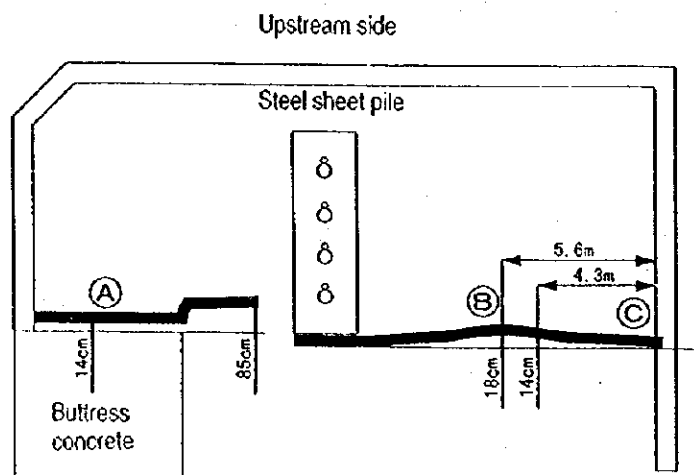
Figure 2.6 Shape Changes in the Anchoring Work

Vertical load appears to have been applied to the tie-rod along with the settlement of the fill material in the upper section but, in the anchoring sheet piles, considerable tensile load has been operating upon the river side, with shape changes at the top of the anchoring sheet piles reaching 140 mm in the buttress section and 180 mm and 140 mm, respectively, in the B and C portions. Based on these shape changes, the tie-rod has bent downward in the central portion, though no abnormalities were found in the pile installation section, ring joints, or turnbuckles.

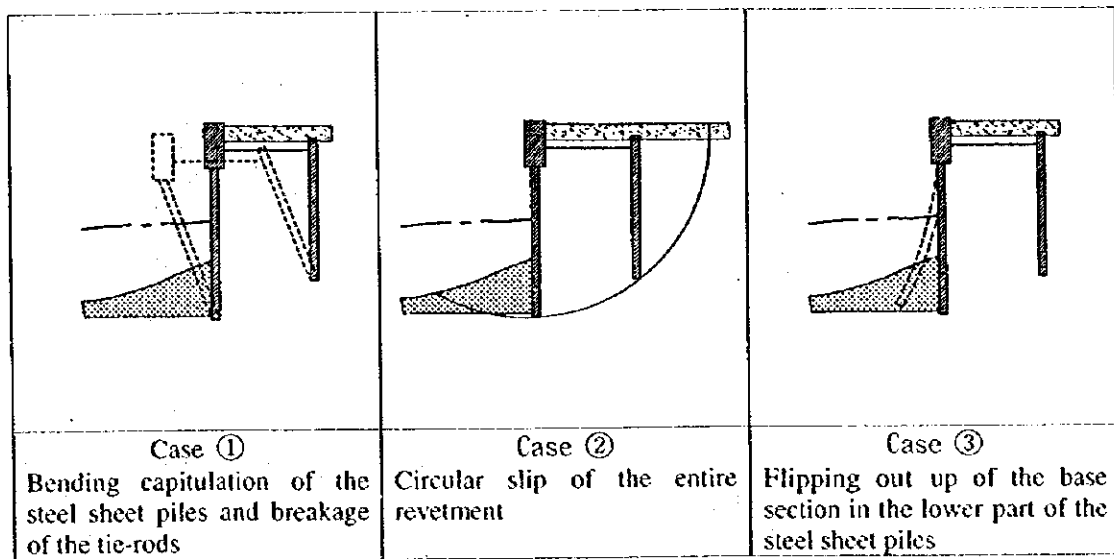
Fig. 3-1 Presumed Mechanism of Collapse

Since the front foundation has been scoured, the front revetment is in unstable condition. The destructive mechanism is believed to be as follows :

- ① bending capitulation of the steel sheet piles and breakage of the tie-rods ;
- ② circular slip of the entire revetment; and
- ③ flipping out up of the base section in the lower part of the steel sheet piles.

In case of the subject facilities, as it is feared that the case ② and ③ among above three types of collapse will especially be expected to occur, each case studies were examined.

From a design standpoint, the revetment structure has not maintained the necessary degree of safety. Accordingly, it is vital that the foundation level in front of the revetment of the dock be restored without delay.

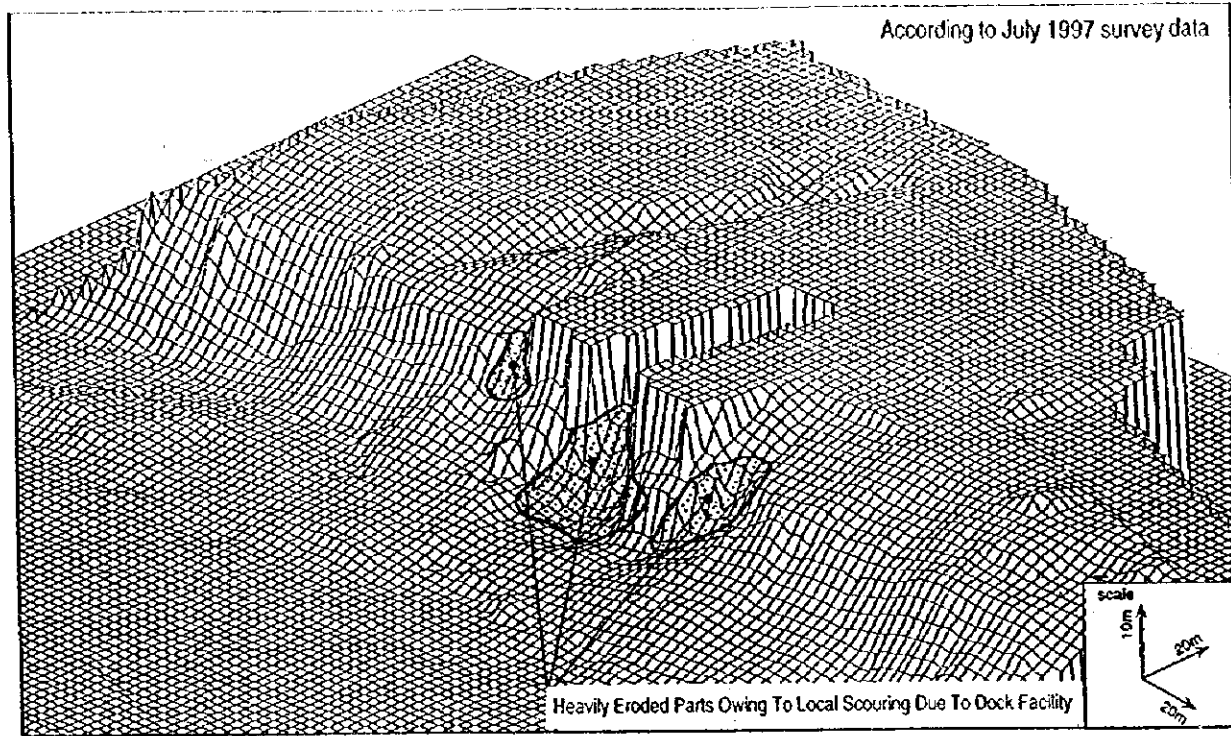
Fig.-1 Heavily Eroded Parts Owing To Local Scouring Due To Dock Facility
 (According to July 1997 survey data)
