BASIC DESIGN STUDY REPORT
ON
THE PROJECT FOR PROTECTION WORKS
FOR MEGHNA BRIDGE
IN
THE PEOPLE'S REPUBLIC OF BANGLADESH

FEBRUARY 1998

JAPAN INTERNATIONAL COOPERATION AGENCY
PACIFIC CONSULTANTS INTERNATIONAL
NIPPON KOEI CO., LTD.

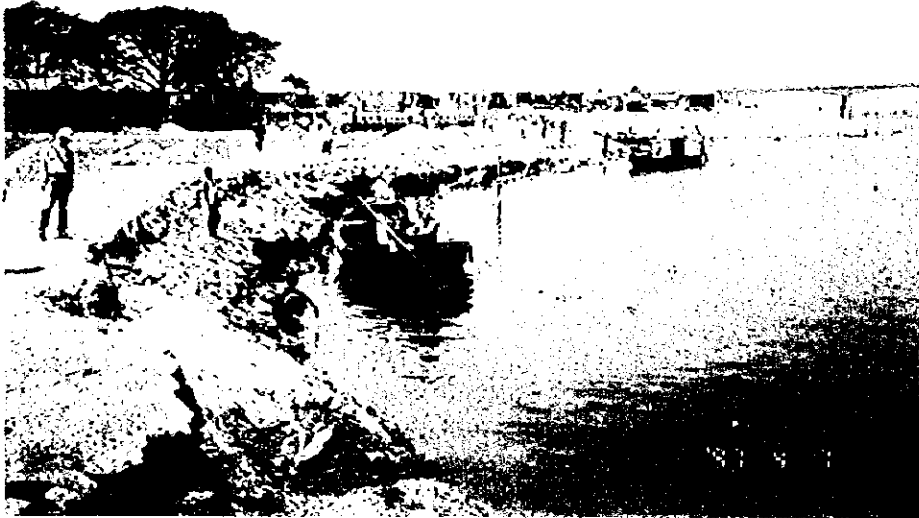
Erosion of River Bank
(Left Bank, Upstream)

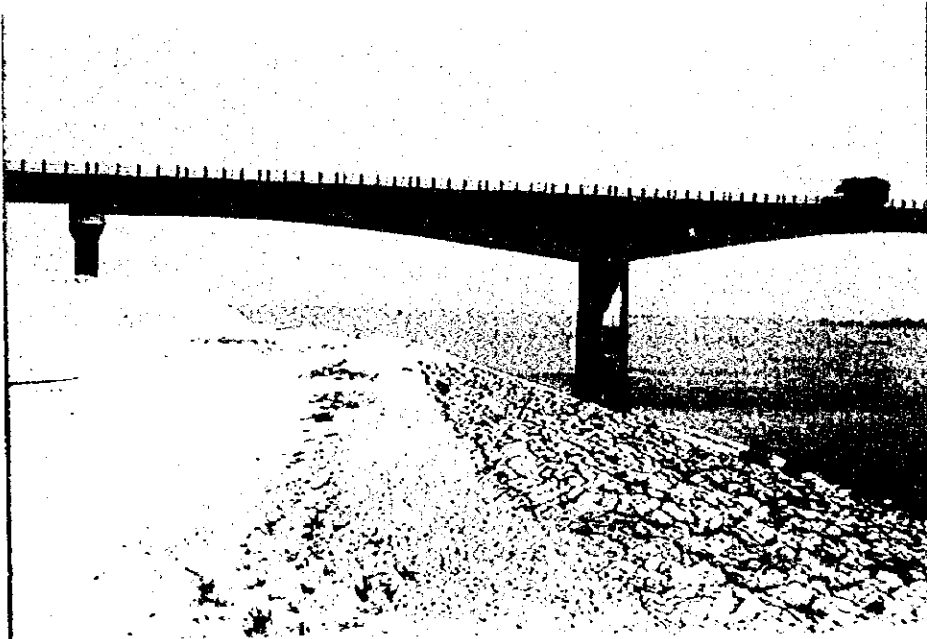
Existing Condition of
Gabions Revetment
(Left Bank, Upstream side)

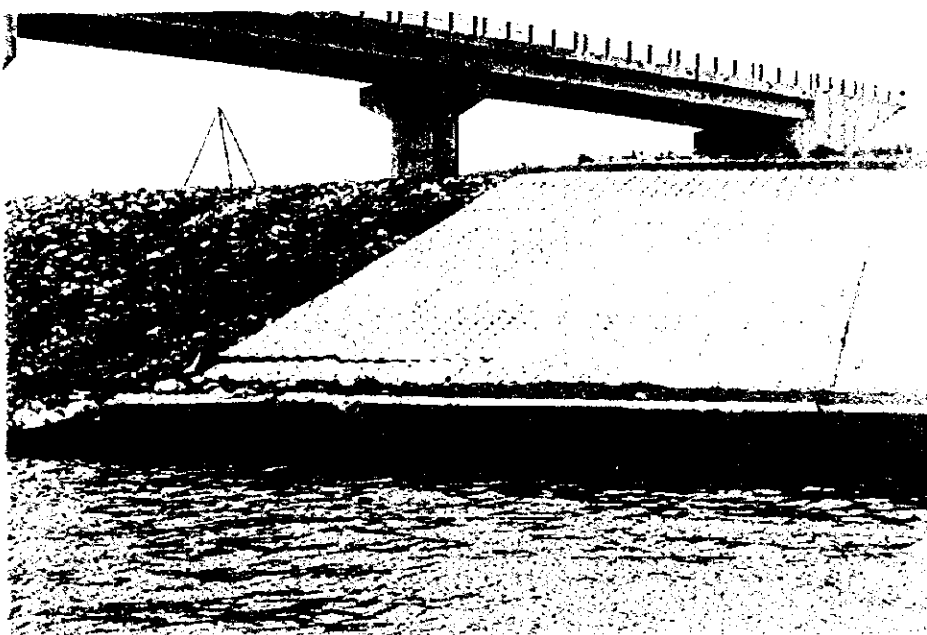
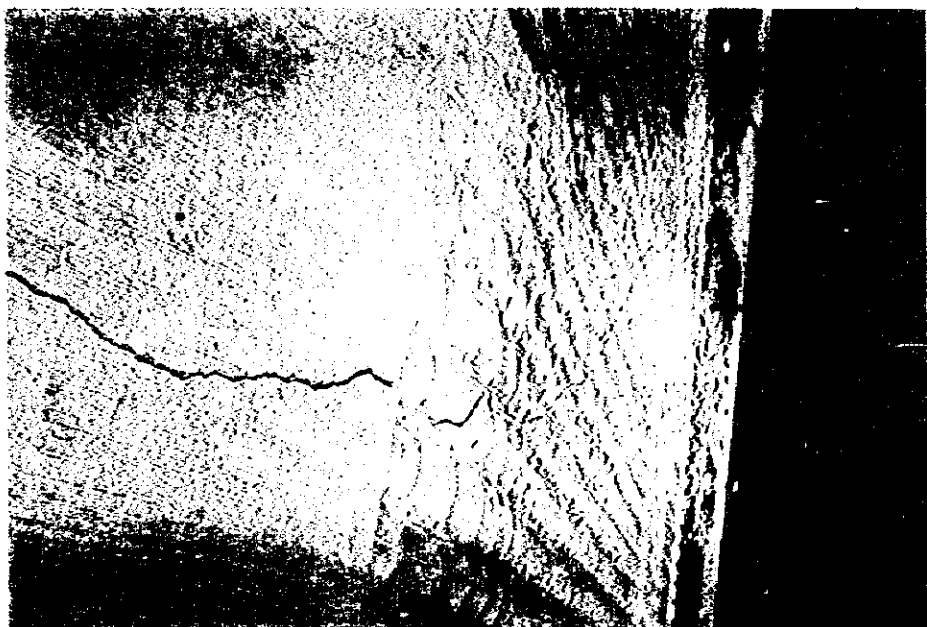
Existing Condition of
Geotextile Form Concrete
Revetment
(Left Bank, Downstream side)

Same as above

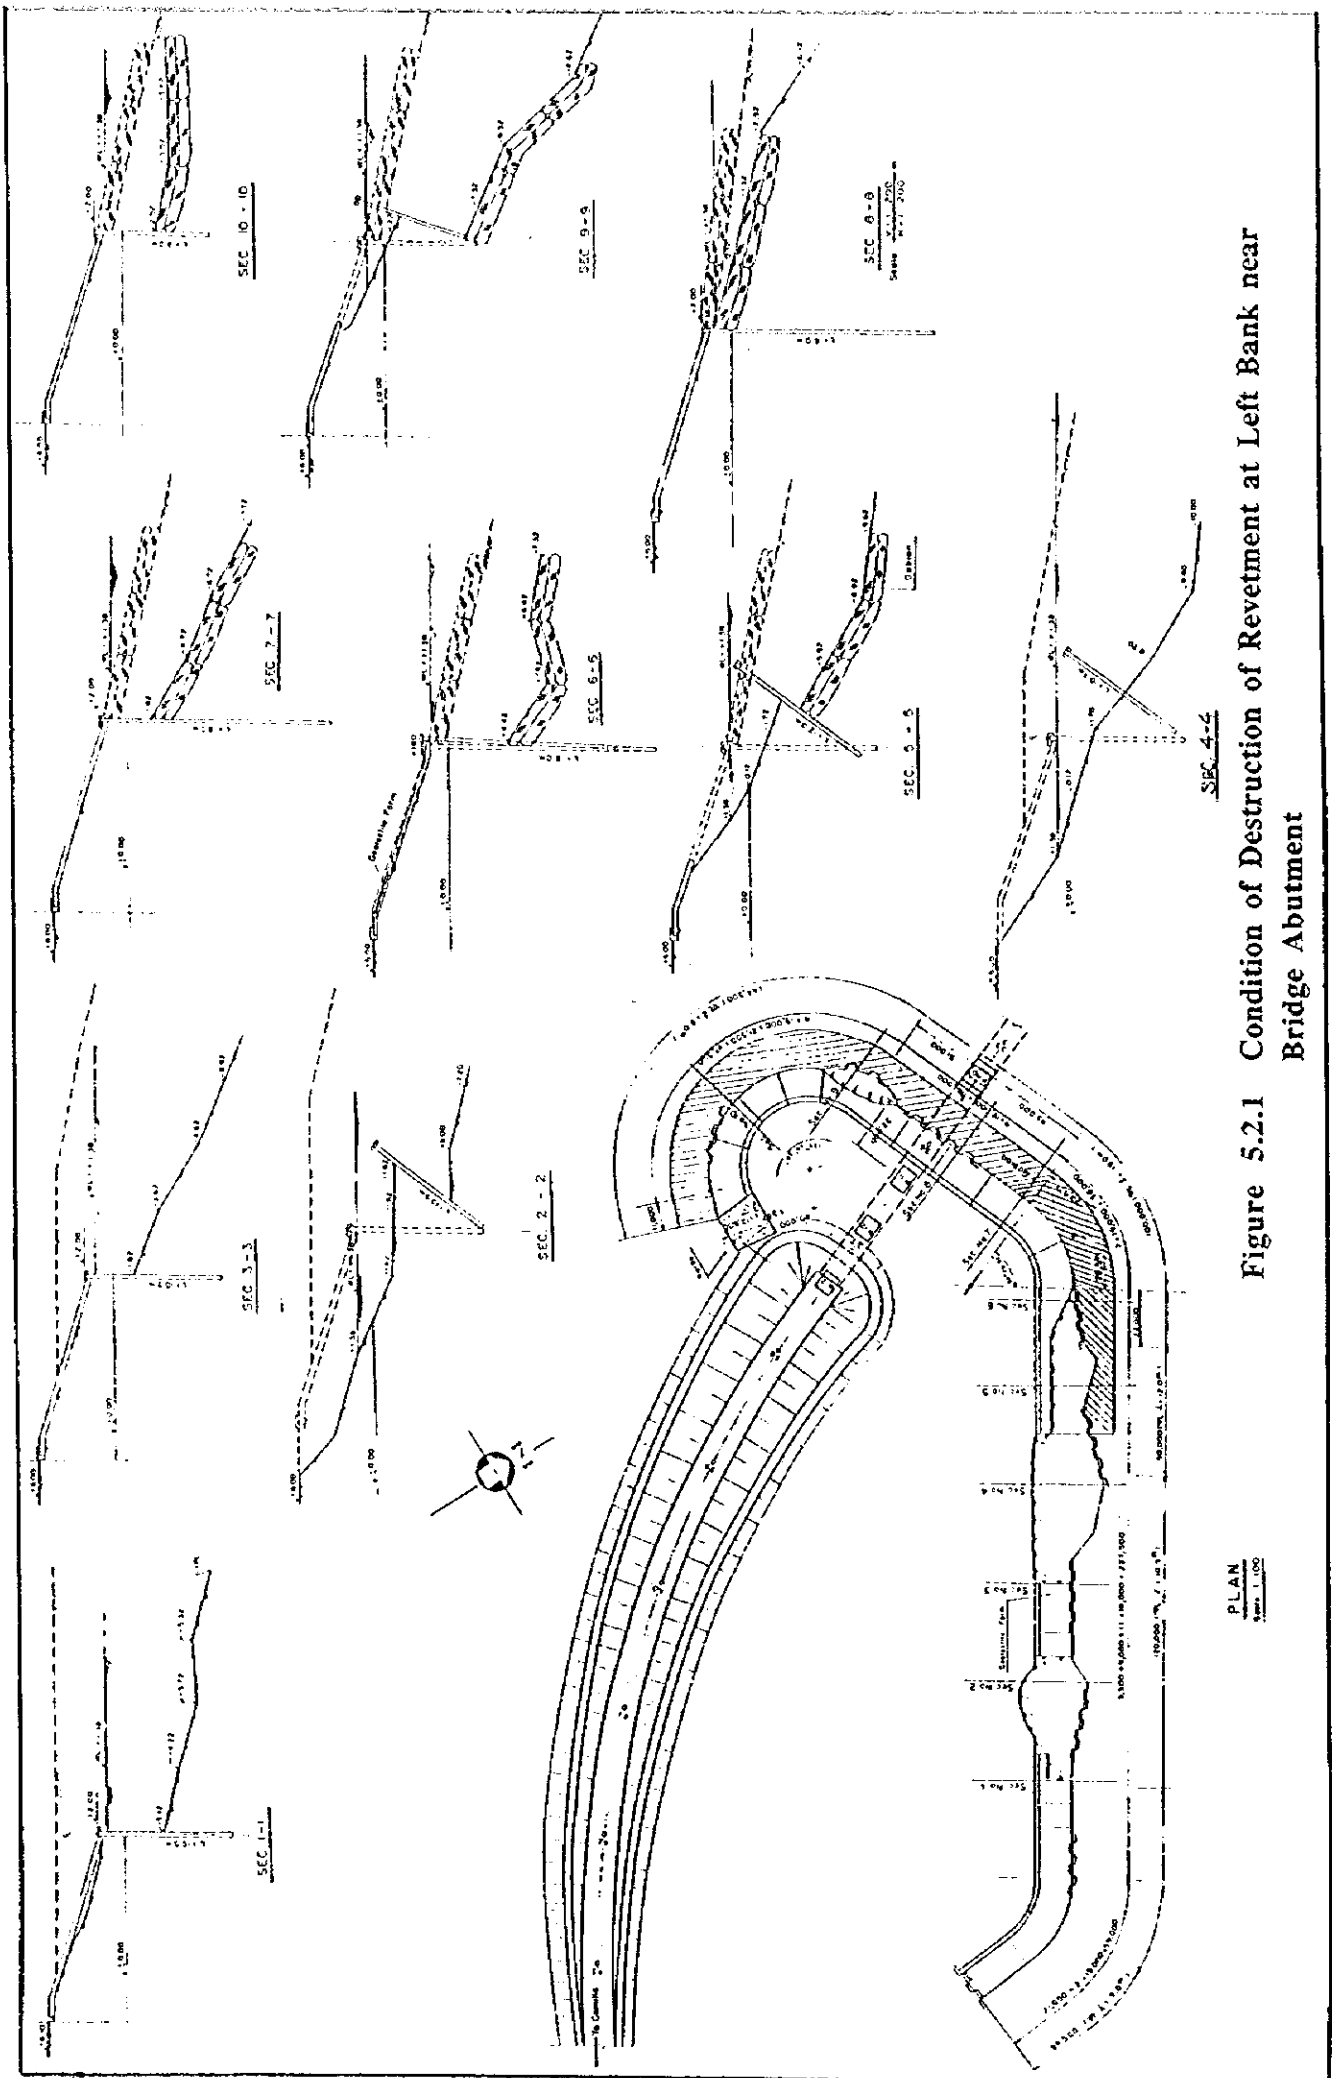
Figure 5.2.1 Condition of Destruction of Retement at Left Bank near Bridge Abutment

The revetment has been damaged due to serious erosion at its foot portion. Specially, in the stretch where sheet piles are driven to a depth of 9 m to 18m, the revetment has leaned toward the water side because of reduction of the passive soil pressure. Around 38% (195 m in length) of the completed stretch, has been affected. The status of sheet piles is shown in Fig. 5.2.1.

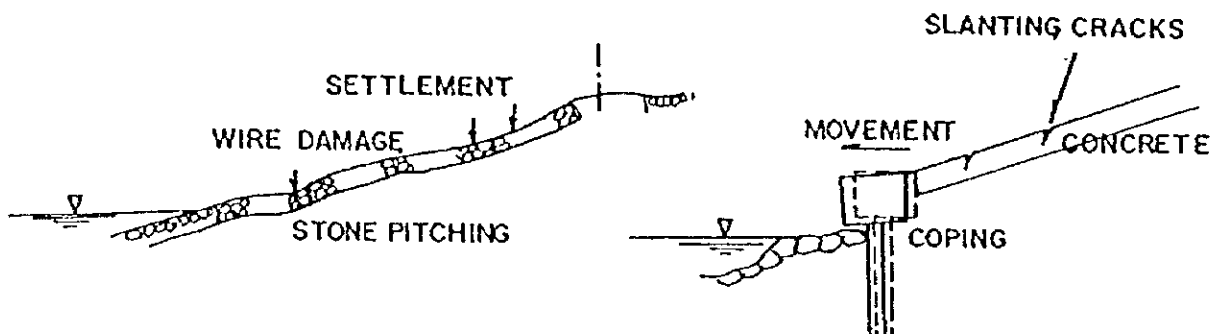
Fig. 5.3.3 Features of Distortion of Existing Revetment

Although the repaired gabion protection has subsided at some portions, a stable slope is formed. In the stretch where the geotextile concrete remains, a crack of 0.5 to 1.0 cm wide has developed on the surface, traversing from upstream to downstream beneath the Bridge. Further, the head coping portion of sheet piles has inclined toward the center of the river and cracks are also confirmed.

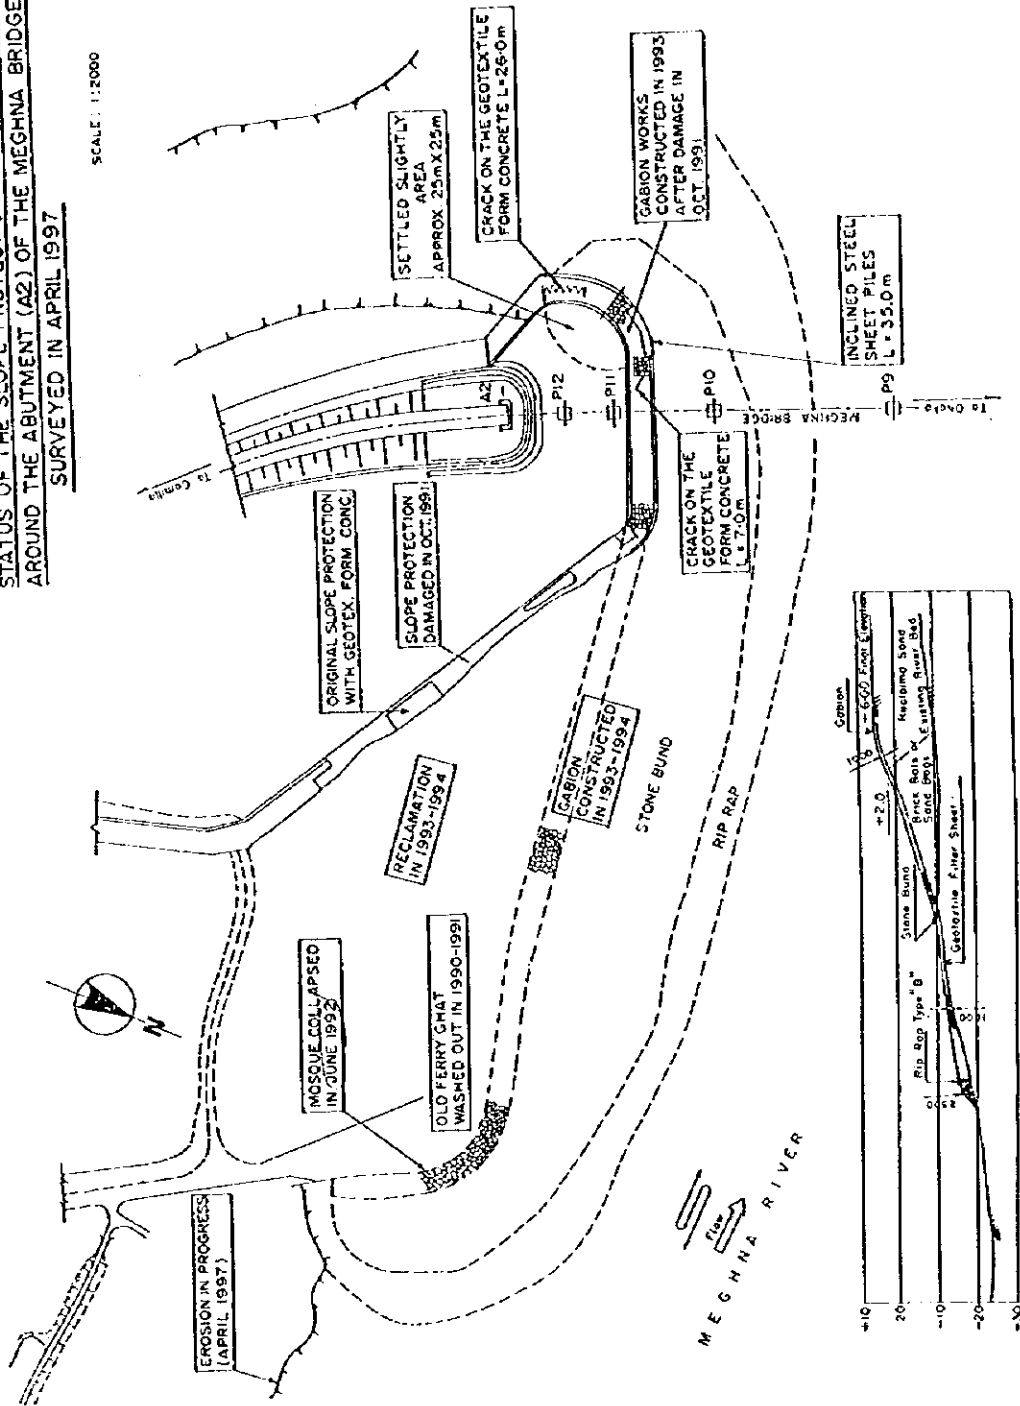
Figure 5.3.1 Present Status of Existing Revetment

The past major events and present condition of the existing revetment clarified through the First Survey on the left bank are illustrated in Fig. 5.3.1. Further, the details of erosion of the bank and displacement of the revetment are explained as follows:

STATUS OF THE SLOPE PROTECTION WORKS DAMAGED AROUND THE ABUTMENT (A2) OF THE MEGHNA BRIDGE SURVEYED IN APRIL 1997
