5.6 Site Geology and Characteristics of Riverbed Material

CHAPTER 6
CONDITION OF EROSION IN
THE VICINITY OF MEGHNA BRIDGE

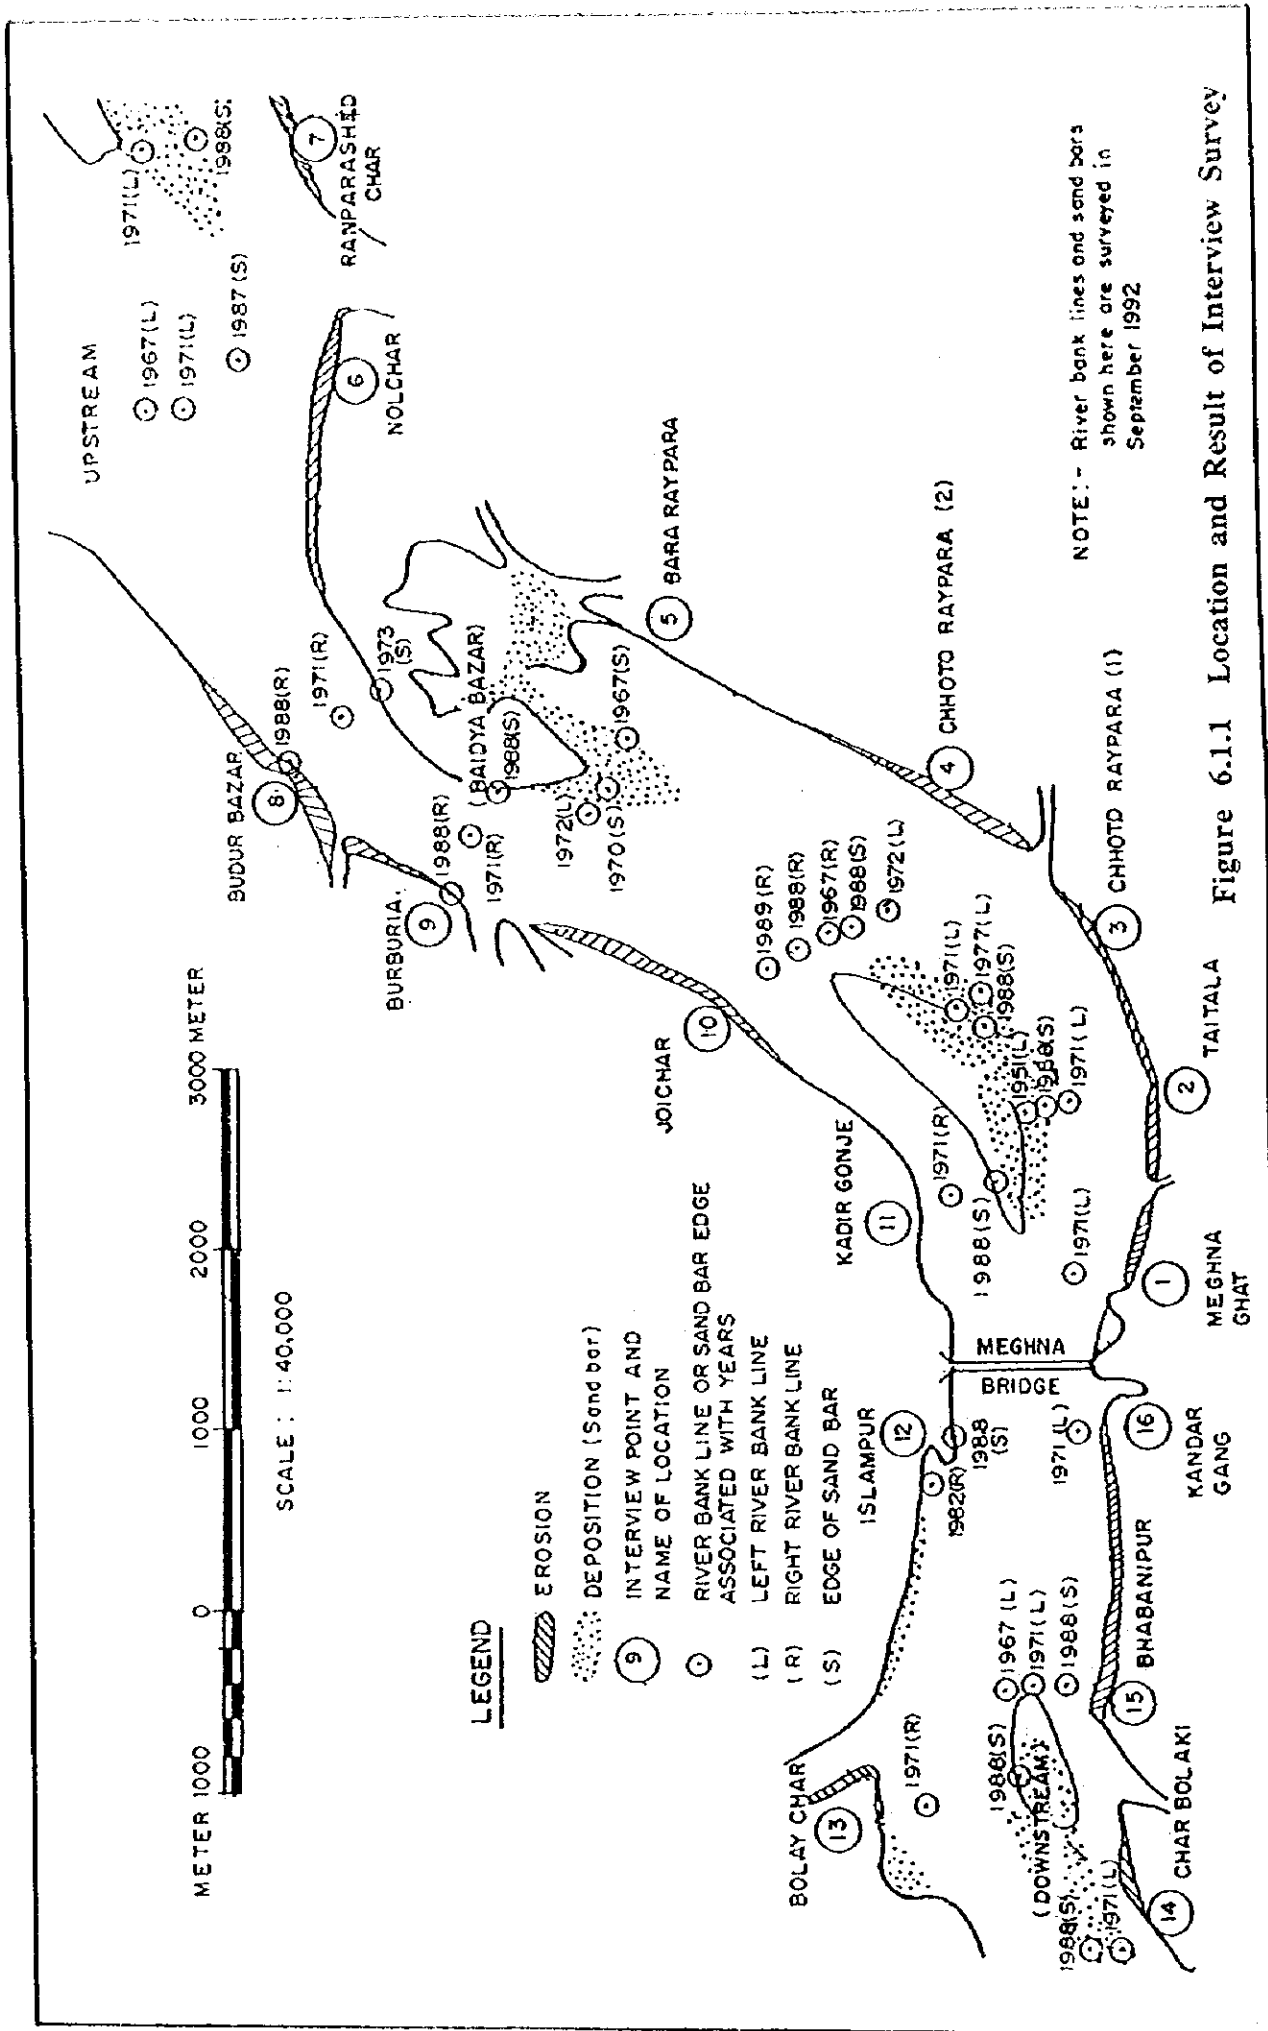
Figure 6.1.1 Location and Result of Interview Survey

The river left bank near the old ferry ghat is seriously eroded. From 1991 to 1997, erosion advanced approx. 500 m. The erosion area extends about 3 km toward the upstream side. The degree of erosion along the bank diminishes in the area upstream of Taitala. Near the Chhoto Raypara (2) survey point, erosion gradually changes to deposition. From 0 km to 3 km upstream, the 1988 floods caused an erosion of 100 m to 250 m of the river bank. In the last 27 years, i.e., 1971 to 1997, the rate of erosion estimated based on the interview survey is 10 m to 25 m a year.

About 27 years ago, that is in Bangladesh's Independence Year of 1971, the left bank was at the edge of the sand bar, but at present it is in front of the Taitala and Chhoto Raypara survey points. A village which had been located at the old bank edge shifted to Chhoto Raypara and Bara Raypara where the surveys were carried out this time. In the past 20 to 30 years, the bank erosion in this area was approx. 700 m and the rate was 15 m to 35 m a year. Due to the presence of finer sand particles, this area is highly prone to erosions during the presence flood season and falling river stage (August to November). By wave

actions of river flow, the bank erosion continues even in the dry season (December to May).

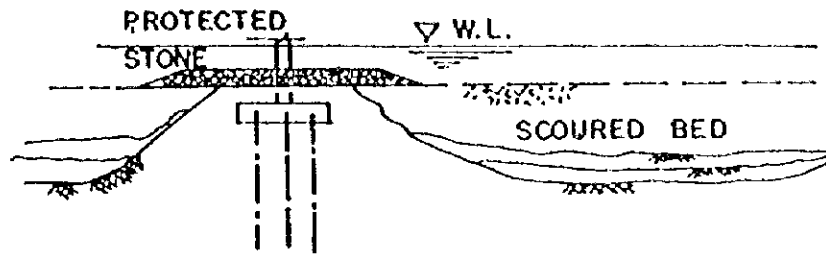
On the Dahka side of the pier, the pitched stone mat forms a slope of the slope approx. 25 m long and the riverbed consists of a loose sand layer. The present riverbed including the pier section is considered to be experiencing the process as shown in Fig. 6.3.2.

- (i) The river bed has been gradually scoured by large scale floods

- (ii) The pitched stones fell down as the scouring of the riverbed proceeded.

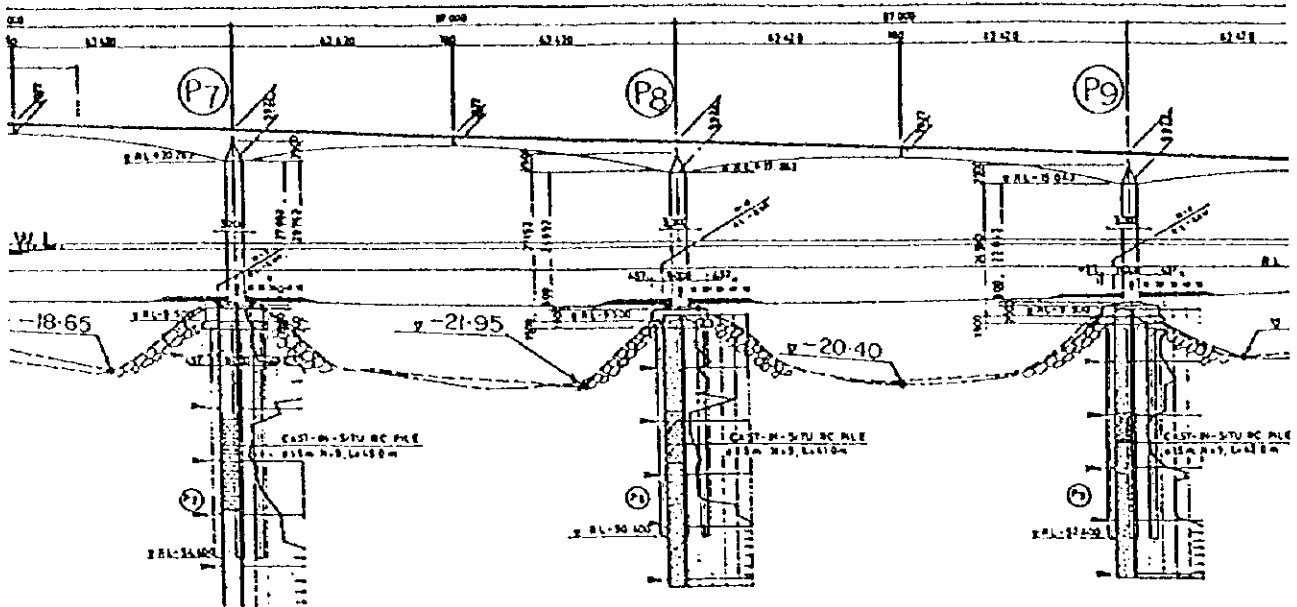
Figure 6.4.1 Existing Riverbed at the Meghna Bridge

The lowest bed elevation between the piers of the Meghna Bridge was measured to be R.L.-21.95 between P7 and P8 as shown in Figure 6.4.1.

In order to prevent further scouring in the future, however, the provision of protection works around the piers and the riverbed between the piers is recommended. Besides, river cross-section survey along the centerline of the bridge should be conducted periodically in the future.

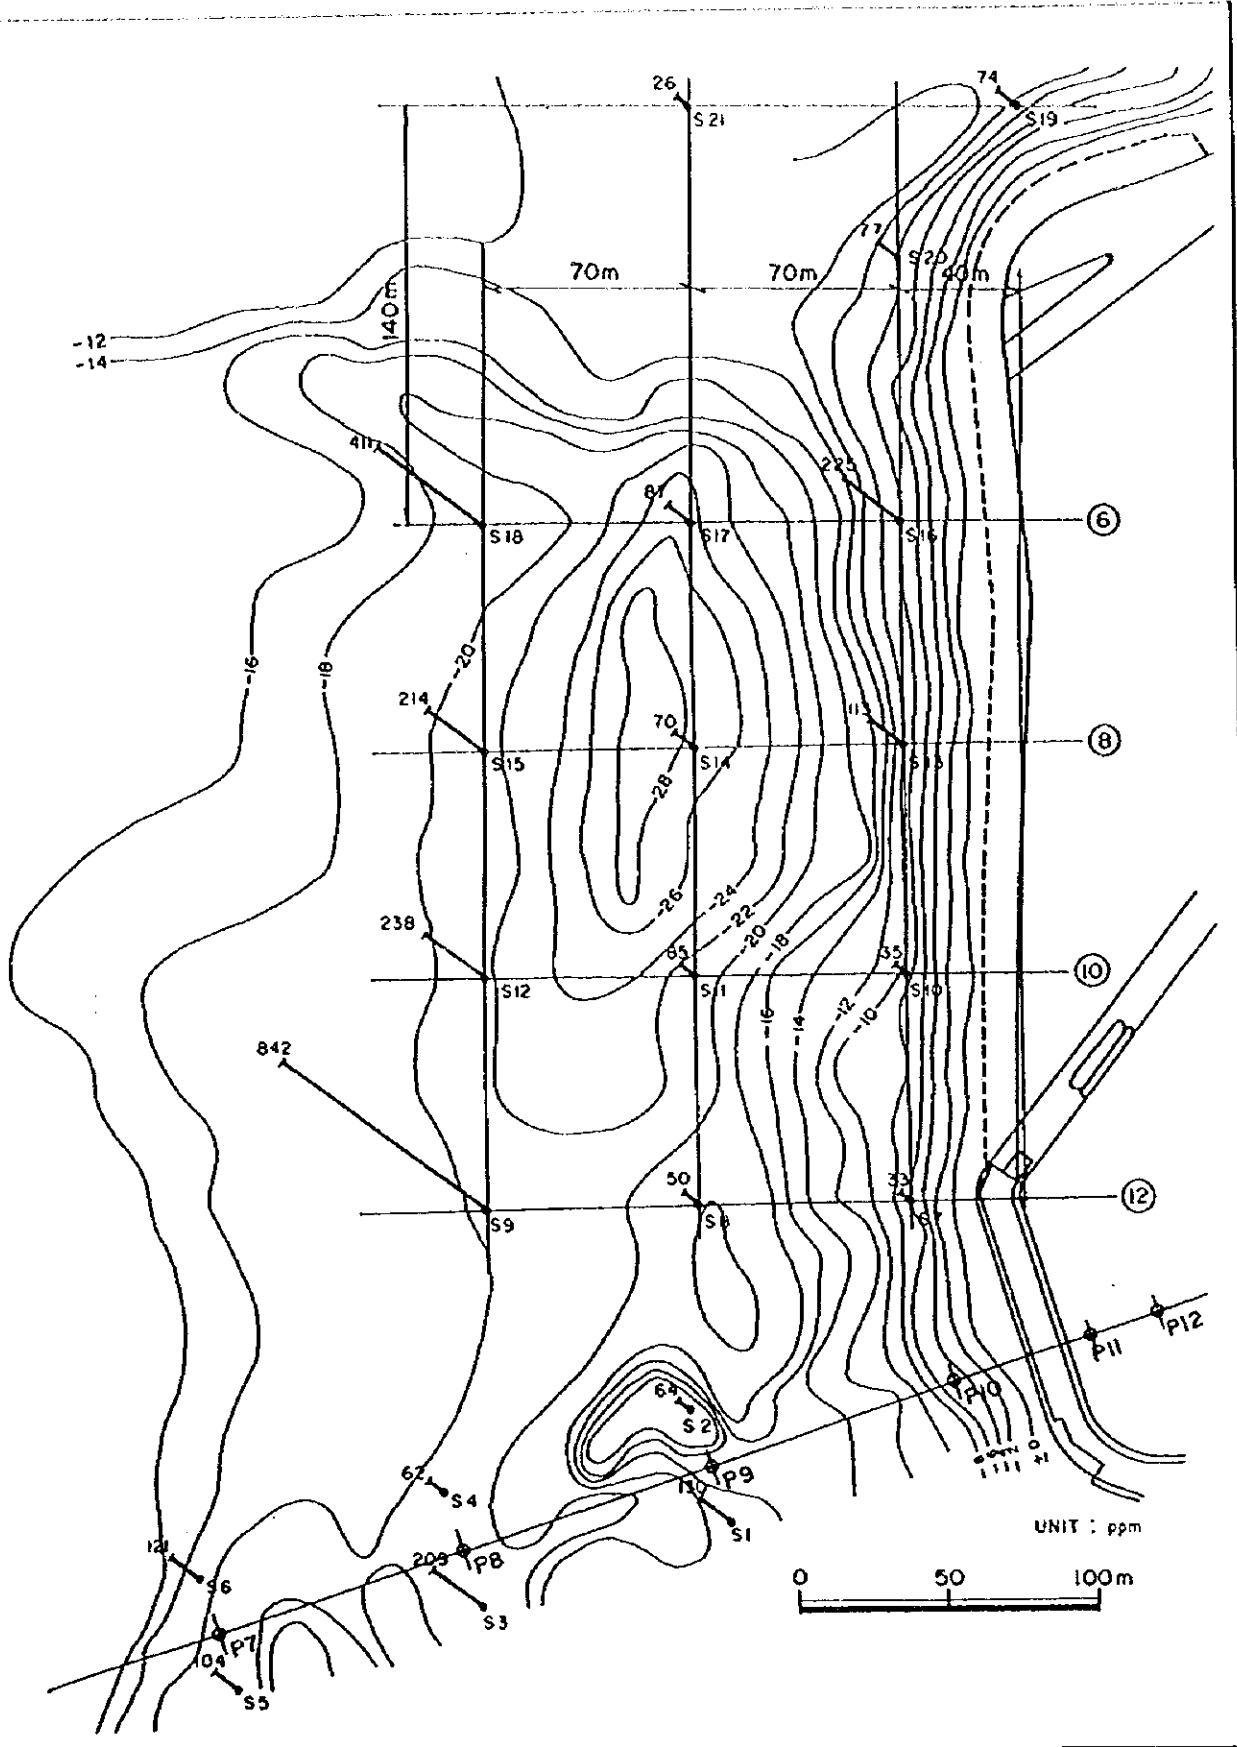
**Figure 6.5.7 Result of Laboratory Tests
of SS Contents**

The result of laboratory test for SS contents is shown in Table 6.5.3 and illustrated in Fig. 6.5.7 with the contour line of the riverbed which was drawn based on the echo sounding in the Second Survey. According to this record, more than twice concentration of SS was observed on the downstream side of P8 and P9 compared with that on the upstream side of the piers. At pier P7, the upstream SS concentration was a little higher than the downstream one.

On the other hand, in front of the existing revetment a relatively high SS concentration was observed along the survey line between P8 and P9. This survey line approximately coincides with the boundary of the dead

flow area due to the gap of the shoreline between the existing revetment and its upstream stretch. Accordingly, the turbulence of suspended solid accumulated on the riverbed due to vortexes is deemed as one of the reason for high concentration. As a whole, the observed values near the revetment are higher than those at on the downstream side of the piers.

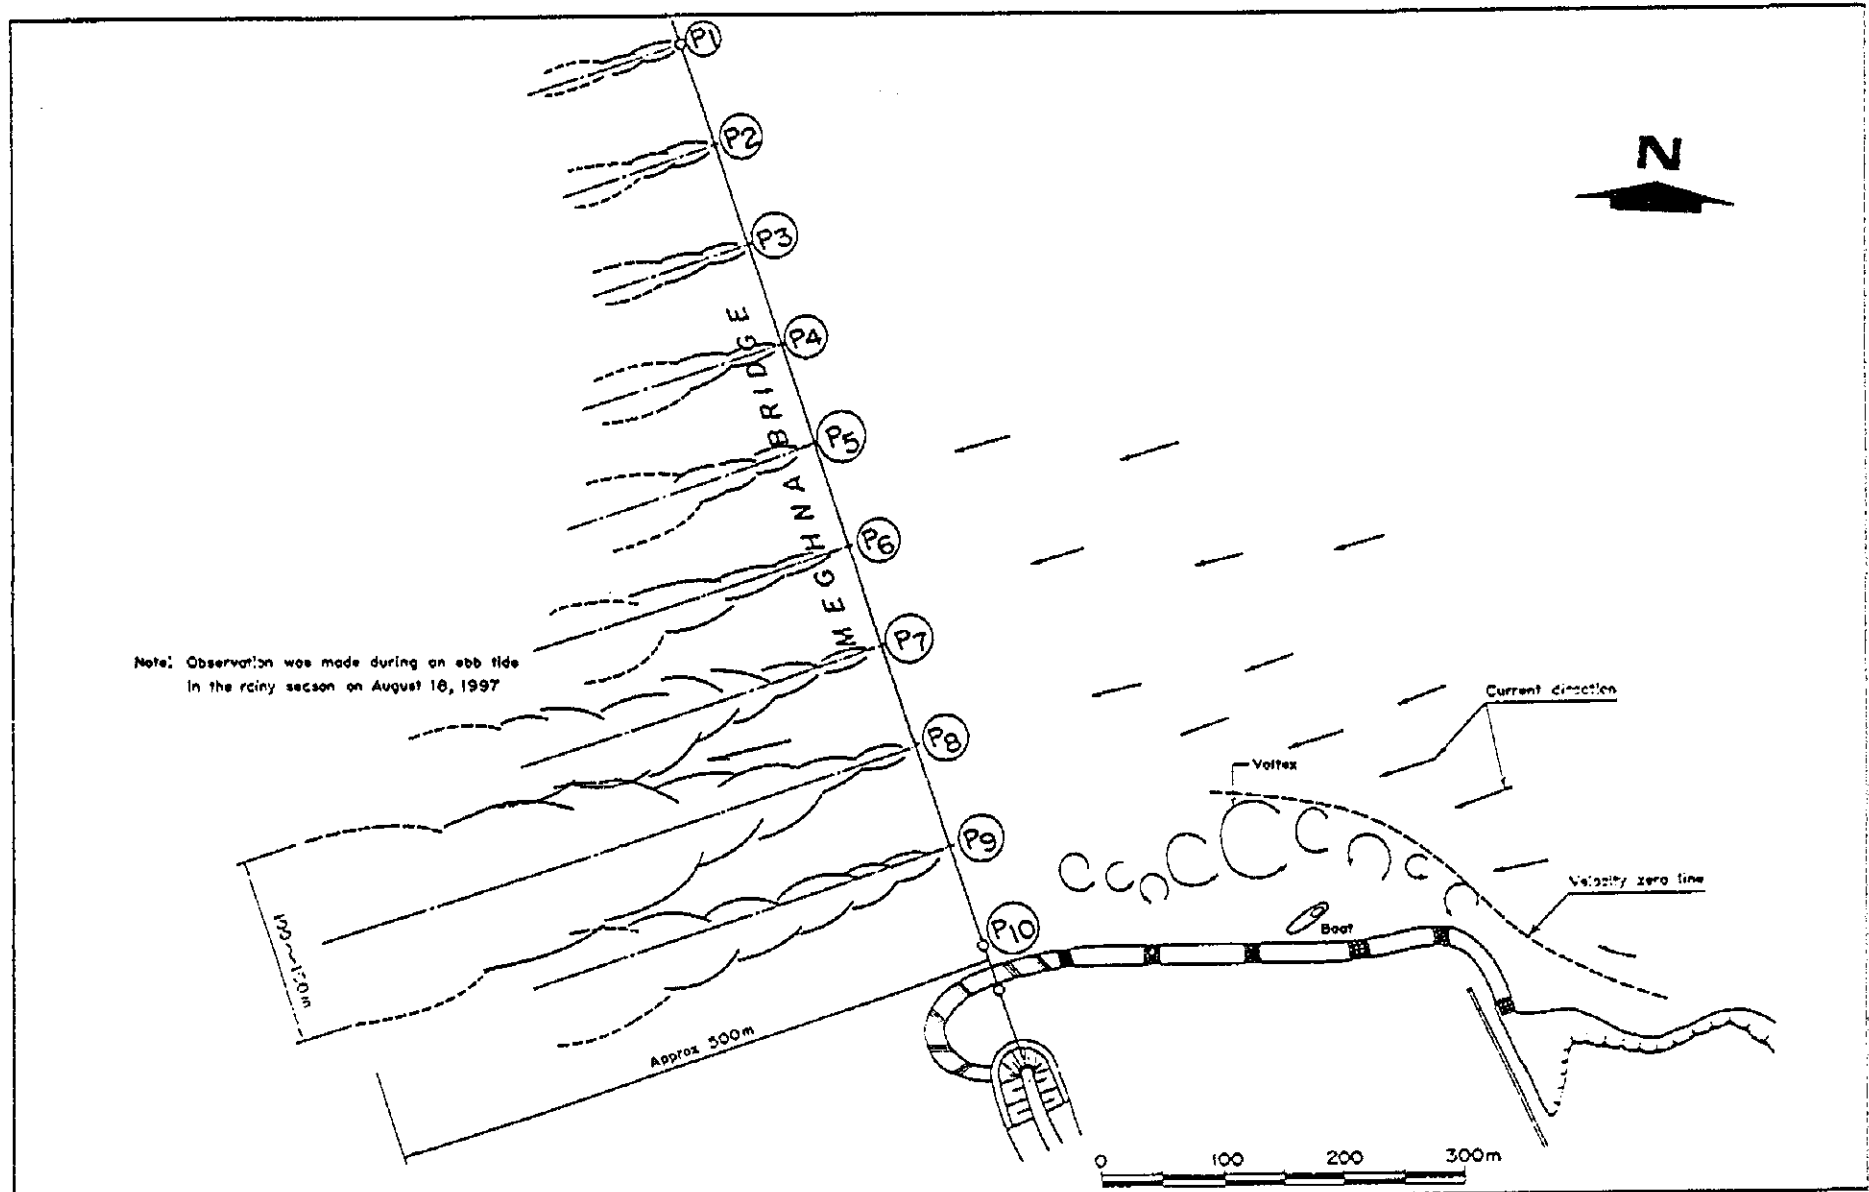
Figure 6.5.8 Observed Result of Surface Vortex

Further, the condition of surface flow in front of the revetment and propagation of vortexes downstream of each pier are illustrated based on the field observation made at 4 p. m. (RL. +4.70 m) on Aug. 18, 1997 (Fig. 6.5.8).

The boundary of the dead flow area extends almost up to the center of P8 and P9. On the other hand, the flow direction at the sites located outside the survey line along the extension from P9 is uniformly toward downstream. Thus, it is judged that this area might be out of the dead flow area. The measurement of flow velocity and direction was carried out on Aug. 10 when the water level was at RL. +4.20 to +4.25 m. The boundary of the dead flow area shifted closer to the shoreline because the water level was 50 cm lower on Aug. 18 when the observation of water surface condition was conducted.

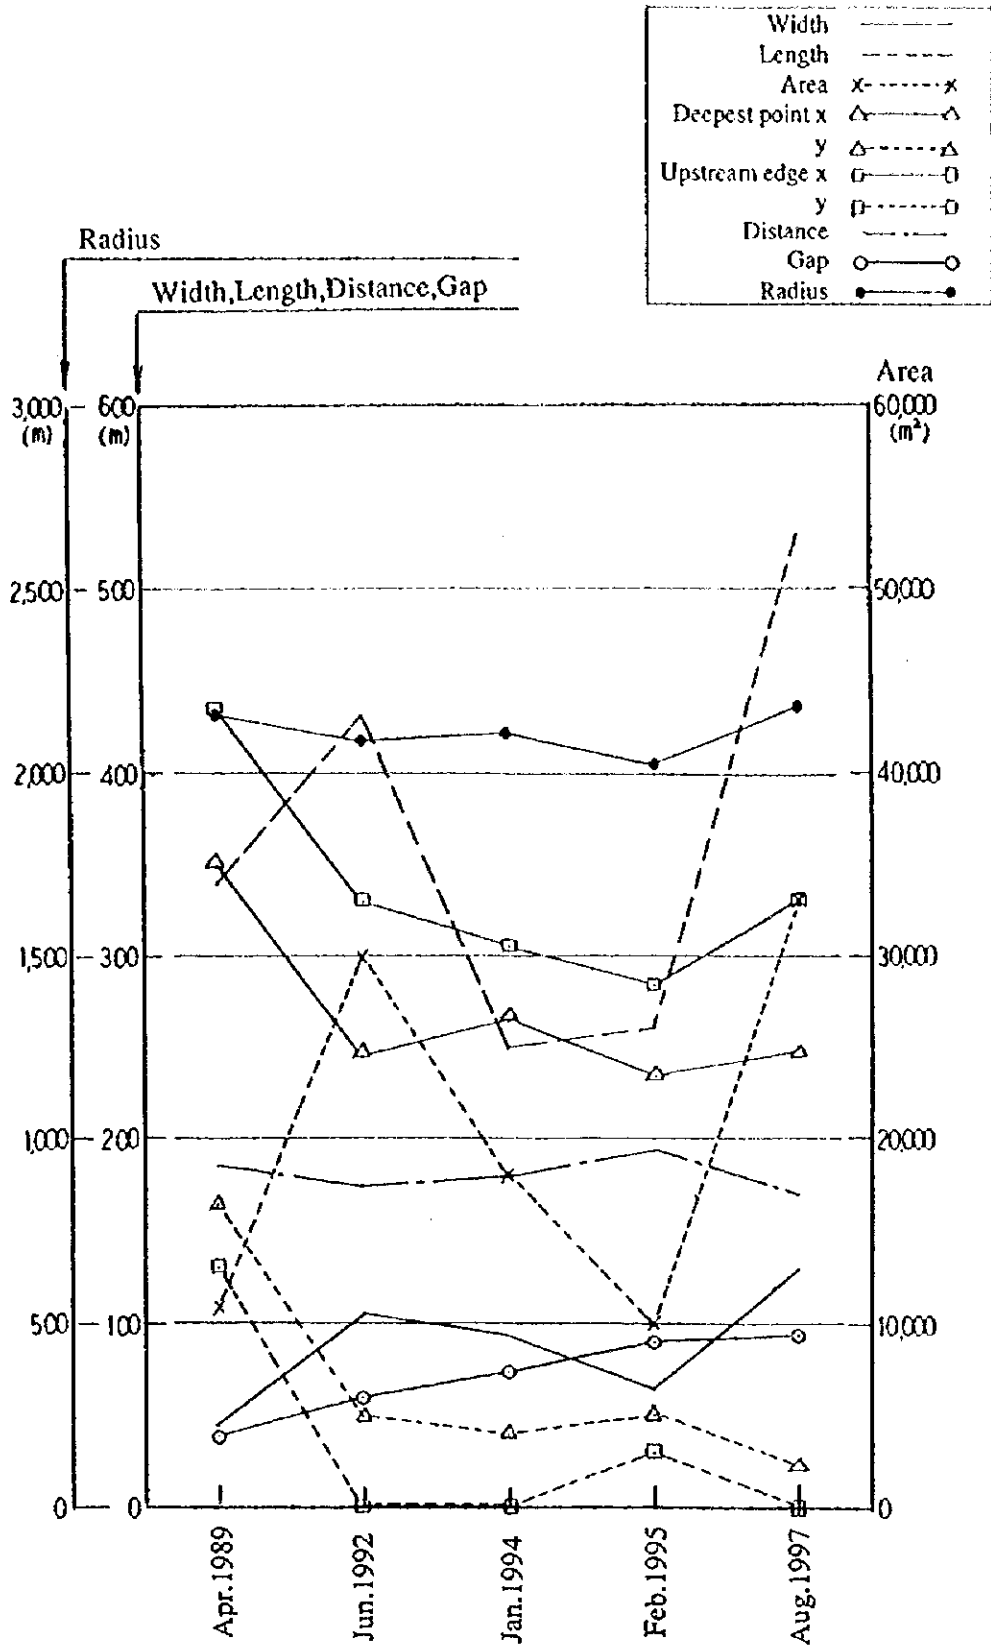
Figure 6.5.10 Trend of Deep Scoured Pool

From 1989 to 1992, the scoured pool moved toward the shoreline and downstream due to the large scale landslide at the site of the existing revetment. However, after the completion of the revetment in February 1994, significant movement of the pool has not occurred. Further, the speed of development of the gap between the tip of the old ferry ghat and the upstream shoreline seems to become moderate after 1995. In this regard, it is closely related to the tendency of development of the right side small channel.

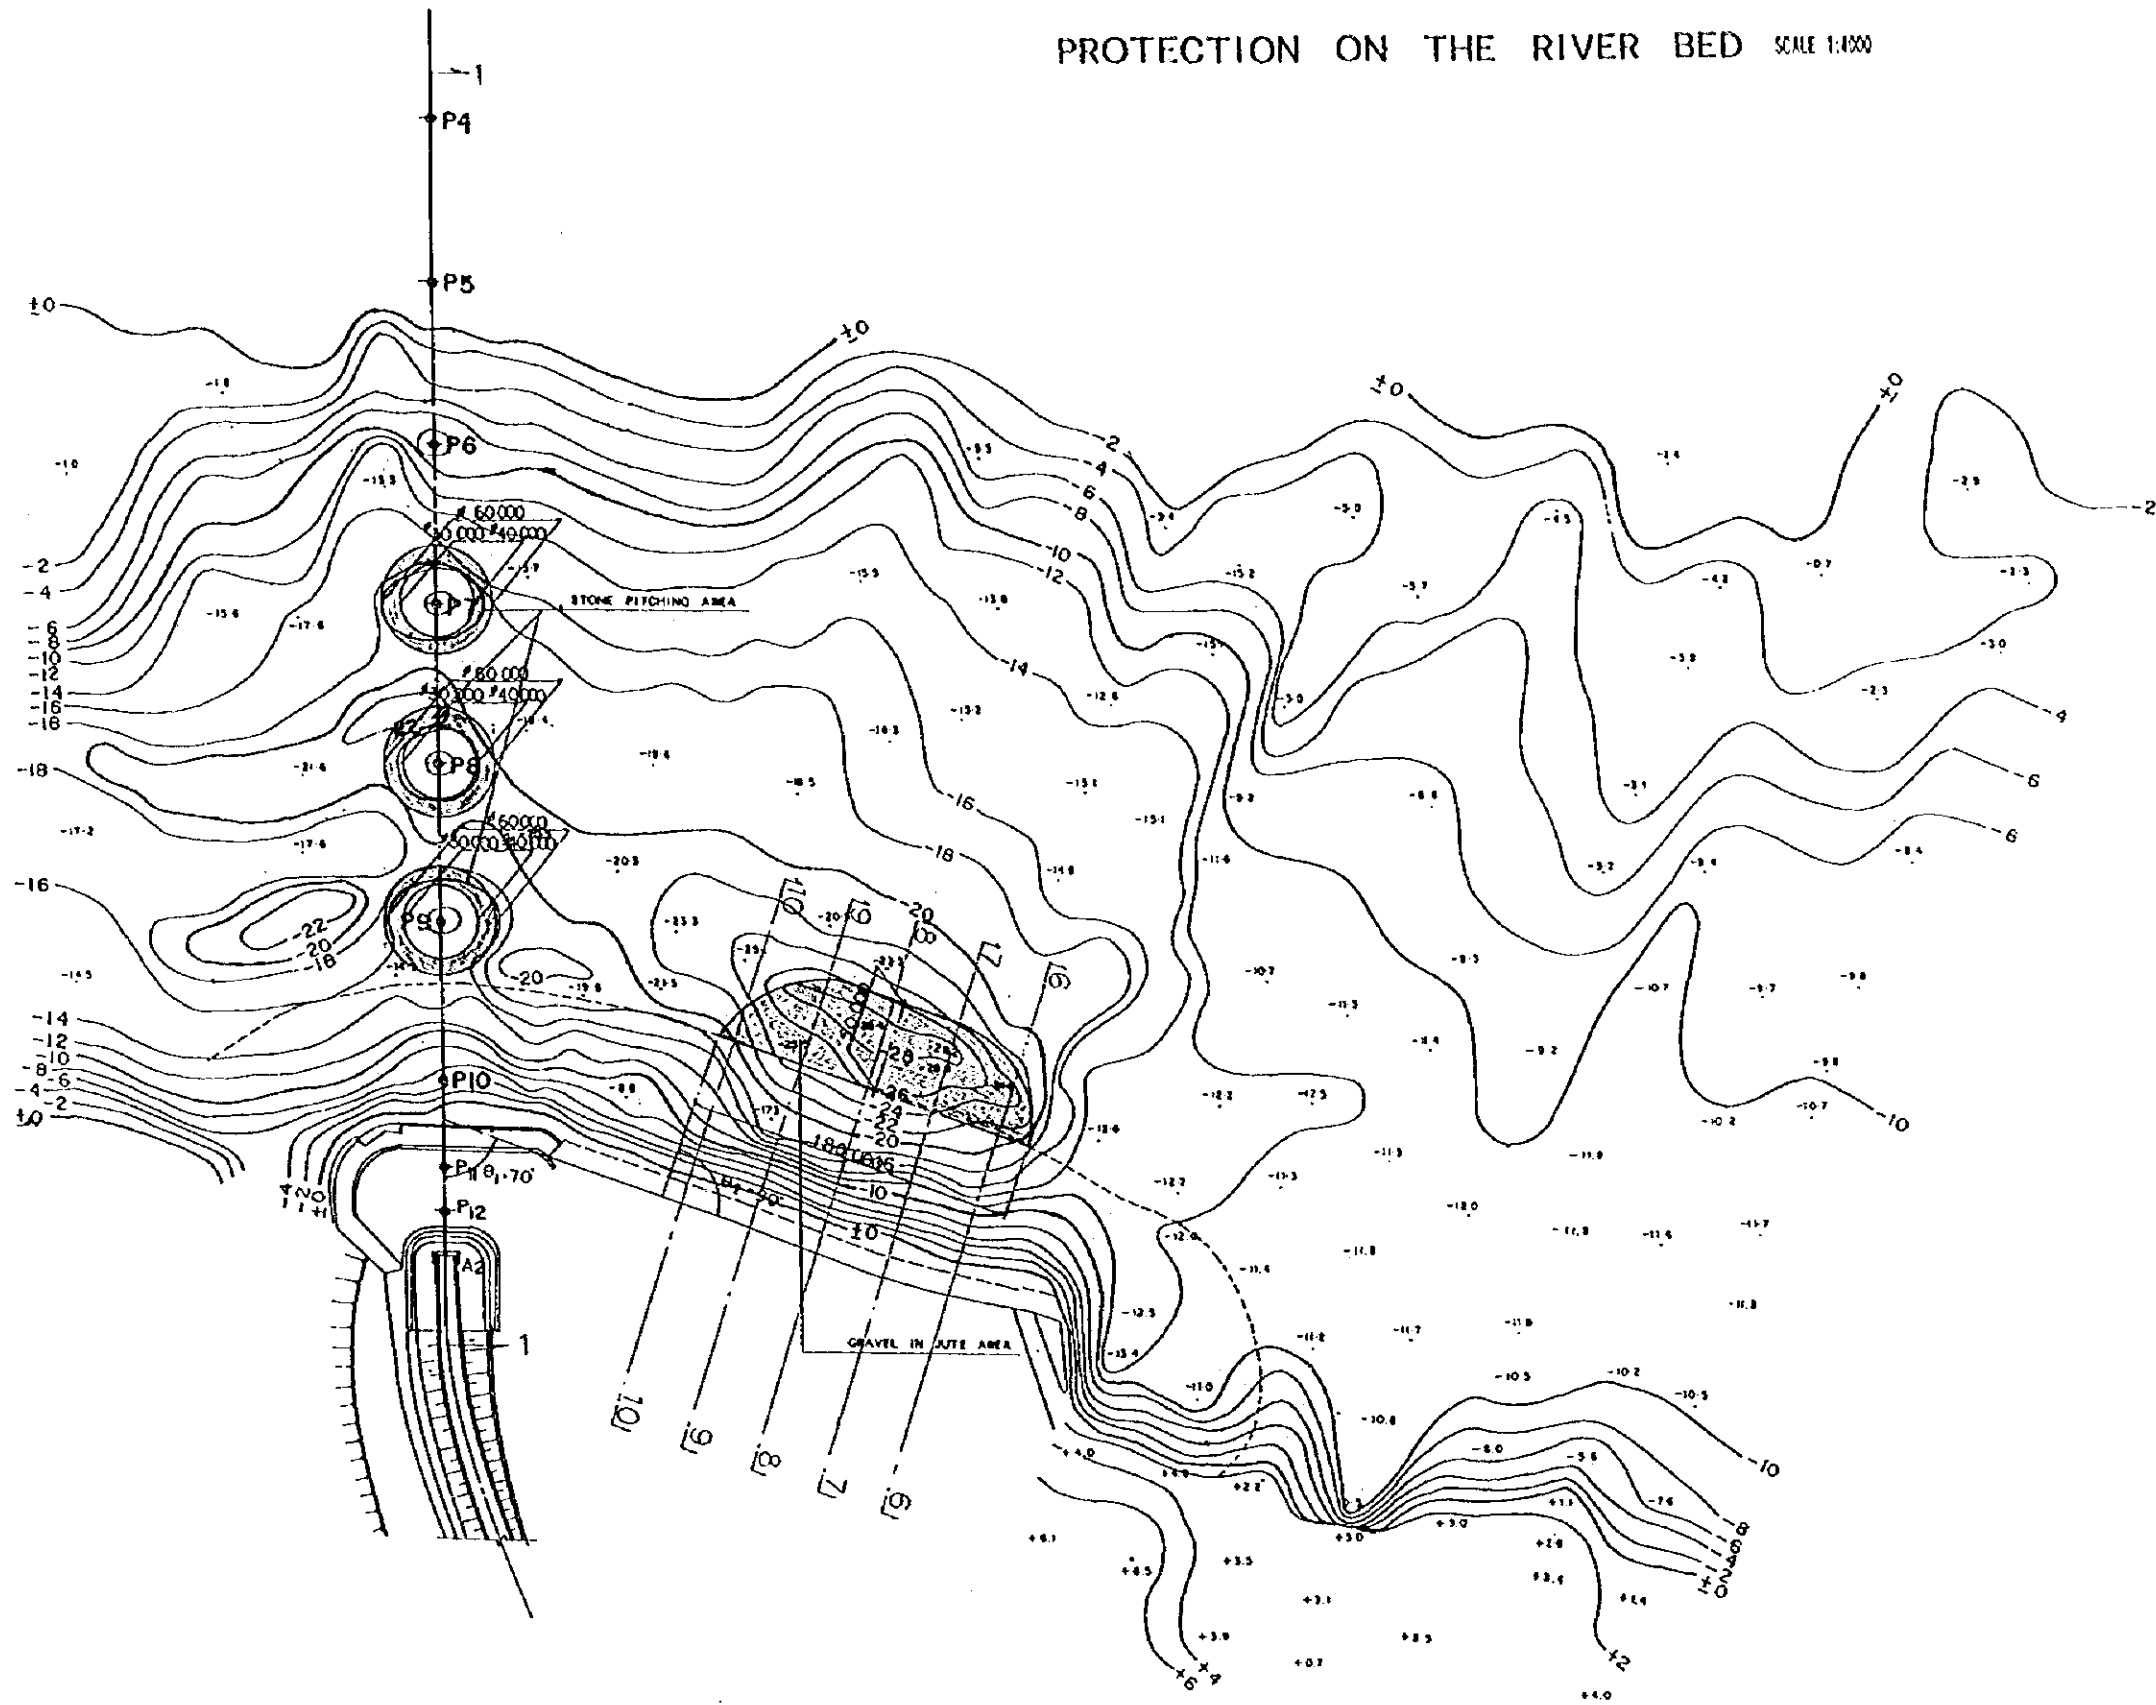
Figure 9.1 Protection on the Riverbed

At present, the areas around the foundations of piers P7, P8 and P9, which are located in the riverbed lowering area, are covered with stone mats provided for the protection of pier foundations and the existing stone mats are forming lenticular shapes. The riverbed between stone mats is composed of a hard sand layer (N-value; 30 to 40), therefore scouring would not proceed easily. However, the thickness of the said sand layer is relatively small. The stratum below R.L. -24 m to -26 m is composed of silty sand layers. Therefore in the case the existing exposed sand layer is eroded, further scouring may occur unexpectedly rapidly.

In view of the above situation, the provision of additional protection works by stone pitching around the existing stone mats is recommended.

- a. River bed armoring around the bridge pier footings (P7, P8 and P9)
 - One meter thick stone mat protection.
- b. River bed armoring for the deeply scoured area in front of the existing revetment (on the left bank, about 250 meters upstream of the Meghna bridge)
 - One meter thick sacked gravel mat protection.
- c. Grading work around the Comilla side abutment and the repair of the existing revetment
 - Grading of the area on the rear side of the existing revetment and replacement of existing concrete filled fabric tubes with new gabions.

NOTE: The extent of existing stone mound around pier footings shall be checked prior to the stone pitching work.
