2.6 REHABILITATION PRIORITY AND PROJECT INVESTMENT PLAN

3.2 GENERAL BRIDGE INSPECTION

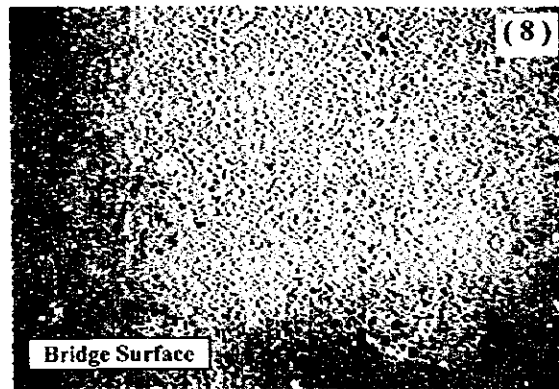
Wear damage was seen on pier and abutment foundations caused by water flow, or on top of slab caused by vehicle running because of no pavement surfaced. Photo (8) shows a wear example on slab.

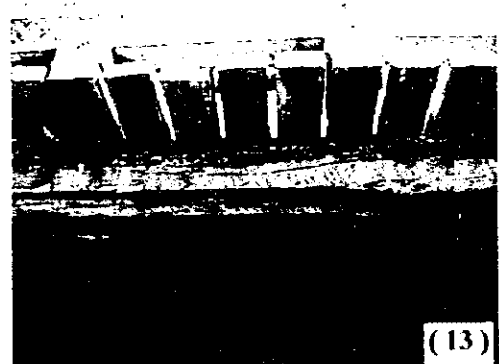
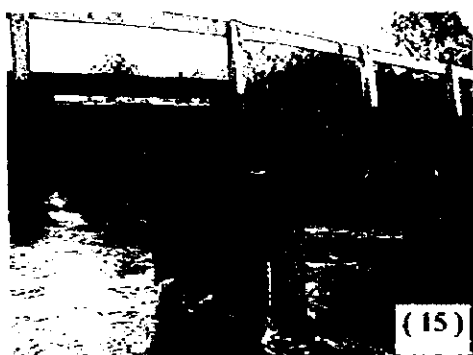
There were few damages caused by fungi or parasites on timber components, therefore most damages were due to moisture and weathering by overage wood. As a few case, decay from fungi was observed on components of Miraflores Bridge (refer to Photo (13)). If proper protection on timber components were treated, propagation of these damages would be able to prevent. Unfortunately, timber components of objective bridges

didn't have such protection so that serious damage, especially for decay, was observed. All kind of damages of timber can be checked in Pocolun Bridge of which the traffic was closed due to destruction as shown in Photo (14). It was difficult to find out the timber cracking because justification by whether the cracking was from external forces (live load or earthquake) or artificial device was impossible in this inspection. On the other hand, losses of timber components near the part touching with water were observed in many cases (Photo (15)). It was not kind of timber damage, but Malleco was destructed by fire as shown in Photo (16). Timber pavements were in good condition because of periodical replacement by the MOP.
