3.4 REHABILITATION DESIGN

3.4.2 Repair Design

The purpose of the repair design is to show examples of various repairs for the bridges to be repaired. The repair designs were based on the information of each bridge collected by general inspection and the results of damage inspection. The repair methods were decided in accordance with the repairing scheme studied in **Clause (4) of Chapter 3.2.3**.

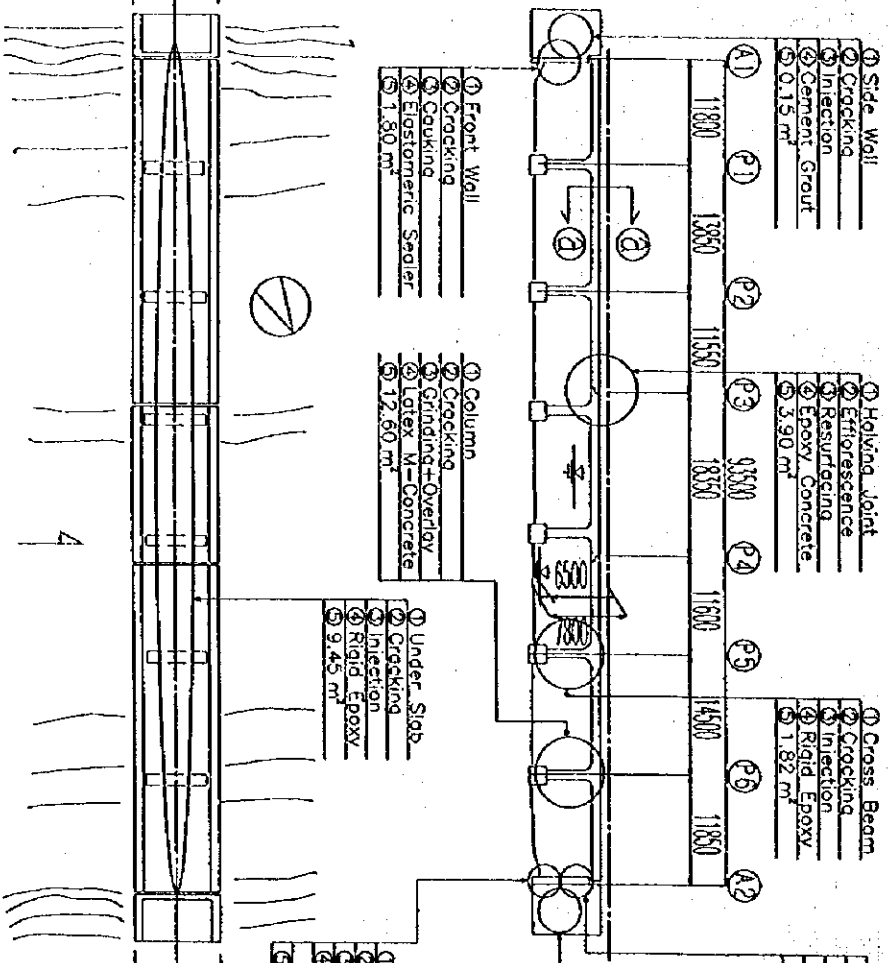
REPAIR METHODS AND QUANTITIES			
BRIDGE NUMBER	2	YEAR OF BUILT	
BRIDGE NAME	DAVID GARCIA	BRIDGE LENGTH	93.05 m
REGION	V	BRIDGE WIDTH	8.30m
ROUTE NAME	E-85	TRAFFIC VOLUME

- ① Side Wall
- ② Cracking
- ③ Injection
- ④ Cement Grout
- ⑤ 0.15 m³

- ① Hollow Joint
- ② Efflorescence
- ③ Resurfacing
- ④ Epoxy Concrete
- ⑤ 3.90 m²

- ① Cross Beam
- ② Cracking
- ③ Injection
- ④ Rigid Epoxy
- ⑤ 1.82 m²

- ① Column
- ② Cracking
- ③ Grinding+Overlay
- ④ Latex M-Concrete
- ⑤ 12.60 m²

- ① Under Slab
- ② Cracking
- ③ Injection
- ④ Rigid Epoxy
- ⑤ 9.45 m²

- ① Front Wall
- ② Cracking
- ③ Delamination
- ④ Pre-Pack
- ⑤ Coarse Aggregate + Cement Sand Grout
- ⑥ 6.0 m²

- ① Front Wall
- ② Cracking
- ③ Cracking
- ④ Cracking
- ⑤ Elongometric Sealer
- ⑥ 1.05 m²

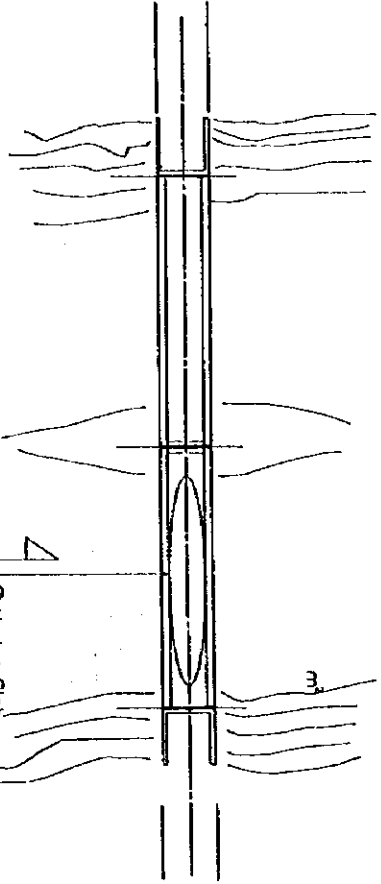
REPAIR METHODS AND QUANTITIES	
BRIDGE NUMBER	4
BRIDGE NAME	VENTANAS
REGION	V
ROUTE NAME	F-30-E
YEAR OF BUILT	
BRIDGE LENGTH	30.00m
BRIDGE WIDTH	11.20m
TRAFFIC VOLUME

① Railing (sp)	② Expansion Joint	③ Beam at End
② Aging of Coat	③ Breakage	④ Erosion/scence
③ Repainting	④ Replacement	⑤ Grinding/Coating
④ Oil/Airyd	⑤ Steel Joint	⑥ Linseed Oil
⑤ 71.0 m ²	⑥ 9.0 m	⑦ 7.20 m
		⑧ 0.45 m ²
		⑨ 0.75 m ²

① Footing	① Well	① Footing	① Front Wall
② Scalling/Spalling	② Scalling/Spalling	② Cracking	② Scalling
③ Pre-Pack	③ Patching	③ Ingeking	③ Coating
④ Coarse Agr.	④ Concrete	④ Rigid Epoxy	④ Cement Concrete
⑤ 19.50 m ²	⑤ 36.0 m ²	⑤ 0.40 m ²	⑤ 15.0 m ²

① Beam	② Beam at End
② Erosion/scence	③ Breakage
③ Grinding/Coating	④ Pre-Pack
④ Linseed Oil	⑤ Coarse Agr.
⑤ 7.20 m	⑥ Cement's G
	⑦ 0.45 m ²

① Side Wall
② Cracking
③ Caiking
④ F.S. Mortar
⑤ 0.75 m ²

① Under Slab
② Scalling/Spalling
③ Coating
④ Unseed Oil
⑤ 147.0 m ²

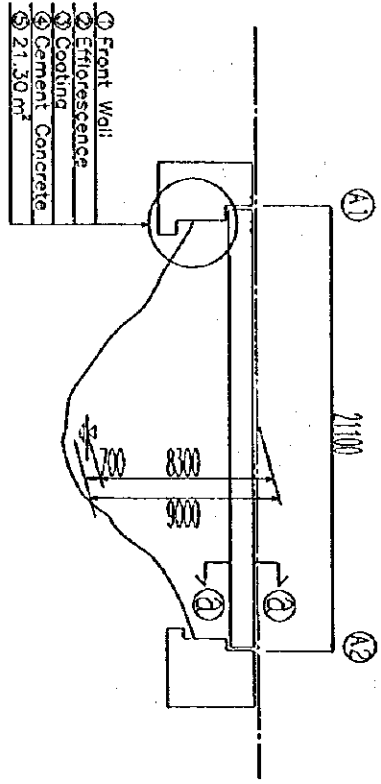
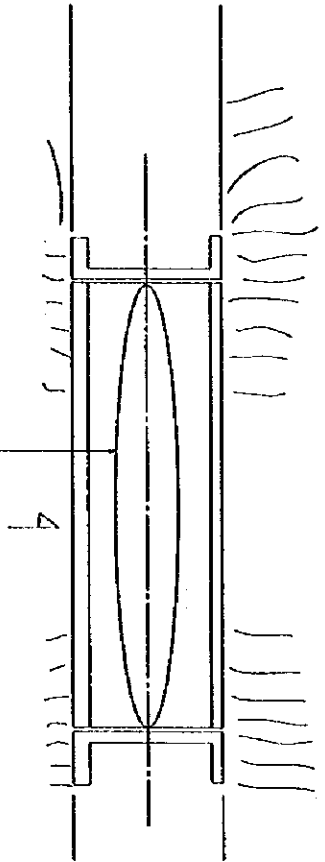
REPAIR METHODS AND QUANTITIES				
BRIDGE NUMBER	11	YEAR OF BUILT		
BRIDGE NAME	EL INDIO	BRIDGE LENGTH	21.10m	
REGION	X	BRIDGE WIDTH	7.60m	
ROUTE NAME		TRAFFIC VOLUME

- ① Front Wall
- ② Efflorescence
- ③ Coating
- ④ Cement Concrete
- ⑤ 21.30 m²

- ① Under Slab
- ② Efflorescence
- ③ Resurfacing
- ④ Epoxy Concrete
- ⑤ 101.0 m²

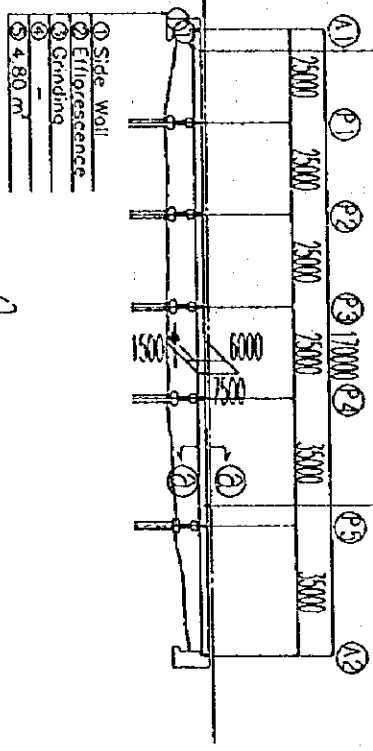
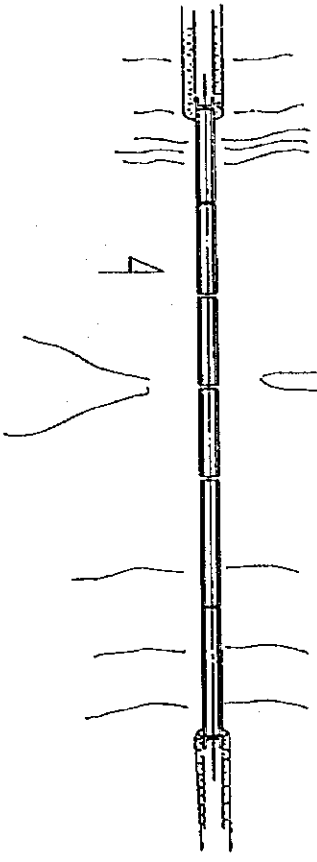
REPAIR METHODS AND QUANTITIES			
BRIDGE NUMBER	17	YEAR OF BUILT	
BRIDGE NAME	MEDINA	BRIDGE LENGTH	170.00m
REGION	K	BRIDGE WIDTH	4.75m
ROUTE NAME	S-539	TRAFFIC VOLUME

- ① Front Wall
- ② Scolling
- ③ Replacement
- ④ Portland Cement
- ⑤ 2.50 m³

- ① Steel Beam
- ② Aging of Coat
- ③ Repointing
- ④ Oil/Alkyd
- ⑤ 956.0m

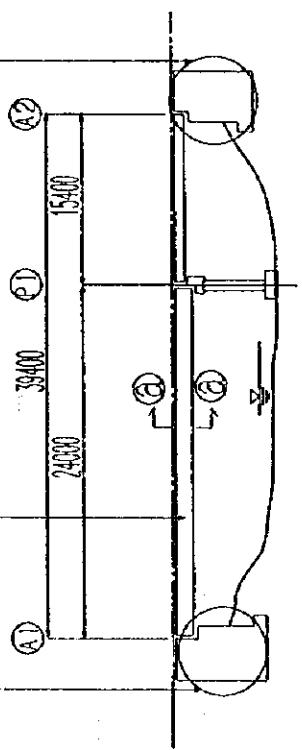
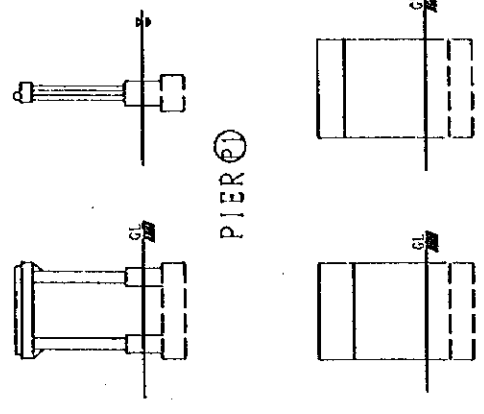
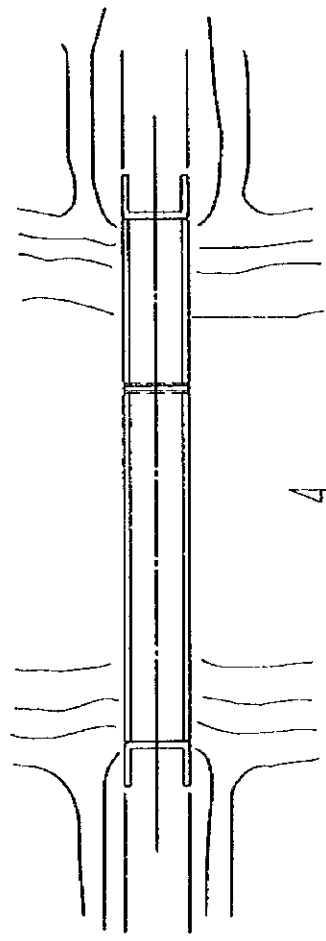
REPAIR METHODS AND QUANTITIES	
BRIDGE NUMBER	18
BRIDGE NAME	CAVTIN 88
REGION	IX
ROUTE NAME	R-925
YEAR OF BUILT	39.40m
BRIDGE LENGTH	3.85m
BRIDGE WIDTH	6/day(1996)
TRAFFIC VOLUME

- ① Side Wall
- ② Breakage
- ③ Replacement
- ④ Portland-Cement
- ⑤ 1.70 m

- ① Steel Beam
- ② Aging of Coat
- ③ Repainting
- ④ Oil/Akya
- ⑤ 237.0 m

- ① Side Wall
- ② Honeycomb
- ③ Dry-Pock
- ④ Concrete
- ⑤ 1.70 m

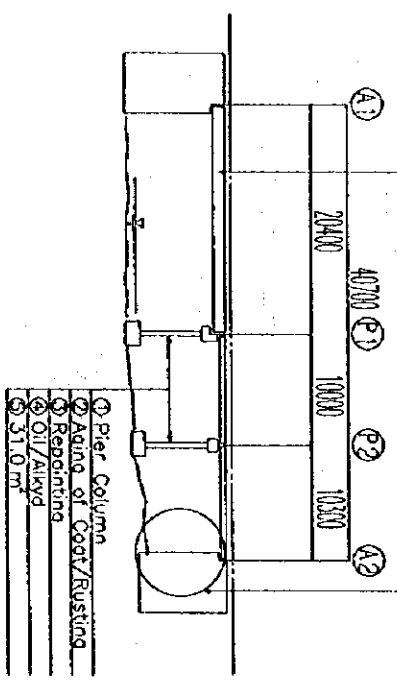
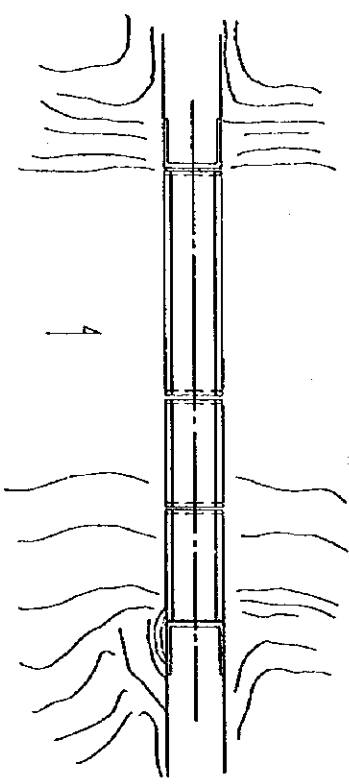
REPAIR METHODS AND QUANTITIES	
BRIDGE NUMBER	19
BRIDGE NAME	SALVA TU ALMA
REGION	X
ROUTE NAME	S-553
YEAR OF BUILT	
BRIDGE LENGTH	40.70m
BRIDGE WIDTH	4.63m
TRAFFIC VOLUME	76/day(1996)

- ① Steel Beam
- ② Aging of Coat/Rusting
- ③ Repainting
- ④ Oil/Akyd
- ⑤ 245.0 m²

- ① Front Wall
- ② Cracking
- ③ Caiking
- ④ Cement Grout
- ⑤ 0.40 m³

- ① Pier Column
- ② Aging of Coat/Rusting
- ③ Repainting
- ④ Oil/Akyd
- ⑤ 31.0 m²

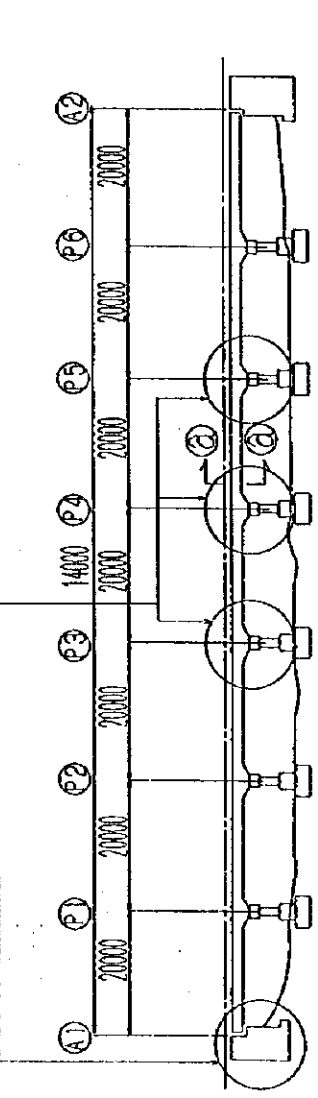
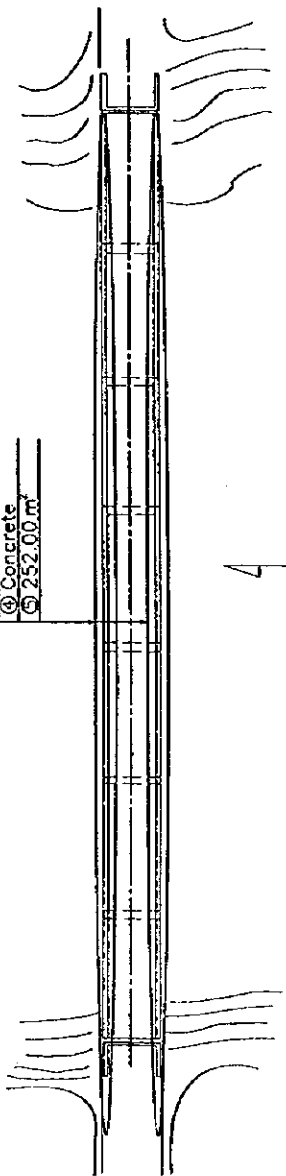
REPAIR METHODS AND QUANTITIES			
BRIDGE NUMBER	20	YEAR OF BUILT	
BRIDGE NAME	QUINCHILCA	BRIDGE LENGTH	140.00m
REGION	X	BRIDGE WIDTH	6.80m
ROUTE NAME		TRAFFIC VOLUME	839/day(1992)

- ① Side Wall
- ② Cracking
- ③ Injection
- ④ Cement Grout
- ⑤ 0.25 m³

- ① Beam of Supporting Point
- ② Delamination
- ③ Pre-Pack
- ④ Coarse Agr.+Cement S.G
- ⑤ 18.00 m³

- ① Foot Way
- ② Scalloping
- ③ Overlaying
- ④ Concrete
- ⑤ 252.00 m²
