MINISTRY OF PUBLIC WORKS
THE REPUBLIC OF CHILE

**THE REHABILITATION AND CONSERVATION
PROGRAM ON THE BRIDGES
IN
THE REPUBLIC OF CHILE
(PHASE 2)**

**APPENDIX II
(VOLUME 4/8)**

RESULTS OF GENERAL INSPECTION

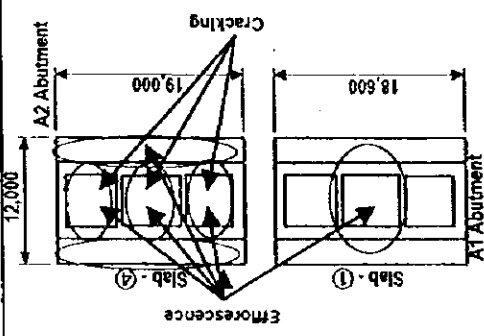
<p>Cracking</p> <p>Efflorescence</p> <p>A2 Abutment</p> <p>12,000</p> <p>19,000</p> <p>18,600</p> <p>A1 Abutment</p> <p>Slab-4</p> <p>Slab-1</p>	Cracking	<table border="1"> <thead> <tr> <th>X</th> <th>Y</th> <th>Z</th> <th>All member</th> </tr> </thead> <tbody> <tr> <td></td> <td>Large</td> <td>Large</td> <td>II</td> </tr> <tr> <td></td> <td>Small</td> <td>Small</td> <td>II</td> </tr> <tr> <td>Large</td> <td>Medium</td> <td>Large</td> <td>II</td> </tr> <tr> <td></td> <td>Small</td> <td>Small</td> <td>III</td> </tr> <tr> <td></td> <td>Small</td> <td>Small</td> <td>IV</td> </tr> <tr> <td></td> <td>Large</td> <td>Large</td> <td>III</td> </tr> <tr> <td></td> <td>Large</td> <td>Small</td> <td>III</td> </tr> <tr> <td>Small</td> <td>Medium</td> <td>Large</td> <td>IV</td> </tr> <tr> <td></td> <td>Small</td> <td>Small</td> <td>IV</td> </tr> <tr> <td></td> <td>Small</td> <td>Small</td> <td>IV</td> </tr> </tbody> </table> <p>Damage was observed, but rehabilitation is not needed. Follow-up inspection must be executed.</p>	X	Y	Z	All member		Large	Large	II		Small	Small	II	Large	Medium	Large	II		Small	Small	III		Small	Small	IV		Large	Large	III		Large	Small	III	Small	Medium	Large	IV		Small	Small	IV		Small	Small	IV	III

<p>Cracking</p> <p>Efflorescence</p> <p>Slab-4</p>

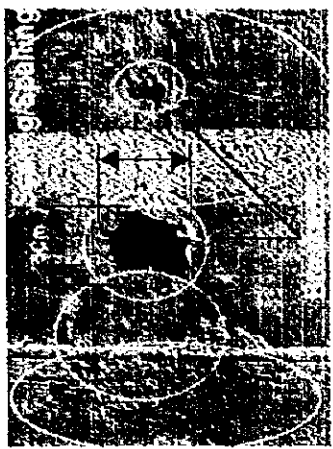
<p>Scaling/Spalling Breakage Y: no exposed reinforcement bar Z: over 1.0m²</p>	Scaling/Spalling Breakage	<p>Scaling/Spalling</p> <table border="1"> <tr> <td>Y</td> <td>Z</td> <td>Main Member</td> <td>Secondary Member</td> </tr> <tr> <td>Large</td> <td>Large</td> <td>II</td> <td>II</td> </tr> <tr> <td>Small</td> <td>Small</td> <td>IV</td> <td>IV</td> </tr> </table> <p>Damage was observed, but rehabilitation is not needed. Follow-up inspection must be executed.</p> <p>Breakage</p> <table border="1"> <tr> <td>Y</td> <td>All Members</td> <td>Degree of damage was</td> </tr> <tr> <td>Large</td> <td>Large</td> <td>large so</td> </tr> <tr> <td>Small</td> <td>Small</td> <td>that rehabilitation must be needed.</td> </tr> </table>	Y	Z	Main Member	Secondary Member	Large	Large	II	II	Small	Small	IV	IV	Y	All Members	Degree of damage was	Large	Large	large so	Small	Small	that rehabilitation must be needed.	Scaling/Spalling III Breakage II

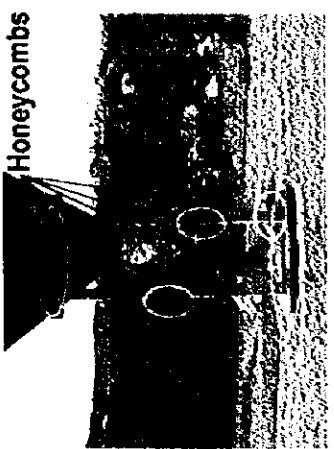
<p>Y: no exposed reinforcement bar Z: less 1.0m²</p>	Honeycombs	<table border="1"> <tr> <td>Y</td> <td>Z</td> <td>Main Member</td> <td>Secondary Member</td> </tr> <tr> <td>Large</td> <td>Large</td> <td>II</td> <td>II</td> </tr> <tr> <td>Small</td> <td>Small</td> <td>IV</td> <td>IV</td> </tr> </table> <p>Damage is observed, the degree must be recorded.</p>	Y	Z	Main Member	Secondary Member	Large	Large	II	II	Small	Small	IV	IV	IV

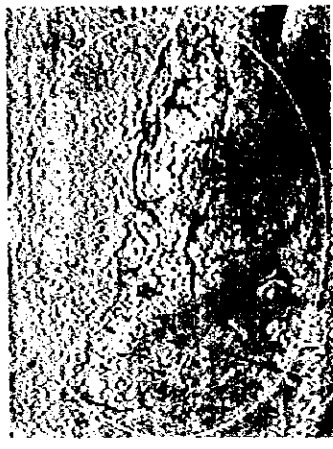
<p>Cracking X: main part Y: $\leq 0.3\text{mm}$ Z: less 50cm Scaling/ Spalling Y: no exposed reinforcement bar, but deep Z: less 1.0m²</p>	Cracking Scaling/Spalling	<p>Cracking</p> <table border="1"> <thead> <tr> <th></th> <th>X</th> <th>Y</th> <th>Z</th> <th>Main Member</th> <th>Secondary Member</th> </tr> </thead> <tbody> <tr> <td>Large</td> <td></td> <td></td> <td></td> <td>II</td> <td>III</td> </tr> <tr> <td>Medium</td> <td></td> <td></td> <td></td> <td>III</td> <td>IV</td> </tr> <tr> <td>Small</td> <td></td> <td></td> <td></td> <td>IV</td> <td>IV</td> </tr> </tbody> </table> <p>Degree of damage was large so that rehabilitation must be needed.</p> <p>Scaling/ Spalling</p> <table border="1"> <thead> <tr> <th></th> <th>Y</th> <th>Z</th> <th>Main Member</th> <th>Secondary Member</th> </tr> </thead> <tbody> <tr> <td>Large</td> <td></td> <td></td> <td>II</td> <td>III</td> </tr> <tr> <td>Small</td> <td></td> <td></td> <td>IV</td> <td>IV</td> </tr> </tbody> </table> <p>Degree of damage was observed, the degree must be recorded.</p>		X	Y	Z	Main Member	Secondary Member	Large				II	III	Medium				III	IV	Small				IV	IV		Y	Z	Main Member	Secondary Member	Large			II	III	Small			IV	IV	Cracking II Scaling/ Spalling IV

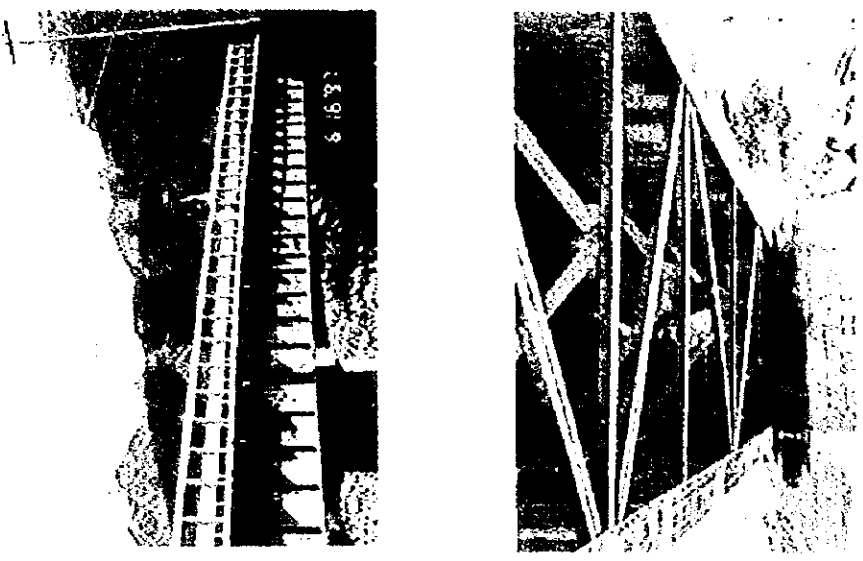
<p>Y : Means Depth Z : Means Width</p> <ul style="list-style-type: none"> • Must protect against rusting by coating. • Repairing Object is all in all. 	Y	Z	All Members	Large	Large	II	Small	Small	II	Small	Large	II	Small	Small	III	II

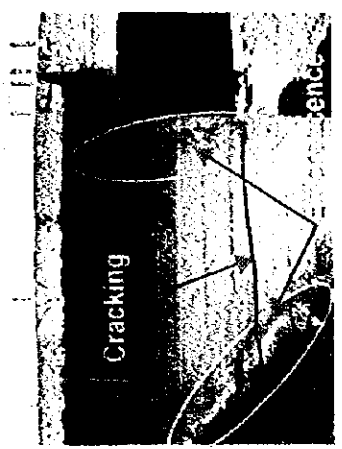
<p>Cracking Efflorescence X: main part Y: over 0.3mm Z: over 50cm</p>	Cracking Efflorescence	<p>Cracking</p> <table border="1"> <tr><td>X</td><td>Y</td><td>Z</td><td>Main Member</td><td>Secondary Member</td></tr> <tr><td>Large</td><td>Large</td><td>Small</td><td>II</td><td>II</td></tr> <tr><td>Large</td><td>Medium</td><td>Small</td><td>II</td><td>IV</td></tr> <tr><td>Small</td><td>Large</td><td>Small</td><td>V</td><td>V</td></tr> <tr><td></td><td>Large</td><td>Small</td><td>V</td><td>V</td></tr> </table> <p>Degree of damage is large so that rehabilitation must be executed.</p> <p>Efflorescence</p> <table border="1"> <tr><td>Z</td><td>Main Member</td><td>Secondary Member</td></tr> <tr><td>Large</td><td>II</td><td>II</td></tr> <tr><td>Small</td><td>II</td><td>IV</td></tr> </table> <p>Damage was observed, but rehabilitation is not needed. Follow-up inspection must be executed.</p>	X	Y	Z	Main Member	Secondary Member	Large	Large	Small	II	II	Large	Medium	Small	II	IV	Small	Large	Small	V	V		Large	Small	V	V	Z	Main Member	Secondary Member	Large	II	II	Small	II	IV	Cracking II Efflorescence III

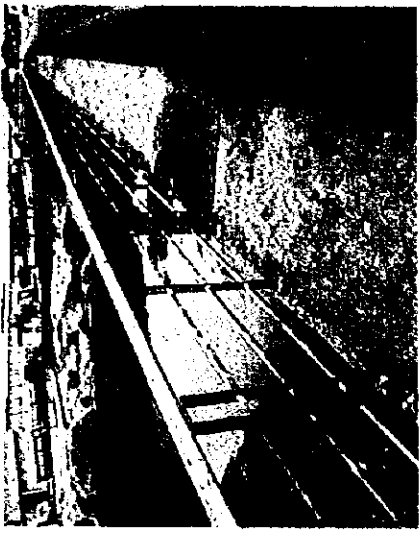
<p>30m</p>	Rusting Aging of Coat	<table border="1"> <tr> <td>Y</td> <td>Z</td> <td>Sub Members</td> </tr> <tr> <td>Large</td> <td>Large</td> <td>II</td> </tr> <tr> <td>Small</td> <td>Small</td> <td>III</td> </tr> <tr> <td>Small</td> <td>Large</td> <td>IV</td> </tr> <tr> <td>Small</td> <td>Small</td> <td>IV</td> </tr> </table> <p>Y : Means Depth Z : Means Width</p> <p>Must protect against rusting by coating.</p>	Y	Z	Sub Members	Large	Large	II	Small	Small	III	Small	Large	IV	Small	Small	IV	III

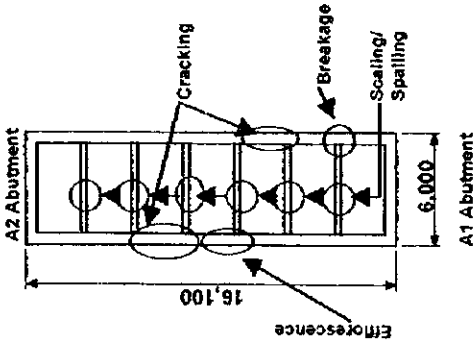
<p>Cracking X: main part 0.3 > Y \geq 0.2mm Z: less 50cm</p> <p>Scaling/ Spalling Y: no exposed reinforcement bar Z: over 0.1m²</p> <p>Breakage Y: remarkable damage</p> <p>Efflorescence Z: over 0.1m²</p>	Cracking Scaling/Spalling	<p>Cracking</p> <table border="1"> <tr> <th>Crack</th> <th>Width</th> <th>Depth</th> <th>Length</th> <th>Number</th> <th>Remarks</th> </tr> <tr> <td> </td> <td> </td> <td> </td> <td> </td> <td> </td> <td> </td> </tr> </table> <p>Although damage rank is III, cracking is caused on important member, so that rehabilitation must be needed.</p> <p>Scaling/ Spalling</p> <table border="1"> <tr> <th>Y</th> <th>Z</th> <th>Member</th> <th>Secondary Member</th> </tr> <tr> <td>Large (Small)</td> <td> </td> <td> </td> <td> </td> </tr> <tr> <td>Small (Small)</td> <td> </td> <td> </td> <td> </td> </tr> </table> <p>Damage was observed, but rehabilitation is not needed. Follow-up inspection must be executed.</p>	Crack	Width	Depth	Length	Number	Remarks							Y	Z	Member	Secondary Member	Large (Small)				Small (Small)				Cracking III*

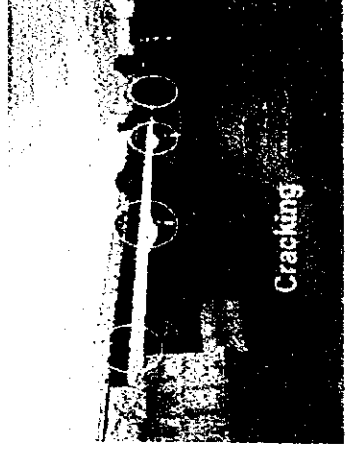
<p>P4 Pier P5~P7 Pier</p>	Cracking	The Damage (Cracking and) were observed, the rank was not justified because of inspection by distant view	No rank

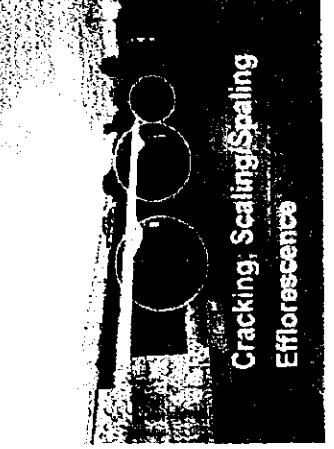
Cracking Scaling/Spalling Efflorescence	The Damages (Cracking, Scaling/Spalling and Efflorescence) were observed, the rank was not justified because of inspection by distant view.	No rank

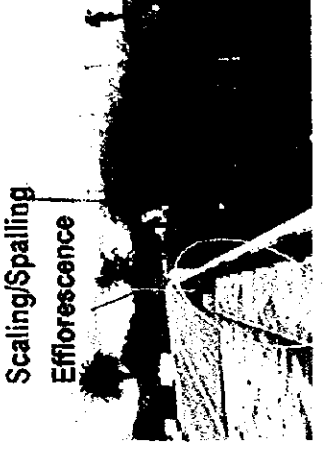
<p>Scaling/Spalling is distributed over the surface.</p> <p>Scaling/Spalling Y: no exposed reinforcement bar Z: over 1,0m²</p> <p>Efflorescence Z: less 1,0m²</p>	Scaling/Spalling Efflorescence	<p>Scaling/Spalling</p> <table border="1" data-bbox="1077 884 1197 1131"> <thead> <tr> <th></th> <th>Main Member</th> <th>Secondary Member</th> </tr> </thead> <tbody> <tr> <td>V</td> <td></td> <td></td> </tr> <tr> <td>Z</td> <td>Large</td> <td>Small</td> </tr> <tr> <td></td> <td>Large</td> <td>Small</td> </tr> <tr> <td></td> <td>Small</td> <td>Large</td> </tr> <tr> <td></td> <td>Small</td> <td>Large</td> </tr> <tr> <td></td> <td>Large</td> <td>Small</td> </tr> <tr> <td></td> <td>Small</td> <td>Large</td> </tr> <tr> <td></td> <td>Large</td> <td>Small</td> </tr> <tr> <td></td> <td>Small</td> <td>Large</td> </tr> </tbody> </table> <p>Damage was observed, but rehabilitation is not needed. Follow-up inspection must be executed.</p> <p>Efflorescence</p> <table border="1" data-bbox="1292 884 1412 1131"> <thead> <tr> <th></th> <th>Main Member</th> <th>Secondary Member</th> </tr> </thead> <tbody> <tr> <td>Z</td> <td>Large</td> <td>Small</td> </tr> <tr> <td></td> <td>Large</td> <td>Small</td> </tr> <tr> <td></td> <td>Small</td> <td>Large</td> </tr> <tr> <td></td> <td>Small</td> <td>Large</td> </tr> <tr> <td></td> <td>Large</td> <td>Small</td> </tr> <tr> <td></td> <td>Small</td> <td>Large</td> </tr> </tbody> </table> <p>Damage was observed, but rehabilitation is not needed. Follow-up inspection must be executed.</p>		Main Member	Secondary Member	V			Z	Large	Small		Large	Small		Small	Large		Small	Large		Large	Small		Small	Large		Large	Small		Small	Large		Main Member	Secondary Member	Z	Large	Small		Large	Small		Small	Large		Small	Large		Large	Small		Small	Large	Scaling/Spalling IV Efflorescence IV

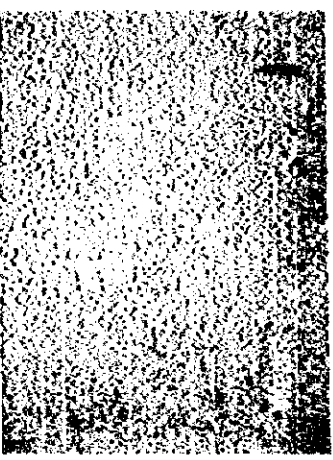
<p>5,480</p> <p>Y: no exposed reinforcement bar Z: over 1.0m²</p>	Wear	<table border="1"> <tr> <td>Y</td> <td>Z</td> <td>All members</td> </tr> <tr> <td>Large</td> <td></td> <td>II</td> </tr> <tr> <td>Small</td> <td></td> <td>III</td> </tr> <tr> <td>Large</td> <td></td> <td>IV</td> </tr> <tr> <td>Small</td> <td></td> <td>IV</td> </tr> </table> <p>Damage was observed, but rehabilitation is not needed. Follow-up inspection must be executed.</p>	Y	Z	All members	Large		II	Small		III	Large		IV	Small		IV	III
