BRIDGE NUMBER		YEAR OF BUILT	
BRIDGE NAME	CAUTIN	BRIDGE LENGTH	140.00m
REGION	X	BRIDGE WIDTH	7.00m
ROUTE NAME		TRAFFIC VOLUME

BRIDGE NO. C BRIDGE NAME : CAUTIN

B. DAMAGE RANK AND DECISION ON REHABILITATION

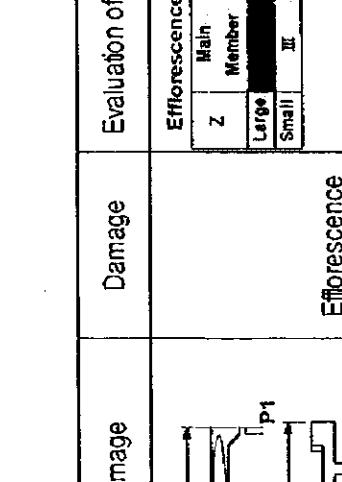
<p>Cracking (1) X: main part Y \geq 0.3mm Z: less 50cm</p> <p>Cracking (2) X: main part Y \geq 0.3mm Z: over 50cm</p>	<p>Damage</p> <p>Cracking</p>	<p>Evaluation of Damage</p> <p>Cracking</p> <table border="1" data-bbox="606 1008 790 1209"> <thead> <tr> <th>X</th> <th>Y</th> <th>Z</th> <th>Main Member</th> <th>Secondary Member</th> </tr> </thead> <tbody> <tr> <td>Large</td> <td>Small</td> <td>II</td> <td>II</td> <td>II</td> </tr> <tr> <td>Medium</td> <td>Small</td> <td>III</td> <td>III</td> <td>IV</td> </tr> <tr> <td>Small</td> <td>Small</td> <td>IV</td> <td>V</td> <td>V</td> </tr> </tbody> </table> <p>Degree of damage is large, so that rehabilitation must be needed.</p>	X	Y	Z	Main Member	Secondary Member	Large	Small	II	II	II	Medium	Small	III	III	IV	Small	Small	IV	V	V	<p>Damage Rank</p> <p>II</p>	<p>Picture</p>

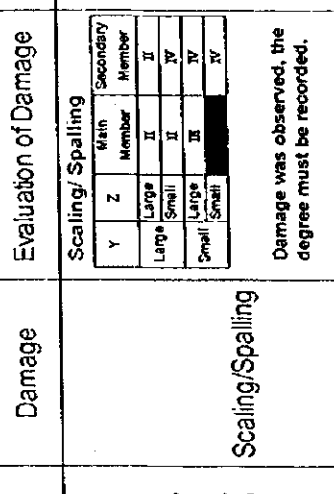
Large	Small	III	IV																						
Small	Small	IV	IV																						
Delamination	<p>Delamination Y: exposed reinforcement bar Z: less 1.0m²</p>	<table border="1" data-bbox="622 873 798 1075"> <tr> <td colspan="2">Delamination</td> <td colspan="2">Secondary Member</td> </tr> <tr> <td>Y</td> <td>Z</td> <td>Main Member</td> <td>Member</td> </tr> <tr> <td>Large</td> <td>Small</td> <td>II</td> <td>IV</td> </tr> <tr> <td>Large</td> <td>Small</td> <td>III</td> <td>IV</td> </tr> <tr> <td>Small</td> <td>Small</td> <td>IV</td> <td>IV</td> </tr> </table> <p>Although damage rank is III, reinforcement bar was exposed so that rehabilitation must be needed.</p>	Delamination		Secondary Member		Y	Z	Main Member	Member	Large	Small	II	IV	Large	Small	III	IV	Small	Small	IV	IV	*III

<p>Delamination</p>	
Delamination		Secondary Member																							
Y	Z	Main Member	Member

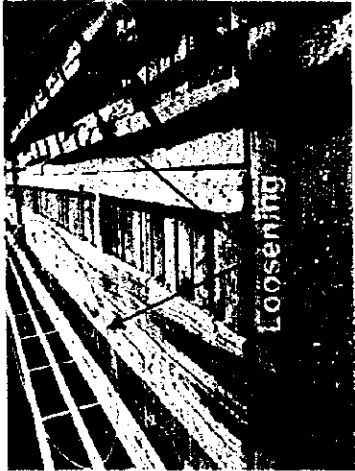
<p>Z: whole area but not excessive loosening</p>	Loosening	<table border="1"> <tr> <td>Z</td> <td>All Members</td> </tr> <tr> <td>Large</td> <td></td> </tr> <tr> <td>Small</td> <td>IV</td> </tr> </table> <p>Degree of damage is large, so that rehabilitation must be needed.</p>	Z	All Members	Large		Small	IV	II

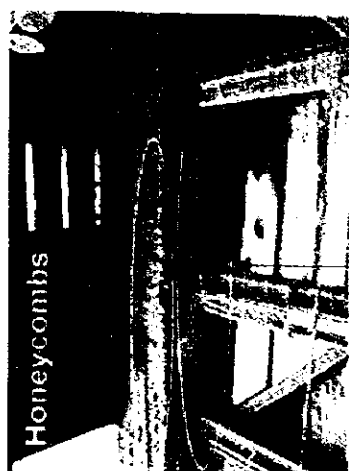
<p>Efflorescence Z: less 1.0m²</p> <p>Honeycombs Y: no exposed reinforcement bar Y: less 1.0m²</p>	Efflorescence	<table border="1" data-bbox="438 862 550 1108"> <tr> <td>Z</td> <td>Main Member</td> <td>Secondary Member</td> </tr> <tr> <td>Large</td> <td>II</td> <td>II</td> </tr> <tr> <td>Small</td> <td></td> <td>IV</td> </tr> </table> <p>Damage was observed, but rehabilitation is not needed. Follow-up inspection must be executed.</p>	Z	Main Member	Secondary Member	Large	II	II	Small		IV	III

<p>Honeycombs</p>					
		Z	Main Member	Secondary Member															
Large	II	II																	
Small		IV																	
Honeycombs	<table border="1" data-bbox="821 862 965 1108"> <tr> <td>Y</td> <td>Z</td> <td>Main Member</td> <td>Secondary Member</td> </tr> <tr> <td>Large</td> <td>Small</td> <td>II</td> <td>II</td> </tr> <tr> <td>Small</td> <td>Small</td> <td>III</td> <td>IV</td> </tr> <tr> <td></td> <td></td> <td></td> <td>IV</td> </tr> </table> <p>Damage was observed, the degree must be recorded.</p>	Y	Z	Main Member	Secondary Member	Large	Small	II	II	Small	Small	III	IV				IV	IV

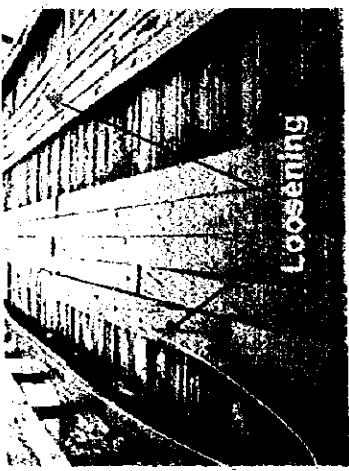
<p>5,000</p> <p>Z: whole connections and excessive loosening</p>	Loosening	<table border="1" data-bbox="268 896 367 1131"> <tr><td>Z</td><td>All Members</td></tr> <tr><td>Large</td><td></td></tr> <tr><td>Small</td><td>IV</td></tr> </table> <p>Degree of damage is large, so that rehabilitation must be needed.</p>	Z	All Members	Large		Small	IV	II

<p>Loosening</p>									
Z	All Members																			
Large																				
Small	IV																			
Hand Railing
