**FEASIBILITY STUDY  
ON  
TAUNSA BARRAGE IRRIGATION SYSTEM REHABILITATION  
IN  
THE ISLAMIC REPUBLIC OF PAKISTAN**

***Annex A***  
***Gate Structure***

## ANNEX A GATE STRUCTURE

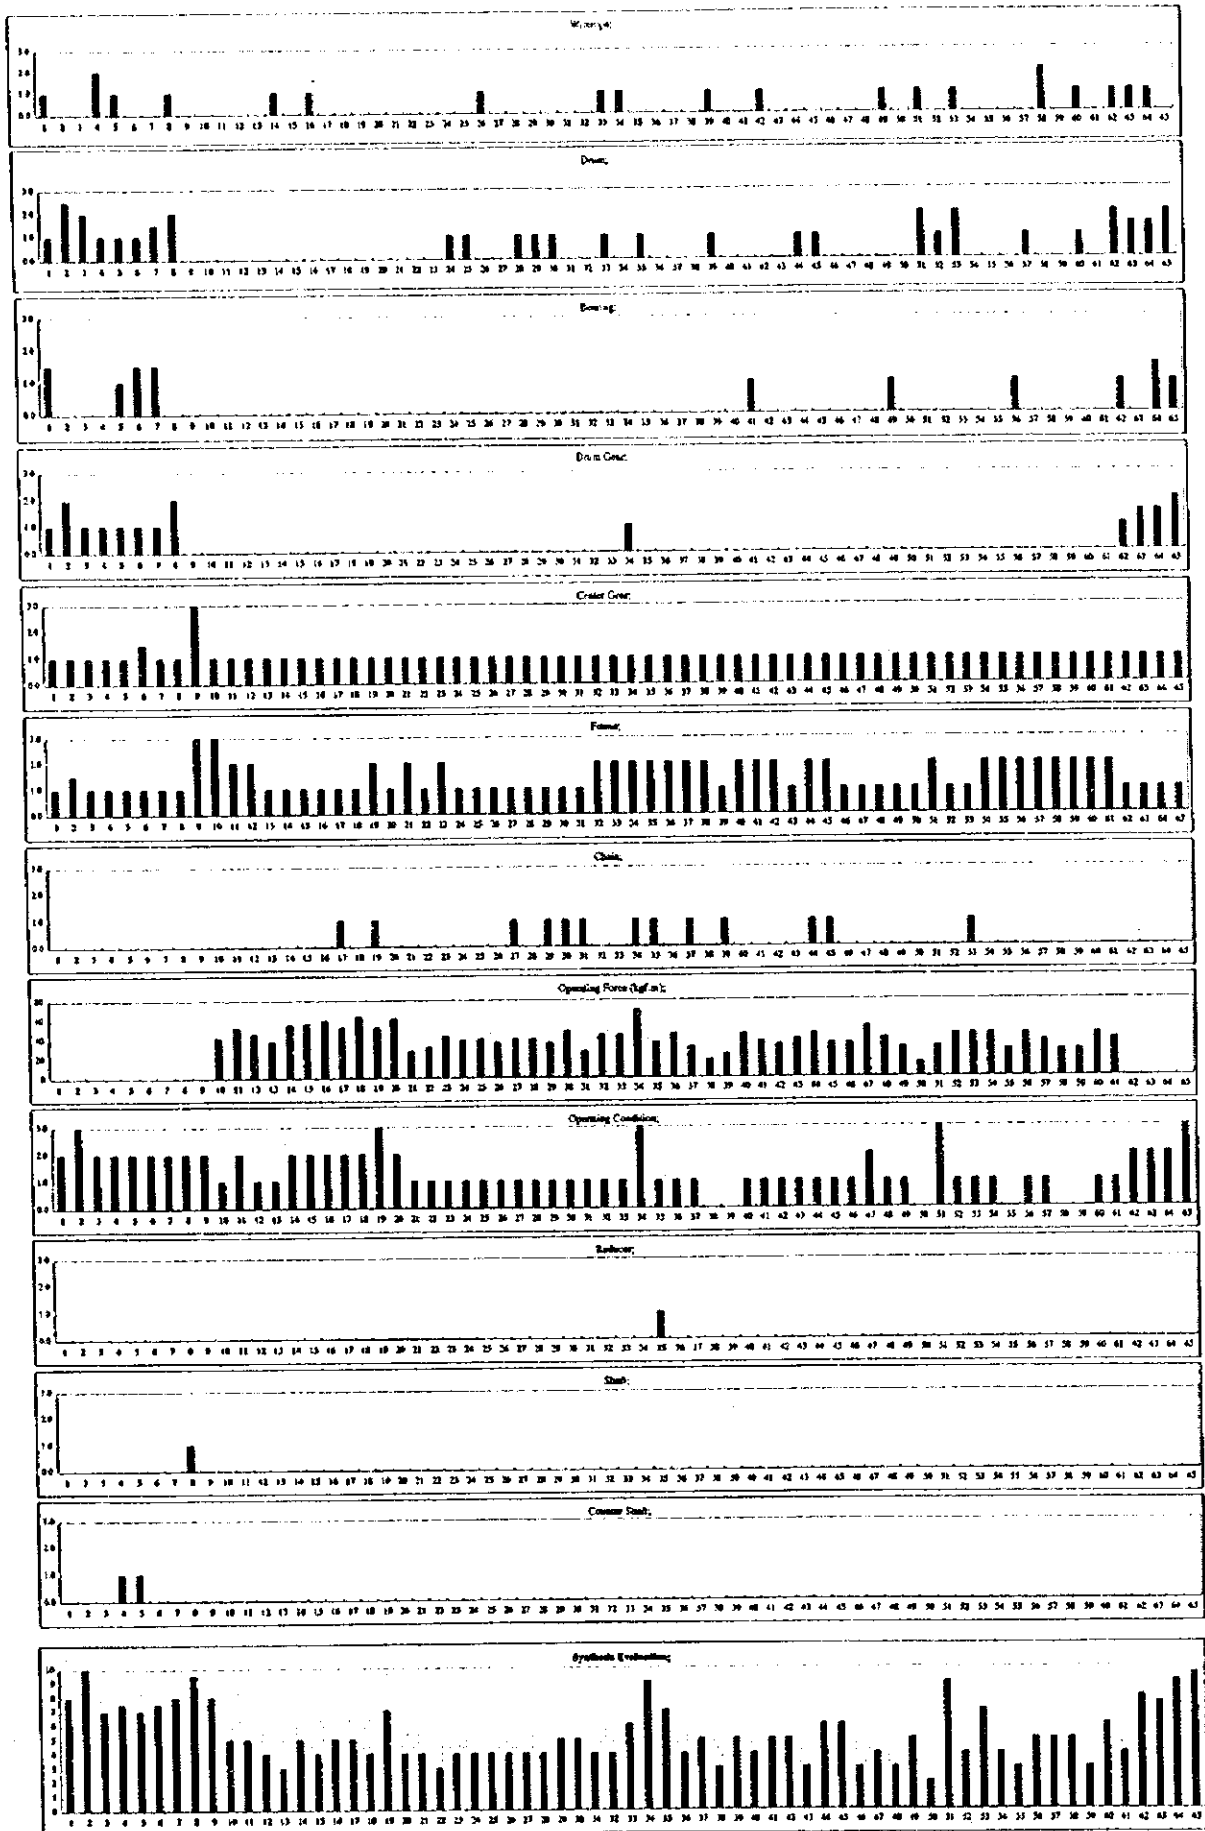
Fig A2.1 Result of Inspection on Hoisting Devices

- 1) **Wire rope;**  
Wire ropes are under good condition remaining initially lubricated oil/grease, without any damage of element wire, corrosion or deformation. Results of measuring of the diameter of wire rope were sound as original. Almost one third of total number of wire ropes for roller trains were missing or damaged. As shown in Fig. A2.1, Distribution of damages in a line of gates is scattered.

- 2) **Drum;**  
Drum bodies are under good condition without any damage or wear with only partial surface corrosion, excepting one bearing was damaged. No lubrication was almost practiced. As drum body was not designed so as to restrain the axis thrust, the drum and mount frame contacted and shaved each other. Distribution of damages in a line of gates is scattered. However, worst damages are inspected in undersluices.

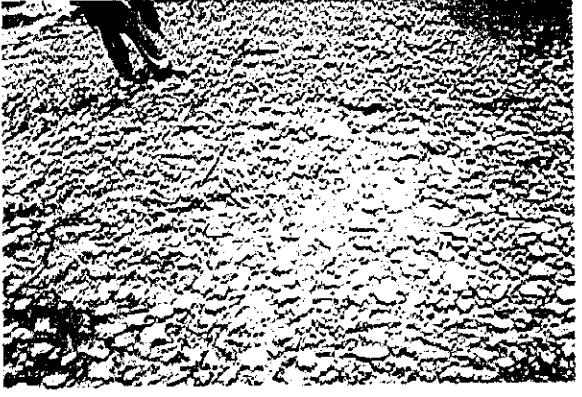
Concrete Damage (Bottom)

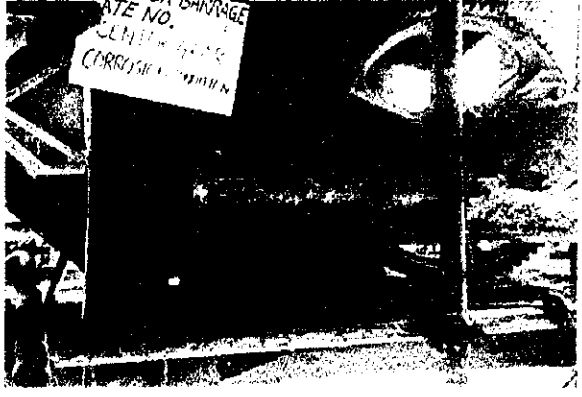
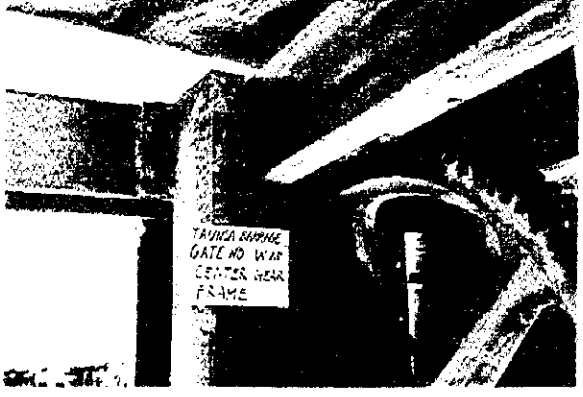
Basement Corrosion

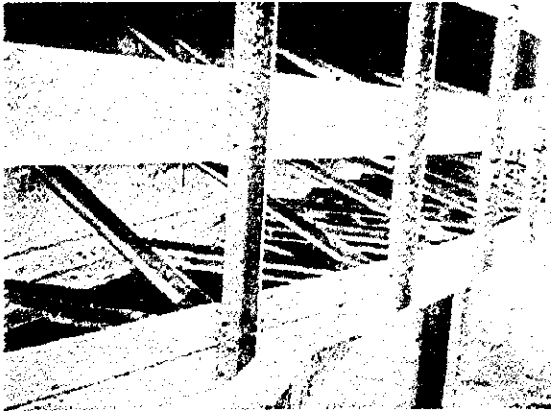
Gate No. U3L (Lower Undersluice Gate)

Skin Plate	Thickness-Avg	Top 9.9 Mid 9.8 Low 9.4 Btm 8.6 (9.5mm)		N	Wire Rope	Main-Left	Y: - Distortion: - Corrosion: - Oil: -		G	
	Corrosion	U/S-Bottom (L) M S		↑		Main-Right	Y: - Distortion: - Corrosion: - Oil: -		G	
	Damage-Rivet	Corner-L 4 Corner-R 11				Roller Train-L	Y: - Distortion: - Corrosion: - Oil: -		N	
Truss	Thickness-Avg	Bottom Flange 20.8, Bottom Web 21.0 (22.2mm)				Roller Train-R	Y: - Distortion: - Corrosion: - Oil: -		N	
	Distortion				Drum	Left	Damage: - Function: Over Lapping		RS	
End Girder	Thickness-Avg	L-Bottom 10.4, R-Bottom 11.6 (12.7mm)				Right	Damage: - Function: Touching Frame		↑	
	Remodeling	Left No Right No			Bearing	Drum	Damage: - Oil: -		↓	
	Distortion	Left No Right Bend				Counter Shaft	Damage: - Oil: -		RS	
Bottom	Thickness-Avg	Flange 14.7 mm (16.0), Web 8.2 mm (9.7)				Reduction Gear	Damage: - Oil: -		C

Girder	Corrosion	L (M) S			Gear	Drum Gear-L	Damage: - Fitting: - Backlash: - Oil: -		RS	
Rocker	Remodeling	Left No Right No				Drum Pinion-L	Damage: -		↑	
Assembly	Distortion	Left 2 m Ab. Right Heavy Ab.				Drum Gear-R	Damage: - Fitting: - Backlash: - Oil: -			
	Others	No Function				Drum Pinion-R	Damage: -			
Roller Train	Missing	Left 2 Right 1				Gear-Middle	Damage: - Fitting: - Backlash: - Oil: -			
	Diameter-Roller	Average 147.6 mm				Pinion-Middle	Damage: -			
	Distortion	Left - Right -			Basement	Drum-L	Damage: - Corrosion: L M (S)		↓	
Seal	Left	Lost				Drum-R	Damage: - Corrosion: L M (S)		↓	
	Bottom	Lost				Drive Device	Damage: - Corrosion: L (M) S		RS	
	Right	Lost			Drive Chain	Damage: - Looseness: - Oil: -		C		
Inclination	Top Level Difference - mm		↓	Chain Sprocket	Damage: - Corrosion: L (M) S		↑			
Leakage	(L) M S		N	Reduction Gear	Damage: - Corrosion: L (M) S					
<b>Sill</b>					Cover	Drum-L	Damage: - Corrosion: L M (S)		↓

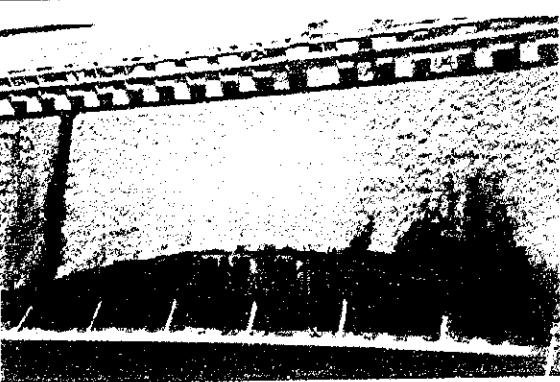
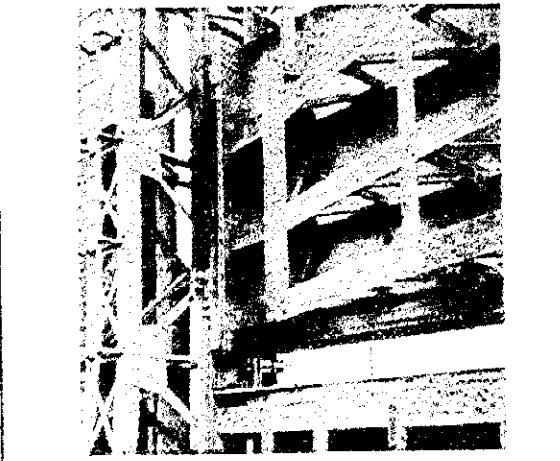
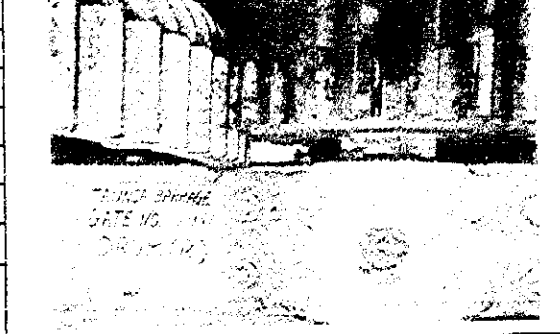
Gate No. U4U (Upper Undersluice Gate)

Skin Plate	Thickness-Avg	Top 10.0 Mid 9.9 Low 10.0 Btm 10.1 (9.5mm)	N	↑	Wire Rope	Main-Left	γ: - Distortion: - Corrosion: - Oil: -	G		
	Corrosion	U/S-Bottom L M (S)				Main-Right	γ: - Distortion: - Corrosion: - Oil: -	G		
Truss	Thickness-Avg	Bottom Flange 19.2, Bottom Web 18.7 (19.1mm)			Roller Train-L	Broken	N			
	Distortion			Roller Train-R	γ: - Distortion: - Corrosion: - Oil: -	N				
End Girder	Thickness-Avg	L-Bottom 12.5, R-Bottom 12.3 (12.7mm)			Drum	Left	Damage: - Function: -	RS		
	Remodeling	Left No Right No		Right		Damage: - Function: -	↑			
	Distortion	Left - Right -		Bearing	Drum	Damage: - Oil: -	↓			
Bottom	Thickness-Avg	Flange 11.6 mm (16.3), Web 9.0 mm (9.4)			Counter Shaft	Damage: - Oil: -	RS			
	Corrosion	(L) M S			Reduction Gear	Damage: - Oil: -	C			
Rocker	Remodeling	Left No Right No		Gear	Drum Gear-L	Damage: - Fitting: 90% Backlash: - Oil: -	RS

Assembly	Distortion	Left - Right -			Drum Pinion-L	Damage: - Miss Alignment	↑			
	Others	No Function			Drum Gear-R	Damage: - Fitting: 90% Backlash: - Oil: - Touching Frame				
Roller Train	Missing	Left 0 Right 0			Drum Pinion-R	Damage: - Miss Alignment				
	Diameter-Roller	Average 152.4 mm			Gear-Middle	Damage: - Fitting: - Backlash: - Oil: -				
	Distortion	Left - Right -		Pinion-Middle	Damage: -					
Seal	Left	1.5 m Broken		Basement	Drum-L	Damage: - Corrosion: L M (S)	↓			
	Bottom	Good			Drum-R	Damage: - Corrosion: L M (S)				
	Right	2.0 m Broken			Drive Device	Damage: - Corrosion: L (M) S	RS			
Inclination	Top Level Difference - mm		↓	Drive Chain	Damage: - Looseness: - Oil: -	C				
Leakage	L M (S)		N	Chain Sprocket	Damage: - Corrosion: L (M) S	↑				
Sill					Reduction Gear	Damage: - Corrosion: L (M) S				
Side Seal	Abrasion-Max	Left: - mm, Right: - mm	RS	Cover	Drum-L	Damage: - Corrosion: L M (S)

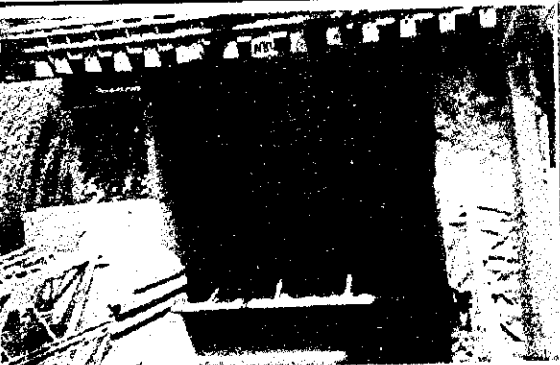
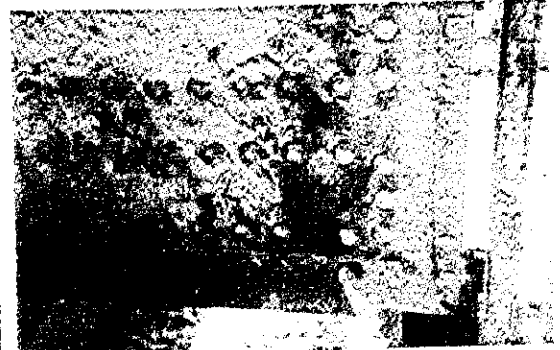
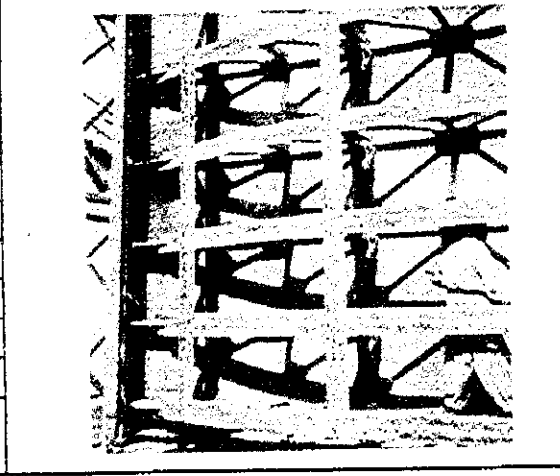
Gate No. N8U (Upstream Lock Gate)

Survey Item		Survey Result		Judge	Survey Item		Survey Result		Judge	Photograph
Gate Leaf										
Skin Plate	Thickness-Avg	Top 9.8 Mid 9.9 Low 9.3 Btm - (9.5mm)		G	Wire Rope	Main-Left	y: - Distortion: - Corrosion: - Oil: -		G

Corrosion	U/S-Bottom L (M) S		RS		Main-Right	y: - Distortion: - Corrosion: - Oil: -		G	
	Damage-Rivet	Corner-L - Corner-R -		-		Roller Train-L	y: - Distortion: - Corrosion: - Oil: -		N	
				Roller Train-R		y: - Distortion: - Corrosion: - Oil: -		N		
Truss	Thickness-Avg	Bottom Flange 9.7, Bottom Web 9.6 (11.1mm)		G	Drum	Left	Damage: - Function: -		RS	
	Distortion			G		Right	Damage: - Function: -		↑	
End Girder	Thickness-Avg	L-Bottom 10.6, R-Bottom 10.6 (11.1mm)		C	Bearing	Drum	Damage: - Oil: -		↓	
	Remodeling	Left No Right No		↑		Counter Shaft	Damage: - Oil: -		RS	
	Distortion	Left - Right -				Reduction Gear	Damage: - Oil: -		C	
Bottom Girder	Thickness-Avg	Flange - mm (16.3), Web - mm (9.4)			Gear	Drum Gear-L	Damage: - Fitting: - Backlash: - Oil: -		RS

Corrosion	L M S				Drum Pinion-L	Damage: -		↑	
Rocker Assembly	Remodeling	Left No Right No				Drum Gear-R	Damage: - Fitting: - Backlash: - Oil: -			
	Distortion	Left M.Ab. Right M.Ab.				Drum Pinion-R	Damage: -			
Roller Train	Missing	Left 0 Right 0				Gear-Middle	Damage: - Fitting: - Backlash: - Oil: -			
	Diameter-Roller	Average 152.3 mm				Pinion-Middle	Damage: -			
	Distortion	Left - Right -			Basement	Drum-L	Damage: - Corrosion: L M (S)		↓	
Seal	Left	6 m Broken				Drum-R	Damage: - Corrosion: L M (S)			
	Bottom	Lost				Drive Device	Damage: - Corrosion: L (M) S		RS	
	Right	6 m Broken			Drive Chain	Damage: - Looseness: - Oil: -		C		
Inclination	Top Level Difference - mm		↓	Chain Sprocket	Damage: - Corrosion: L (M) S		↑			
Leakage	(L) M S		C	Reduction Gear	Damage: - Corrosion: L (M) S					
Sill										
Side Seal	Abrasion-Max	Left: - mm, Right: - mm		RS	Cover	Drum-L	Damage: - Corrosion: L M (S)		↓

Roller Truck	Abrasion-Max Left: - mm, Right: - mm		RL		Drum-R	Damage: - Corrosion: L M (S)			
Roller Guard	Missing	Left 0 Right 0		N		Gear-Middle	Damage: - Corrosion: L (M) S		C	
	Defect	Left 0 Right 0		N	Counter Shaft	Damage: Touching Corrosion: L M S		G		
Sill Beam	Abrasion	L M S		-	Counter Weight	Damage: - Corrosion: L M S		RS		
Concrete	Damage-Left	L M S		-	Hoisting	Wet Condition	- kg-m			
	Damage-Right	L M S		-		Torque	Dry Condition 3.5 kg-m		RS	
	Damage-Bottom	L M S		-	Superstructure	Damage: - Corrosion: L M (S)		RS
