Survey Results of Gate Structure

Gate No.	W19	(Main Weir Gate)	Survey Item	Survey Result	Judge	Survey Item	Survey Result	Judge	Photograph
Gate Leaf	Thickness-Avg	Top 10.0 Mid 10.0 Low 9.8 Blm 9.2 (9.5mf)			G	Wire Rope	% Distortion: -- Corrosion: -- Oil: --	G	
	Corrosion	U/S-Bottom L M S				Main-Left	% Distortion: -- Corrosion: -- Oil: --	G	
	Damage-Rivet	Corner-L -- Corner-R --				Main-Right	% Distortion: -- Corrosion: -- Oil: --	C	
Truss	Thickness-Avg	Bottom Flange 18.9 Bottom Web 18.3 (19.1mm)			G	Roller Train-L	% Distortion: -- Corrosion: -- Oil: --	C	
	Distortion					Roller Train-R	% Distortion: -- Corrosion: -- Oil: --	C	
End Girder	Thickness-Avg	L-Bottom 9.9 R-Bottom 10.4 (11.1mm)			C	Left	Damage: -- Function: --	RS	
	Remodeling	Left No Right No				Right	Damage: -- Function: --	↑	
Bottom	Distortion	Left -- Right --				Drum	Damage: -- Oil: --	↓	
	Thickness-Avg	Flange 14.6 mm (16.3), Web 9.5 mm (9.4)				Counter Shaft	Damage: -- Oil: --	RS

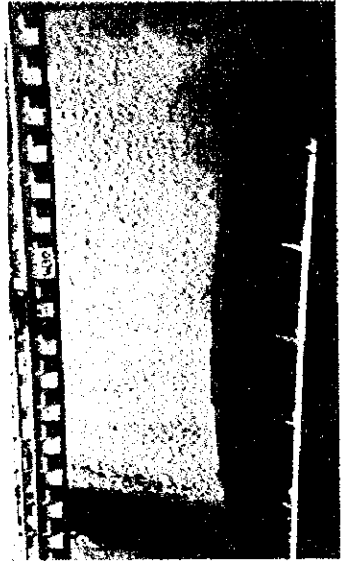
Gate No.	W30	(Main Weir Gate)	Survey Item	Survey Result	Judge	Survey Item	Survey Result	Judge	Photograph
Gate Leaf	Sun Plate	Thickness-Avg	Top - Mid - Low - Blm 8.6 (9.5mm)	G	Hoisting Device	Main-Left	y: - Distortion: - Corrosion: - Oil: -	G

Corrosion	U/S-Bottom L M S		-	Main-Right	y: - Distortion: - Corrosion: - Oil: -	
	Truss	Damage-Rivet	Corner-L - Corner-R -	-	Roller Train-L	y: - Distortion: - Corrosion: - Oil: -	C		
			Thickness-Avg	Bottom Flange 19.1, Bottom Web 18.7 (19.1mm)	G	Roller Train-R	y: - Distortion: - Corrosion: - Oil: -	C	
	End Girder	Distortion	L-Bottom 10.4, R-Bottom 9.6 (11.1mm)	C	Left	Damage: - Function: Miss Alignment	RS		
			Remodeling	Left No Right No	↑	Right	Damage: - Function: Over Lapping	↑	
	Bottom	Distortion	Left - Right -	-	Drum	Damage: - Oil: -	RS		
			Thickness-Avg	Flange 15.3 mm (16.3), Web 9.3 mm (9.4)	-	Counter Shaft	Damage: - Oil: -	RS	
	Girder	Corrosion	Left - Right -	-	Reduction Gear	Damage: - Oil: -	C

Remodeling	Left No Right No	-	Drum Gear-L	Damage: - Fitting: - Backlash: - Oil: -	RS	
	Rocker Assembly	Distortion	Left - Right -	-	Drum Pinion-L	Damage: -	↑		
			Others	No Function	-	Drum Gear-R	Damage: - Fitting: - Backlash: - Oil: -	-	
	Roller Train	Missing	Left - Right -	-	Drum Pinion-R	Damage: -	-		
			Diameter-Roller	Average - mm	-	Gear-Middle	Damage: - Fitting: - Backlash: - Oil: -	-	
	Seal	Distortion	Left - Right -	-	Pinion-Middle	Damage: -	-		
			Left - Bottom - Right -	-	Drum-L	Damage: - Corrosion: L M S	↓		
	Inclination	Leakage	Top Level Difference 85 mm	↓	Drum-R	Damage: - Corrosion: L M S	RS		
			Left - Bottom - Right -	-	Drive Device	Damage: - Corrosion: L M S	RS		
	Sill	Side Seal	Abrasion-Max	Left: - mm, Right: - mm	RS	Drive Chain	Damage: - Looseness: L Oil: -	C	
			Roller Truck	Left: - mm, Right: - mm	RL	Chain Sprocket	Damage: - Corrosion: L M S	↑	
Concrete	Roller Guard	Missing	Left 1 Right 1	N	Reduction Gear	Damage: - Corrosion: L M S	-

Sill Beam	Defect	Left 0 Right 0	N	Cover	Drum-L	Damage: - Corrosion: L M S	
Concrete	Damage-Left	Abrasion	Left M Right S	RS	Drum-R	Damage: - Corrosion: L M S	↓		
		Damage-Right	Left M Right S	RS	Gear-Middle	Damage: - Corrosion: L M S	C		
Concrete	Damage-Bottom	Damage-Left	Left 0 Right 0	N	Counter Shaft	Damage: - Corrosion: L M S	G		
		Damage-Right	Left M Right S	RS	Counter Weight	Damage: - Corrosion: L M S	RS		
Concrete	Damage-Bottom	Damage-Left	Left M Right S	RS	Hoisting	Wet Condition	48 kg-m	RL	
		Damage-Right	Left M Right S	RS	Torque	Dry Condition	5.9 kg-m	RS	
Concrete	Damage-Bottom	Damage-Left	Left M Right S	RS	Superstructure	Damage: - Corrosion: L M S	RS		
		Damage-Right	Left M Right S	RS

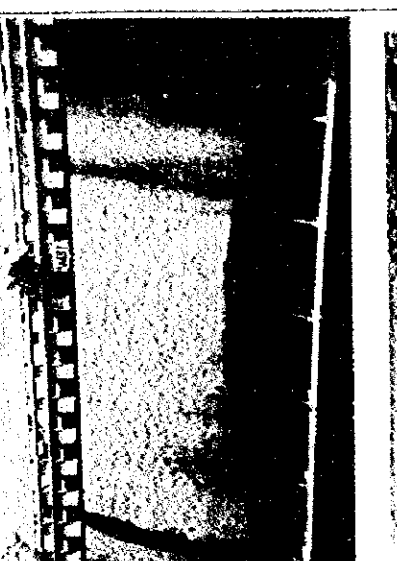
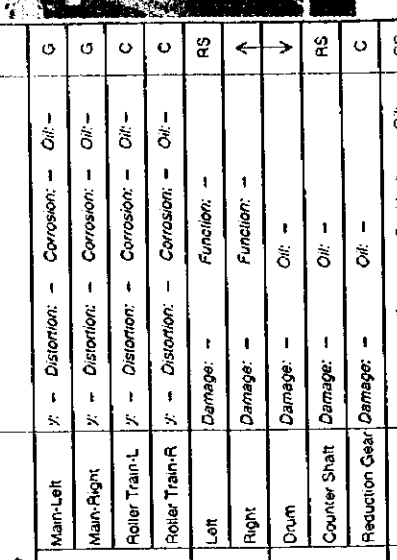
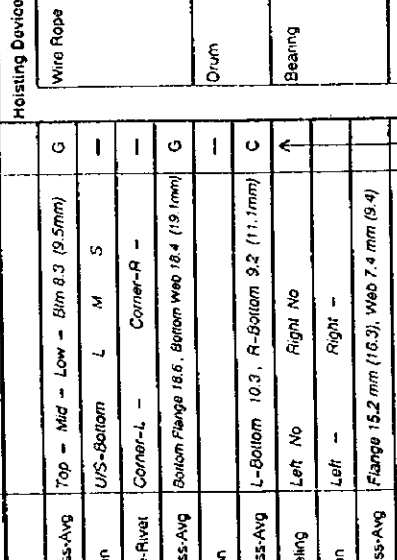
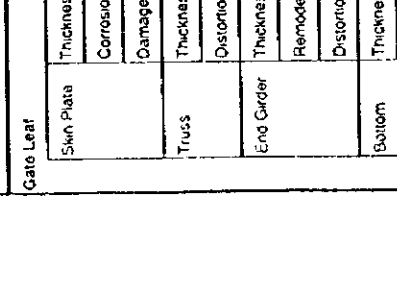
Gate No.	W31	(Main Weir Gate)	Survey Item	Survey Result	Judge	Survey Item	Survey Result	Judge	Photograph
Gate Leaf									
Skin Plate	Thickness-Avg	Top - Mid - Low - Blm 8.3 (9.5mm)		G	Hoisting Device	Main-Left	y: - Distortion: - Corrosion: - Oil: -	G

Corrosion	U/S-Bottom L M S		-		Main-Right	y: - Distortion: - Corrosion: - Oil: -	G	
Truss	Damage-Rivet	Corner-L - Corner-R -		-	Roller Train-L	y: - Distortion: - Corrosion: - Oil: -	C

Thickness-Avg	Bottom Flange 18.6, Bottom Web 18.4 (19.1mm)		G	Roller Train-R	y: - Distortion: - Corrosion: - Oil: -	C		
End Girder	Distortion			-	Left	Damage: - Function: -	RS

Thickness-Avg	L-Bottom 10.3, R-Bottom 9.2 (11.1mm)		C	Right	Damage: - Function: -	↑		
Bottom	Remodeling	Left No Right No		↑	Drum	Damage: - Oil: -	↓

Distortion	Left - Right -			Counter Shaft	Damage: - Oil: -	RS		
Girder	Thickness-Avg	Flange 15.2 mm (16.3), Web 7.4 mm (9.4)			Reduction Gear	Damage: - Oil: -	C

Corrosion	L M S			Drum Gear-L	Damage: - Fitting: - Backlash: - Oil: -	RS		
Rocker	Remodeling	Left No Right No			Drum Pinion-L	Damage: -	↑		
	Distortion	Left - Right -			Drum Gear-R	Damage: - Fitting: - Backlash: - Oil: -			
Assembly	Others	No Function			Drum Pinion-R	Damage: -			
	Missing	Left - Right -			Gear-Middle	Damage: - Fitting: - Backlash: - Oil: -			
Roller Train	Diameter-Roller	Average - mm			Pinion-Middle	Damage: -			
	Distortion	Left - Right -			Drum-L	Damage: - Corrosion: L M S			
Seal	Left	-			Drum-R	Damage: - Corrosion: L M S	↓		
	Bottom	-			Drive Device	Damage: - Corrosion: L M S	RS		
Inclination	Right	-			Drive Chain	Damage: - Looseness: L Oil: -	C		
	Top Level Difference	120 mm		↓	Chain Sprocket	Damage: - Corrosion: L M S	↑		
Leakage		L M S		C	Reduction Gear	Damage: - Corrosion: L M S			
					Cover	Damage: - Corrosion: L M S			
Sill	Side Seal	Left: - mm, Right: - mm		RS	Drum-L	Damage: - Corrosion: L M S	↓

Roller Truck	Left: - mm, Right: - mm		RL	Drum-R	Damage: - Corrosion: L M S			
Sill Beam	Roller Guard	Left 0 Right 1		N	Gear-Middle	Damage: - Corrosion: L M S	C		
	Defect	Left 0 Right 0		N	Counter Shaft	Damage: - Corrosion: L M S	G		
Concrete	Abrasion	L M S		RS	Counter Weight	Damage: - Corrosion: L M S	RS		
	Damage-Left	L M S		RS	Hoisting	Wet Condition 24 kg-m	G		
	Damage-Right	L M S		RS	Torque	Dry Condition 4.3 kg-m	RS		
	Damage-Bottom	L M S		RS	Superstructure	Damage: - Corrosion: L M S	RS

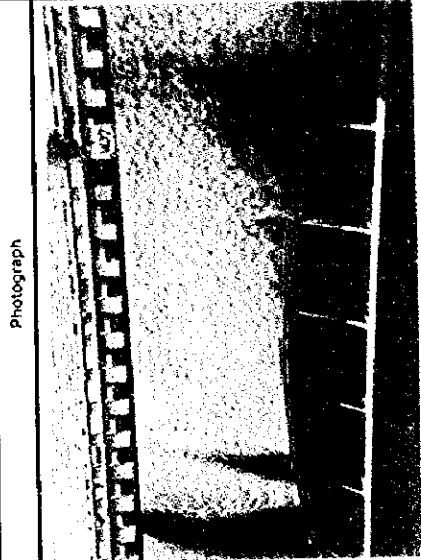
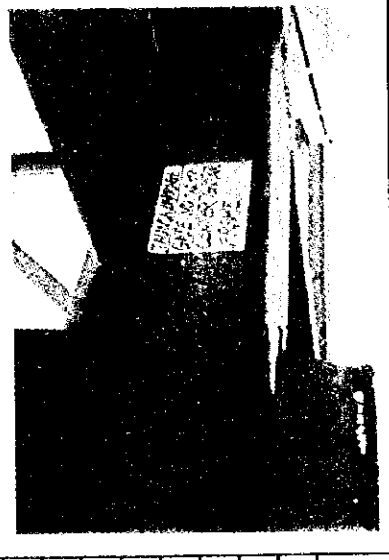
Gate No.	W37	(Main Weir Gate)	Survey Result	Judge	Survey Item	Survey Result	Judge
Gate Leaf							
Skin Plate	Thickness-Avg	Top - Mid - Low - Blm - (9.5mm)	-		Wire Rope	Main-Left Main-Right Roller Train-L Roller Train-R	C G C C
	Corrosion	L/S-Bottom L M S	-		Drum	Left Right	RS ↑
	Damage-Rivet	Corner-L - Corner-R -	-		Bearing	Drum Counter Shaft	↓ RS
	Thickness-Avg	Bottom Flange - , Bottom Web - (19.1mm)	-		Gear	Reduction Gear	C
	Distortion		-			Drum Gear-L Drum Pinion-L	RS ↑
End Girder	Thickness-Avg	L-Bottom - , R-Bottom - (11.7mm)	G			Drum Gear-R Drum Pinion-R	↓ -
	Remodelling	Left No Right No	↑			Gear-Middle	-
	Distortion	Left - Right -	-			Pinion-Middle	-
Bottom	Thickness-Avg	Flange - mm (16.3), Web - mm (9.4)	-		Basement	Drum-L Drum-R	↓ ↓
Girder	Corrosion	L M S	-			Drive Device	RS
Rocker	Remodelling	Left No Right No	-			Chain	-
Assembly	Distortion	Left - Right -	-			Chain Sprocket	-
	Others	No Function	-			Reduction Gear	-

Roller Train	Missing	Left - Right -	-			Cover	-
	Diameter-Roller	Average - mm	-			Drum-L Drum-R	↓ ↓
	Distortion	Left - Right -	-			Gear-Middle	C
Seal	Left	-	-			Counter Shaft	G
	Bottom	-	-			Counter Weight	RS
	Right	-	-			Hoisting	RL
Inclination		Top Level Difference 160 mm	↓			Torque	RS
Leakage		(L) M S	C			Superstructure	RS
Sill							
	Side Seal	Abrasion-Max Left: - mm, Right: - mm	RS				
	Roller Truck	Abrasion-Max Left: - mm, Right: - mm	RL				
	Roller Guard	Missing Left 0 Right 0	N				
		Defect Left 1 Right 1	N				
	Sill Beam	Abrasion L M S	-				
	Concrete	Damage-Left L (M) S	RS				
		Damage-Right L (M) S	RS				
		Damage-Bottom L M (S)	RS

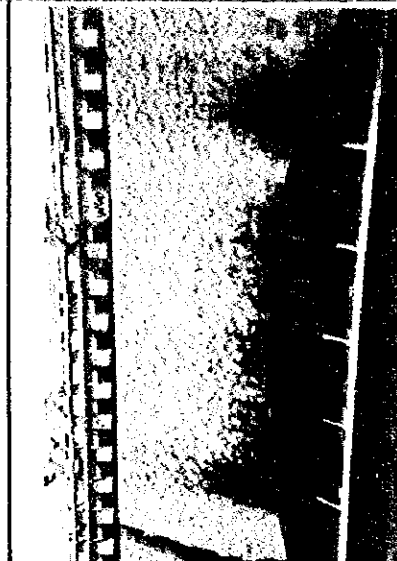
Gate No. W40 (Main Weir Gate)

Survey Item	Survey Result	Judge	Survey Item	Survey Result	Judge	Photograph
Gate Leaf						
Thickness-Avg	Top - Mid - Low - 81m - (9.5mm)	-	Moisting Device			
Corrosion	U/S-Bottom L M S	-	Wire Rope	Main-Left Main-Right Roller Train-L Roller Train-R	Y - Distortion - Corrosion - Oil - Y - Distortion - Corrosion - Oil - Y - Distortion - Corrosion - Oil - Y - Distortion - Corrosion - Oil -

Damage-Rivet	Corner-L - Corner-R -	-	Drum	Left Right	Damage - Function - Damage - Function -	
Thickness-Avg	Bottom Flange - , Bottom Web - (19.1mm)	-	Bearing	Drum	Damage - Oil -	
Distortion		-	Counter Shaft	Reduction Gear	Damage - Oil - Damage - Oil -	
Thickness-Avg	L-Bottom - , R-Bottom - (11.1mm)	C	Gear	Drum Gear-L Drum Pinion-L Drum Gear-R Drum Pinion-R	Damage - Fitting - Backlash - Oil - Damage - Damage - Fitting - Backlash - Oil - Damage -	
Remodeling	Left No Right No	↑	Basement	Drum-L Drum-R	Damage - Corrosion - L M S Damage - Corrosion - L M S

Distortion	Left - Right -		Drive Chain	Drive Device	Damage - Corrosion - L M S	
Thickness-Avg	Flange - mm (16.3), Web - mm (9.4)		Chain Sprocket	Reduction Gear	Damage - Corrosion - L M S Damage - Corrosion - L M S	
Corrosion	L M S		Cover	Drum-L Drum-R	Damage - Corrosion - L M S Damage - Corrosion - L M S	
Remodeling	Left No Right No		Counter Shaft	Counter Shaft	Damage - Corrosion - L M S	
Distortion	Left - Right -		Counter Weight	Counter Weight	Damage - Corrosion - L M S	
Others	No Function		Hoisting	Wet Condition	44.4 kg-m	
Missing	Left - Right -		Torque	Dry Condition	- kg-m	
Diameter-Roller	Average - mm		Superstructure		Damage - Corrosion - L M S	
Distortion	Left - Right -					
Left	-					
Bottom	-					
Right	-					
Inclination	Top Level Difference 20 mm	↓				
Leakage	Ⓛ M S	C				
Sill						
Side Seal	Abrasion-Max Left: - mm, Right: - mm	RS				
Roller Truck	Abrasion-Max Left: - mm, Right: - mm	RL				
Roller Guard	Missing Left 1 Right 1	N

Defect	Left 0 Right 0	N				
Abrasion	L M S	-				
Damage-Left	L M S	RS				
Damage-Right	L M S	RS				
Damage-Bottom	Ⓛ M S	RS

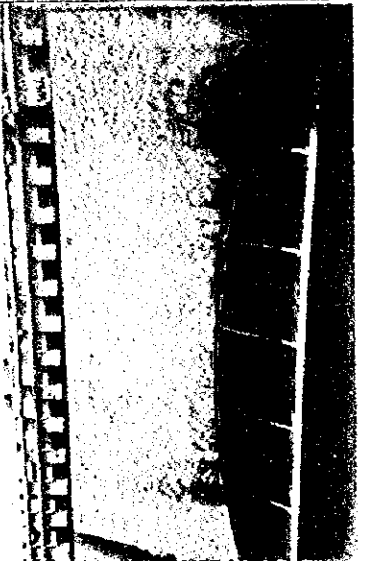
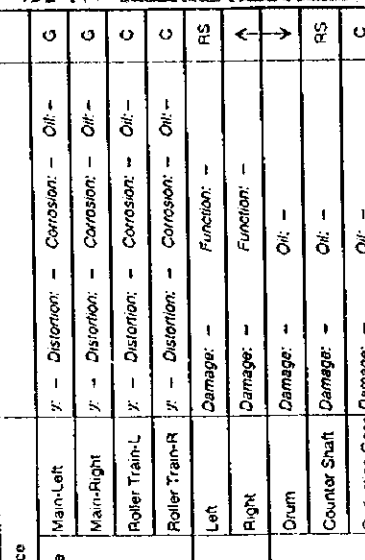
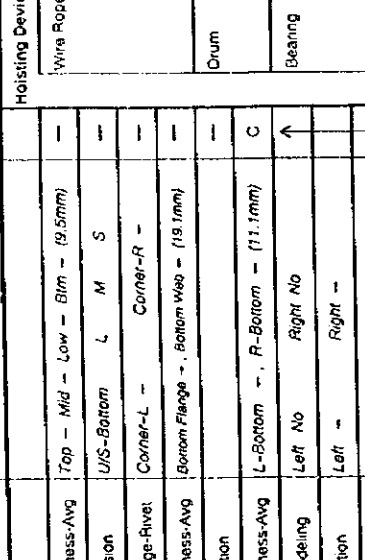
Gate No.	W46	(Main Weir Gate)	Survey Item	Survey Result	Judge	Survey Item	Survey Result	Judge	Photograph	
Gate Leaf	Thickness-Avg	Top - Mid - Low - Blm - (9.5mm)				Wine Rope

Corrosion	L/S-Bottom L M S				Main-Left	y: - Distortion: - Corrosion: - Oil: -	G		
Truss	Damage-Rivet	Corner-L - Corner-R -				Main-Right	y: - Distortion: - Corrosion: - Oil: -	G

Thickness-Avg	Bottom Flange - , Bottom Web - (19.1mm)				Roller Train-L	y: - Distortion: - Corrosion: - Oil: -	G		
End Girder	Distortion					Roller Train-R	y: - Distortion: - Corrosion: - Oil: -	C

Thickness-Avg	L-Bottom - , R-Bottom - (11.1mm)				Left	Damage: - Function: -	RS		
Bottom	Remodeling	Left No Right No				Right	Damage: - Function: -	↑
