# Survey Results of Gate Structure

Gate No. W55 (Main Weir Gate)

Gate No. W56 (Main Weir Gate)		Survey Item	Survey Result	Judge	Survey Item	Survey Result	Judge	Photograph
Gate Leaf					Hoisting Device			
Sun Plate	Thickness-Avg	Top - Mid - Low - Btm - (9.5mm)	—		Wire Rope	Main-Left	Y - Distortion: - Corrosion: - Oil: -

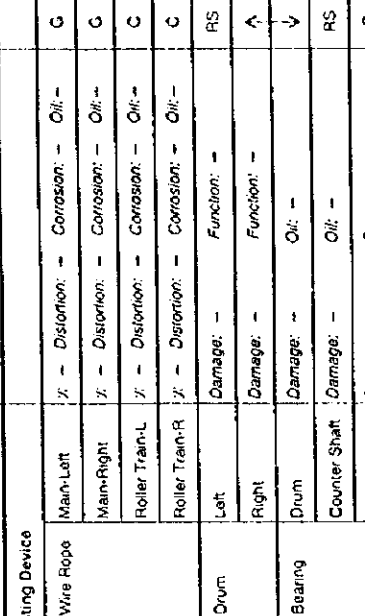
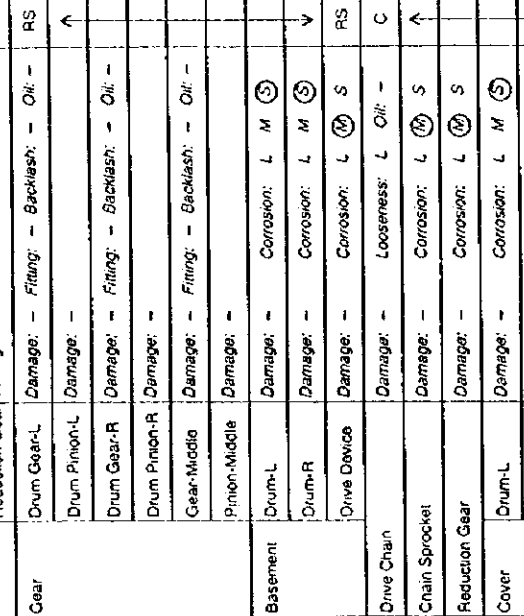
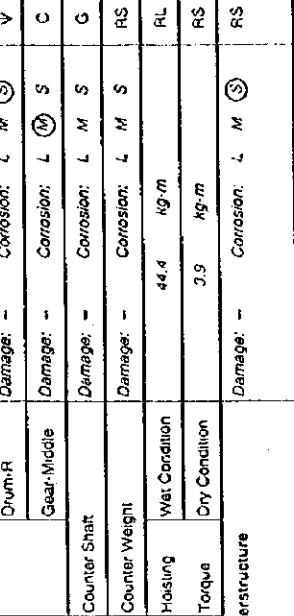
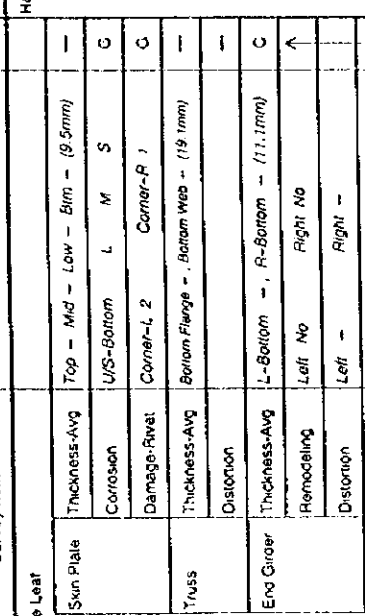
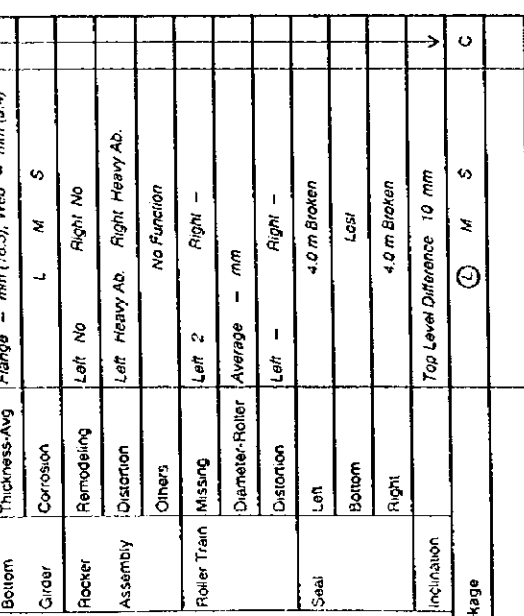
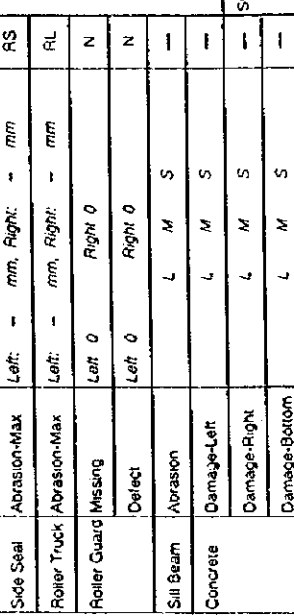
( 64 / 96 )

Corrosion	UIS-Bottom L M S	G		Main-Right	Y - Distortion: - Corrosion: - Oil: -	G	
Truss	Damage-Rivet	Corner-L 2 Corner-R 1	G		Roller Train-L	Y - Distortion: - Corrosion: - Oil: -	G

Thickness-Avg	Bottom Flange - Bottom Web - (19.1mm)	—		Roller Train-R	Y - Distortion: - Corrosion: - Oil: -	C	
End Groove	Distortion		—		Drum	Left	Damage: - Function: -

Thickness-Avg	L-Bottom - R-Bottom - (11.1mm)	C		Right	Damage: - Function: -	A	
Bottom	Remodeling	Left No Right No	↑		Bearing	Drum	Damage: - Oil: -

Distortion	Left - Right -			Counter Shaft	Damage: - Oil: -	RS	
Groove	Thickness-Avg	Flange - mm (16.3), Web - mm (3.4)			Reduction Gear	Damage: - Oil: -	C

Corrosion	L M S			Drum Gear-L	Damage: - Fitting: - Backlash: - Oil: -	RS	
Rocker Assembly	Remodeling	Left No Right No			Drum Pinion-L	Damage: -	↑

Distortion	Left Heavy Ab. Right Heavy Ab.			Drum Gear-R	Damage: - Fitting: - Backlash: - Oil: -		
Roller Train	Others	No Function			Drum Pinion-R	Damage: -

Missing	Left 2 Right -			Gear-Middle	Damage: - Fitting: - Backlash: - Oil: -		
Seal	Diameter-Roller	Average - mm			Pinion-Middle	Damage: -

Distortion	Left - Right -			Drum-L	Damage: - Corrosion: L M S		
Inclination	Left	4.0 m Broken			Drum-R	Damage: - Corrosion: L M S	↓

Bottom	Lost			Drive Device	Damage: - Corrosion: L M S	RS	
Leakage	Right	4.0 m Broken			Drive Chain	Damage: - Looseness: L Oil: -	C

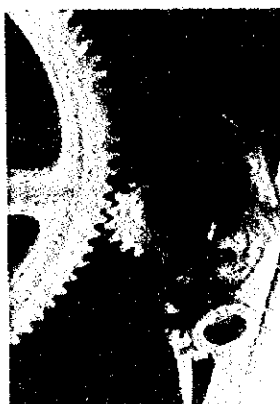
Survey Item		Survey Result		Judge	Survey Item		Survey Result		Judge
Gate Leaf					Hoisting Device				
Skin Plate	Thickness-Avg	Top - Mid - Low - Btm - (9.5mm)		-	Wire Rope	Main-Left	y: - Distortion: - Corrosion: - Oil: -	G	
	Corrosion	U/S-Bottom L M (S)		G		Main-Right	y: - Distortion: - Corrosion: - Oil: -	G	
	Damage-Rivet	Corner-L 1 Corner-R 1		G		Roller Train-L	Broken	C	
	Thickness-Avg	Bottom Flange - , Bottom Web - (19.1mm)		-		Roller Train-R	y: - Distortion: - Corrosion: - Oil: -	C	
Truss	Distortion			-	Drum	Left	Damage: - Function: Miss Alignment	RS	
	Thickness-Avg	L-Bottom - , R-Bottom - (11.1mm)		C		Right	Damage: - Function: -	↑	
	Remodeling	Left No Right No		↑		Drum	Damage: - Oil: -	↓	
	Distortion	Left - Right Small Bend				Counter Shaft	Damage: - Oil: -	RS	
Bottom	Thickness-Avg	Flange - mm (16.3), Web - mm (9.4)			Gear	Reduction Gear	Damage: - Oil: -	C	
	Corrosion	L M S				Drum Gear-L	Damage: - Fitting: - Backlash: - Oil: -	RS

Remodeling	Left No Right No				Drum Pinion-L	Damage: -	↑	
	Distortion	Left Heavy Ab. Right Broken				Drum Gear-R	Damage: - Fitting: 30% Backlash, 4.6 mm Oil: -		
Rocker Assembly	Others	No Function			Pinion-Middle	Drum Pinion-R	Damage: -		
	Missing	Left - Right -				Gear-Middle	Damage: - Fitting: - Backlash: - Oil: -		
	Diameter-Roller	Average - mm				Pinion-Middle	Damage: -		
	Distortion	Left - Right -				Drum-L	Damage: - Corrosion: L M (S)		
Seal	Left	5 m Broken			Basement	Drum-R	Damage: - Corrosion: L M (S)	↓	
	Bottom	Lost				Drive Device	Damage: - Corrosion: L (M) S	RS	
	Right	Lost				Drive Chain	Damage: - Looseness: - Oil: -	C	
	Inclination	Top Level Difference 10 mm		↓		Chain Sprocket	Damage: - Corrosion: L (M) S	↑	
Leakage		L (M) S		C	Cover	Reduction Gear	Damage: - Corrosion: L (M) S		
						Drum-L	Damage: - Corrosion: L M (S)		
						Drum-R	Damage: - Corrosion: L M (S)	↓	
						Gear-Middle	Damage: - Corrosion: L (M) S	C

Sill	Abrasion-Max	Left: - mm, Right: - mm		RS	Counter Shaft	Counter Shaft	Damage: - Corrosion: L M S	G	
	Abrasion-Max	Left: 10 mm, Right: 13 mm		RL		Counter Weight	Damage: - Corrosion: L M S	RS	
	Missing	Left 1 Right 1		N		Hosing	Wet Condition	44.4 kg m	RL
	Defect	Left 0 Right 1		N		Torque	Dry Condition	3.1 kg m	RS
Concrete	Abrasion	L M S		-	Superstructure	Damage: - Corrosion: L M (S)		RS	
	Damage-Left	L M S		-					
	Damage-Right	L M S		-					
	Damage-Bottom	L M S		-

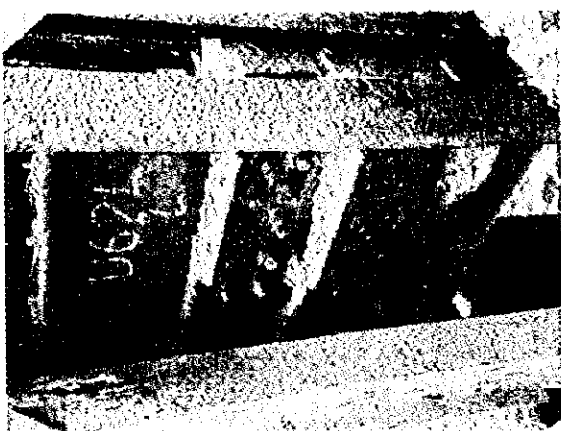
Gate No. U62L (Lower Undersluice Gate)

Hoisting Device							
Wire Rope				Main-Left	% Distortion: - Corrosion: - Oil: -	G	
San Plate	Top - Mid - Low - Btm 8.1 (9.5mm)	N		Main-Right	% Distortion: - Corrosion: - Oil: -	G	
Thickness-Avg	U/S-Bottom (L) M S	↑		Roller Train-L	% Distortion: - Corrosion: - Oil: -	N	
Corrosion	Corner-L 14.5 mm Corner-R 12 mm			Roller Train-R	Broken	N	
Damage-Rivet	Bottom Flange 21.4, Bottom Web 20.7 (22.2mm)			Left	Damage: - Function: Touching Flange	RS	
Thickness-Avg				Right	Damage: - Function: Over Lapping	↑	
Distortion	L-Bottom 10.1, R-Bottom 10.4 (12.7mm)			Drum	Damage: - Oil: -	↓	
End Girder	Left Re Right Re			Counter Shaft	Damage: - Oil: -	RS	
Remodeling	Left - Right Bend			Reduction Gear	Damage: Loose Oil: -	C	
Distortion				Drum Gear-L	Damage: - Fitting: - Backlash: - Oil: -	RS	
Bottom	Flange 14.3 mm (16.0), Web 7.6 mm (9.7)			Drum Pinion-L	Damage: -	↑

Girder	Corrosion L (M) S			Drum Pinion-R	Damage: -		
Roller	Remodeling Left Re Right Re			Gear-Middle	Damage: - Fitting: - Backlash: - Oil: -		
Assembly	Distortion Left - Right -			Pinion-Middle	Damage: -		
Others	Original Type			Drum-L	Damage: - Corrosion: L M (S)	↓	
Roller Train	Missing Left 1 Right -			Drum-R	Damage: - Corrosion: L M (S)	↓	
Diameter-Roller	Average - mm			Drive Device	Damage: - Corrosion: L (M) S	RS	
Distortion	Left - Right -			Drive Chain	Damage: - Looseness: - Oil: -	C	
Left	Lost			Chain Sprocket	Damage: - Corrosion: L (M) S	↑	
Bottom	Lost			Reduction Gear	Damage: - Corrosion: L (M) S		
Right	Lost			Cover	Damage: - Corrosion: L M (S)		
Inclination	Top Level Difference 20 mm	↓		Drum-L	Damage: - Corrosion: L M (S)	↓	
Leakage							
Sill							
Side Seal	Abrasion-Max Left: - mm, Right: - mm	RS		Drum-R	Damage: - Corrosion: L M (S)	↓	
Roller Truck	Abrasion-Max Left: - mm, Right: - mm	RL		Gear-Middle	Damage: - Corrosion: L (M) S	C

Roller Guard	Missing Left 1 Right 1	N		Counter Shaft	Damage: - Corrosion: L M S	C	
Defect	Left 0 Right 0	N		Counter Weight	Damage: - Corrosion: L M S	RS	
Sill Beam	Abrasion Left M S	-		Hoisting	Wet Condition - kg-m	-	
Concrete	Damage-Left L M S	-		Torque	Dry Condition 3.1 kg-m	RS	
Damage-Right	L M S	-		Superstructure		Damage: - Corrosion: L M (S)	RS
Damage-Bottom	L M S	-

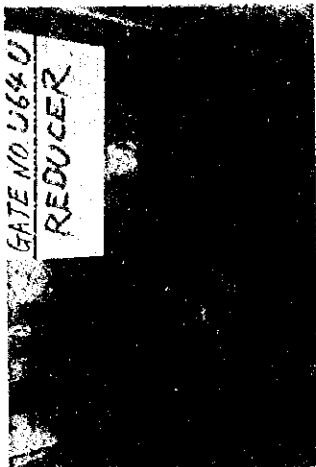
GATE NO U64 J

Survey Item		Survey Result	Judge
Hoisting Device			
Wire Rope	Main-Left	% Distortion: - Corrosion: - Oil: -	G
	Main-Right	% Distortion: - Corrosion: - Oil: -	G
Roller Train-L	Roller Train-L	% Distortion: - Corrosion: - Oil: -	N
	Roller Train-R	% Distortion: - Corrosion: - Oil: -	N
Drum	Left	Damage: - Function: -	RS
	Right	Damage: - Function: -	↑
Bearing	Drum	Damage: - Oil: -	↓
	Counter Shaft	Damage: - Oil: -	RS
Gear	Reduction Gear	Damage: Broken Oil: -	C
	Drum Gear-L	Damage: - Filing: 80% Backlash: - Oil: -	RS
Pinion-L	Drum Pinion-L	Damage: Miss Alignment	↑
	Drum Gear-R	Damage: - Filing: - Backlash: - Oil: -	
Pinion-R	Drum Pinion-R	Damage: Miss Alignment	
	Gear-Middle	Damage: - Filing: - Backlash: - Oil: -	
Basement	Pinion-Middle	Damage: -	
	Drum-L	Damage: - Corrosion: L M S	
Drive Device	Drum-R	Damage: - Corrosion: L M S	↓
	Drive Device	Damage: - Corrosion: L M S	RS
Chain Sprocket	Drive Chain	Damage: - Looseness: - Oil: -	C

Chain Sprocket	Damage: - Corrosion: L M S	↑
Cover	Reduction Gear	Damage: - Corrosion: L M S	
	Drum-L	Damage: - Corrosion: L M S	
Counter Shaft	Drum-R	Damage: - Corrosion: L M S	↓
	Gear-Middle	Damage: - Corrosion: L M S	C
Counter Weight	Counter Shaft	Damage: - Corrosion: L M S	G
	Counter Weight	Damage: - Corrosion: L M S	RS
Torque	Hoisting	Wet Condition	-
	Torque	Dry Condition	17.2 kg-m
Superstructure		Damage: - Corrosion: L M S	RS

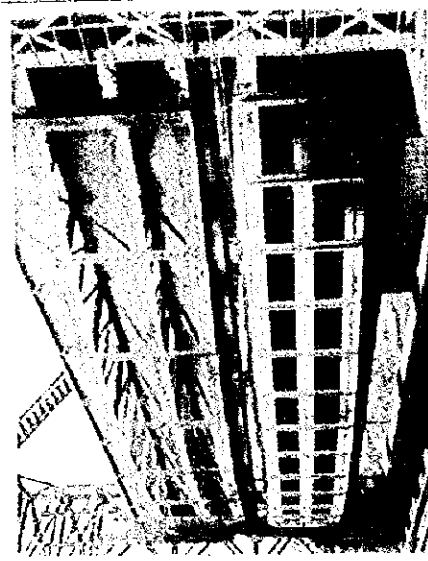
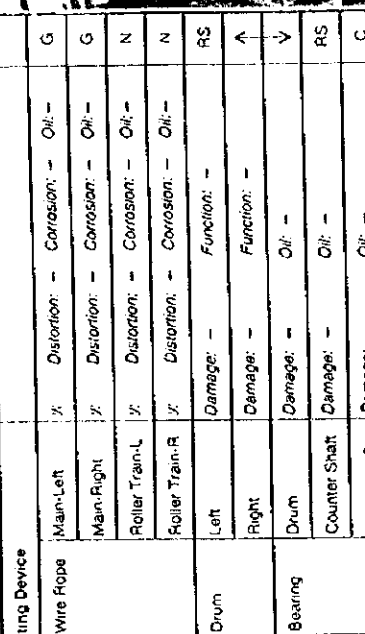
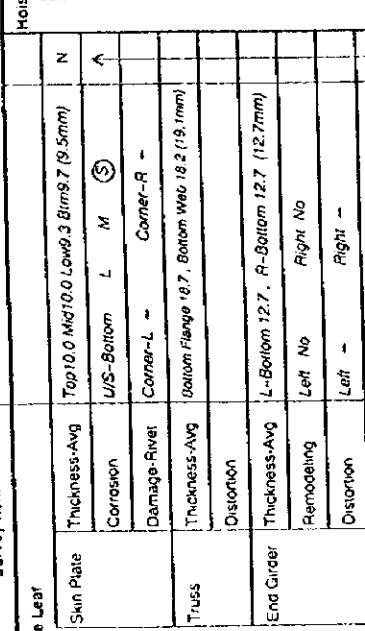
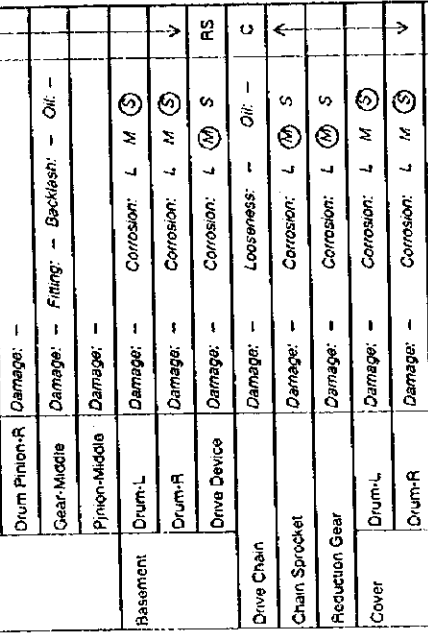
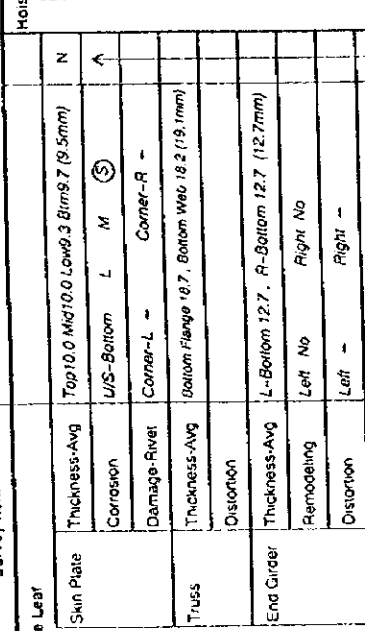
Gate No.	U6SU	(Upper Undersluice Gate)			Survey Item	Survey Result	Judge	Survey Item	Survey Result	Judge	Photograph
Gate Leaf											
Skin Plate	Thickness-Avg	Top 10.0 Mid 10.0 Low 9.3 Rim 9.7 (9.5mm)			N		Wire Rope	Main-Left	Y: Distortion: - Corrosion: - Oil: -	G

Corrosion	U/S-Bottom L M S			↑			Main-Right	Y: Distortion: - Corrosion: - Oil: -	G	
	Damage-Rivet	Corner-L - Corner-R -						Roller Train-L	Y: Distortion: - Corrosion: - Oil: -	N	
Truss	Thickness-Avg	Bottom Flange 18.7, Bottom Web 18.2 (19.1mm)					Roller Train-R	Y: Distortion: - Corrosion: - Oil: -	N

Distortion						Left	Damage: - Function: -	RS		
	Thickness-Avg	L-Bottom 12.7, R-Bottom 12.7 (12.7mm)					Right	Damage: - Oil: -	↑		
End Girder	Remodeling	Left No Right No					Bearing	Drum	Damage: - Oil: -	↓

Distortion	Left - Right -						Counter Shaft	Damage: - Oil: -	RS	
	Thickness-Avg	Flange 12.1 mm (16.3), Web 9.5 mm (9.4)						Reduction Gear	Damage: - Oil: -	C

Left	4 m Broken						Drum-R	Damage: - Corrosion: L M S	↓	
	Bottom	Good						Drive Device	Damage: - Corrosion: L M S	RS	
Inclination	Right	2.5 m Broken					Drive Chain	Damage: - Looseness: - Oil: -	C

Top Level Difference	130 mm			↓			Chain Sprocket	Damage: - Corrosion: L M S		↑
	Leakage	L M S			N			Reduction Gear	Damage: - Corrosion: L M S		
Sill	Abrasion-Max	Left: - mm, Right: - mm			RS		Cover	Drum-L	Damage: - Corrosion: L M S	↓

Roller Truck	Left: 8 mm, Right: 4 mm			N			Drum-R	Damage: - Corrosion: L M S	↑	
	Roller Guard	Left 0 Right 0			N			Gear-Middle	Damage: - Corrosion: L M S	C	
Concrete	Defect	Left 0 Right 0			N		Counter Shaft	Damage: - Corrosion: L M S	G

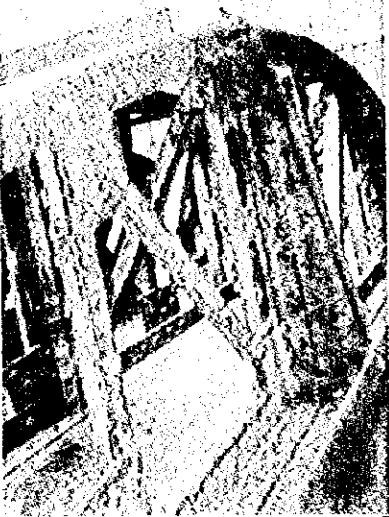
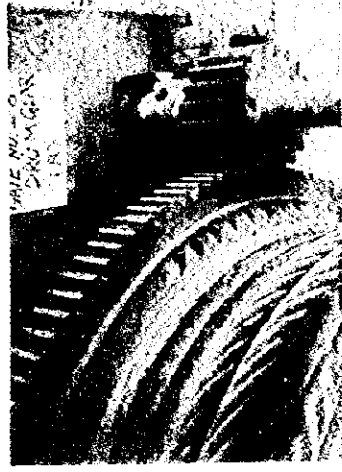
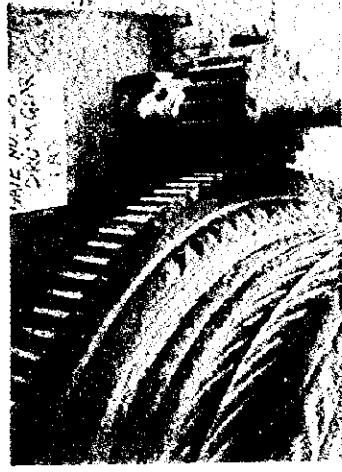
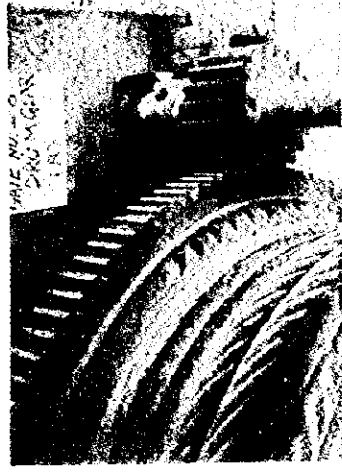
Gate No. D6 (D.G. Khan Canal Regulator Gate)

Survey Item	Survey Result	Judge	Survey Item	Survey Result	Judge	Photograph
<b>Gate Leaf</b>						
Sun Plate	Thickness-Avg	Top 10.1 Mid 9.8 Low 9.5 Rim 9.6 (9.5mm)	G	Man-Left	Y: - Distortion: - Corrosion: - Oil: -

Corrosion	URS-Bottom L M S		Man-Right	Y: - Distortion: - Corrosion: - Oil: -	
	Damage-Rivet	Corner-L - Corner-R -		Roller Train-L	Y: - Distortion: - Corrosion: - Oil: -	
	Thickness-Avg	Bottom Flange 5.5, Bottom Web 7.3 (9.5mm)		Roller Train-R	Broken	
Truss	Distortion	10 mm (T-J, Center, 3 Points)	A	Left	Damage: - Function: -

Thickness-Avg	L-Bottom 7.8, R-Bottom 8.7 (9.5mm)		Right	Damage: - Function: -	
	Remodeling	Left No Right No		Drum	Damage: - Oil: -	
	Distortion	Left - Right -		Counter Shaft	Damage: - Oil: -	
Bottom Girder	Thickness-Avg	Flange 13.5 mm (16.3), Web 7.9 mm (9.4)		Reduction Gear	Damage: - Oil: -

Right	-		Drive Device	Damage: - Corrosion: L M S	
	Top Level Difference	110 mm		Drive Chain	Damage: - Looseness: L Oil: -	
	Leakage	L M S		Chain Sprocket	Damage: - Corrosion: L M S	
Sill	Abrasion-Max	Left: - mm, Right: - mm	G	Reduction Gear	Damage: - Corrosion: L M S

Roller Truck	Left: 5 mm, Right: 4 mm		Cover	Damage: - Corrosion: L M S	
	Roller Guard	Left 0 Right 0		Drum-L	Damage: - Corrosion: L M S	
	Defect	Left 0 Right 0		Drum-R	Damage: - Corrosion: L M S	
Sill Beam	Abrasion	L M S		Gear-Middle	Damage: - Corrosion: L M S

Damage-Left	L M S		Counter Shaft	Damage: - Corrosion: L M S	
	Damage-Right	L M S		Counter Weight	Damage: - Corrosion: L M S	
	Damage-Bottom	L M S		Hoisting	9.3 kg-m	
Concrete	Damage-Right	L M S	G	Torque	0 kg-m

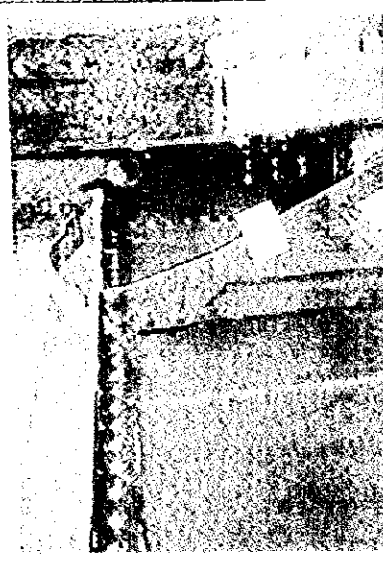
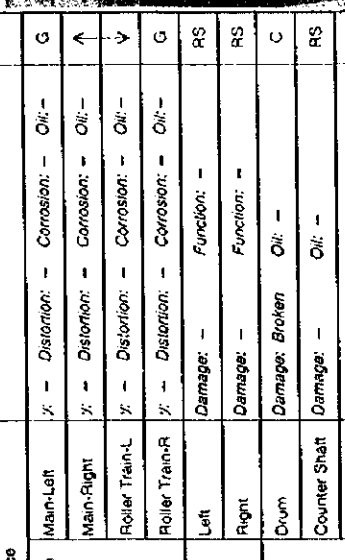
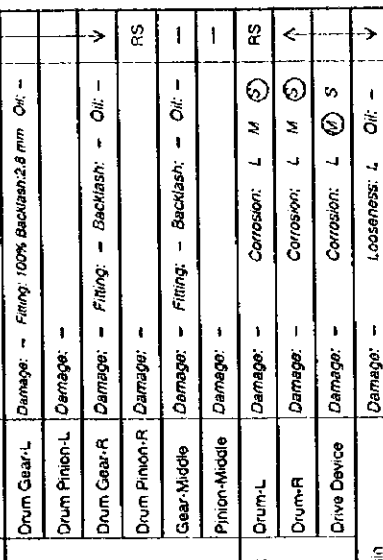
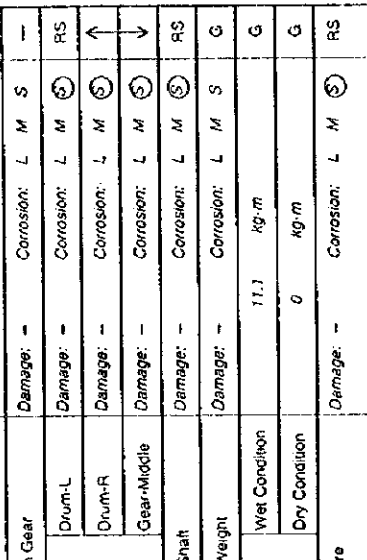
Gate No. M3 (Muzaffargarh Canal Regulator Gate)

Corrosion	U/S-Bottom L M S	-		Main-Right	Y: - Distortion: - Corrosion: - Oil: -	
	Damage-Rivet	Corner-L - Corner-R -	-		Roller Train-L	Y: - Distortion: - Corrosion: - Oil: -	
Truss	Thickness-Avg	Bottom Flange 8.7 Bottom Web 8.6 (9.5mm)	G	Drum	Roller Train-R	Y: - Distortion: - Corrosion: - Oil: -

Distortion		↑		Left	Damage: - Function: -	
End Girder	Thickness-Avg	L-Bottom 8.3 R-Bottom 8.0 (9.5mm)		Bearing	Right	Damage: - Function: -

Remodeling	Left No Right No			Drum	Damage: Broken Oil: -	
	Distortion	Left - Right -			Counter Shaft	Damage: - Oil: -	
Bottom Girder	Thickness-Avg	Flange 13.5 mm (16.3), Web 7.7 mm (9.4)		Gear	Reduction Gear	Damage: - Oil: -

Corrosion	L (M) S			Drum Gear-L	Damage: - Filing: 100% Backlash 2.8 mm Oil: -

Distortion	Left - Right -			Drum-L	Damage: - Corrosion: L M (S)	
	Left	-			Drum-R	Damage: - Corrosion: L M (S)	
Seal	Bottom	- Top Deform		Chain Sprocket	Drive Device	Damage: - Corrosion: L (M) S

Side Seal	Abrasion-Max	Left: - mm, Right: - mm	G		Drum-L	Damage: - Corrosion: L M (S)	
	Abrasion-Max	Left: 3 mm, Right: 5 mm	↑		Drum-R	Damage: - Corrosion: L M (S)

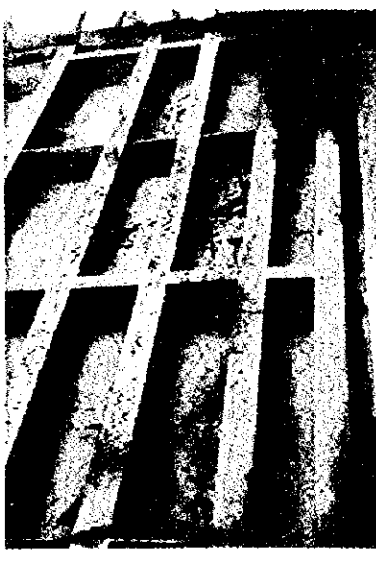
Corrosion	Top: 3 mm, Bottom: 1.0 mm (mm)		Main-Right		
Truss	Thickness-Avg		Drum	Left

Distortion	Bottom Flange 9.6, Bottom Web 6.4 (mm)		Right		
End Girder	Thickness-Avg		Bearing	Drum

Remodeling	L-Bottom 17.1, R-Bottom 16.4 (mm)		Counter Shaft		
	Distortion	Left No Right No	Gear	Reduction Gear		
		Left No Right No		Reduction Gear		
Main Roller	Diameter-Roller	Average - mm	Basement	Drum-L		
	Distortion	Left - Right -		Drum-R		
Seal	Left			Drive Device		
	Bottom					
Inclination	Right					
Leakage	Top Level Difference	750 mm				
Sill	Side Seal	Left: - mm, Right: - mm	Cover	Drum-L		
	Roller Truck	Left: 3 mm, Right: 3 mm		Drum-R		
			Counter Shaft	Reduction Gear		
				Reduction Gear		
Sill Beam	Abrasion	L M S	Counter Weight	Drum-L		
	Damage-Left	L M S		Drum-R
