## ***Annex B***

# ***Hydraulic Structures and Barrage Foundation***

## B.1. Taunsa Barrage Hydraulics Structure

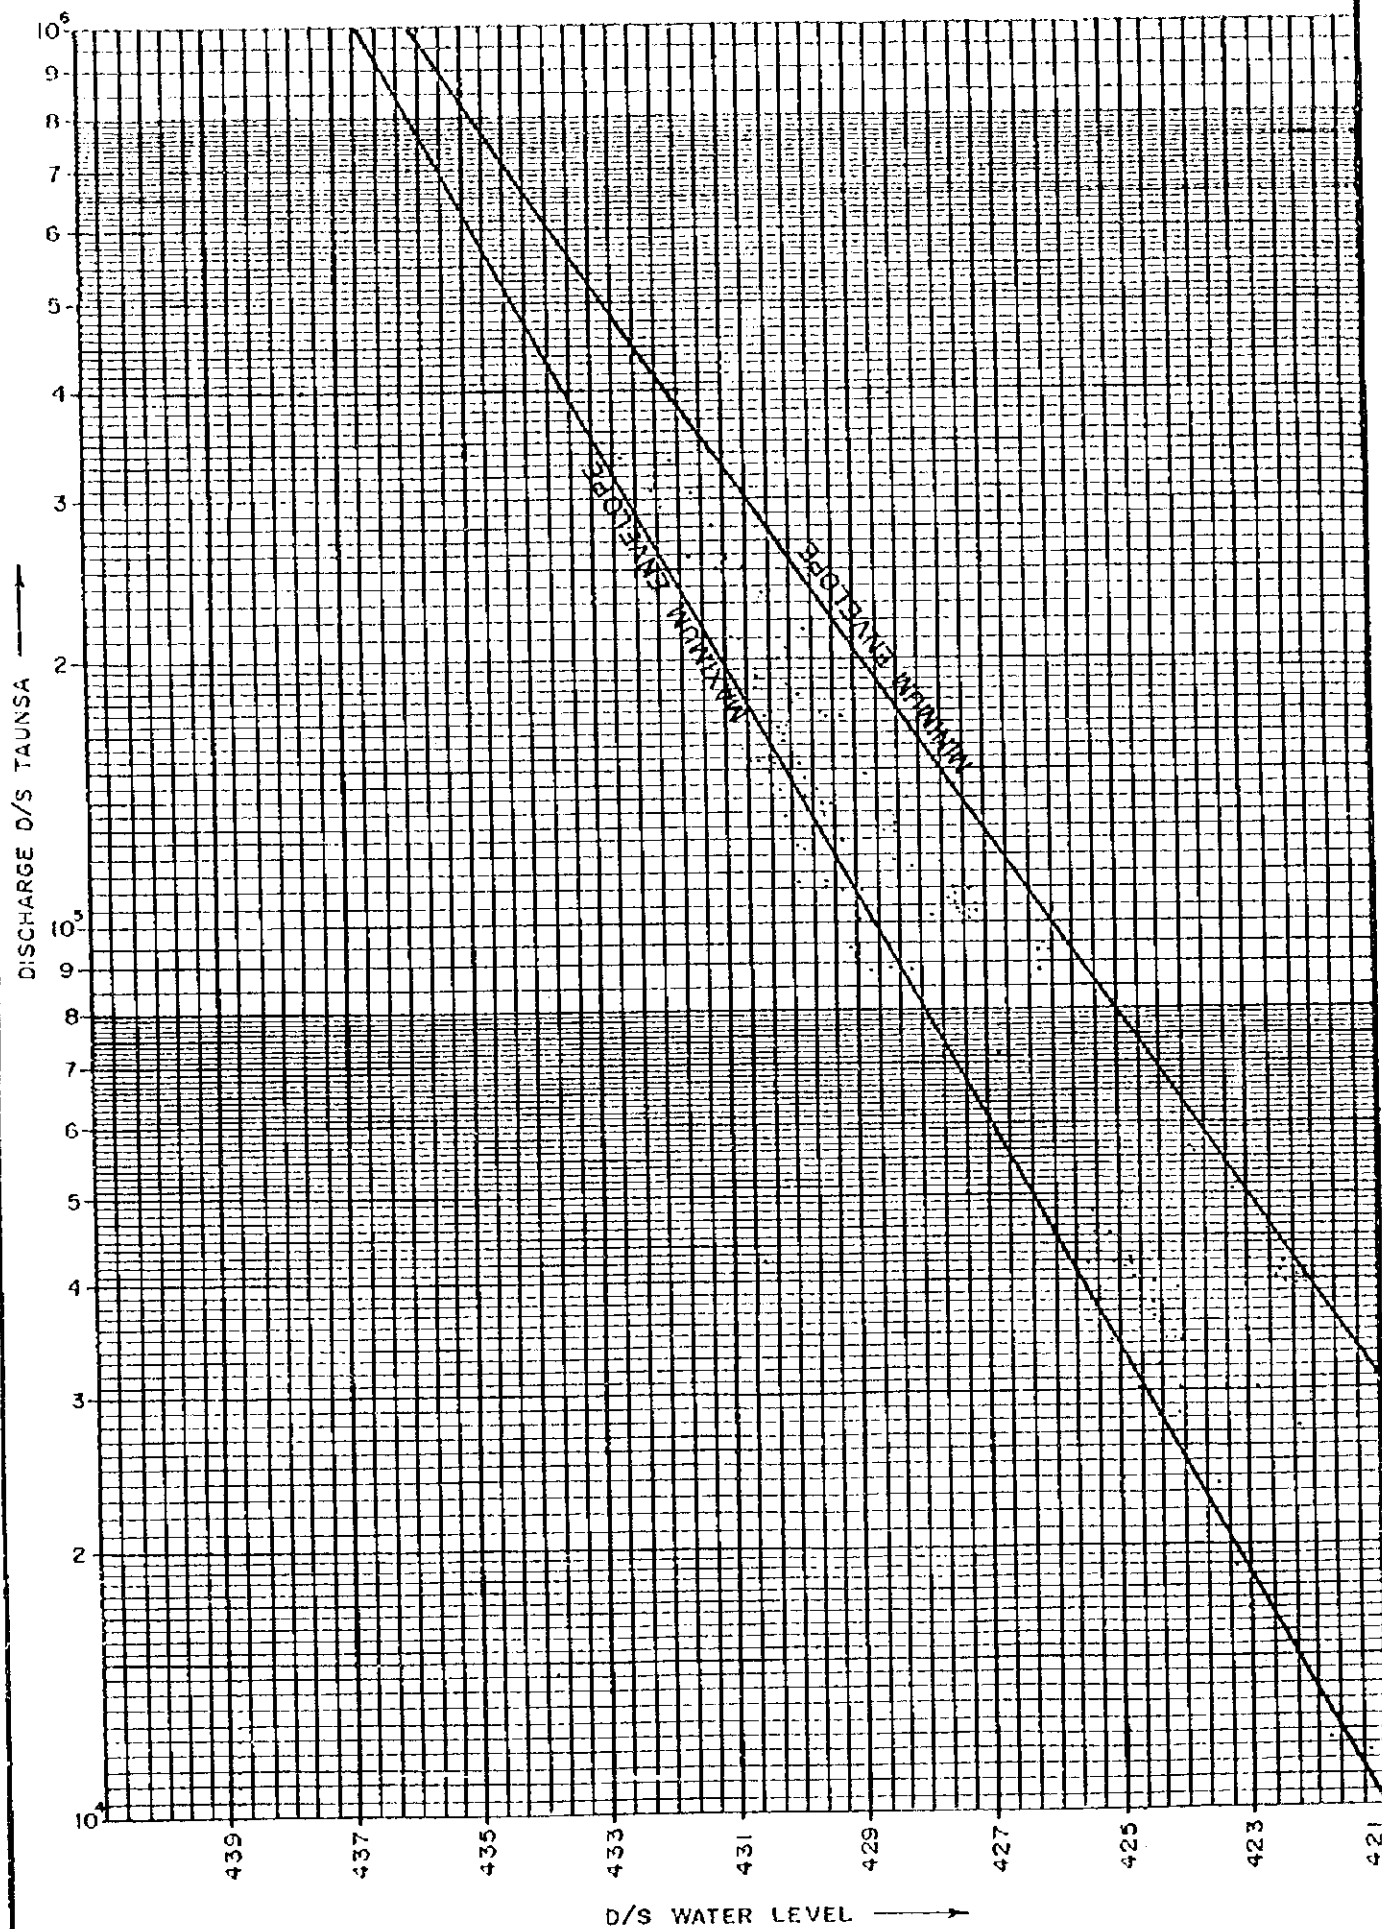
Fig.B2.2.1 Envelope / Lines for the Discharges Observed on D/S in 1993

To analysis the present retrogression status, the gauges and discharges observed on the downstream were plotted on semi-log graph paper and minimum and maximum level envelope lines drawn which allow for inter / extrapolation of levels for discharges other than actually experienced. Such envelope curves / lines, for the recent years appear as Fig.B2.2.1 to B2.2.5. The minimum tail-water-levels obtained from semi-log plots of downstream gauges from 1954 to 1997 are listed in Table B2.2.1 wherein the levels for discharges higher than those actually experienced are extrapolated values. A comparison with the design minimum retrogressed levels is also exhibited by this table. These levels have been used for plotting and presented in Fig.B2.2.6 and compared with the designed tail water rating levels and designed minimum retrogressed levels, which clearly indicated that, although a couple of recovery cycles have been experienced, still the retrogression problem does exist in substantial magnitude. The magnitude of retrogression for 1997 (most recent) levels is exhibited in Table B2.2.2 and Fig.B2.2.7.
