Fig. B2.2.6 Taunsa Barrage Retrogression Curves 1954 - 1997

Fig. B2.2.7 Retrogression Study of Taunsa Barrage

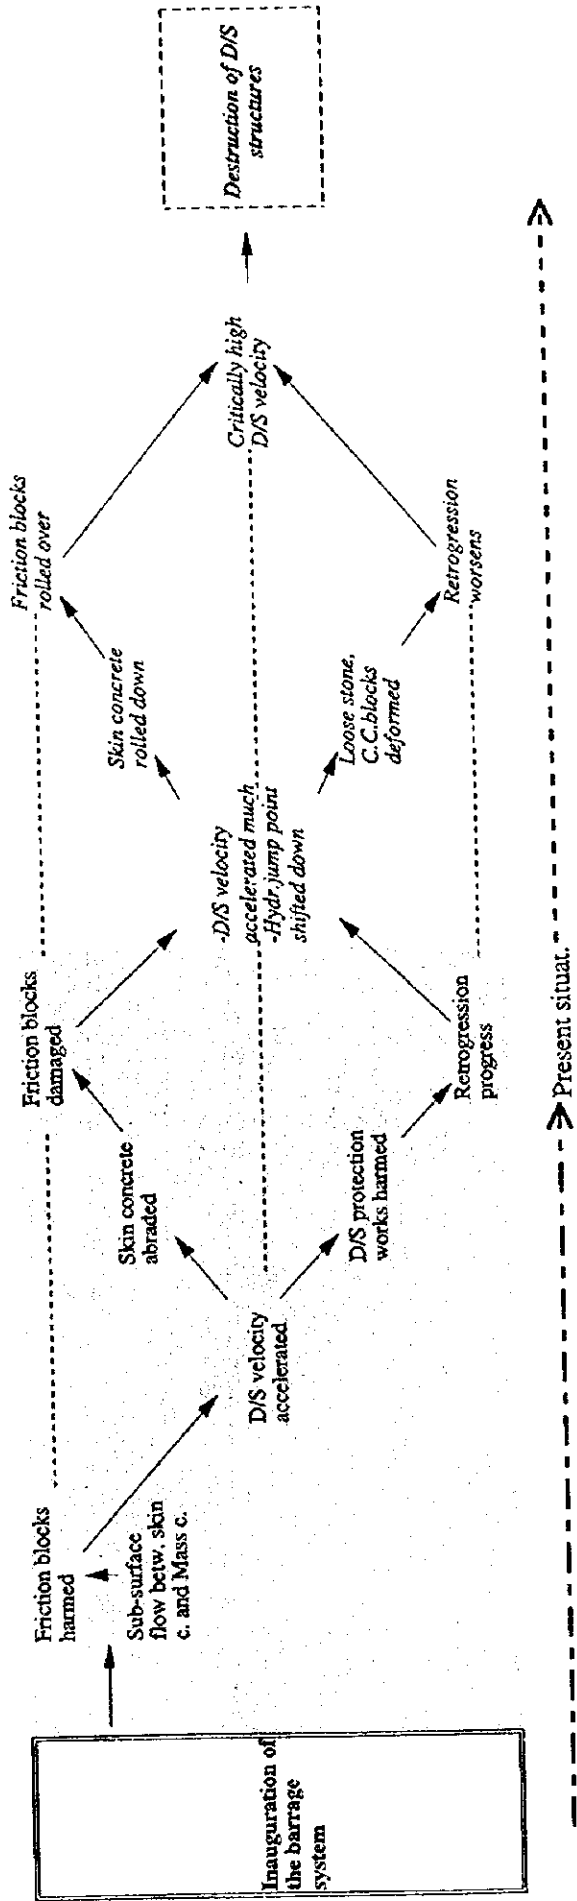
Fig.B.2.3.2 Consideration for the relation of defections in every phases of the Barrage Facilities

Hydraulic structure of the Taunsa Barrage has deteriorated considerably. Such deterioration is not found in limited portion only, but is seen in every sections in different ways. Defects appear in some portions will bring about defects in other sections. Deterioration of the facilities advances in vicious circle. Defect such as frictional wear and destruction of friction blocks etc., were observed. These defects are not the only problems in the sites, but also leads defects in other sections. As shown in the above figure, for instance, a damages of friction blocks will bring about deterioration of skin-concrete, then advance and worsen situation of facilities. The vicious-circle of such damages causes complete destruction of the overall facility.

According to the investigation result during phase 2, Taunsa barrage is identified in the stage of "retrosession progressed" in the above diagram. Comprehensive rehabilitation plan is required essentially.
