## **4. DIFFICULTIES AND PROBLEMS OF TAUNSA BARRAGE**

### **4.1. Damages on the Gate Structure**

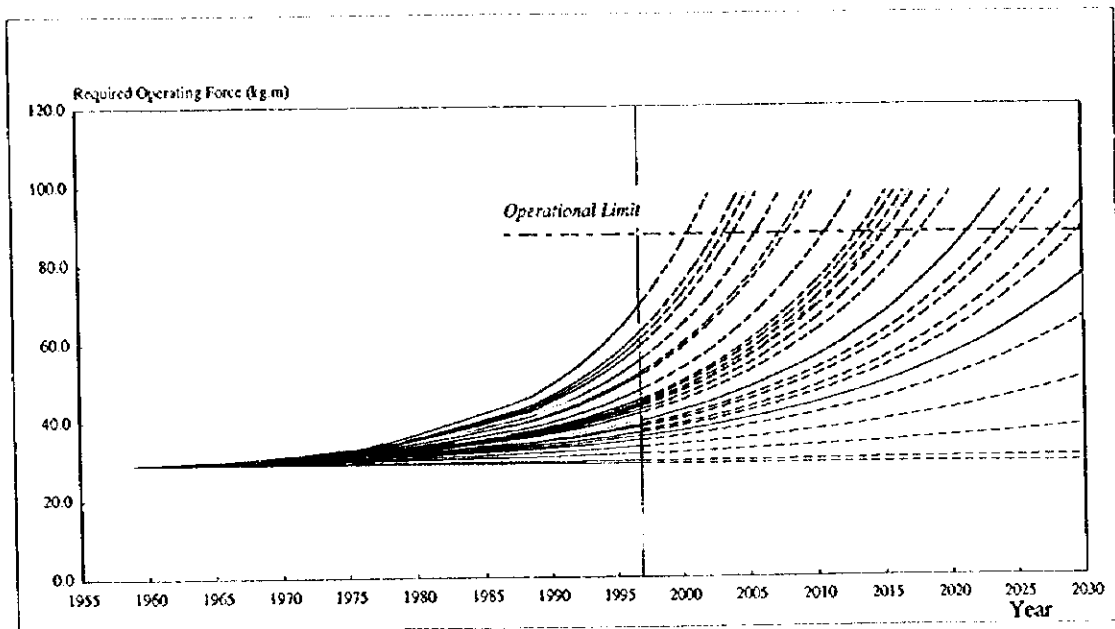
**Fig. 5.1.1 Estimated Deterioration Curve of Taunsa Barrage Weir Gates**

Following figure gives a forecast of increase of gate operation force by each bay, on the bases of measured value of required force as of 1997, year of 39 years passing since Taunsa barrage constructed. Providing that 87 kgm as equivalent to twelve manpower force is a limit of gate operation as being under present manual operation, an inoperative gate will appear in 2001 in the beginning. Then other gates will follow swit with continuity.
