CHAPTER 3

PRELIMINARY ROAD INSPECTION

3.1 General

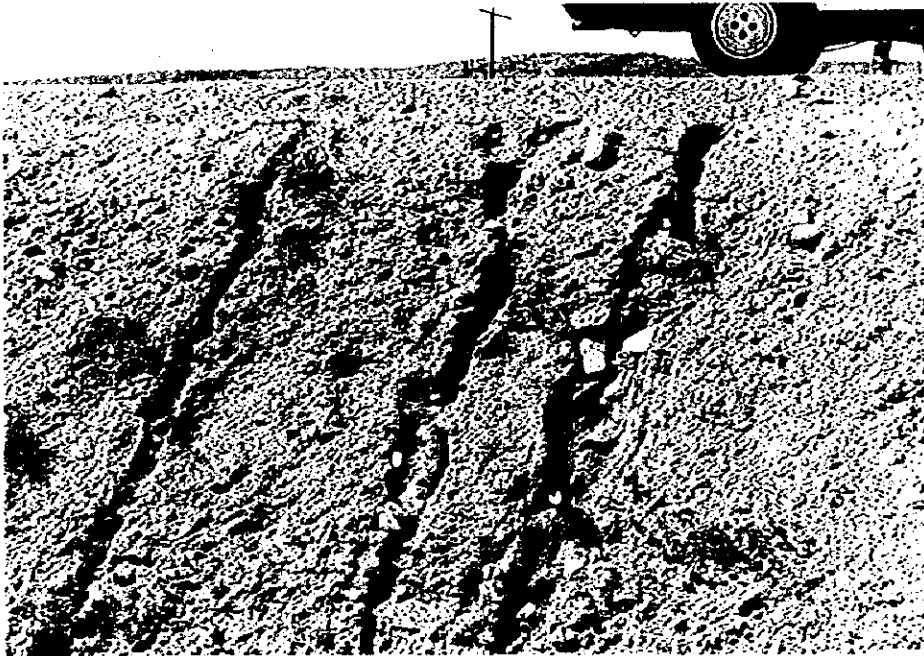
Erosion by rain
and surface run-off

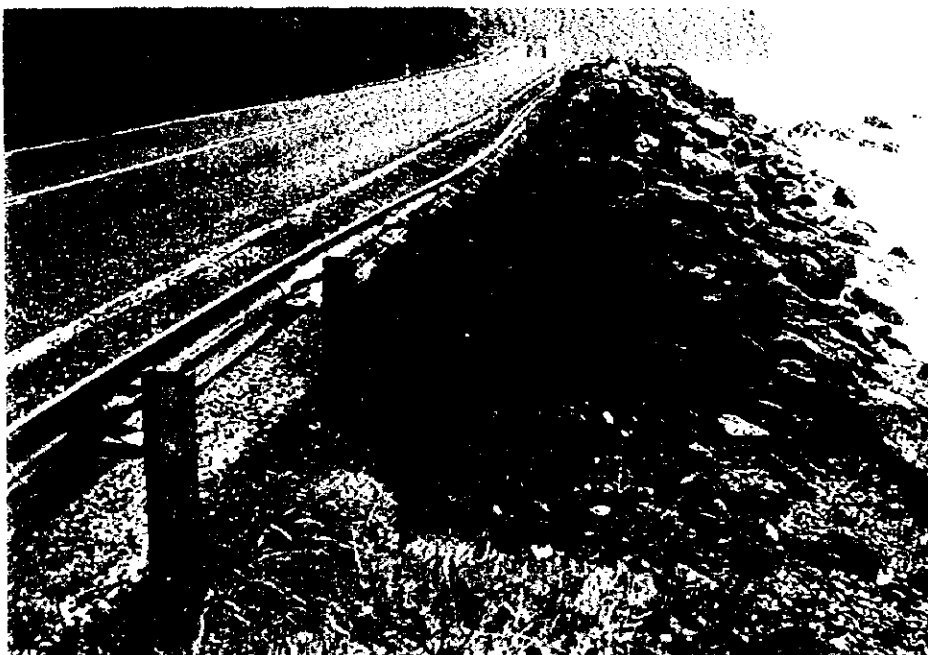
Erosion by
wave action

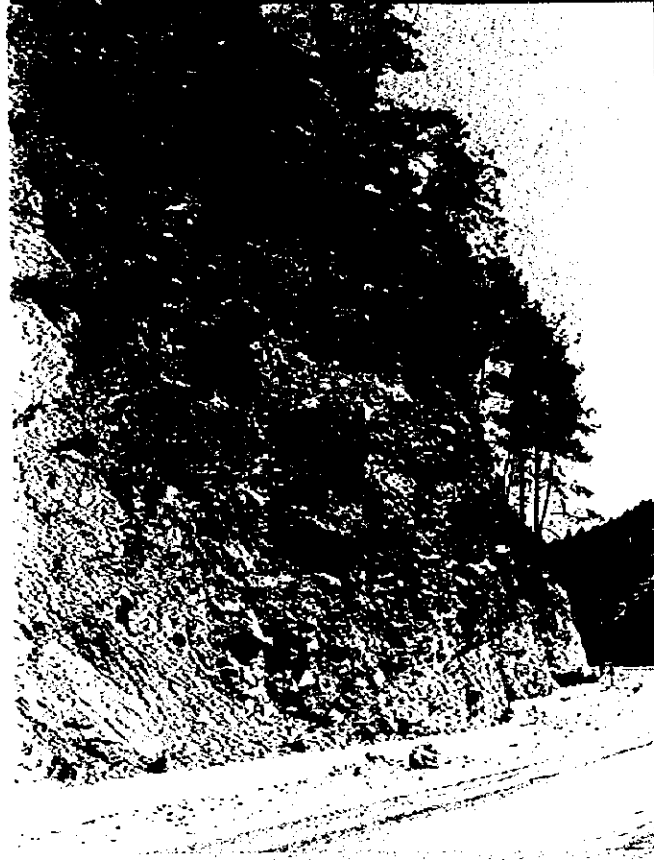
Cracks in slope

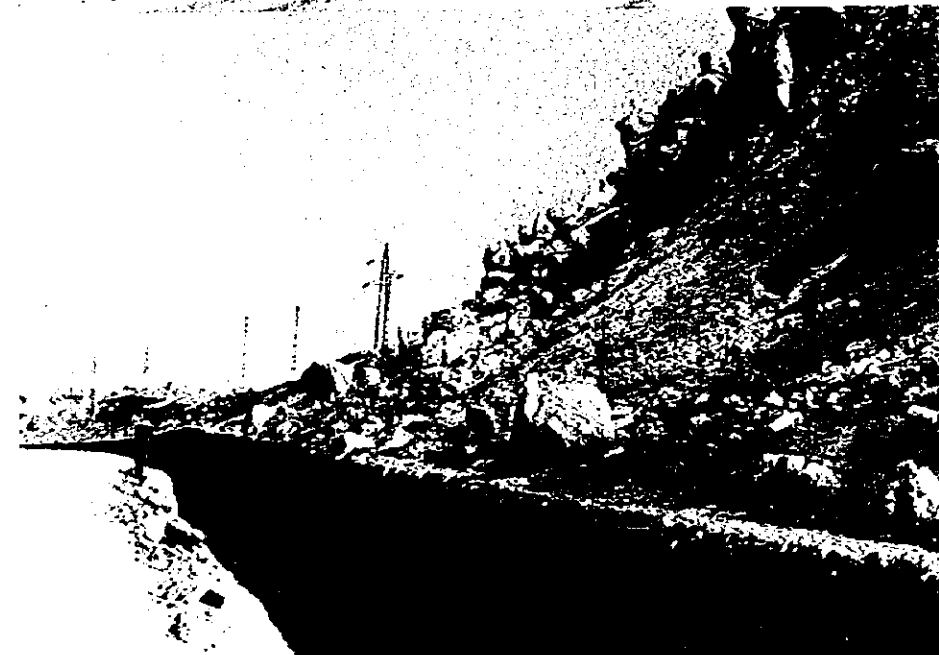
Rock
Avalanche

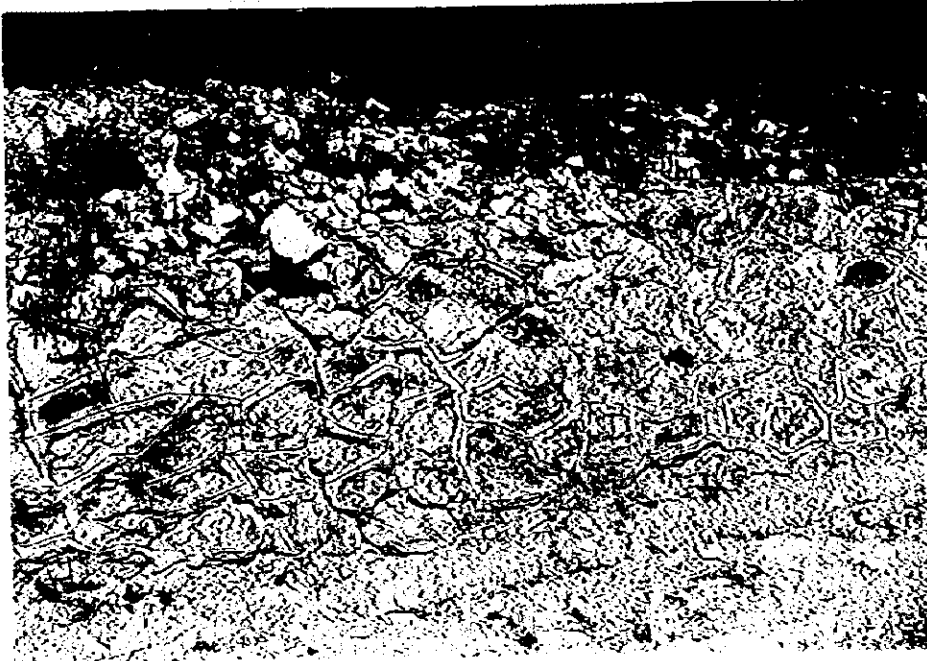
Cracking

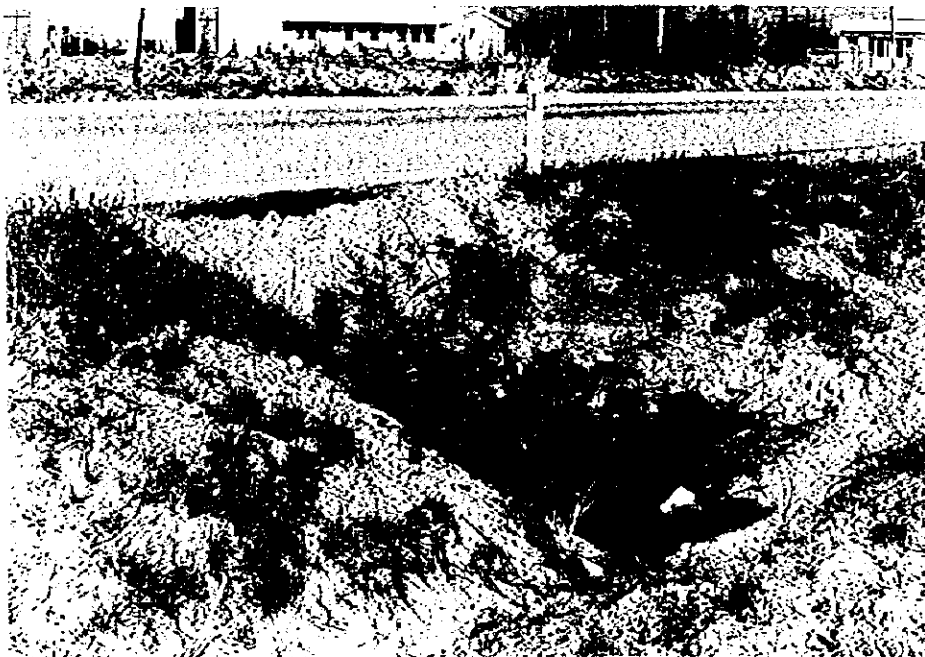
- wash out only - as it is considered as the most serious problem

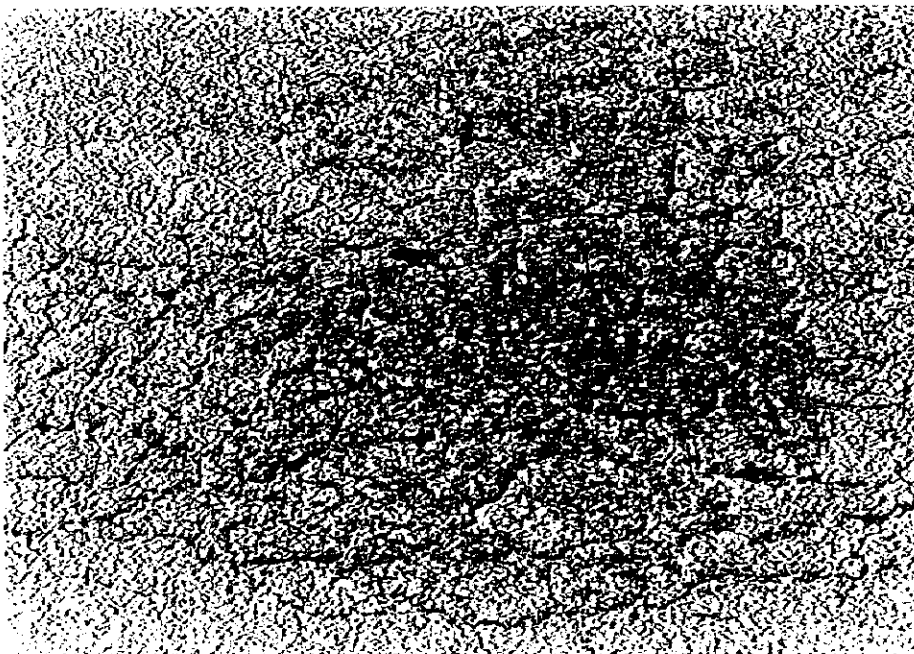
Alligator
Cracks

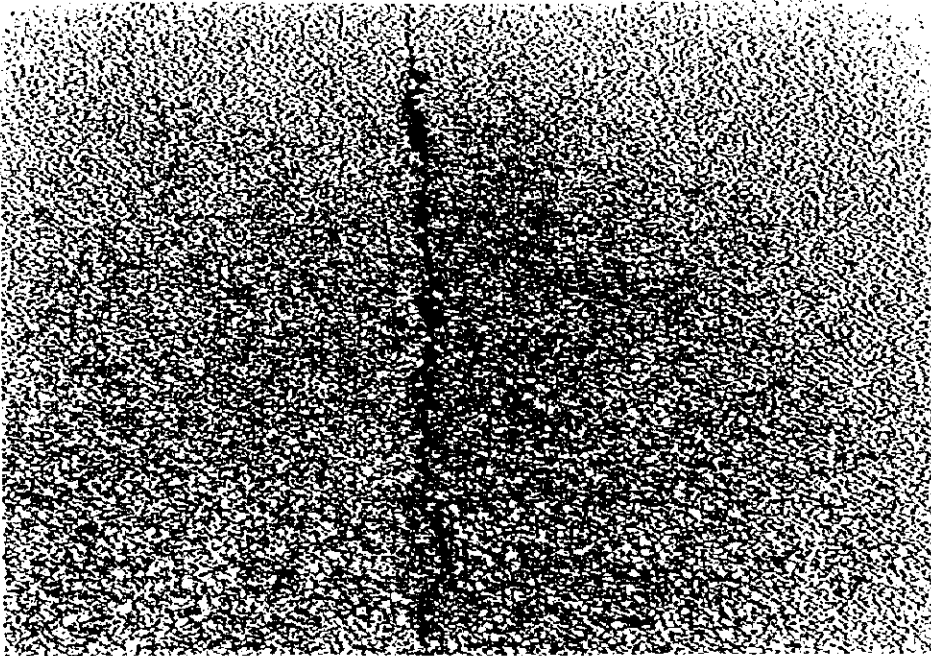
Longitudinal
Cracks

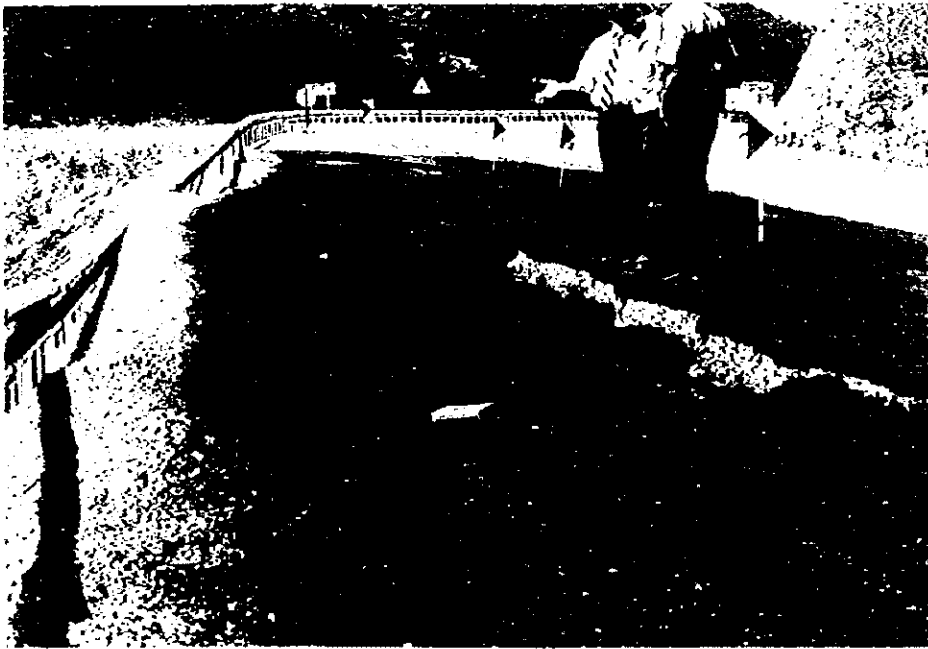
Settlement of
carriageway

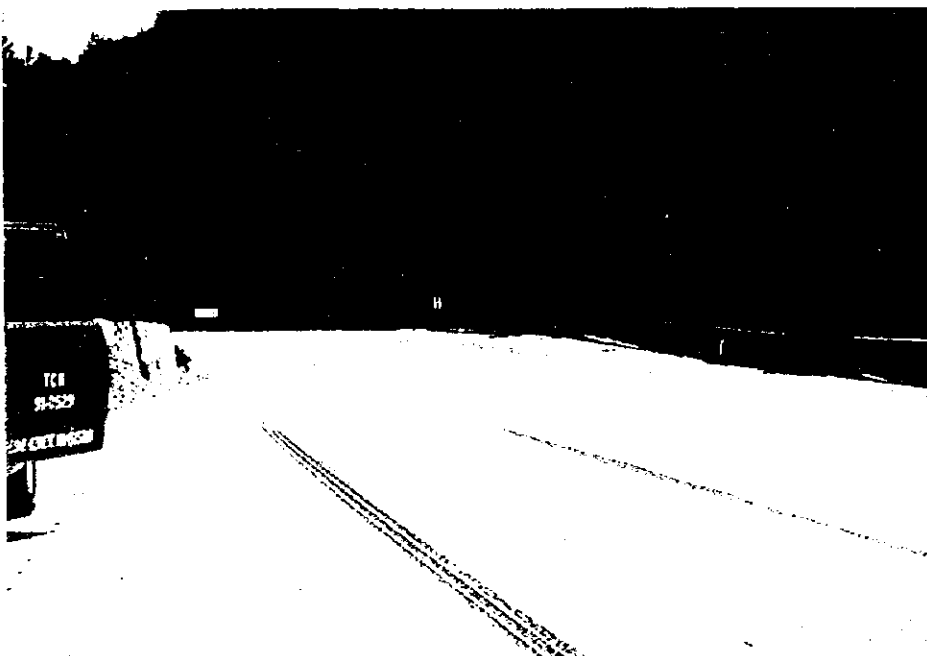
Undulation/
settlement

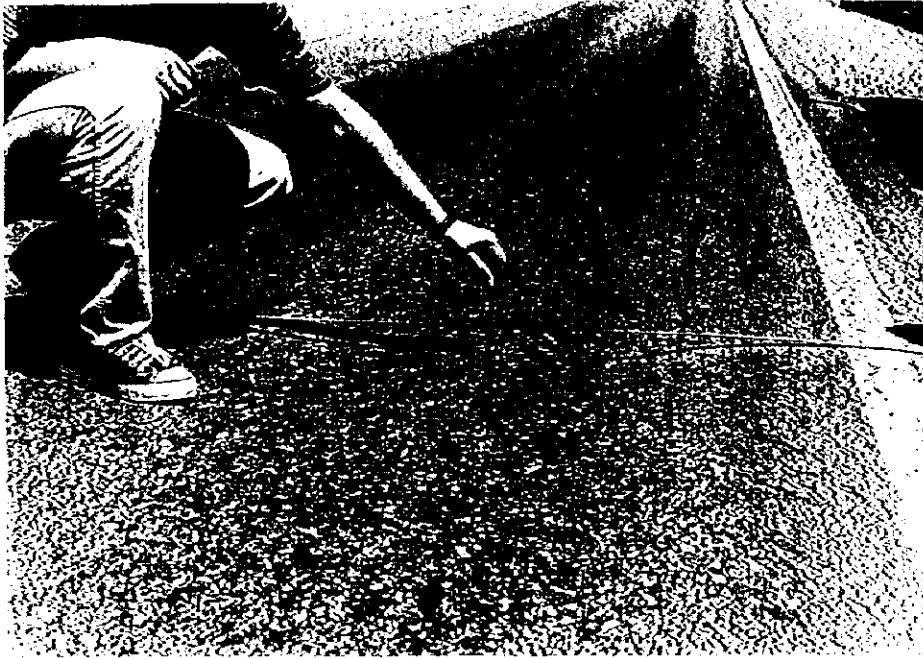
Rutting

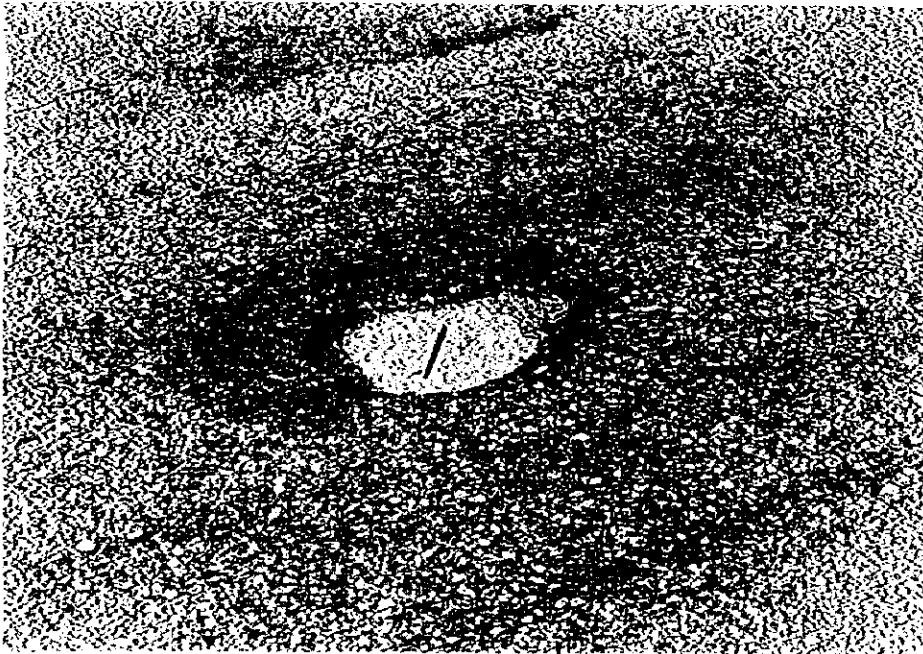
Pothole

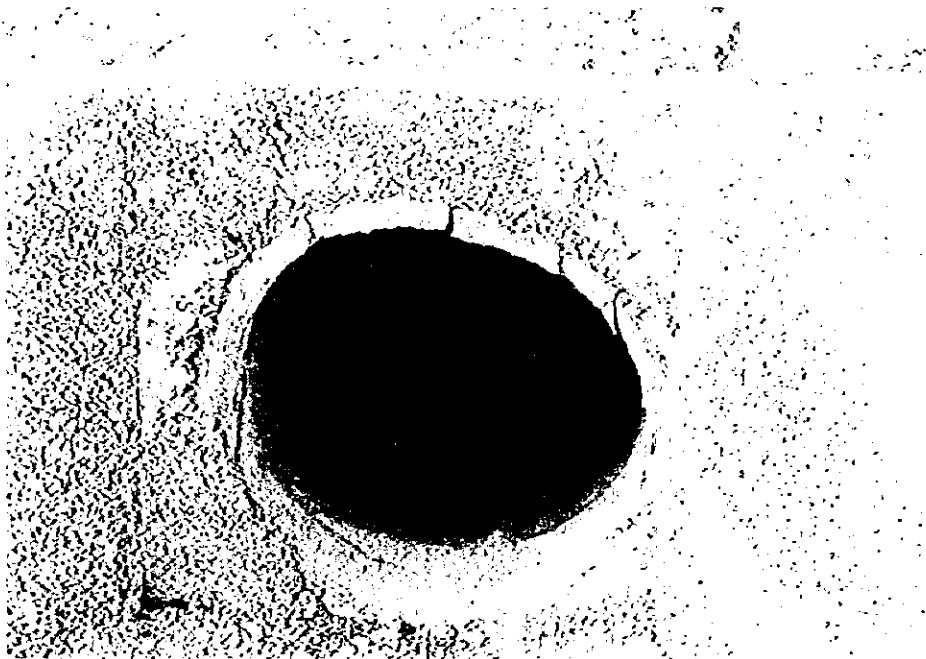
Collapse
