## **6.6 Results of Detailed Inspection**

# PRELIMINARY DESIGN OF REPAIR WORK

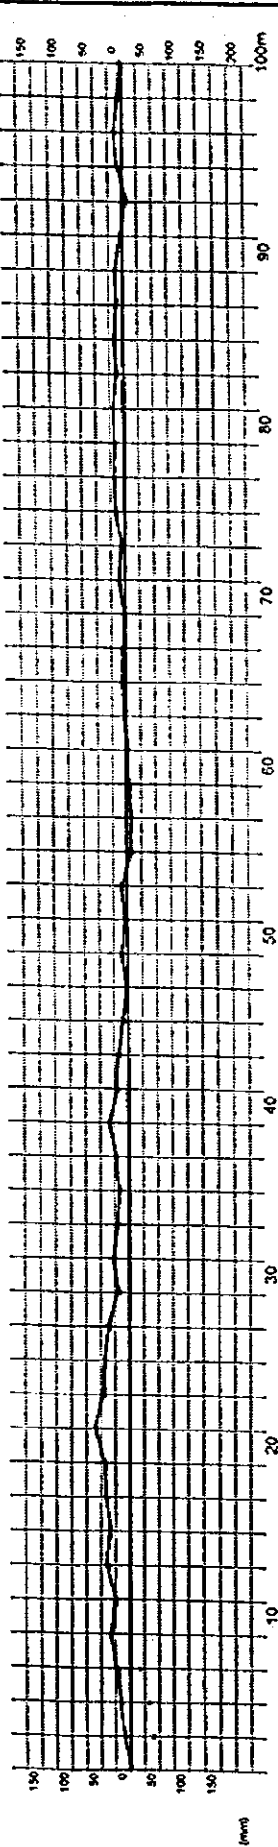
Çatlama Oranı (C) =  $\frac{(c \cdot P/A) \cdot 100}{((c \cdot P/A) \cdot 100 + (c \cdot P/A) \cdot 100)} \cdot 100 = \%$  **75.4**

Boyuna Düzgünlük Standart Sapması  $\sigma =$  **12.9** mm
