THE STUDY ON ARTERIAL HIGHWAY MAINTENANCE IN THE REPUBLIC OF TURKEY

FINAL REPORT DRAWINGS

VOLUME ③

JULY 1998

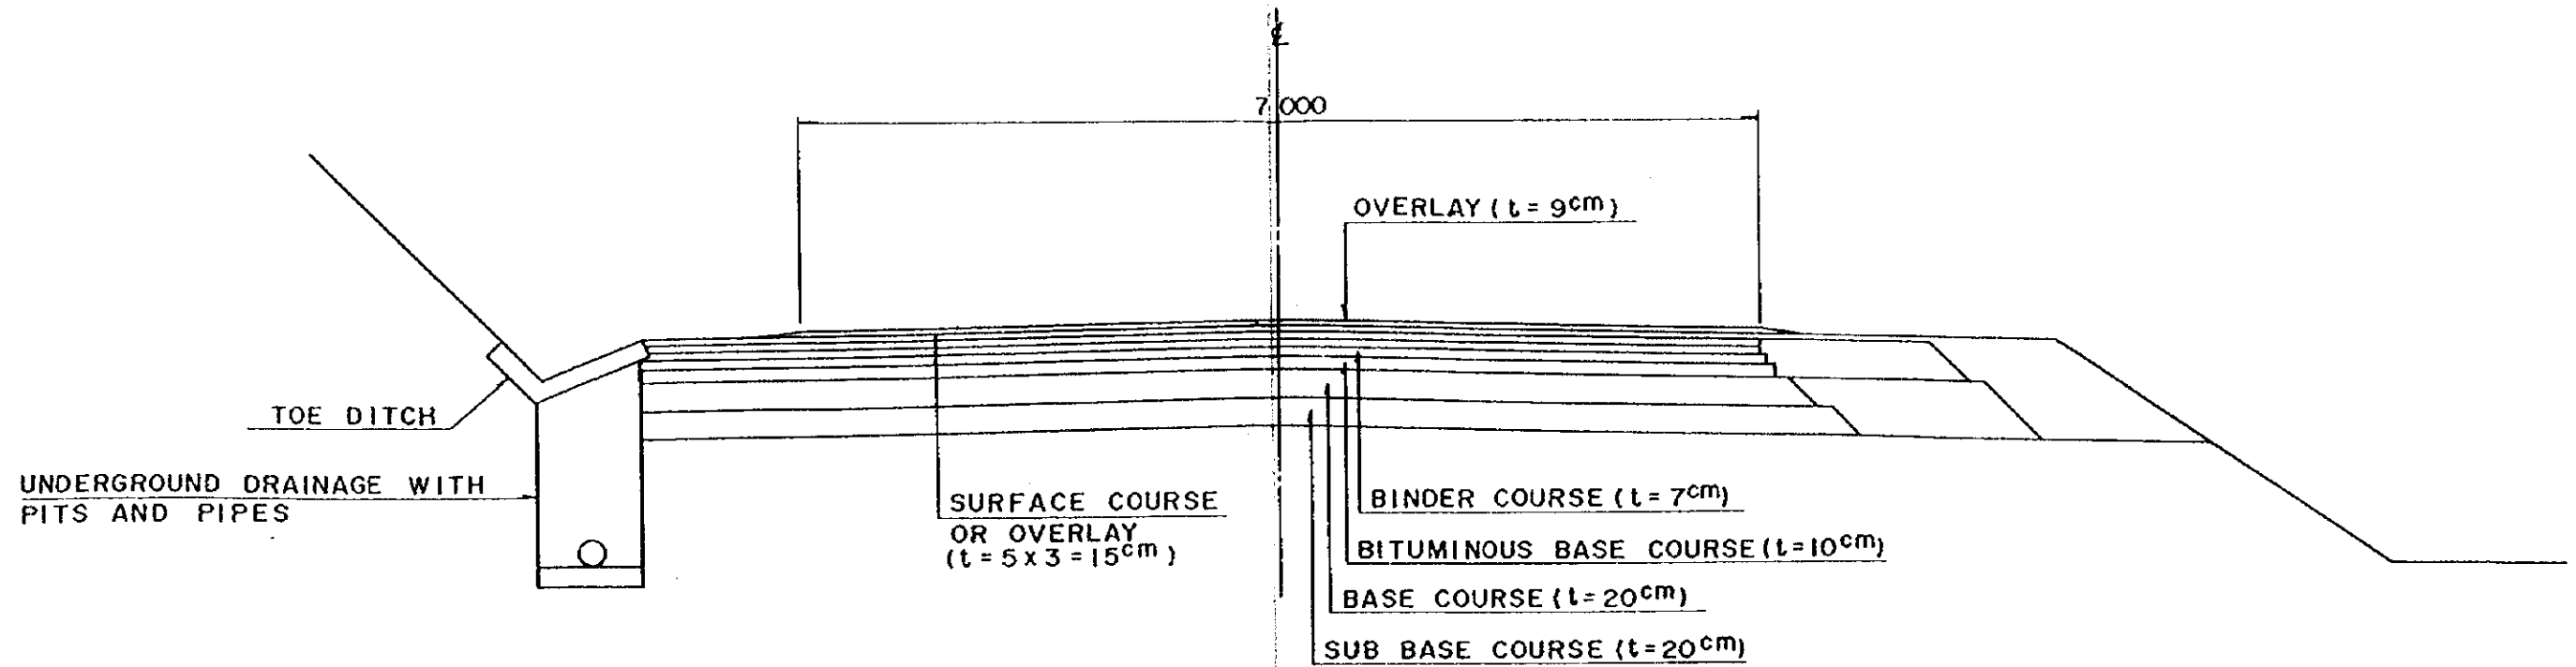
I. PAVEMENT

C(A), R(C), W(C) P(2/10), PSI=1,9 CBR=3,3%, T=32cm, H=72cm

TRAFFIC VOLUME CLASSIFICATION : C
 DESIGN CBR VALUE OF SUBGRADE : 3 %
 TARGET VALUE OF TA (cm) : TA = 35cm
 $TA_0 = 15 \times 0.5 + 7 \times 0.5 + 10 \times 0.6 + 20 \times 0.25 + 20 \times 0.20 = 26 \text{ cm}$
 OVERLAY DEPTH REQUIRED = 35 - 26 = 9cm

Overlay(t=9cm) + Toe ditch + Underground drainage with pits and pipes

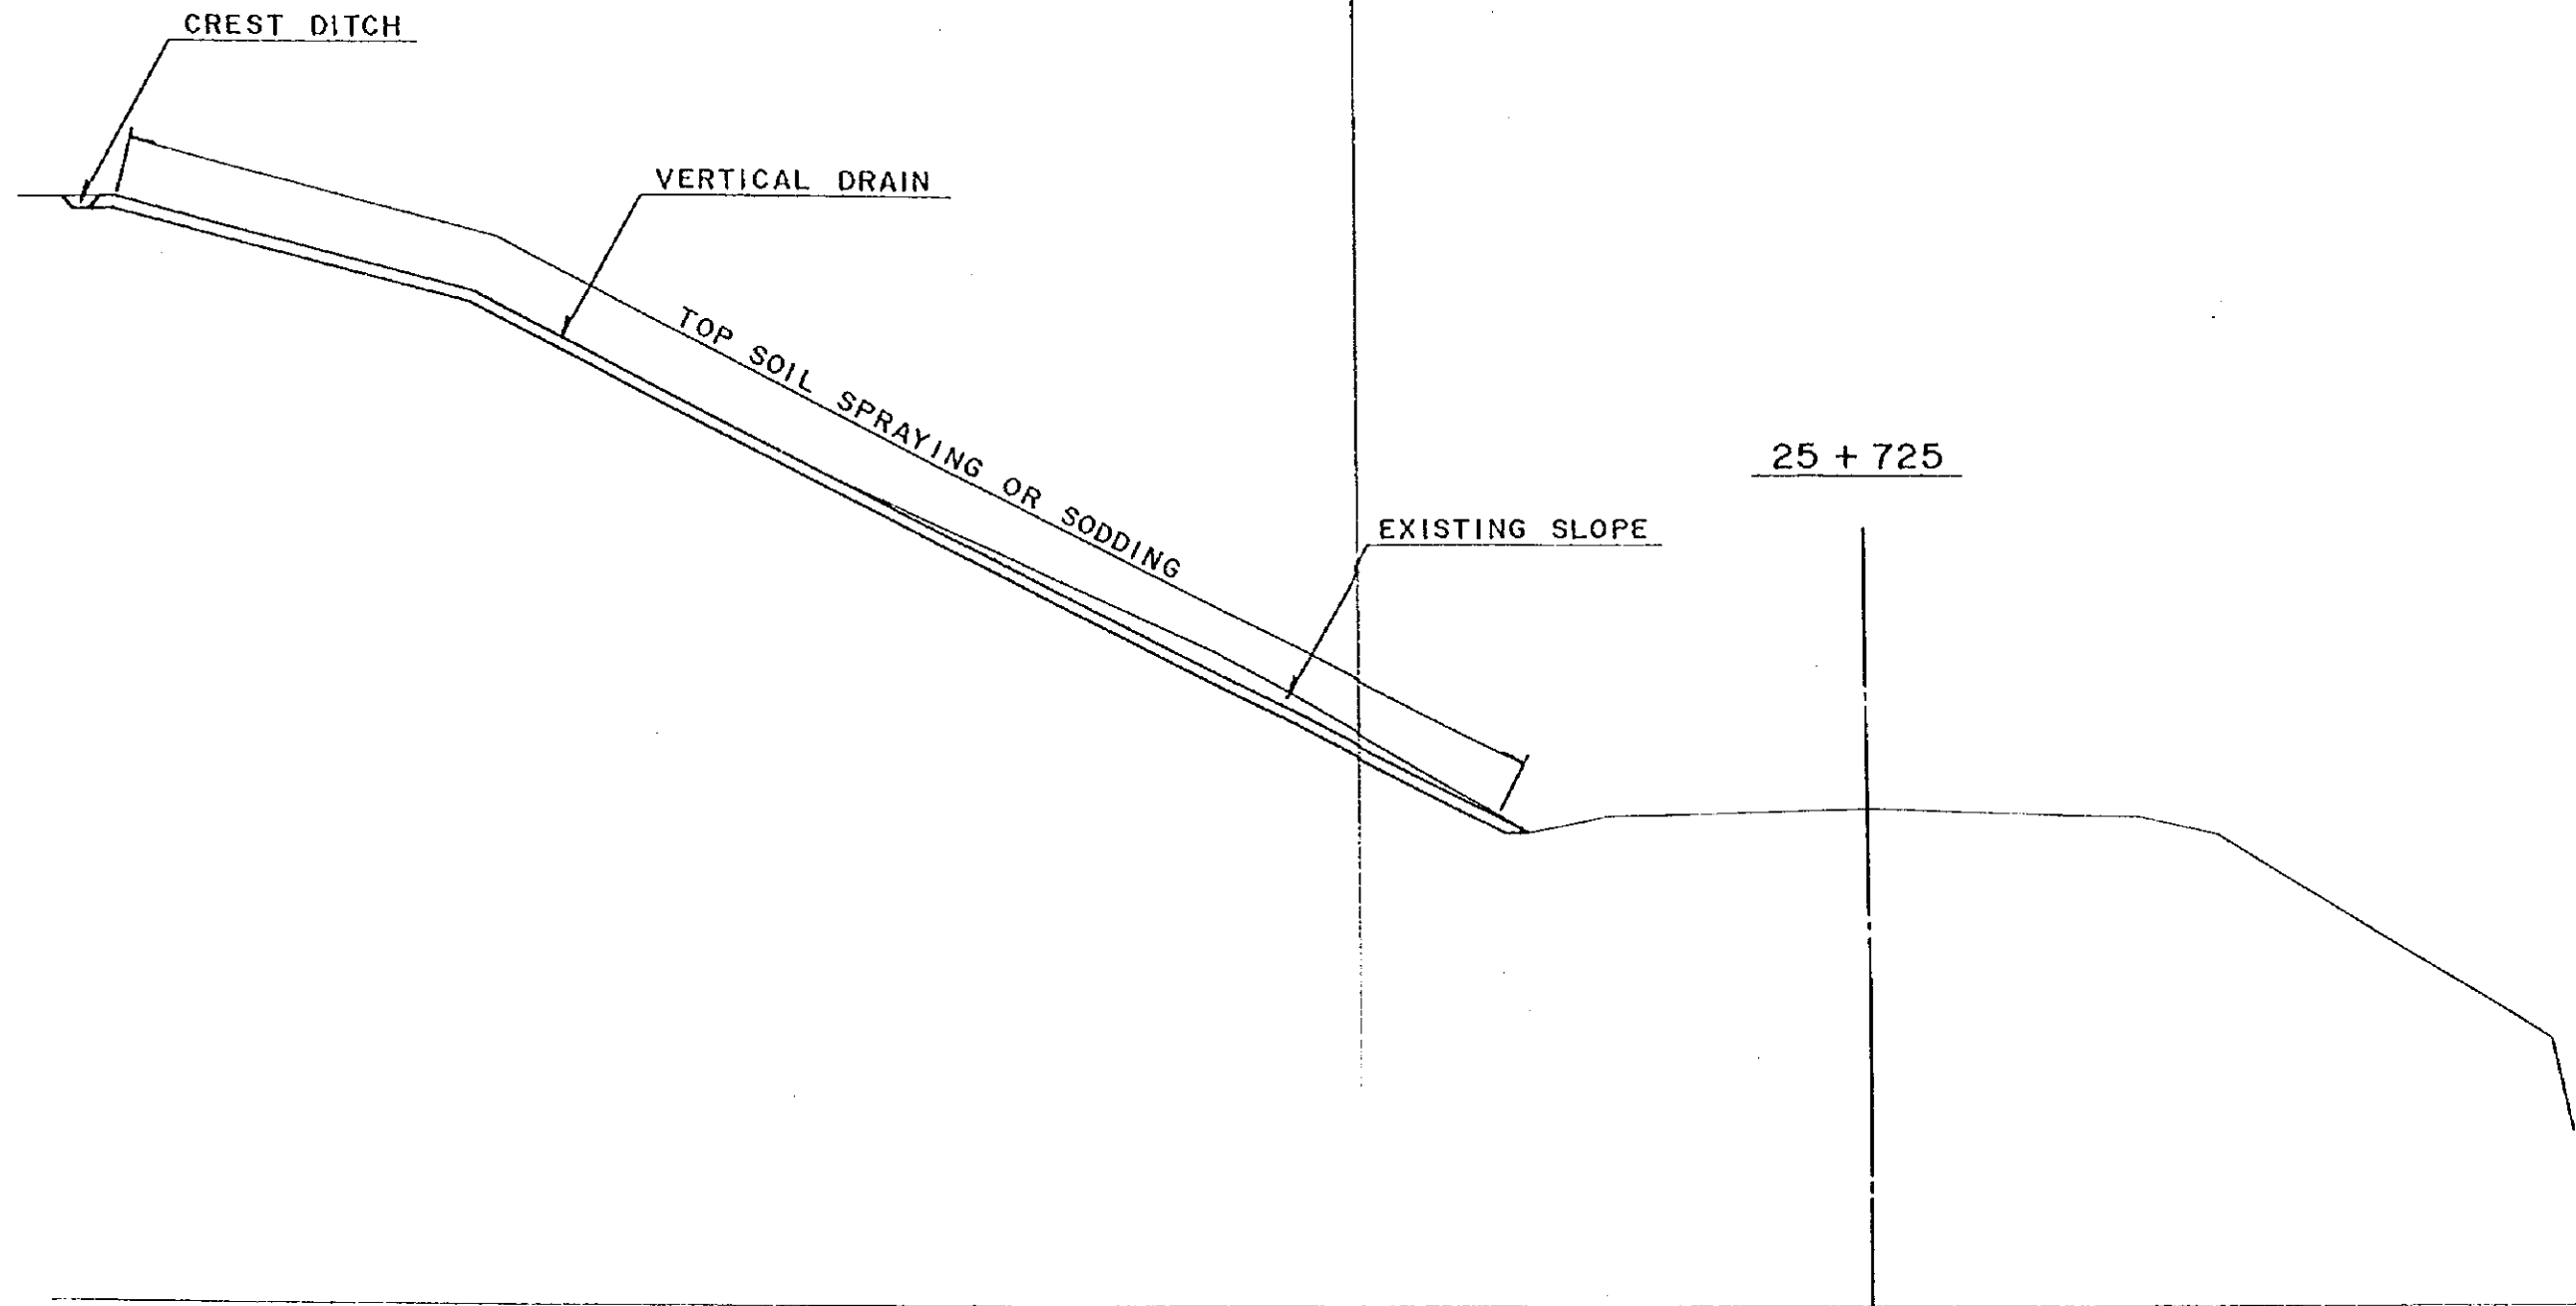
I. SLOPE (EROSION)

Crest ditch, vertical ditch, seed-mix spraying with a gun
 ←—————→
 washing out or erosion
 ←—————→

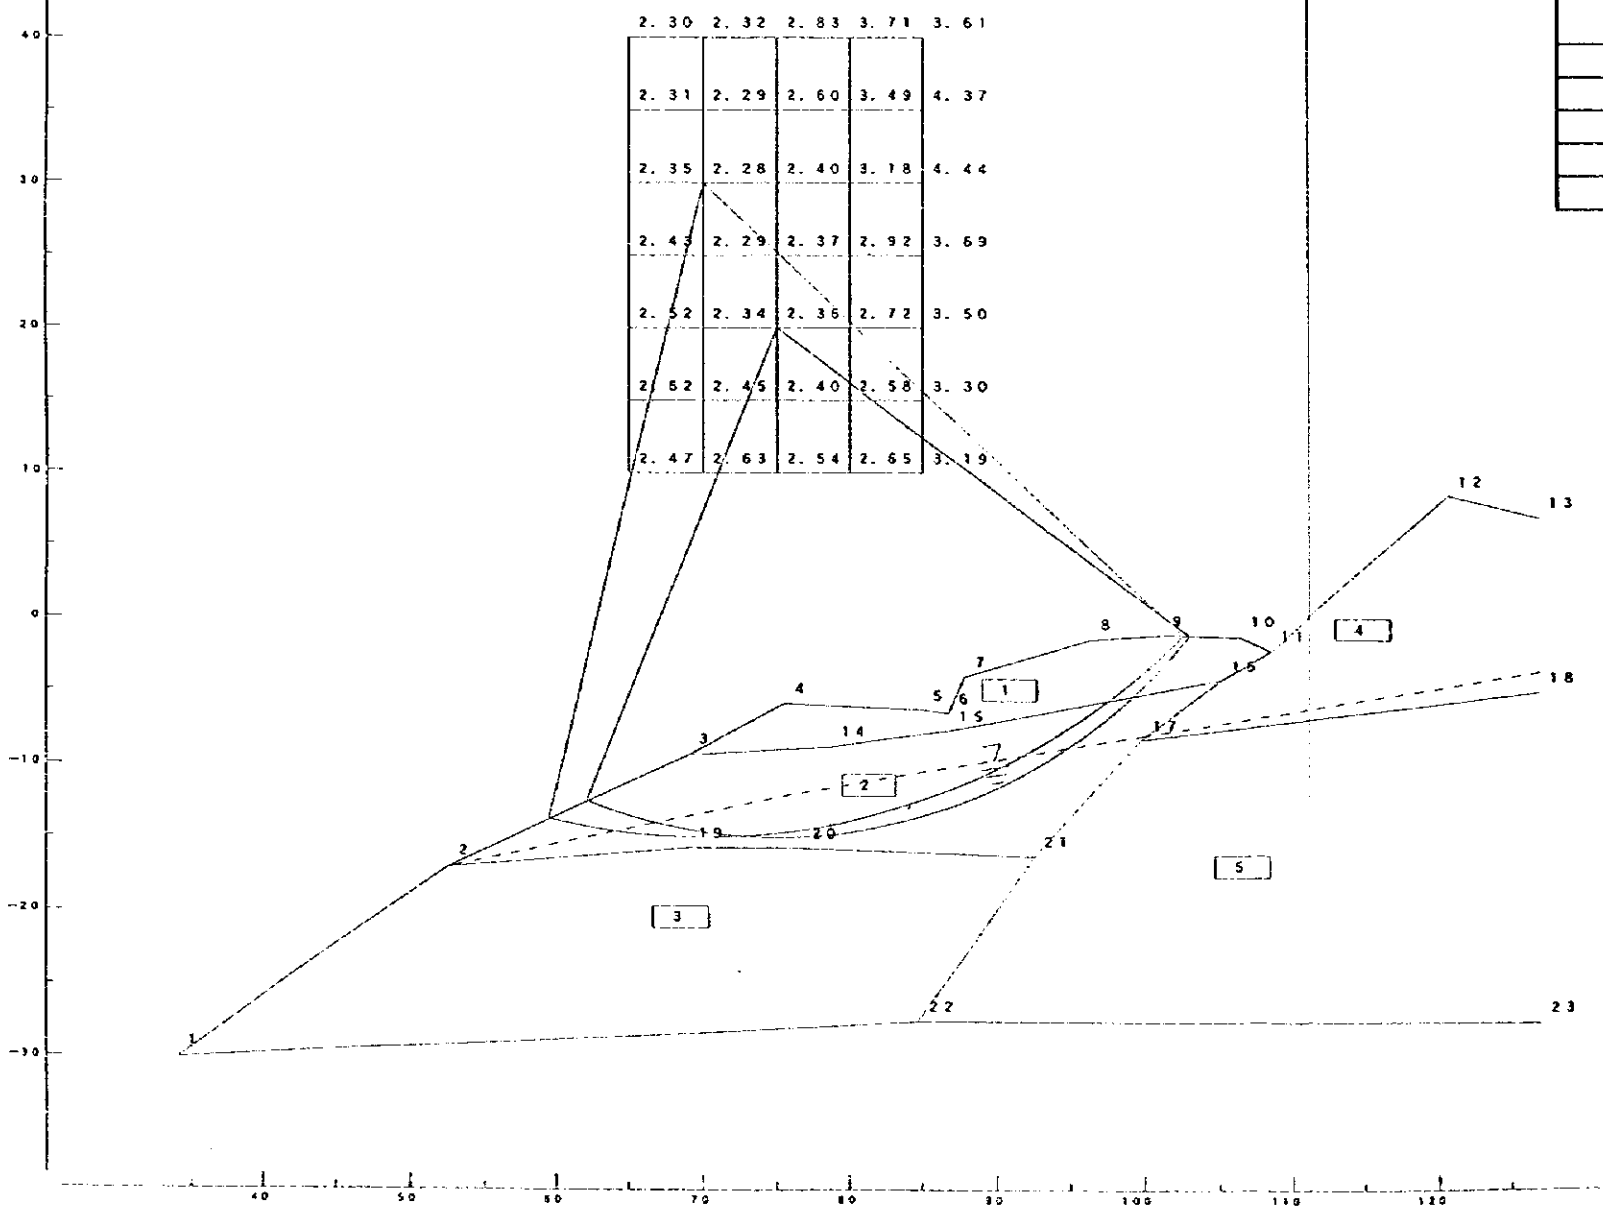
Figure of Safety Factor

200-13 (Present Condition)

Minimum safety factor $Fs_{min} = 2.283$
 Center of circular arc $X = 70.00 (M)$
 $Y = 30.00 (M)$
 Radius $R = 45.00 (M)$
 Moment of resistance $MR = 12217.65 (T^*M)$
 Starting moment $Mo = 5351.12 (T^*M)$

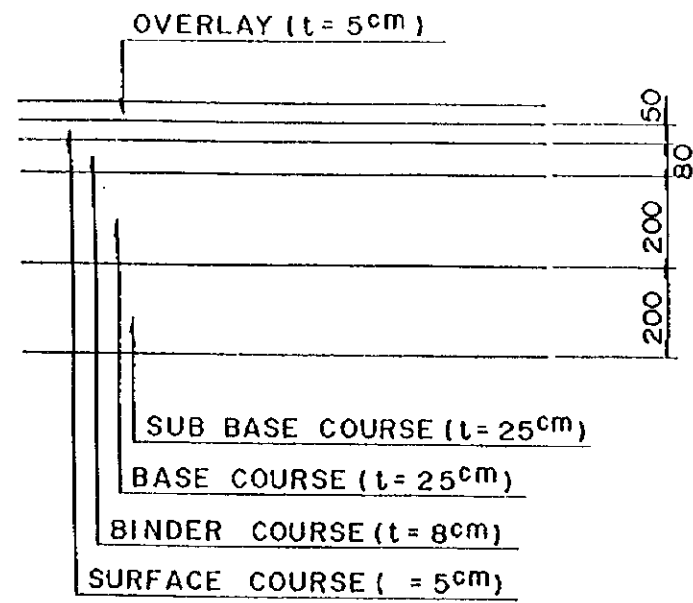
I. PAVEMENT

TRAFFIC VOLUME CLASSIFICATION : C
 DESIGN CBR VALUE OF SUBGRADE : 12 %
 TARGET VALUE OF T_a (cm) : 23 cm
 $T_{a0} = (5+8) \times 0.6 + 20 \times 0.3 + 20 \times 0.25 = 18.8 \text{ cm}$
 OVERLAY DEPTH REQUIRED = $23 - 18.8 \div 5 \text{ cm}$

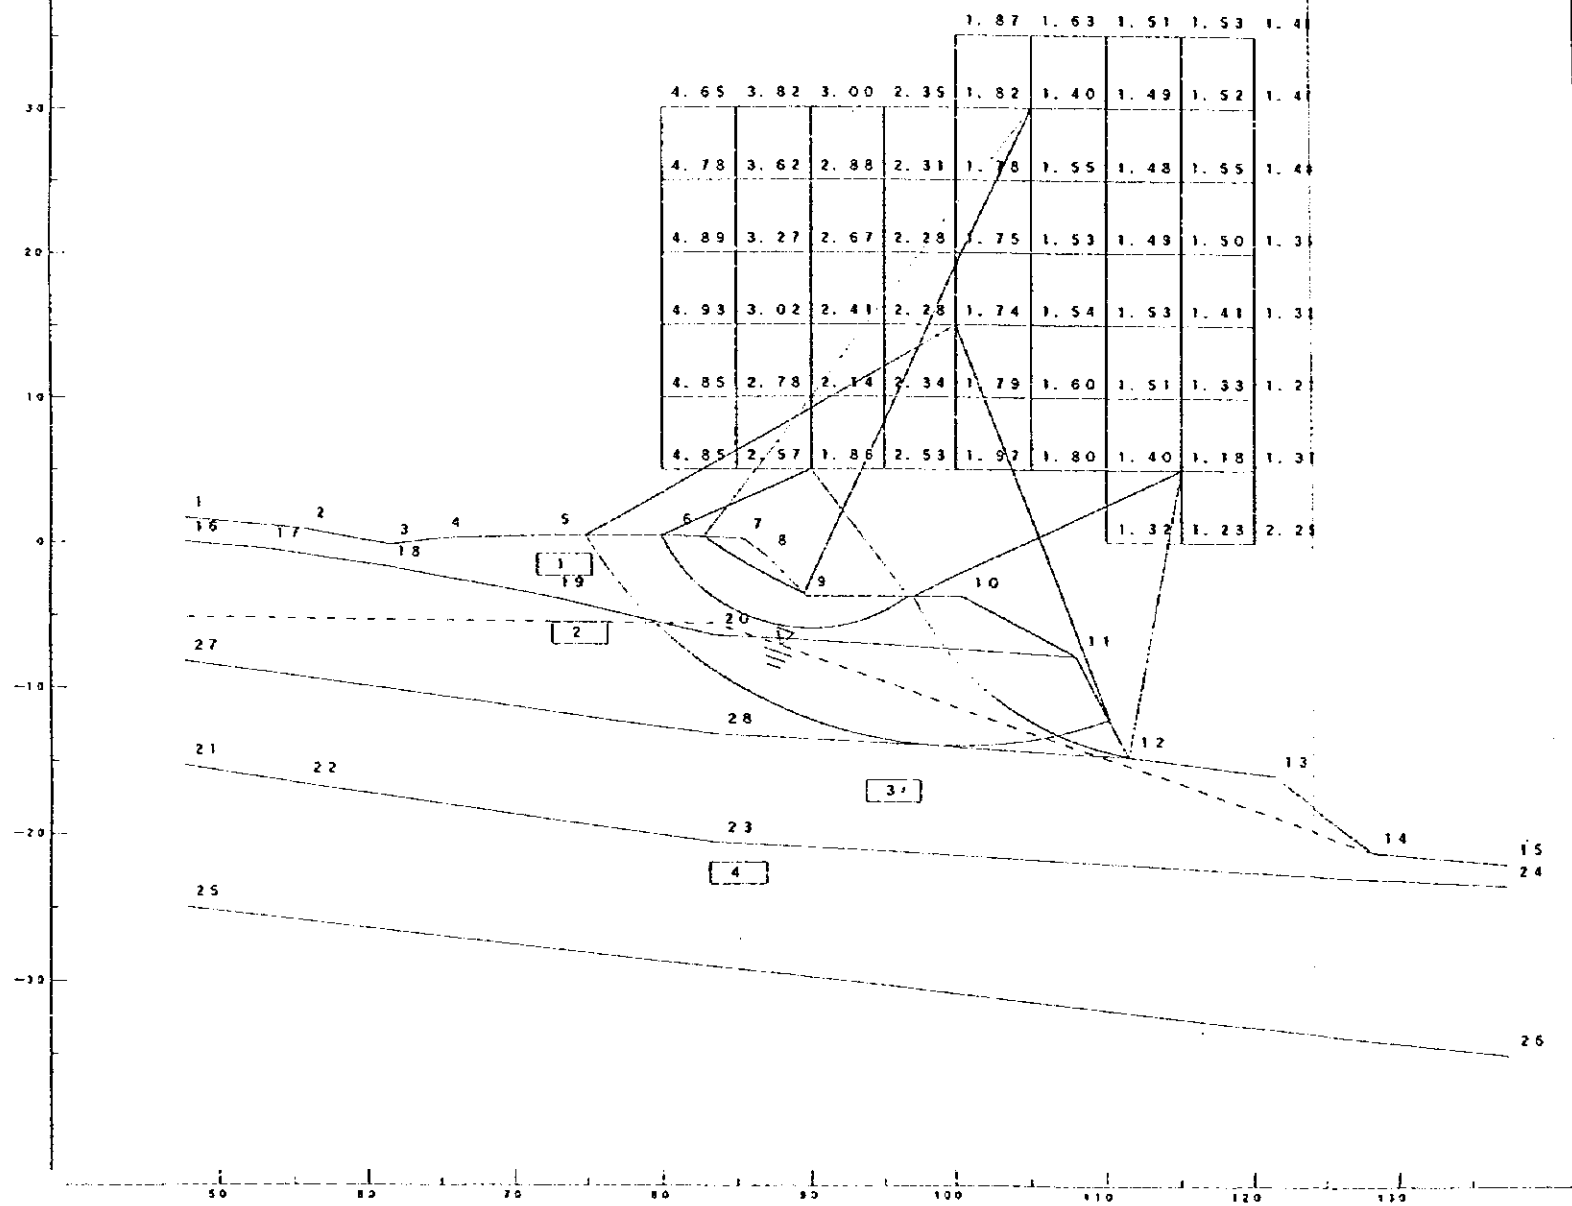
Figure of Safety Factor

100-17 (Present Condition)

Minimum safety factor $F_s \text{ min} = 1.189$
 Center of circular arc $X = 115.00 \text{ (M)}$
 $Y = 5.00 \text{ (M)}$
 Radius $R = 20.000 \text{ (M)}$
 Moment of resistance $MR = 1571.75 \text{ (T}^*\text{M)}$
 Starting moment $Mo = 1321.72 \text{ (T}^*\text{M)}$

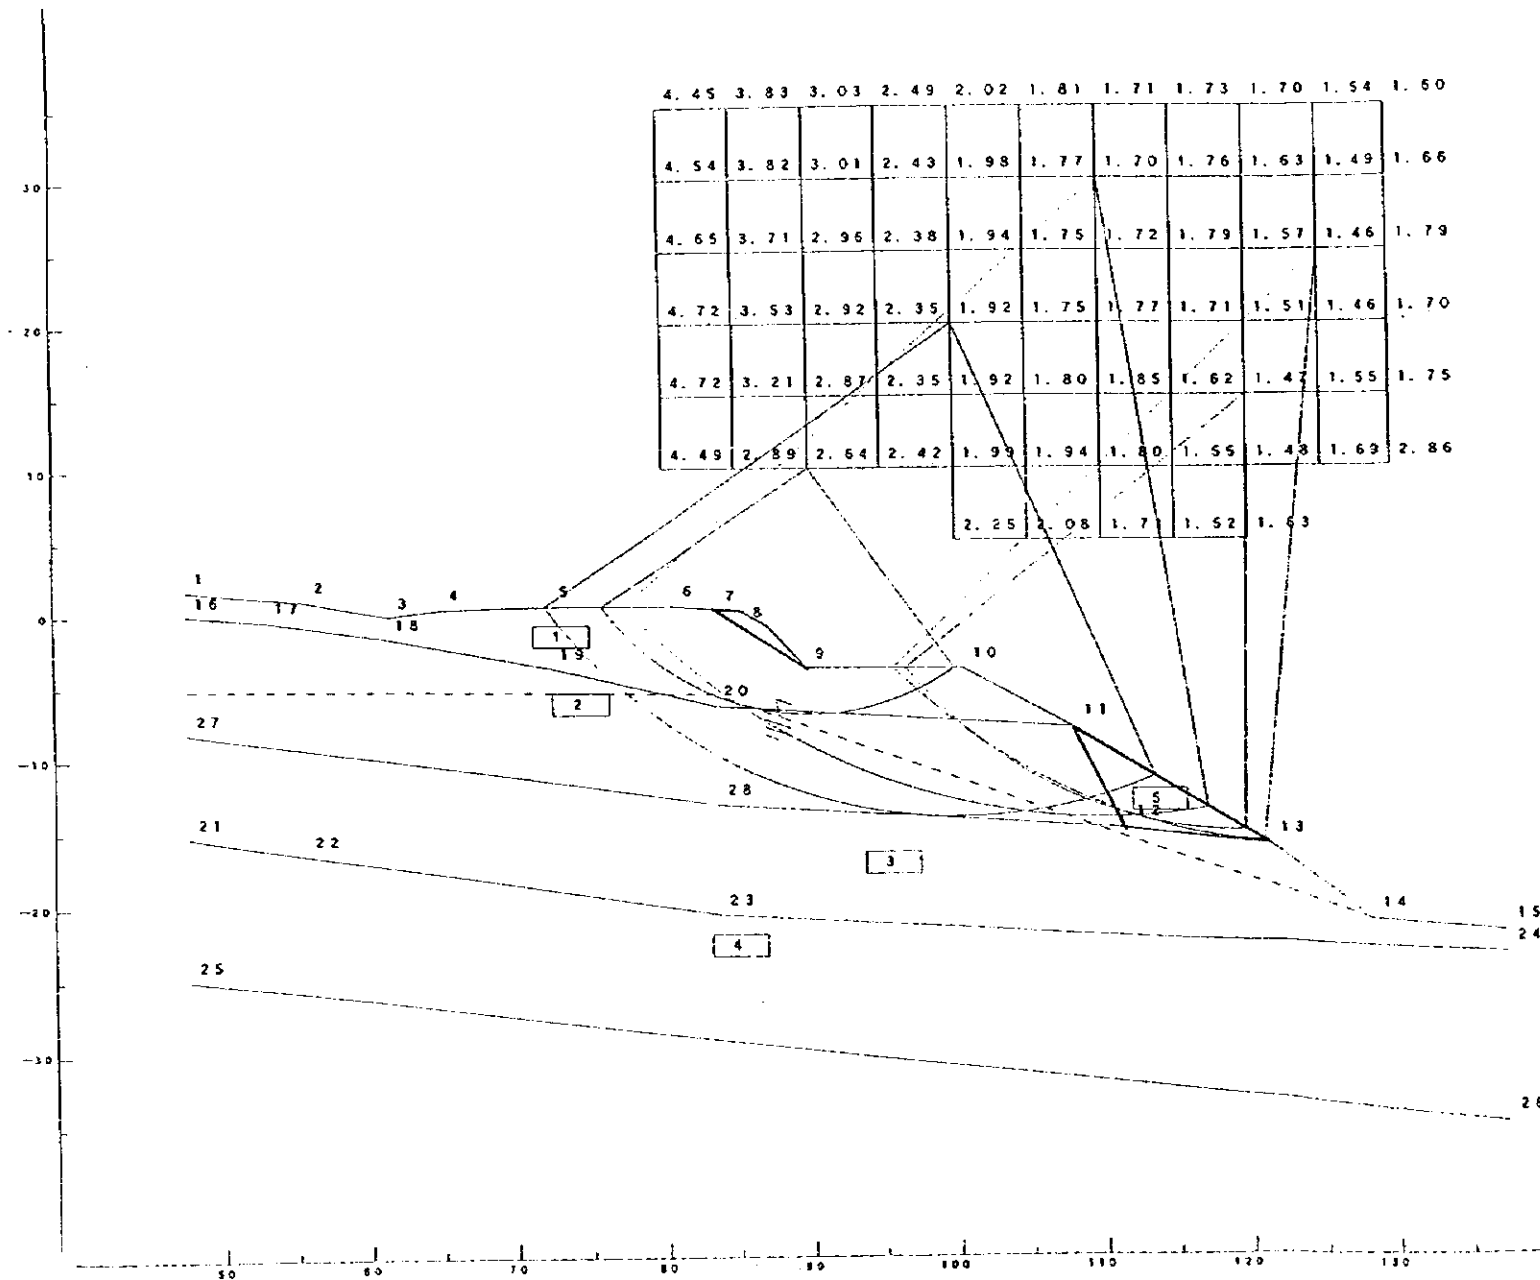
Figure of Safety Factor

100-17 (Countermeasure)

Minimum safety factor $F_s \text{ min} = 1.468$
 Center of circular arc $X = 125.00 \text{ (M)}$
 $Y = 25.00 \text{ (M)}$
 Radius $R = 41.00 \text{ (M)}$
 Moment of resistance $MR = 3974.39 \text{ (T}^*\text{M)}$
 Starting moment $MO = 2706.35 \text{ (T}^*\text{M)}$

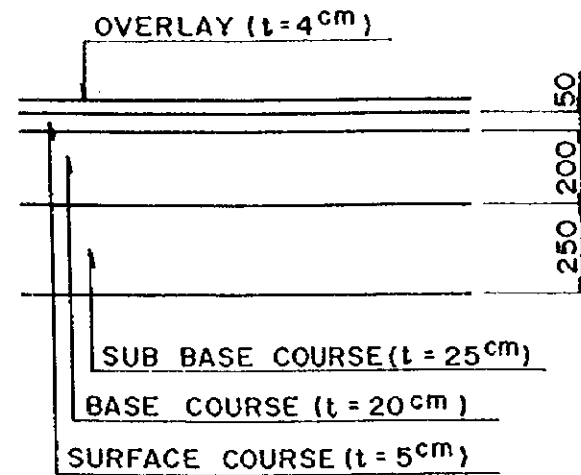
I. PAVEMENT

TRAFFIC VOLUME CLASSIFICATION : C

DESIGN CBR VALUE OF SUBGRADE : 20%

TARGET VALUE OF TA (cm) : 20 cm

$$TA_0 = 5 \times 0.6 + 20 \times 0.35 + 25 \times 0.25 = 16.3 \text{ cm}$$

$$\text{OVERLAY DEPTH REQUIRED} = 20 - 16.3 \approx 4 \text{ cm}$$

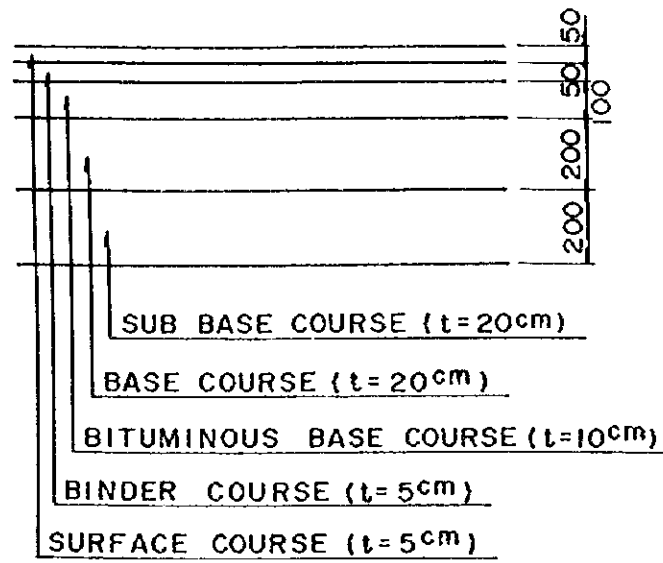
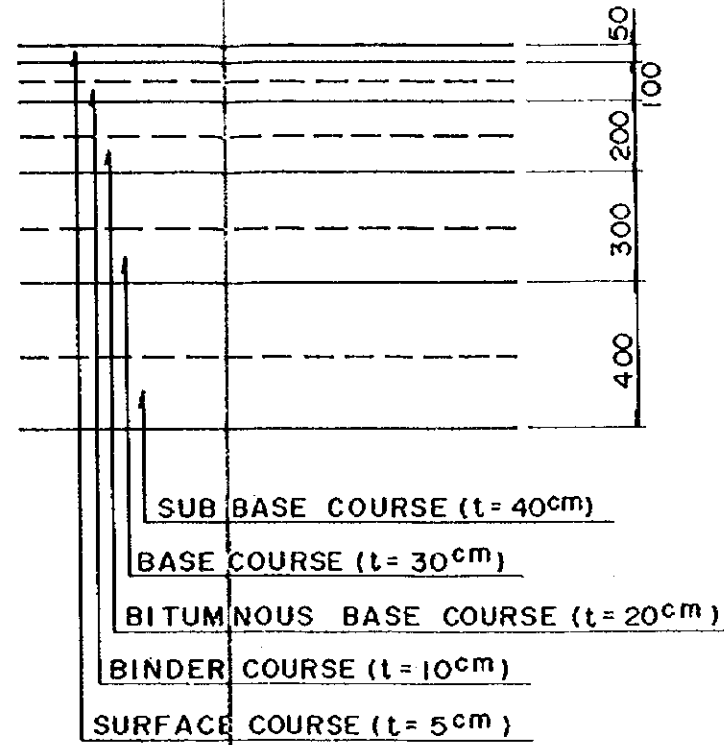
I. PAVEMENT

TRAFFIC VOLUME CLASSIFICATION : D
 DESIGN CBR VALUE OF SUBGRADE : 2 %
 TARGET VALUE OF T_a (cm) : 51^{cm}

$$T_a = (5+10) \times 1.0 + 20 \times 0.8 + 30 \times 0.35 + 40 \times 0.25 = 51.5\text{cm} > 51\text{cm}$$

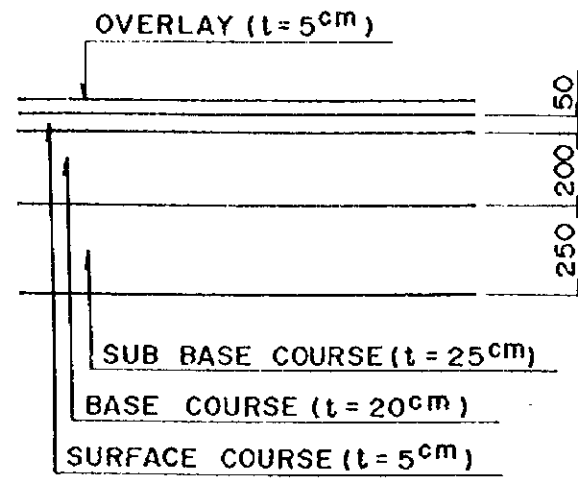
I. PAVEMENT

C (B), R (B), W (B)

TRAFFIC VOLUME CLASSIFICATION : C
 DESIGN CBR VALUE OF SUBGRADE : 20% (ASSUMED)
 TARGET VALUE OF T_A (cm) : 20cm
 $T_{A0} = 5 \times 0.6 + 20 \times 0.30 + 25 \times 0.25 = 15.3 \text{ cm}$
 OVERLAY DEPTH REQUIRED = $20 - 15.3 \approx 5 \text{ cm}$

Overly (t=5cm)

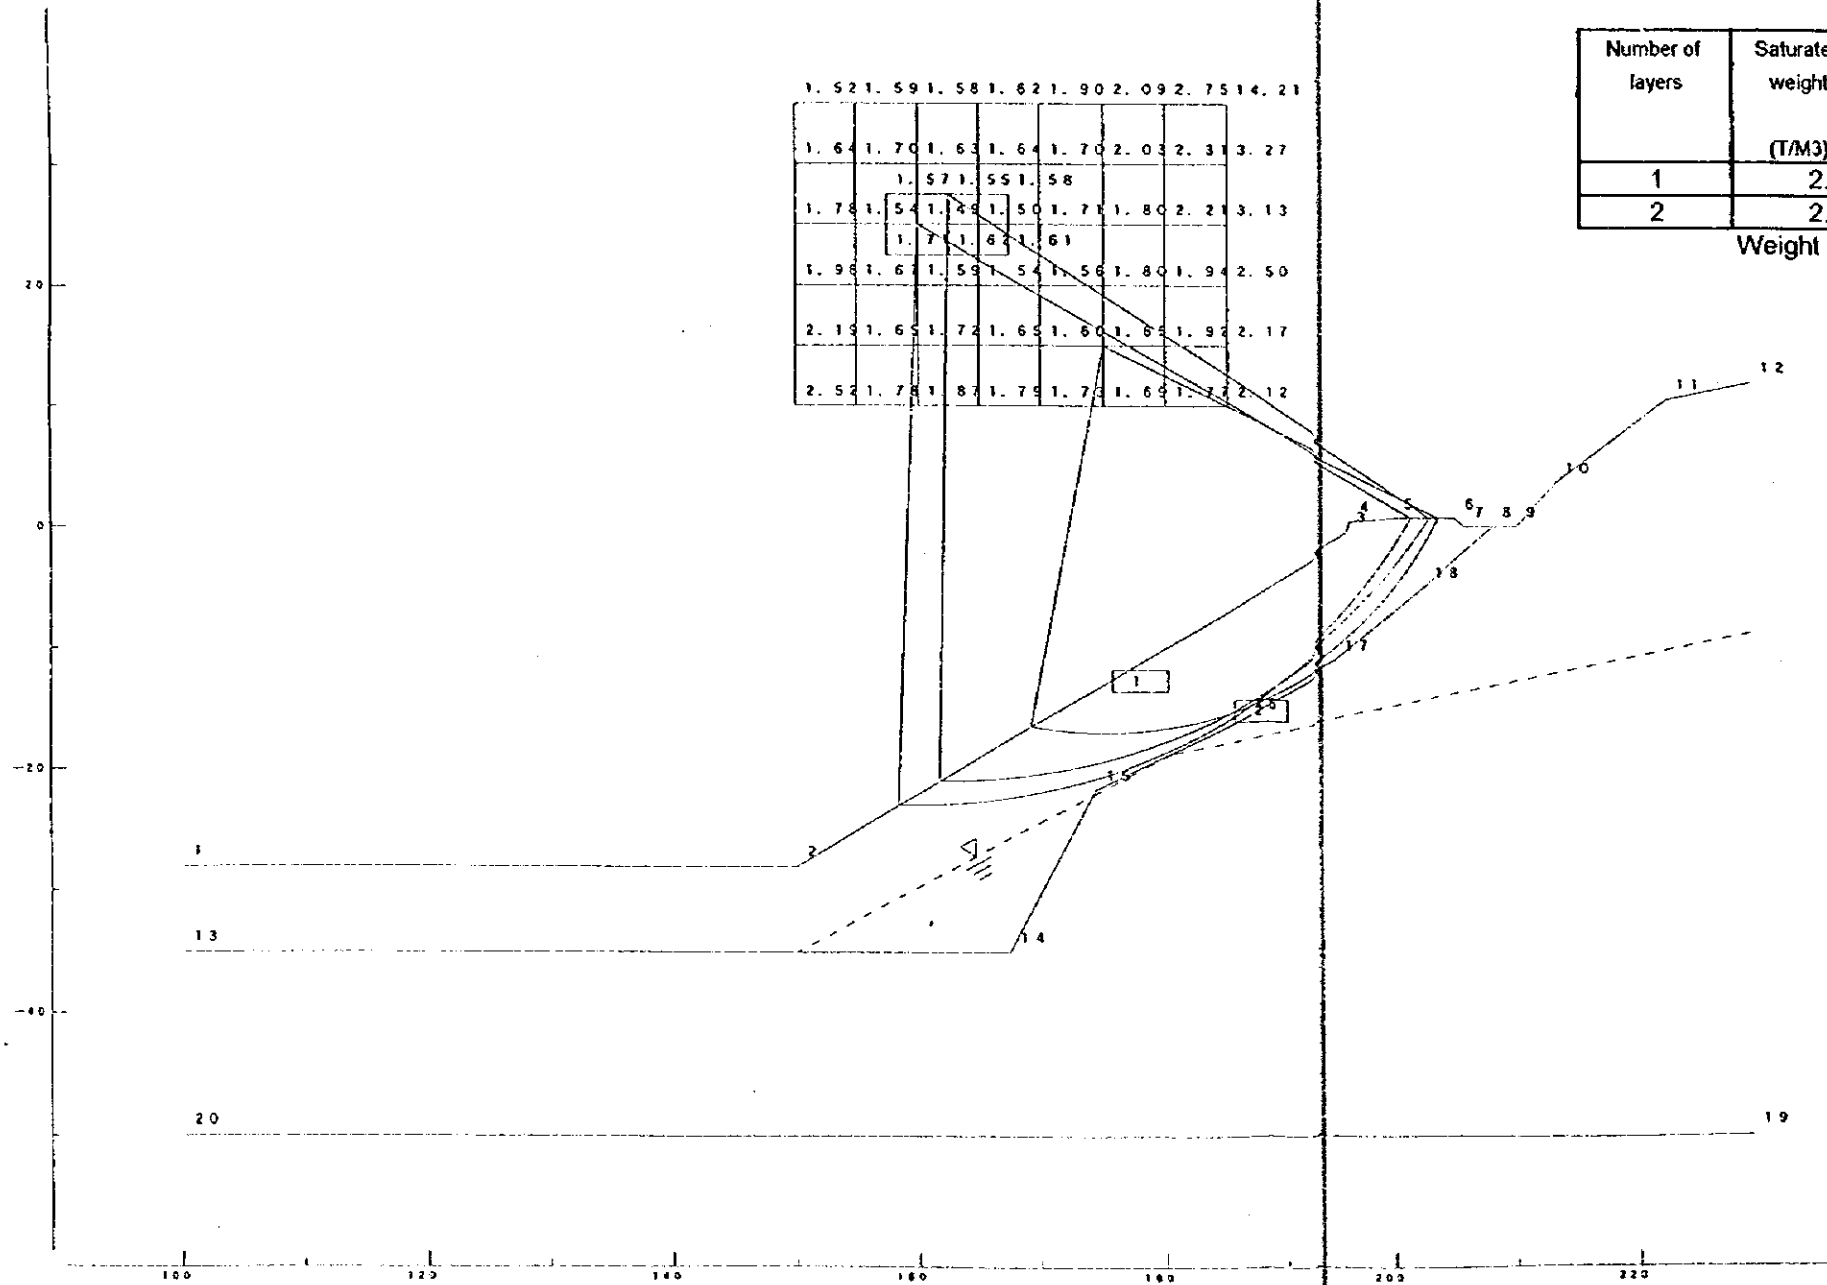
Figure of Safety Factor

010-18 (Present Condition)

Minimum safety factor $F_s \text{ min} = 1.499$
 Center of circular arc $X = 160.00 \text{ (M)}$
 $Y = 25.00 \text{ (M)}$
 Radius $R = 48.00 \text{ (M)}$
 Moment of resistance $MR = 16671.71 \text{ (T}^*\text{M)}$
 Starting moment $Mo = 11121.63 \text{ (T}^*\text{M)}$

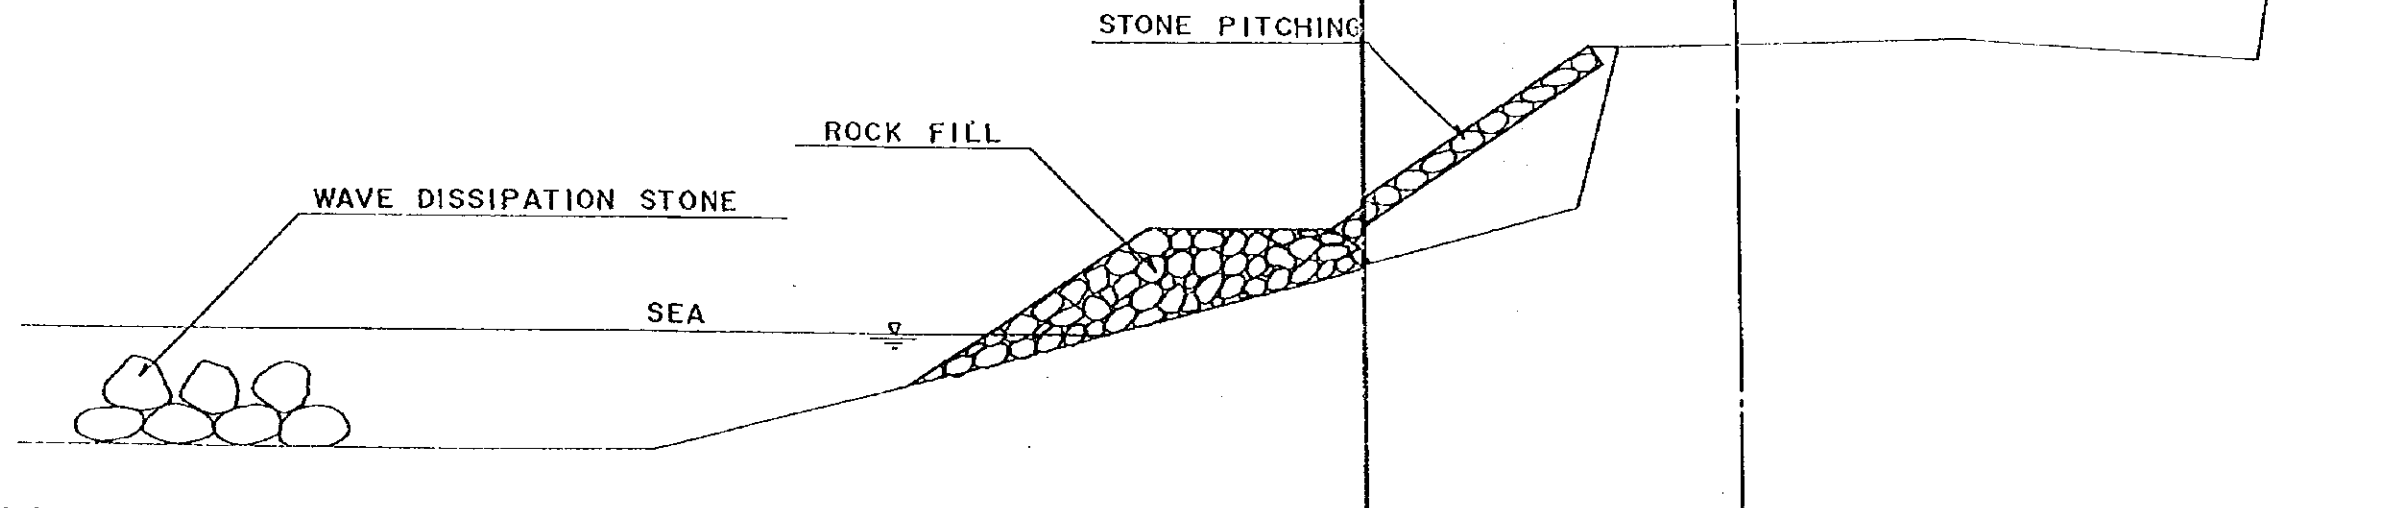
I. SLOPE (EROSION)

← Erosion (Sea) →

Rock Fill, stone pitching, Wave Dissipation stone

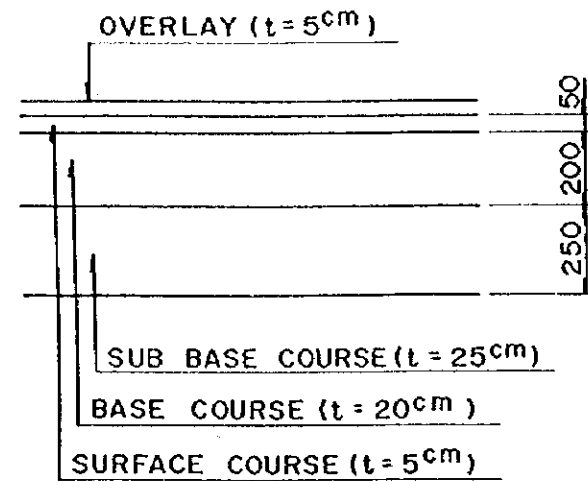
I. PAVEMENT

TRAFFIC VOLUME CLASSIFICATION : C

DESIGN CBR VALUE OF SUBGRADE : 20% (ASSUMED)

TARGET VALUE OF T_A (cm) : 20^{cm}

$$T_{A0} = 5 \times 0.6 + 20 \times 0.30 + 25 \times 0.25 = 15.3 \text{ cm}$$

$$\text{OVERLAY DEPTH REQUIRED} = 20 - 15.3 = 5 \text{ cm}$$

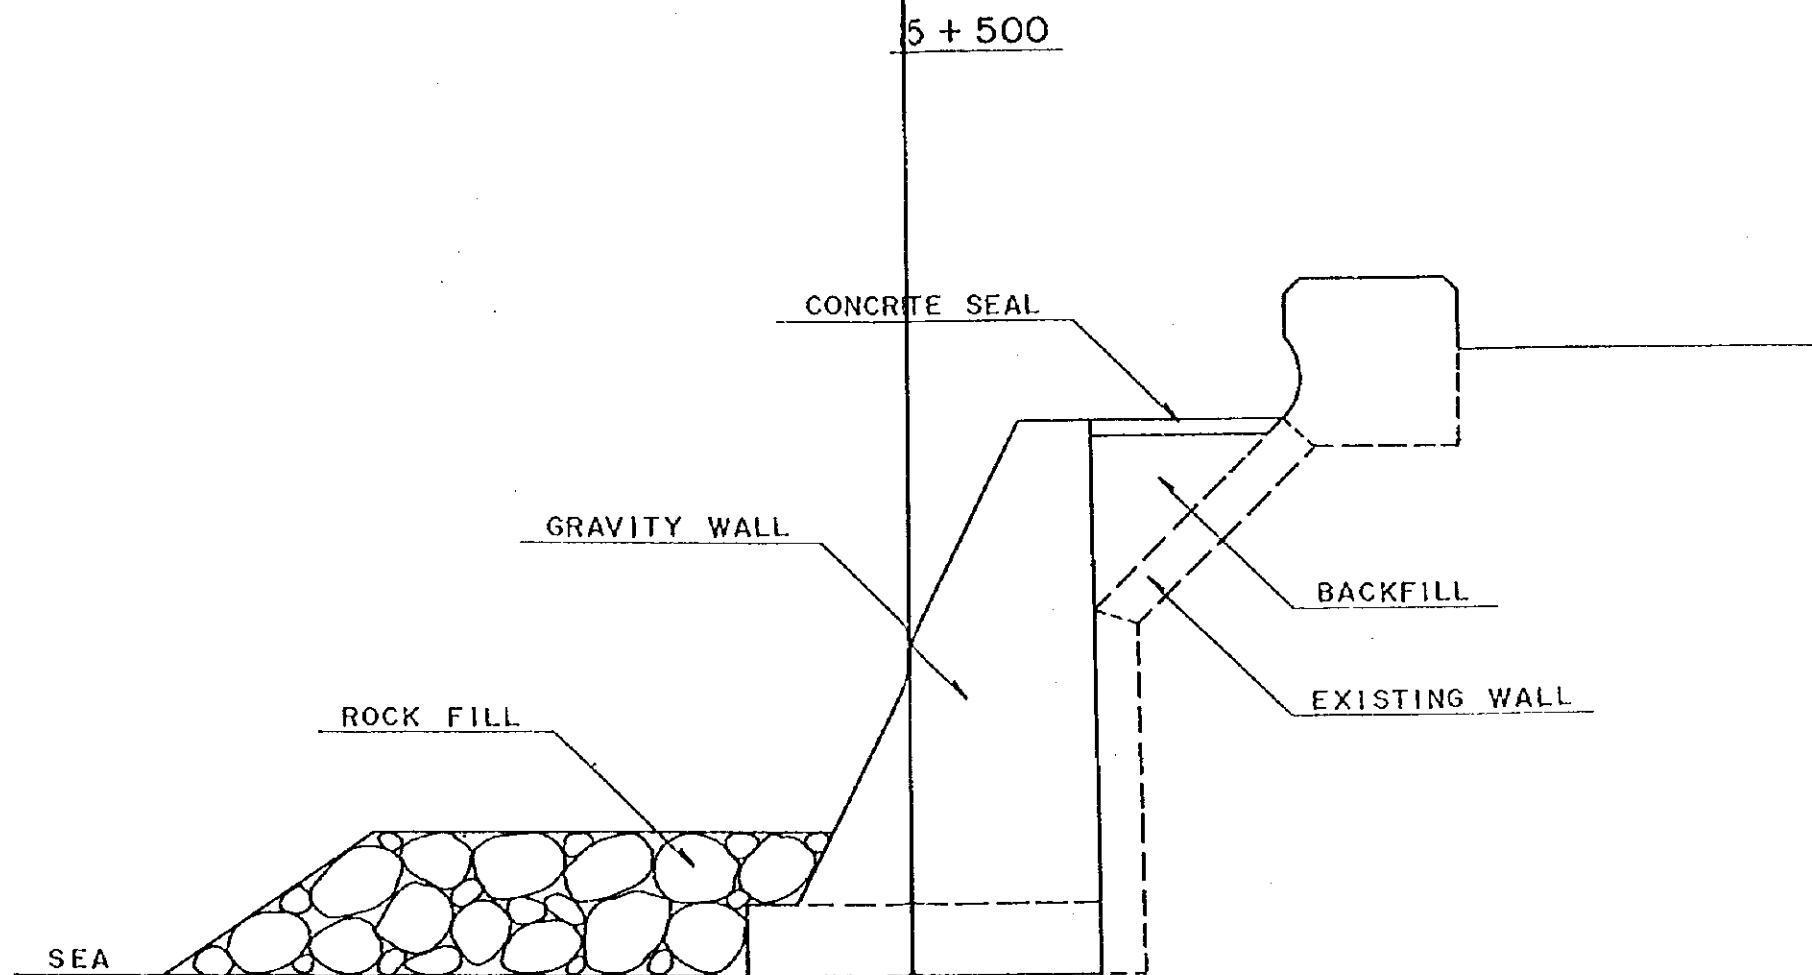
2. RETAINING WALL

Gravity Wall, Rock Fill
 ←→
 Settlement, collapse (sea)
 ←→

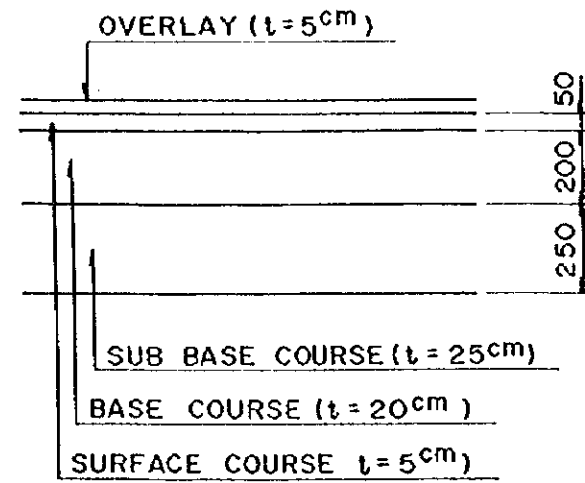
I. PAVEMENT

C (B), (B), W (-)

TRAFFIC VOLUME CLASSIFICATION : C
 DESIGN CBR VALUE OF SUBGRADE : 20% (ASSUMED)
 TARGET VALUE OF TA (cm) : 20^{cm}
 $TA_0 = 5 \times 0.6 + 20 \times 0.30 + 25 \times 0.25 = 15.3\text{cm}$
 OVERLAY DEPTH REQUIRED = $20 - 15.3 \approx 5\text{cm}$

Overly (t=5cm)

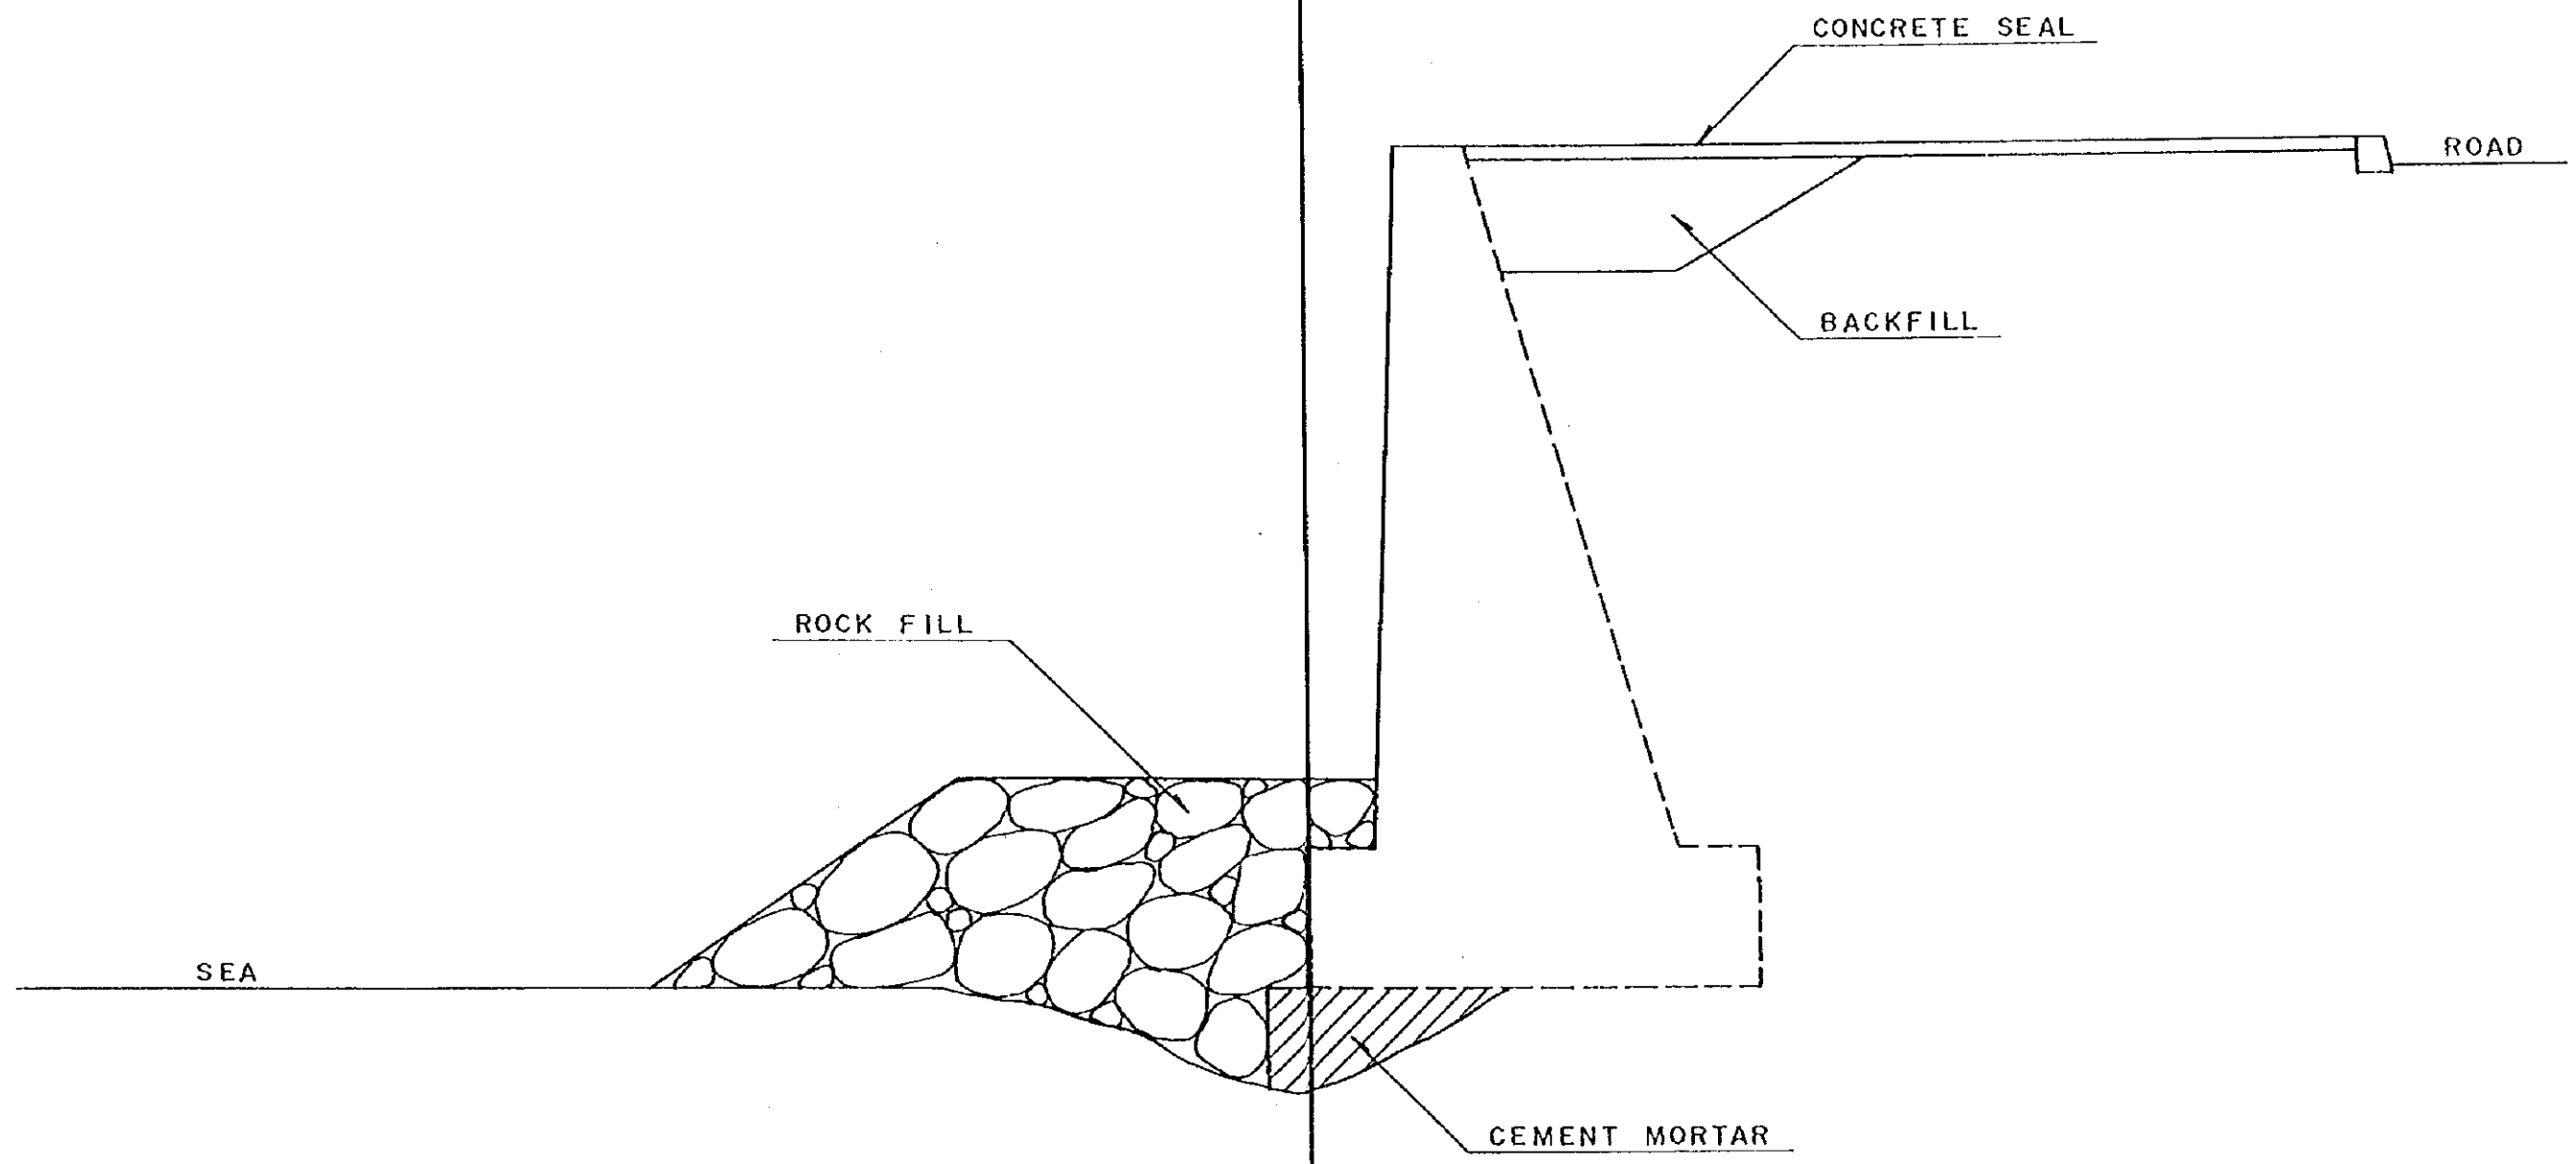
2. RETAINING WALL

Settlement (sea)

Fill (cement mortar), rock fill
