THE STUDY ON ARTERIAL HIGHWAY MAINTENANCE IN THE REPUBLIC OF TURKEY

FINAL REPORT DRAWINGS

VOLUME ③

JULY 1998

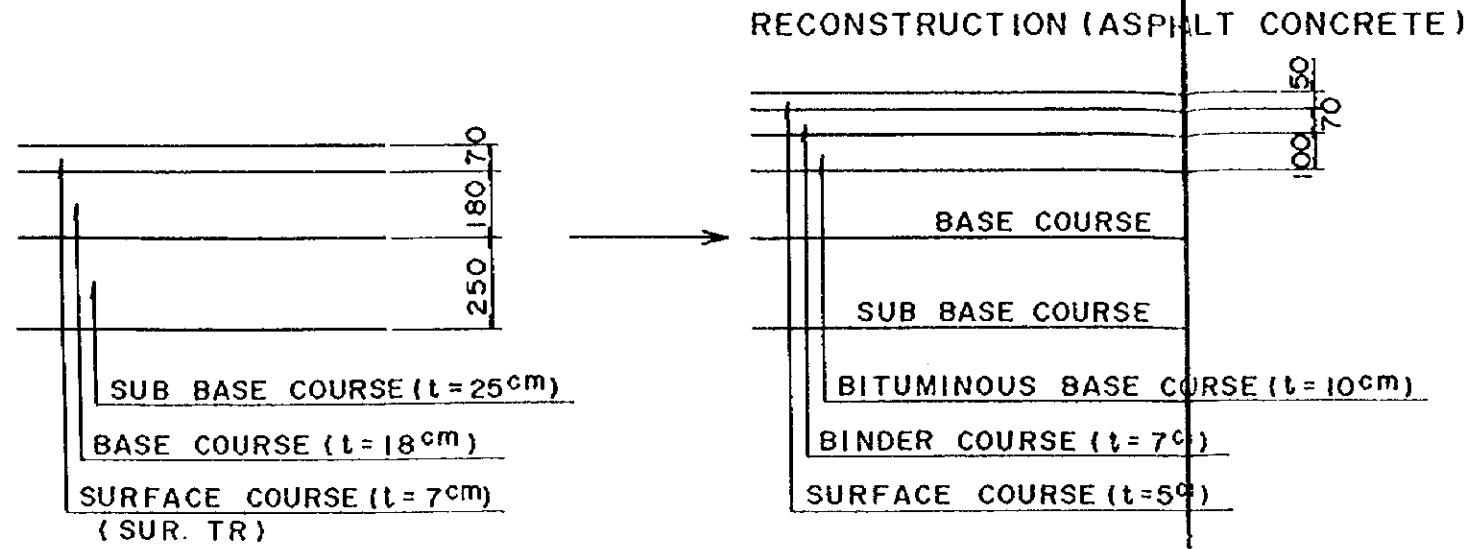
I. PAVEMENT

TRAFFIC VOLUME CLASSIFICATION : C

DESIGN CBR VALUE OF SUBGRADE : 4 %

TARGET VALUE OF TA (cm) : 32 cm

$$TA_0 = 7 \times 0.6 + 18 \times 0.35 + 25 \times 0.25 = 16.8 \text{ cm}$$

$$\text{OVERLAY DEPTH REQUIRED} = (32 - 16.8) \times 1.08 = 19 \text{ cm}$$

$$TA = (5 + 7) \times 1.0 + 10 \times 0.8 + 18 \times 0.35 + 25 \times 0.25 = 32.5 \text{ cm} > 32 \text{ cm}$$

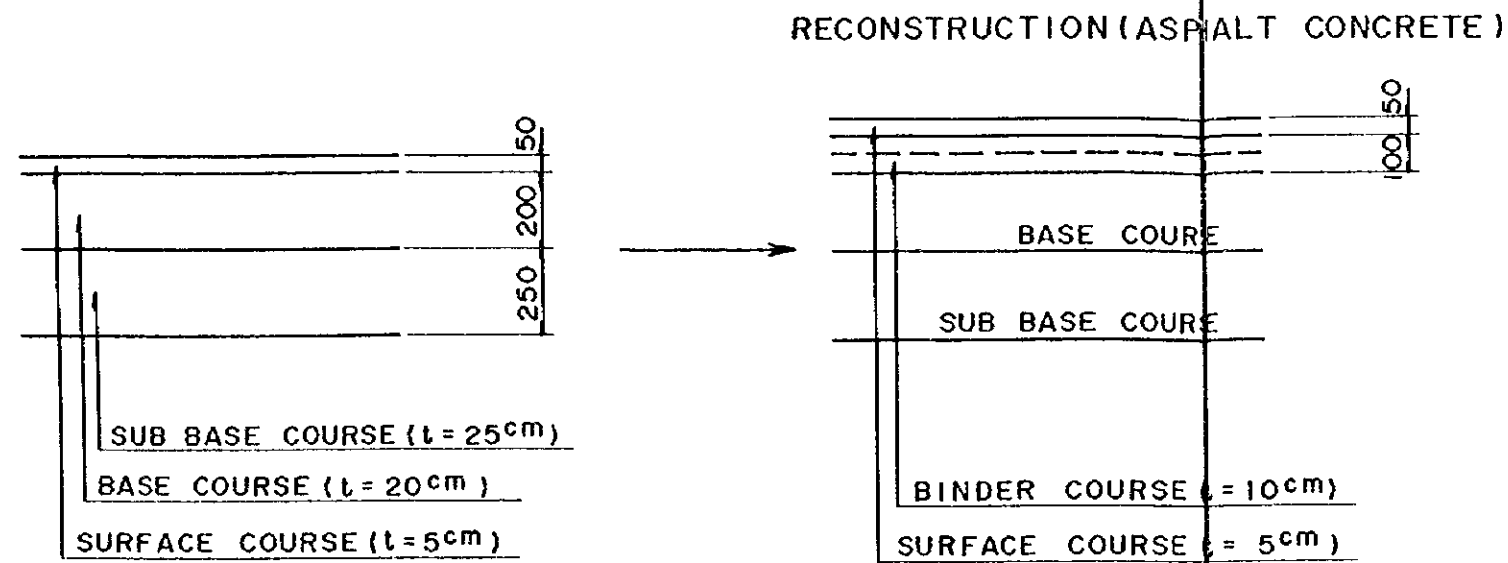
I. PAVEMENT

TRAFFIC VOLUME CLASSIFICATION : C
 DESIGN CBR VALUE OF SUBGRADE : 10% (ASSUMED)
 TARGET VALUE OF T_A (cm) : 24.5cm
 $T_{A0} = 5 \times 0.5 + 20 \times 0.25 + 25 \times 0.20 = 12.5 \text{ cm}$
 OVERLAY DEPTH REQUIRED = $(24.5 - 12.5) \times 1.08 = 15 \text{ cm}$

$T_A = (5 + 10) \times 1.0 + 20 \times 0.25 + 25 \times 0.20 = 25.0 \text{ cm} > 24.5 \text{ cm}$

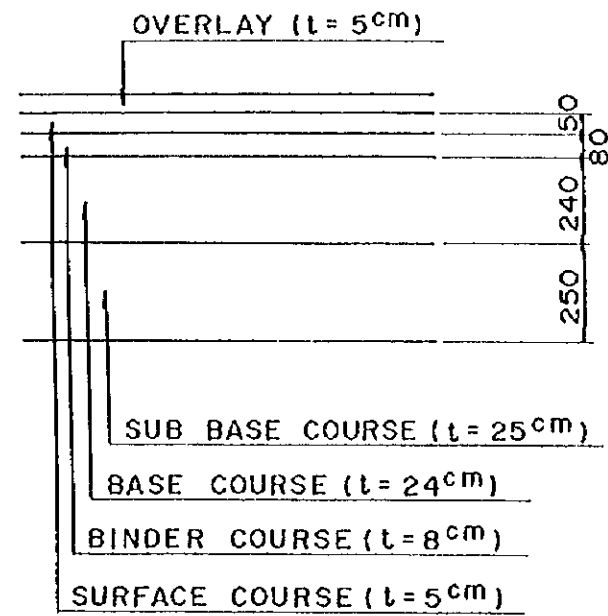
I. PAVEMENT

TRAFFIC VOLUME CLASSIFICATION : C

DESIGN CBR VALUE OF SUBGRADE : 10% (ASSUMED)

TARGET VALUE OF T_A (cm) : 24.5 cm

$$T_{A0} = (5+8) \times 0.6 + 24 \times 0.3 + 25 \times 0.20 = 20.0 \text{ cm}$$

$$\text{OVERLAY DEPTH REQUIRED} = 24.5 - 20 \approx 5 \text{ cm}$$

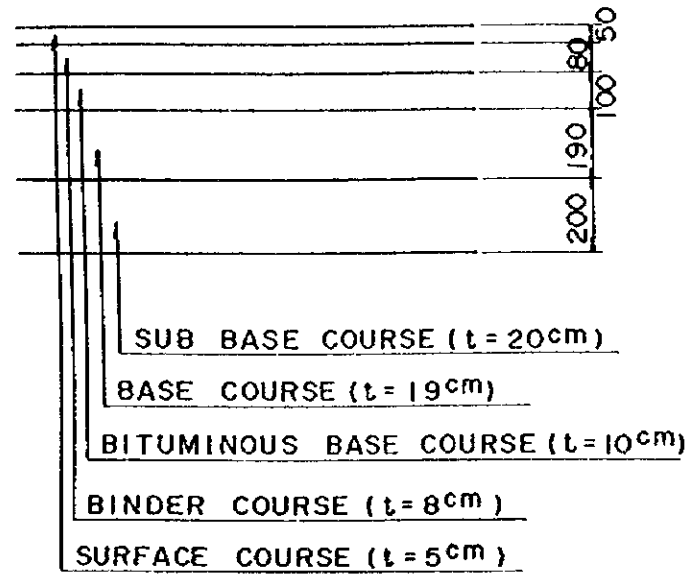
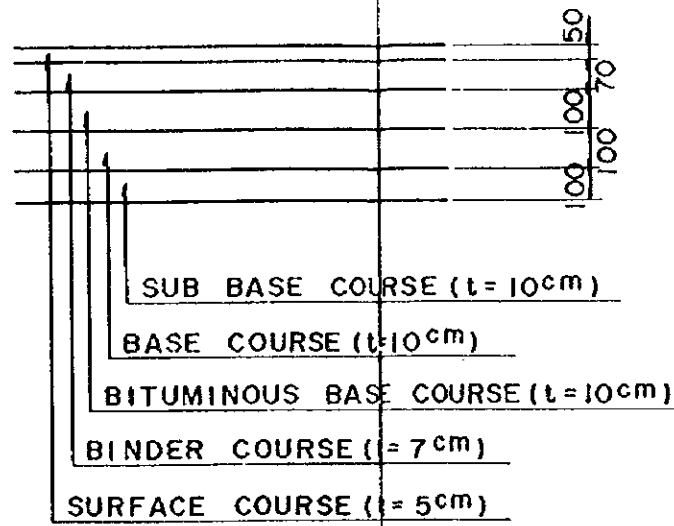
I. PAVEMENT

TRAFFIC VOLUME CLASSIFICATION : D

DESIGN CBR VALUE OF SUBGRADE : 20 %

TARGET VALUE OF T_A (cm) : 26 cm

$$T_{A0} = (5 + 8) \times 0.5 + 10 \times 0.5 + 19 \times 0.25 + 20 \times 0.20 = 20.3 \text{ cm}$$

$$T_A = (5 + 7) \times 1.0 + 10 \times 0.8 + 10 \times 0.35 + 10 \times 0.25 = 26 \text{ cm} \geq 26 \text{ cm}$$

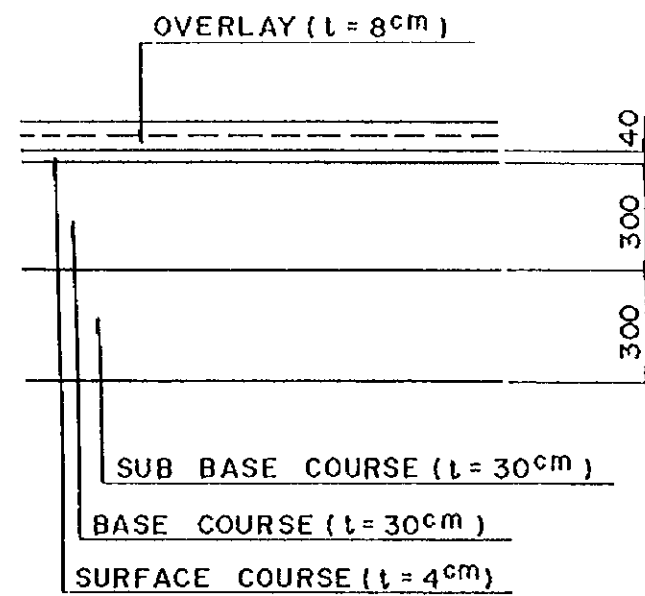
I. PAVEMENT

TRAFFIC VOLUME CLASSIFICATION : C

DESIGN CBR VALUE OF SUBGRADE : 10%

TARGET VALUE OF T_A (cm) : 24.5 cm

$T_{A0} = 4 \times 0.5 + 30 \times 0.30 + 30 \times 0.20 = 17 \text{ cm}$

OVERLAY DEPTH REQUIRED = $24.5 - 17 = 8 \text{ cm}$
