BASIC DESIGN STUDY REPORT ON THE PROJECT FOR THE WHARF REHABILITATION IN TANNA ISLAND IN THE REPUBLIC OF VANUATU

DEPARTMENT OF PUBLIC WORKS
MINISTRY OF INFRASTRUCTURE
AND PUBLIC UTILITIES
REPUBLIC OF VANUATU

JULY 1998

**JAPAN INTERNATIONAL COOPERATION AGENCY
PACIFIC CONSULTANTS INTERNATIONAL**

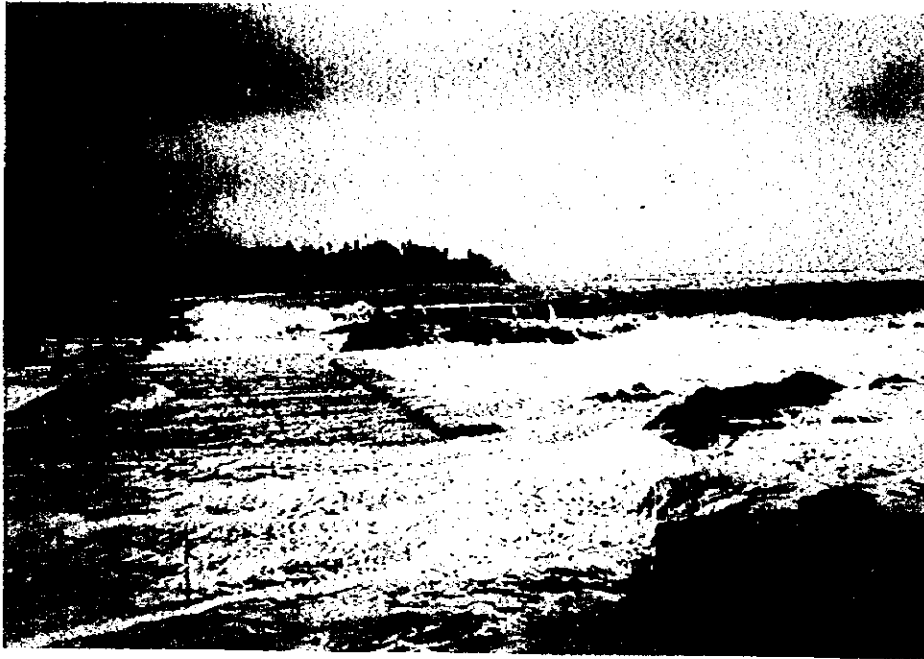
Photograph (1) Cyclone "Yali" (23 Mar. 1998) Attacked

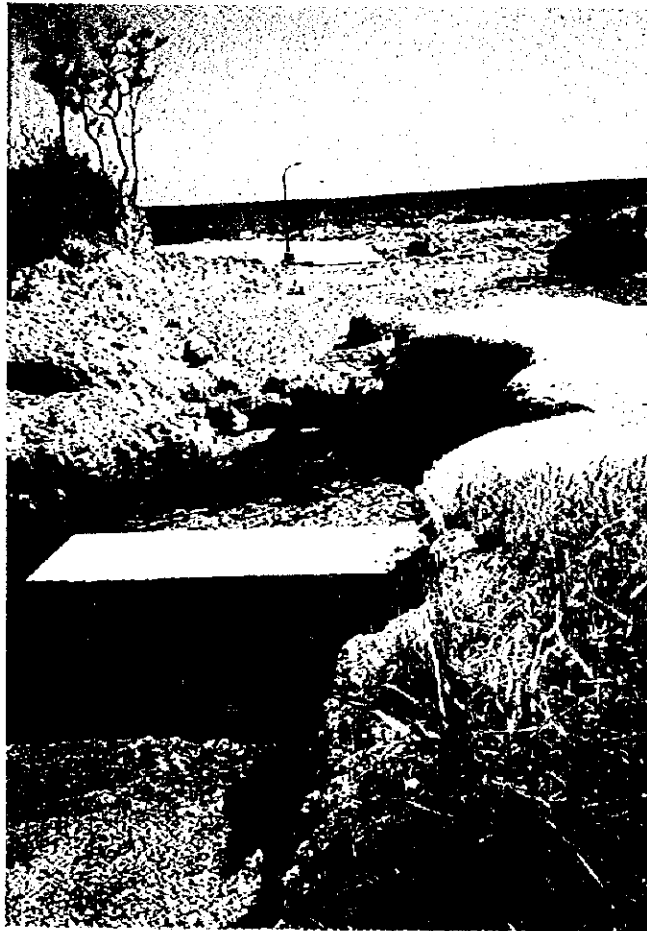
Photograph (2) Damaged Access Road (Gravel Pavement Area)

Portion of the crusher-run pavement damaged and lost during the incident is planned to be replaced with concrete pavement up to the elevation of +3.0 m, where influence of cyclone attack is minimum.

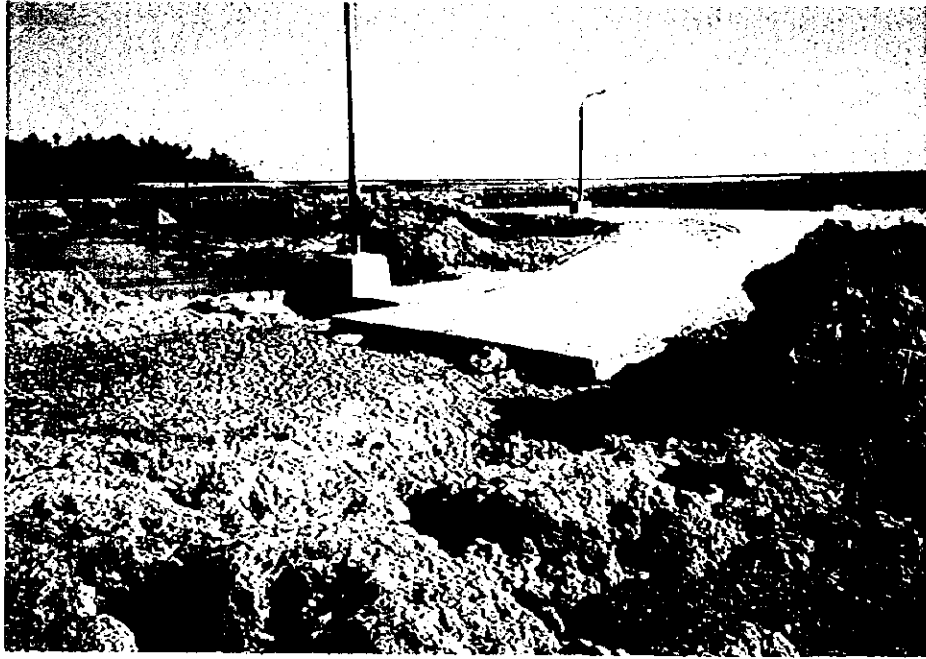
**Photograph (3) Damaged Access Road
(Transition from concrete to gravel pavement)**

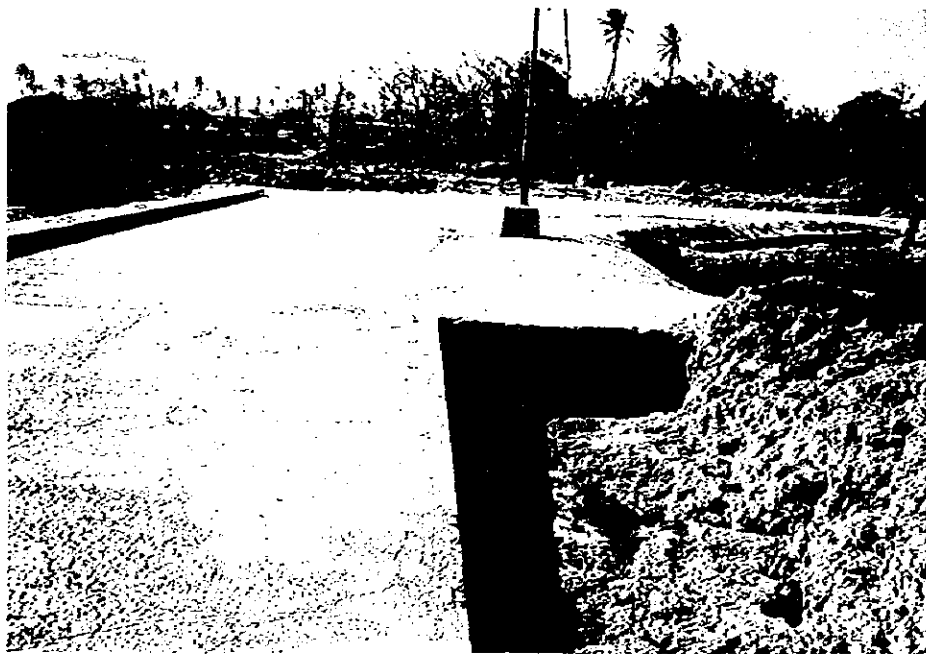
Photograph (4) Damaged Access Road (Concrete moved out)

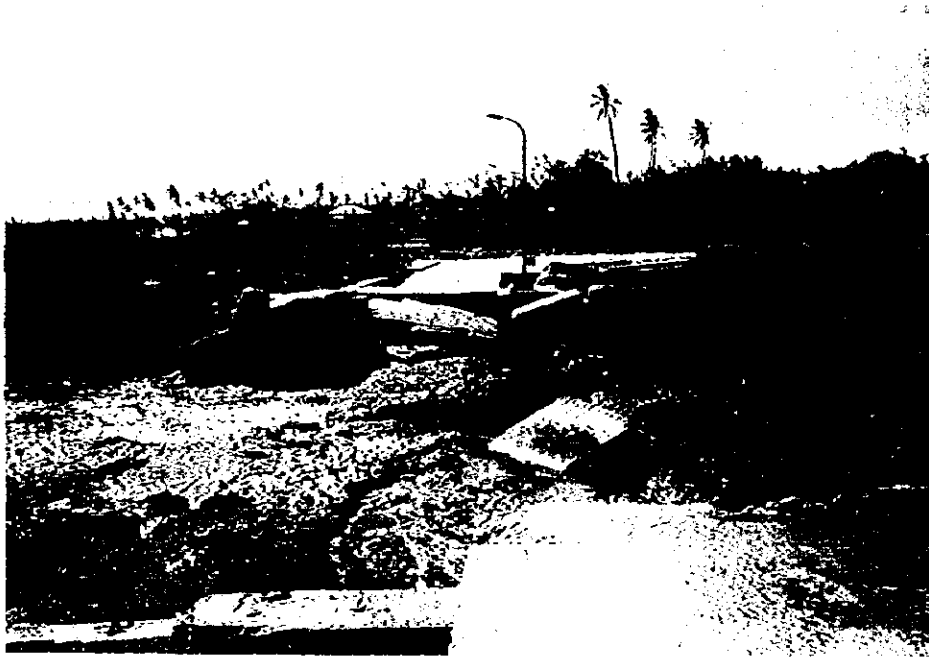
**Photograph (5) Access Road Washed Away
(Area of Connected to the Wharf)**

In other area directly in contact with coral reef, rock is replaced with concrete cast in place. Area damaged by rainfall and cyclic attack of reflecting waves is also protected by revetment of steel sheet pile type.

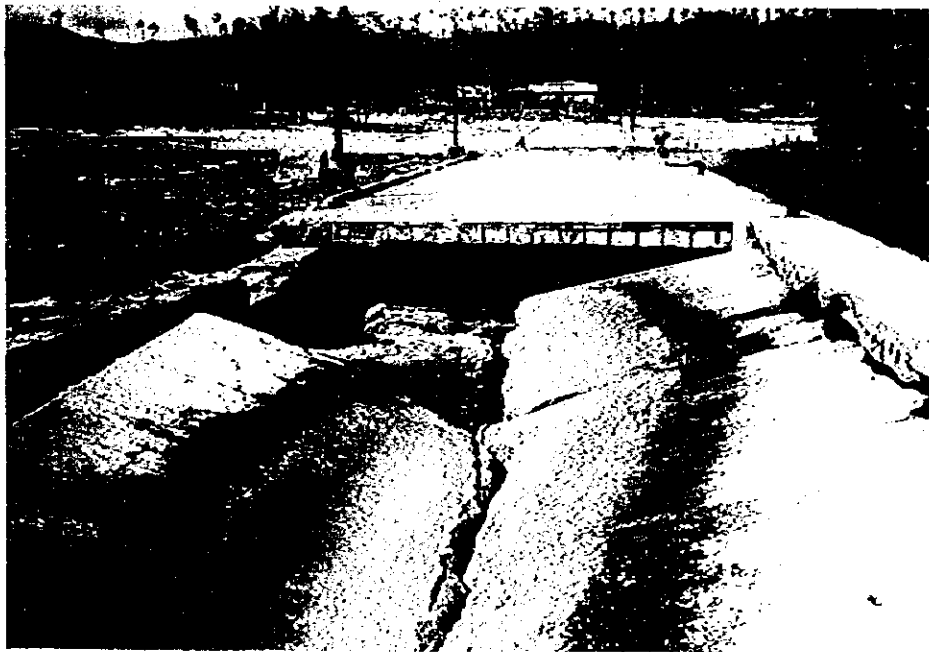
Photograph (6) Damaged Wharf (See from West to East)

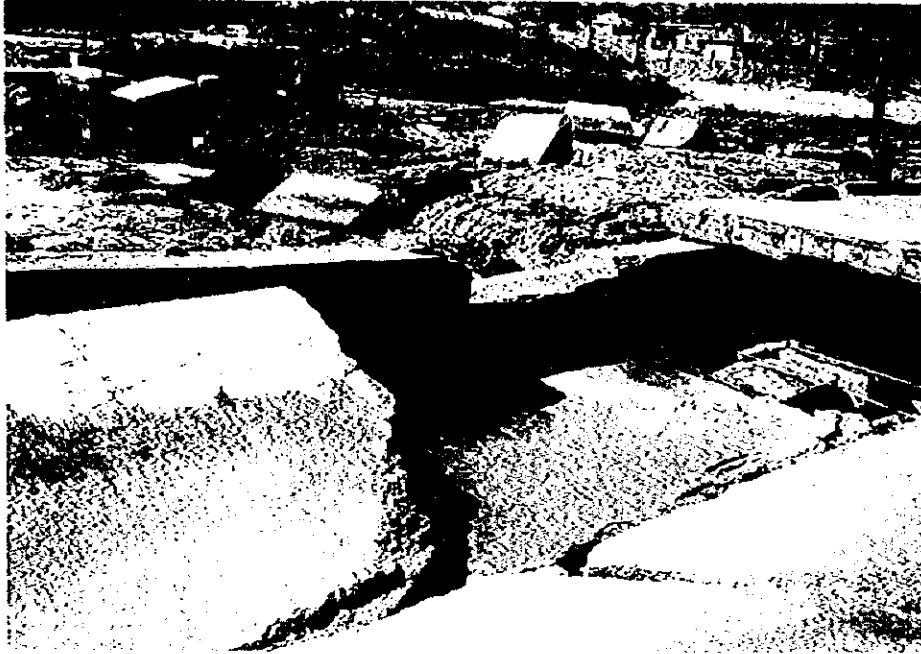
Photograph (7) Damaged Anchor Concrete Block (Wharf)

Fill materials behind the sheet pile walls were washed out at some portions for about 25 m along the wall line. Concrete anchor blocks installed at such position shall be sealed below the low tide elevation by new steel sheet pile wall of 34 m in total length against possible wash out of the foundation fill. The existing anchor blocks can be used at other portion of 22 m length, for the foundation of the blocks are well set up on the existing coral rock without any wash out.

The existing concrete anchor blocks are not demolished in order to secure temporary construction space for the rehabilitation, although wash out of the foundation for the concrete blocks is evident. Along the portion where the foundation was washed out, new steel sheet piles are driven from the western corner of the wharf to eastward in order to prevent future washout from the foundation as shown in Figure 2.2. The sheet piles are driven behind the existing concrete blocks, which are fixed with the blocks by new anchor coping to be formed with new concrete cast in place.

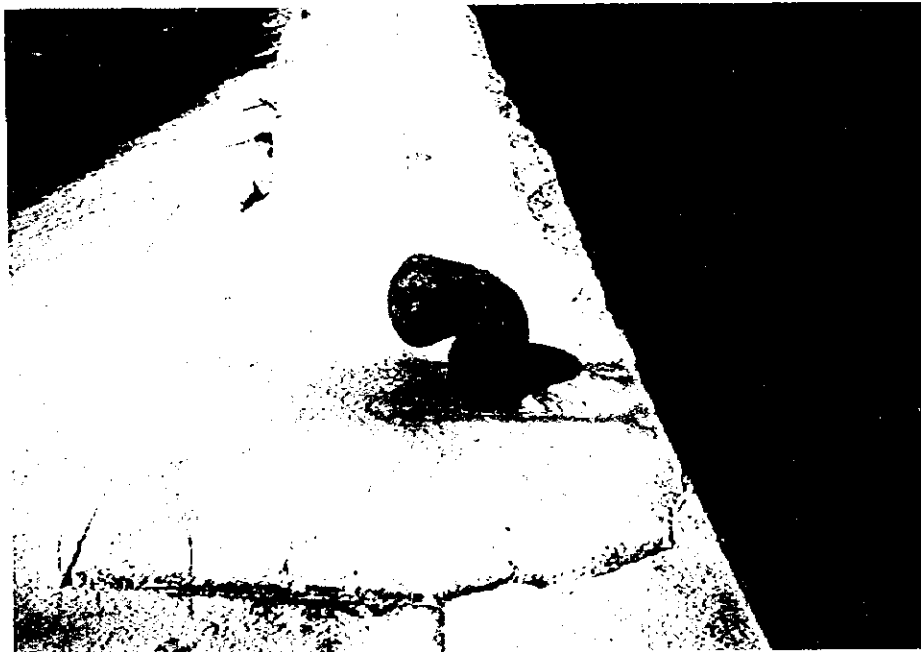
Photograph (10) Conditions of Bollard and Concrete Surface of the Wharf

Abrasive damage is significant in the coping concrete of the sheet pile wall. The upper portion shall be tipped off and replaced with new concrete. Curbs damaged should be replaced monolithically. Upper bolts for fender installation are also damaged, thus be replaced at the time of coping concreting.

It is observed that corrosion of the bitts originally installed is more severe than normally found in other port and harbour facilities. Reason for such severe corrosion is assumed due to regular splash of seawater in extreme conditions and lack of proper maintenance. In the present

rehabilitation, anti-corrosive materials should be adopted for mooring fixtures.

Complete replacement of the mooring bitts is scheduled, as severe corrosion of the materials is obvious. Anti-corrosive bitts of stainless steel are to be installed instead of the original cast-iron ones. Cost of the new bitts is estimated to be almost the same as the original.
