NATIONAL HIGHWAY BRIDGE CONSTRUCTION

THE KINGDOM OF BHUTAN

FINAL REPORT
VOLUME 3
APPENDIX

Appendix-A
Outline of 22 Bridges

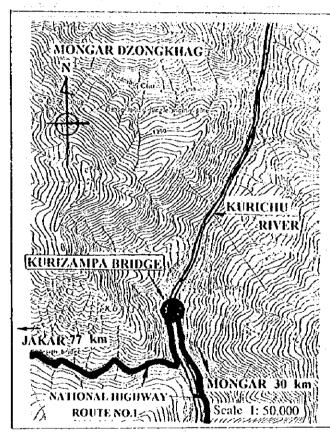
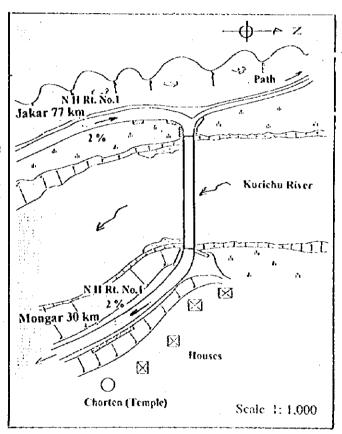
BRIDGE NO. 1 KURIZAMPA BRIDGE

8. Maintenance, especially repainting manner, is not

satisfactory.

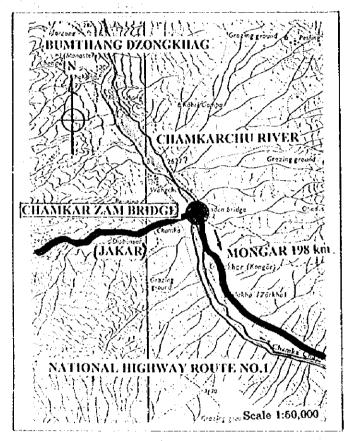
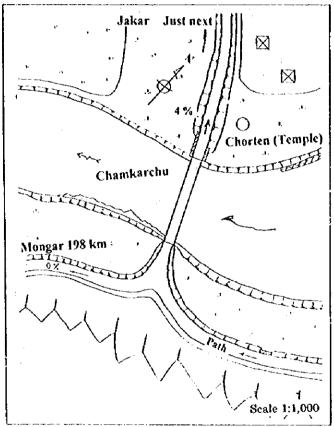
BRIDGE NO. 2 CHAMKAR ZAM BRIDGE

1.8 Maintenance, especially on the underside of superstructure, is not satisfactory. The rust has gone into steel members.

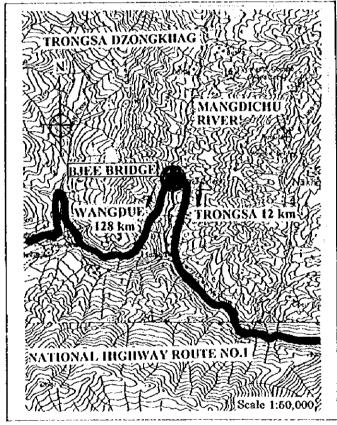
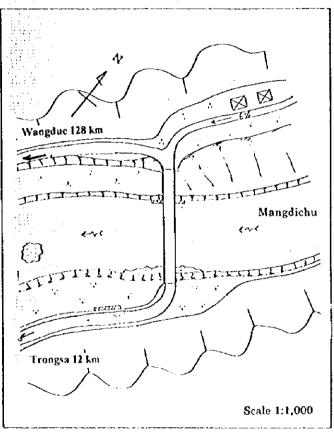
BRIDGE NO. 3 BJEE BRIDGE

8. The underside of the superstructure is very rusty and there is no sign of past maintenance. A turn-buckle doesn't work as shown in the photo, pins are missing, and main beams are crushed by vehicles and left bent severely at 24 locations.

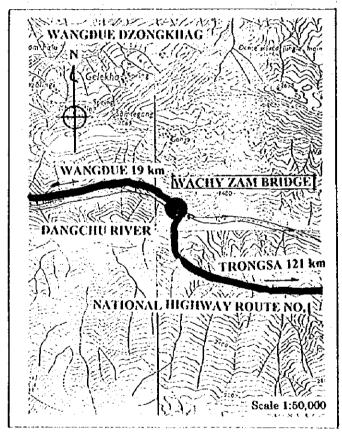
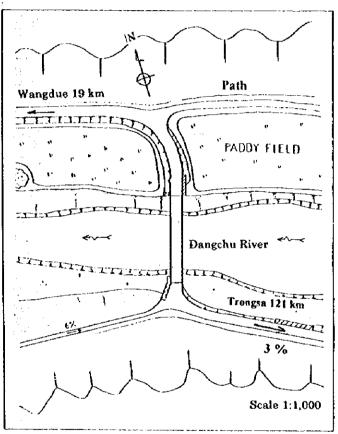
BRIDGE NO. 4 WACHY ZAM BRIDGE

8. Main steel members are seriously got rusted into

the mother materials.

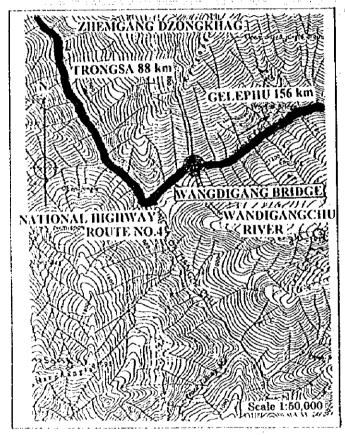
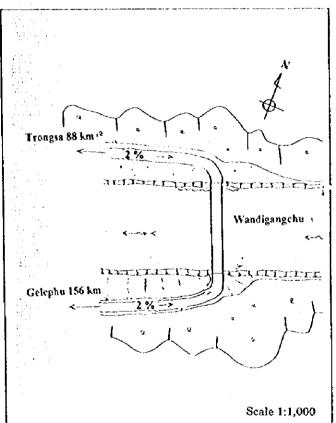
BRIDGE NO. 6 WANGDIGANG BRIDGE

8.One pin on the end post is missing, and main frames were crushed and bent at 3 locations.

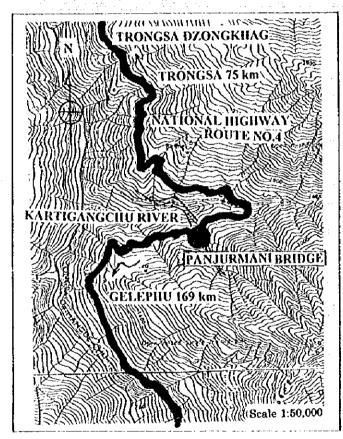
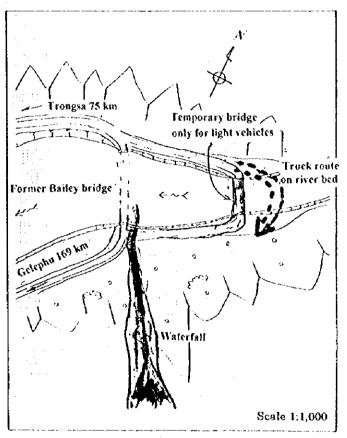
BRIDGE NO. 7 PANJURMANI BRIDGE

8. Former Bailey bridge was damaged by flood and falling trees.

Existing steel girder with log deck is a temporary one. Heavy trucks are crossing the river bed at upper stream.

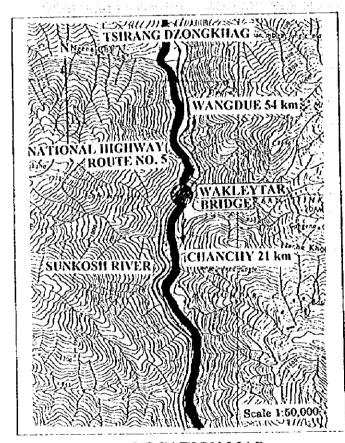
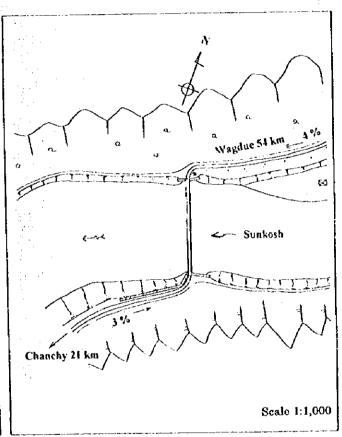
BRIDGE NO. 16 WAKLEYTAR BRIDGE

8. Members underside of superstructure is very rusty. The above photo shows one example of very rusty turn-buckles,

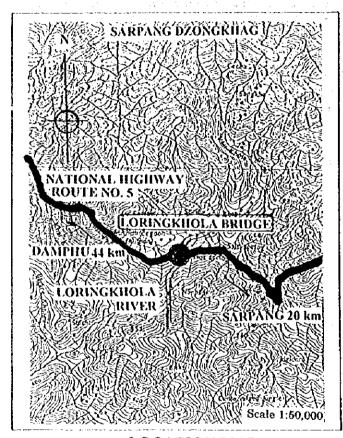
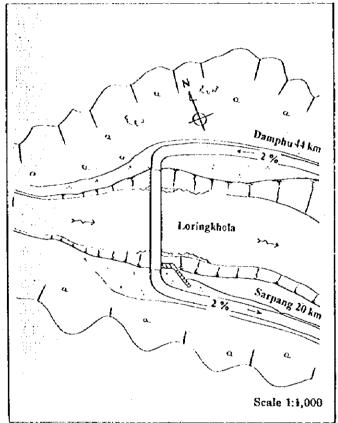
BRIDGE NO. 20 LORINGKHOLA BRIDGE

8. Environment the bridge site is very wet by the high waterfall at the upper stream side.
