Appendix-B

Photographs of Site Conditions (5 Bridges)

Appendix-C

Bridges Survey Results (22 Bridges)

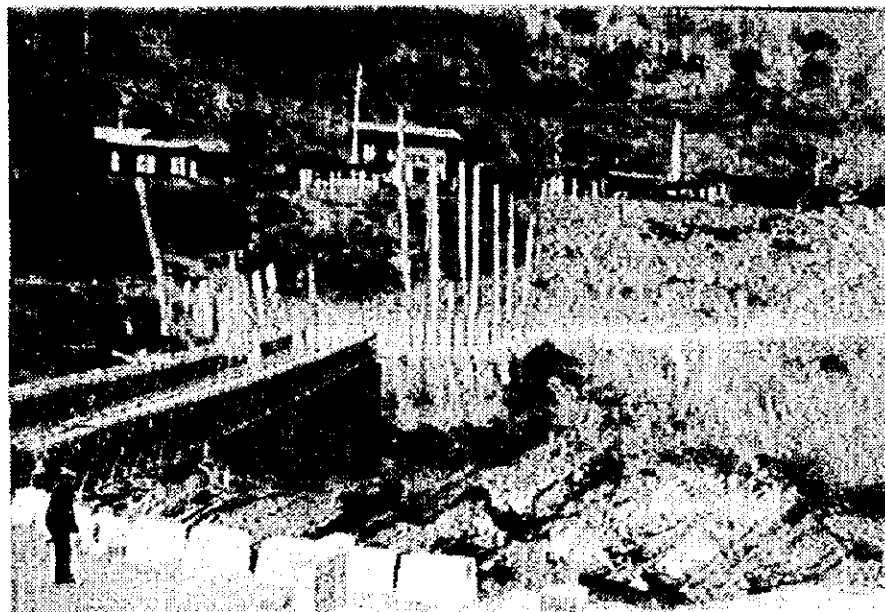
Left bank
Rock is
outcropping.

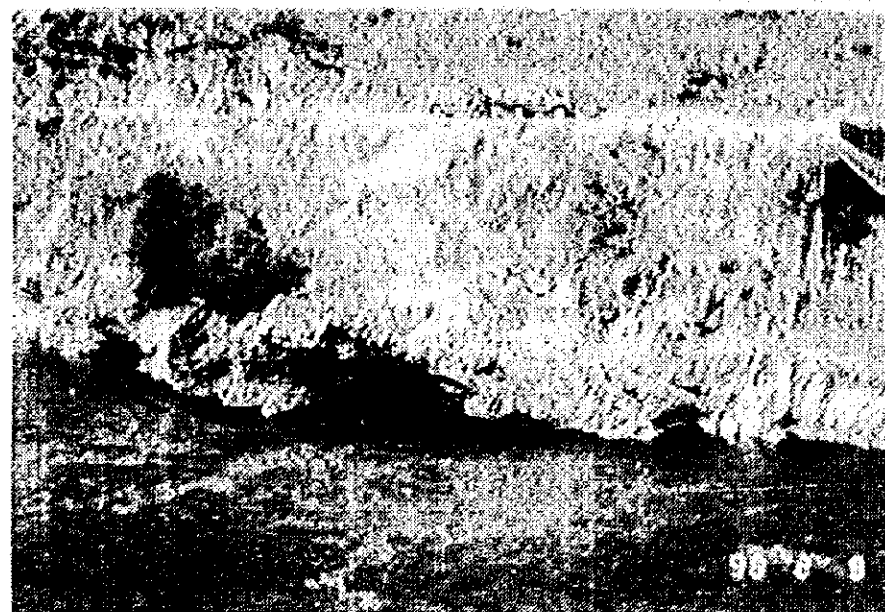
Right bank
Rock was scored
at lower part.

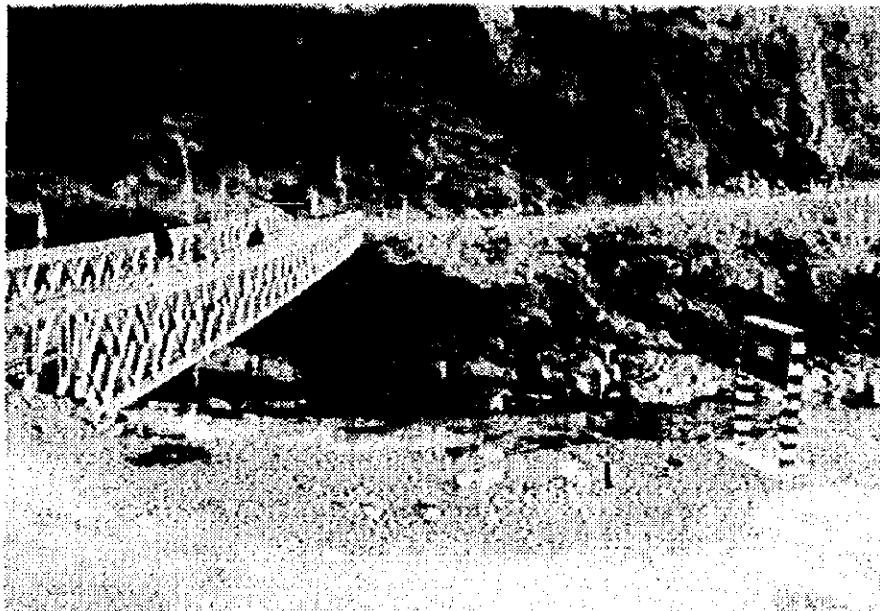
Left bank
Rock is
outcropping.

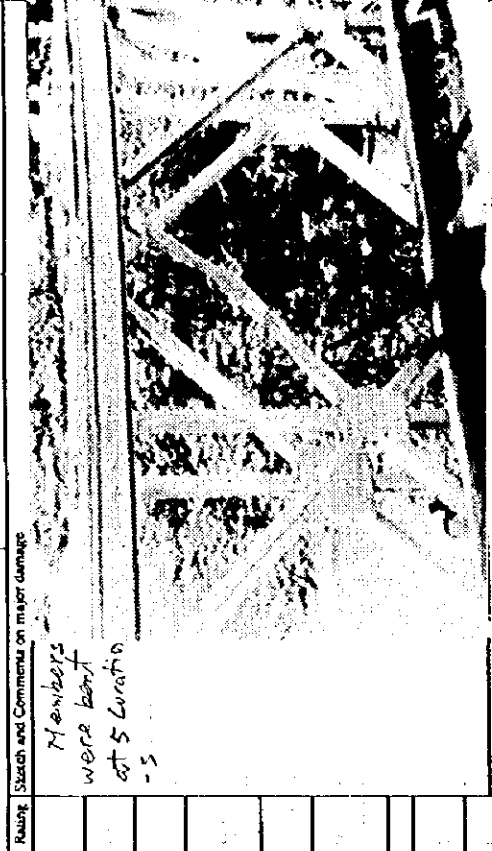
Rating Sketch and Comments on major damage
Members were best at 5 location

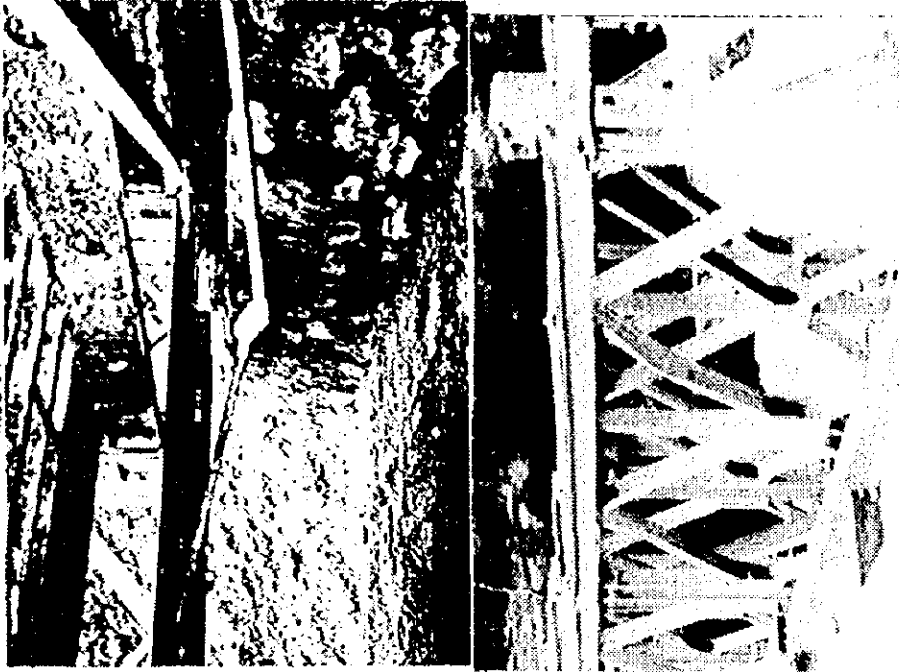
Comments on major damage: Turn outside buckle was broken. wasn't very bc.
 Comments on repair: Main bolts were crushed.

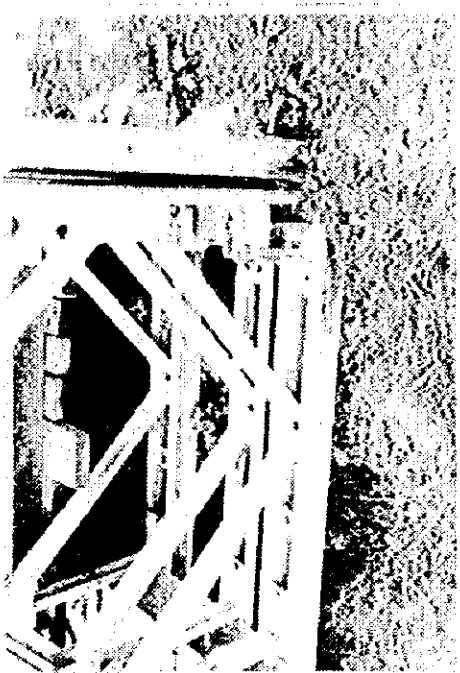
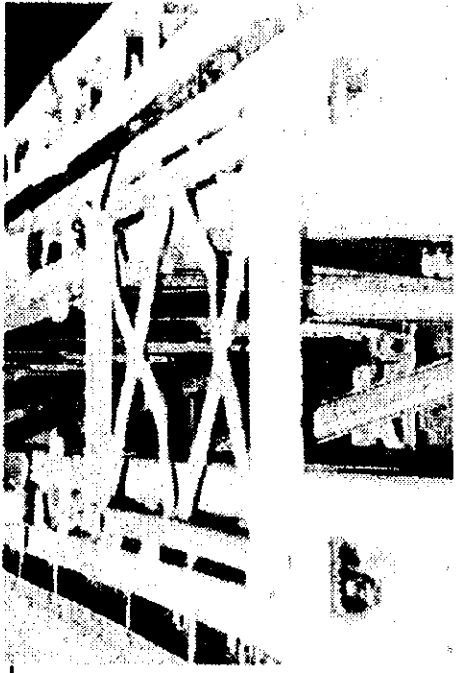
Photo Album No.	<i>Port members on bearings.</i>	Photo Album No.	
Elevation

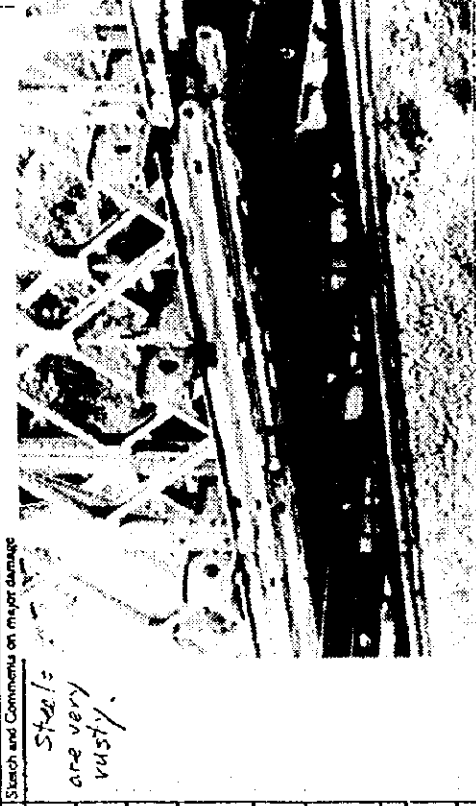
Rating: 3
 Sketch and Comments on major damage:
Steels are very rusty.

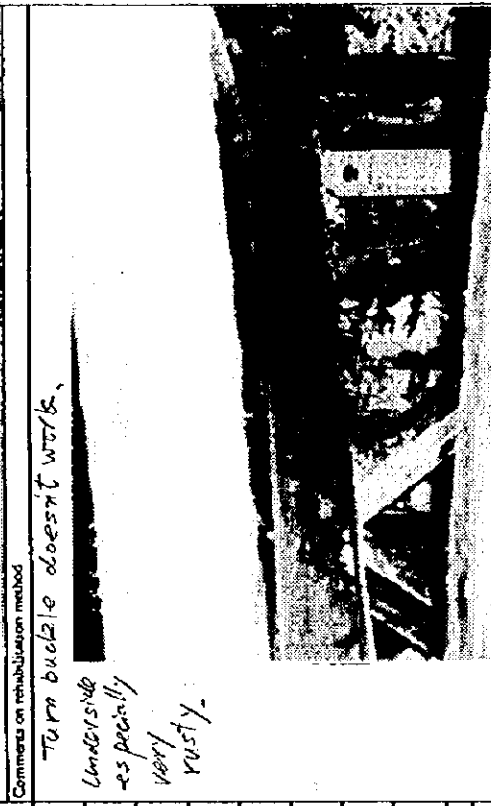
Comments on rehabilitation method:
Turn buckle doesn't work, underside especially very rusty.

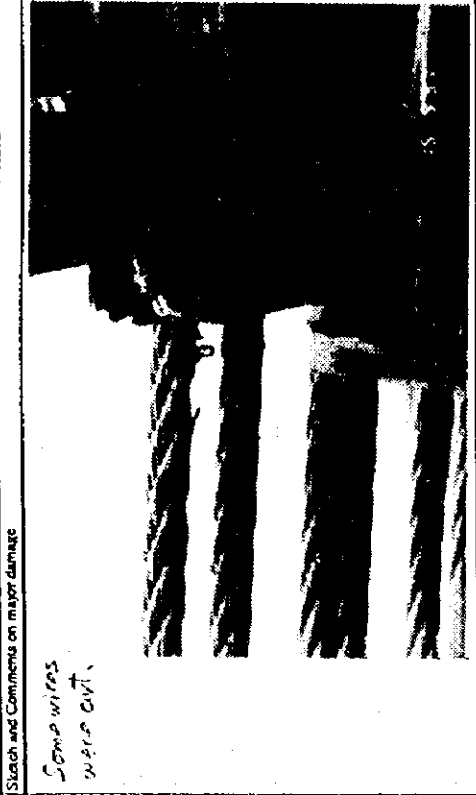
Some wires were cut.

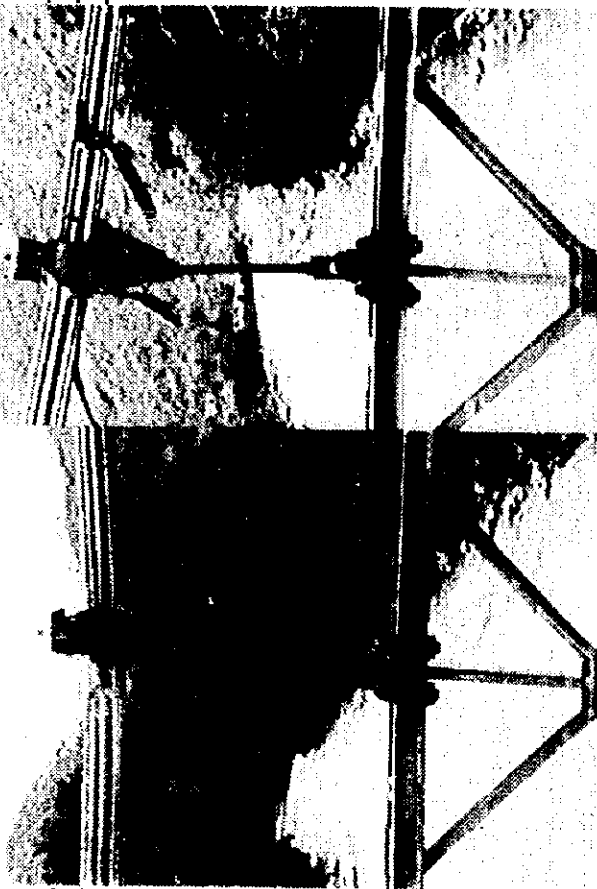
Hanger ropes on side vertical
