Bridge Inventory

SER No. 6 155.6 Km

NAME OF BRIDGE Wondisarj		CLASS OF ROAD N.H. 4		CROSSING: NAME OF RIVER OR ROAD Wandari, Panchkoti		COMPLETED 1989		MAINTENANCE BY Wondisarj	
Design Information		No		Date of Preparation 15/9/99		Prepared by Wondisarj		Load Intention No	
Type of Bridge		Superstructure RC. / DS		Design Loading DKL Timber		BS		No. of Joints 151	
Substructure		Abutment MASON		Pier		Skew		deg. Abt.	
Length of Bridge		30.5		m Span		30.3		m	
Width of Bridge		9.96		m Carriageway		2.35		m	
Allied Ancies		Overall		Pedestrianway		m		Design Quantity	
Traffic Volume		(Year)		Ratio of Heavy Vehicle		%		m	
Final Record of Repair		Pavement		Deck Slab		Painting		m	
Others		Main Beam		Others		Repair etc.		m

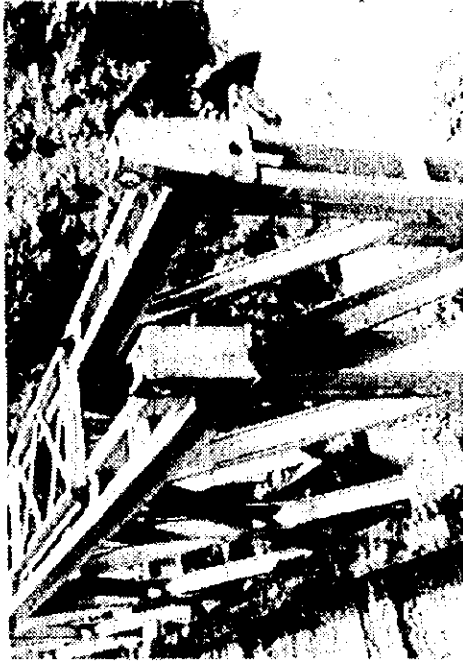
1. Pins are off.
2. Maintenance is not good.
3. It is suggested to make good as soon as possible.

Rusty pins

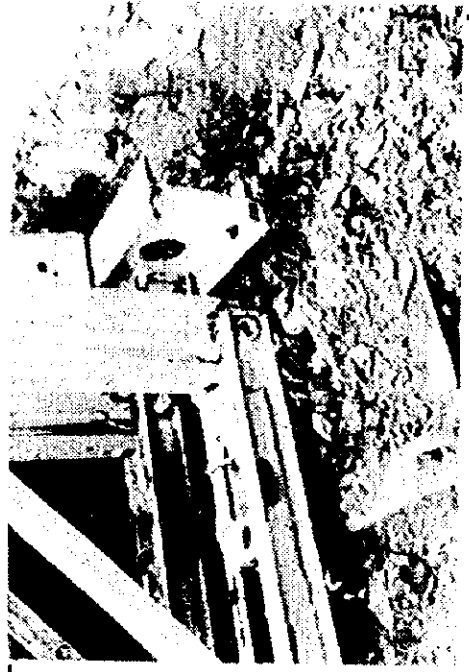
1. Big rocks damaged concrete on bridge.
2. Bailey doesn't touch to concrete bridge.
3. Bailey is not straight laterally.
4. Bearing is to be cleaned. At present there is space behind bearings.

No space behind bearing.

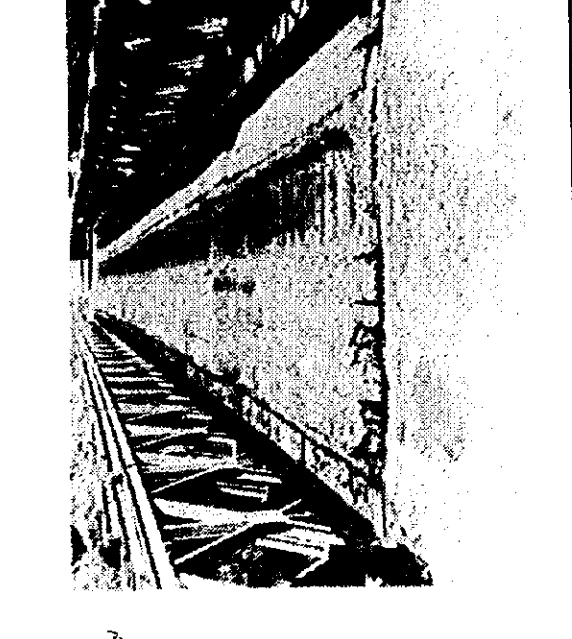
1. Sag of main girder is 7cm.
2. Lateral displacement is 0cm.
3. Deck slab is deteriorated. To be replaced.

<i>7/11/1943</i>
		<i>Deteriorated deck slab and pavement.</i>

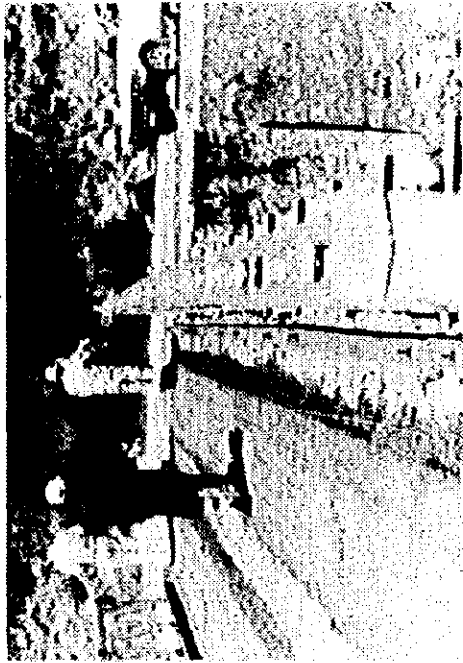
1. There is no sag.
2. Lateral displacement is 3cm, from the time of completion.

Lateral displacement of 3cm
