Bridge Inventory

List of Permanent Bridges on National Highways in Bhutan

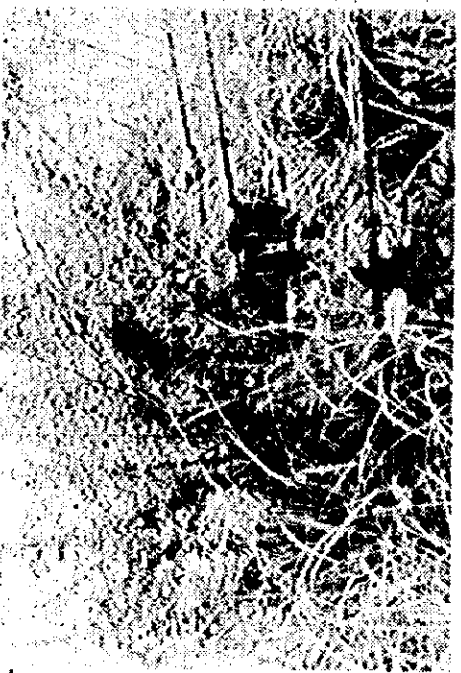
NAME OF BRIDGE <i>Taniguchi</i>		SER. No. <i>21</i>		Date of inspection	
Front					
Photo Album No. <i>(2)</i> <i>Under loading bearing plate didn't slide.</i>		Photo Album No. <i>(3)</i> <i>Bad maintenance on anchorage</i>

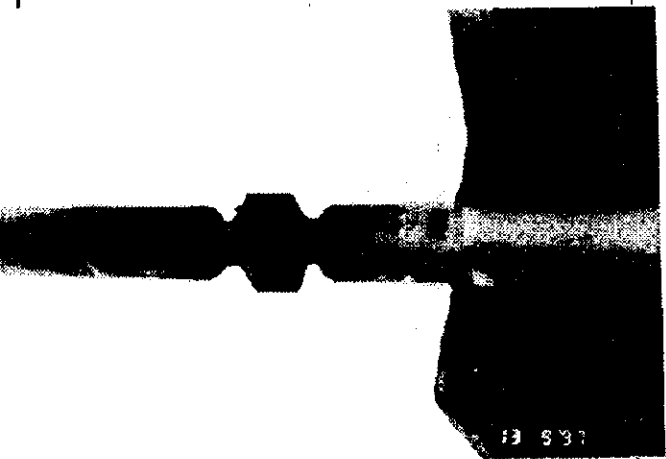
Elevation					
Photo Album No. <i>(3)</i> <i>Hanger at span has no space to screw up.</i>		Photo Album No. <i>(4)</i> <i>Very rusty deck soffit.</i>

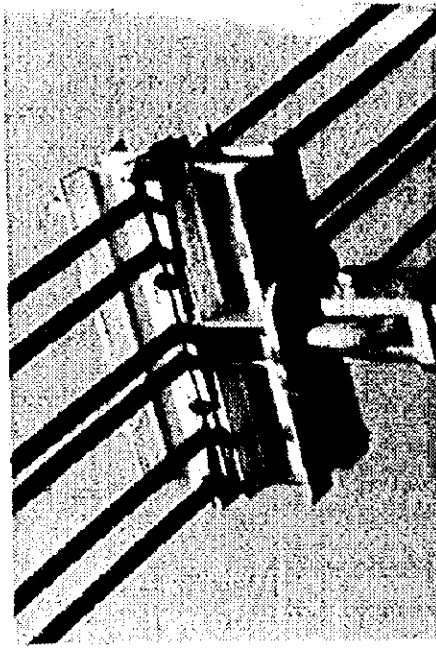
Wooden piling was broken. 1 cable is almost to go out.

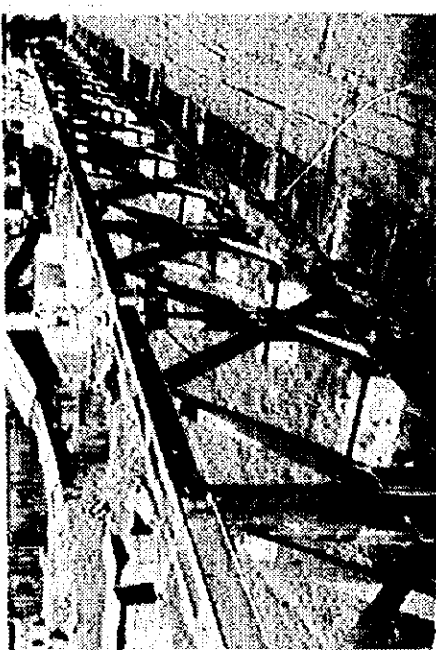
Rusty members. This pier was replaced, when buckling occurred.
