**THE AFTERCARE STUDY ON
THE NATIONAL WATER MASTER PLAN
JAPAN INTERNATIONAL COOPERATION AGENCY**

**Figure -
Existing Water Supply Schemes
(630 SIAYA District)**

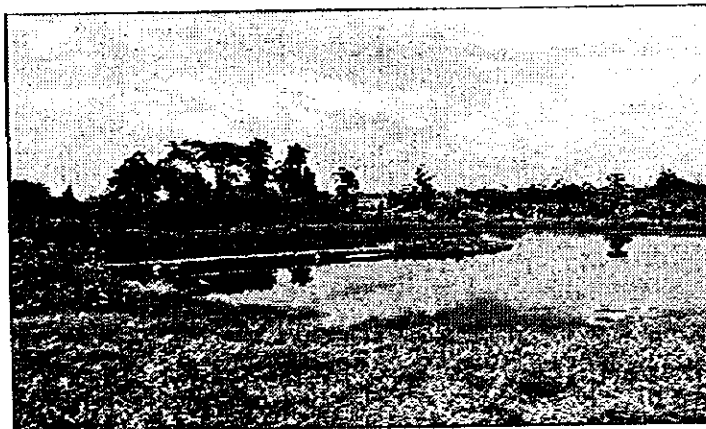
Waste stabilization Pond: note sludge accumulation near outlet pipe

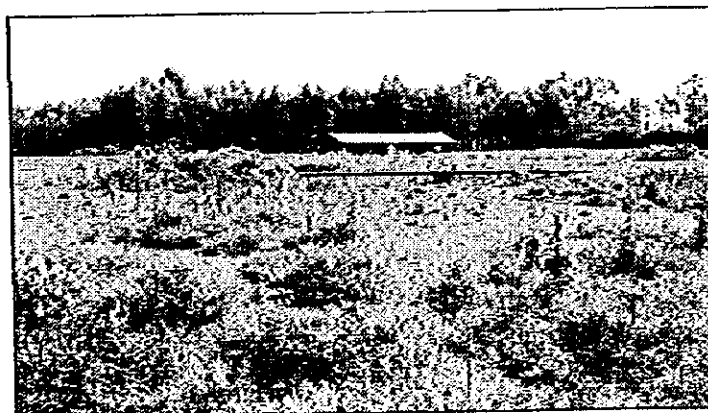
Waste stabilization Pond: pond is dry and area is used for cattle grazing.

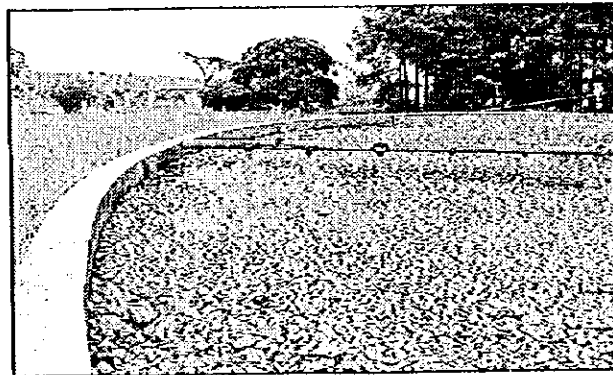
Trickling Filter: note rotating arm stalled in one location, rock media is saturated with silt & debris

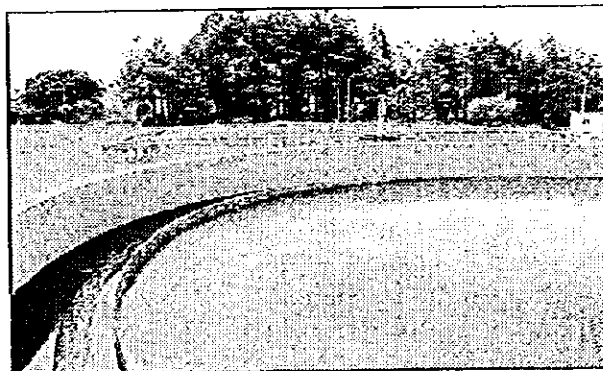
Primary clarifier: note floating chunks of dark scum indicating anaerobic activity and process overloading

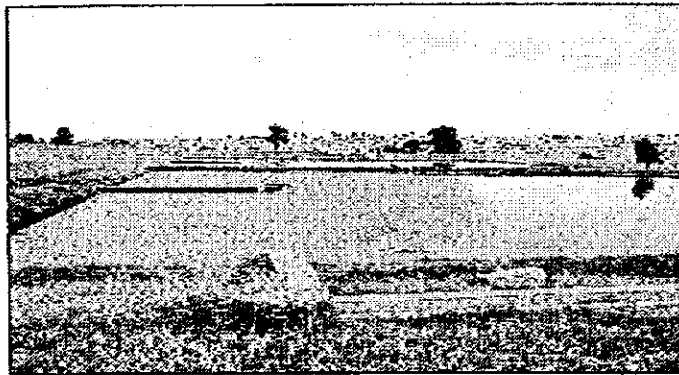
6. The absence of a grit removal system has resulted in sludge accumulation in the anaerobic ponds.			
Sewers			
1. Sewers are operating satisfactorily

Anaerobic Pond: note heavy scum and accumulation of sludge & debris at inlet structure

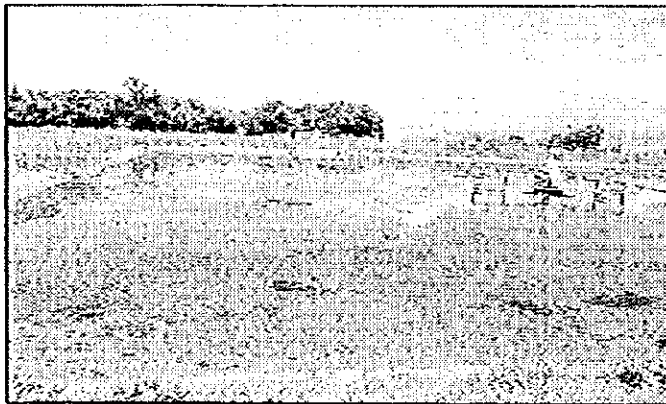
Note: Oxidation lagoons are used as anaerobic ponds

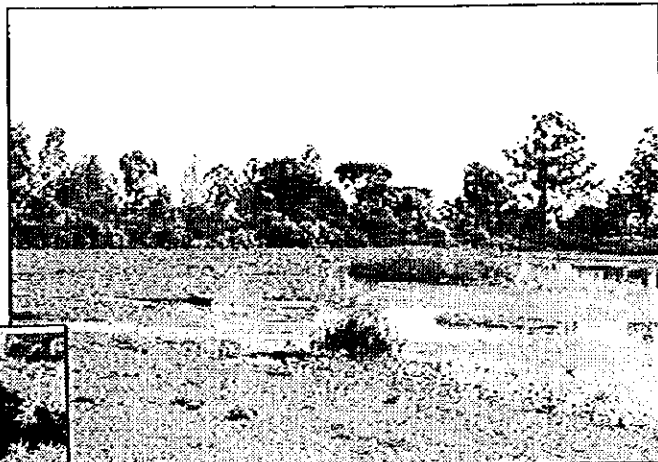
Primary Facultative Pond: note sludge accumulation & plant growth.

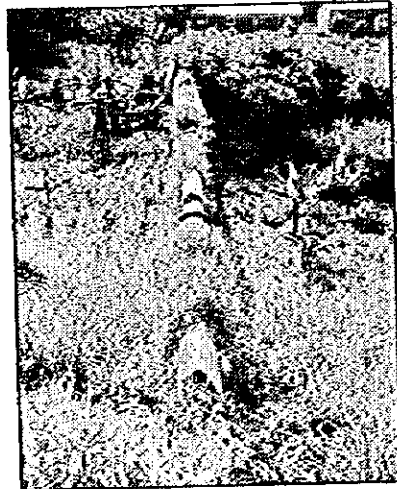
3. The flow of sewage into the ponds is very low probably due to leakage or blockage of sewers. Sewage from part of the network is leaking straight into the river from the aerial crossing.

Trunk Sewer: cast iron main crossing river, note complete failure & discharge of sewage to river
