SITE SURVEY CHECK LIST

2. Name of School Kurua GPS

2. Name of School Banskhali G.P.S

資料11. 自然条件調査結果

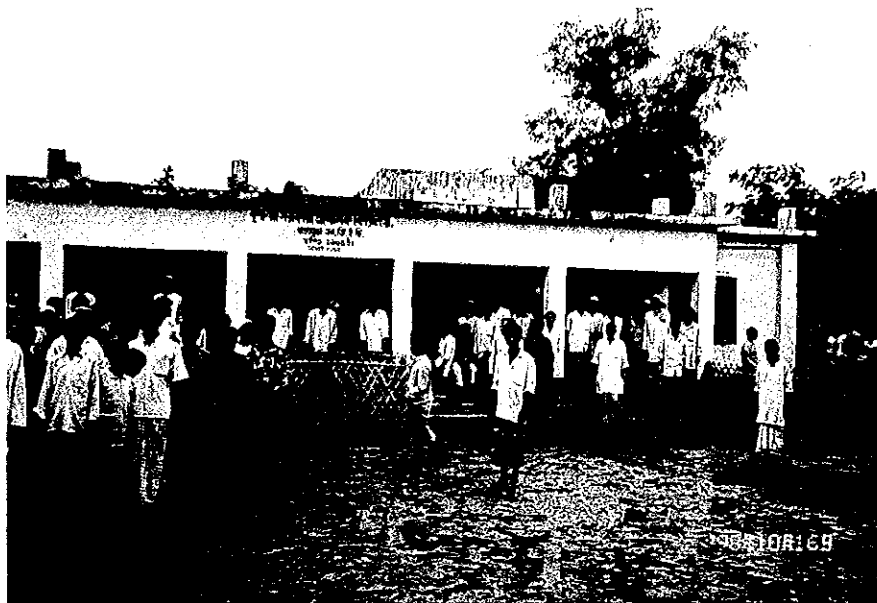
校舎全景

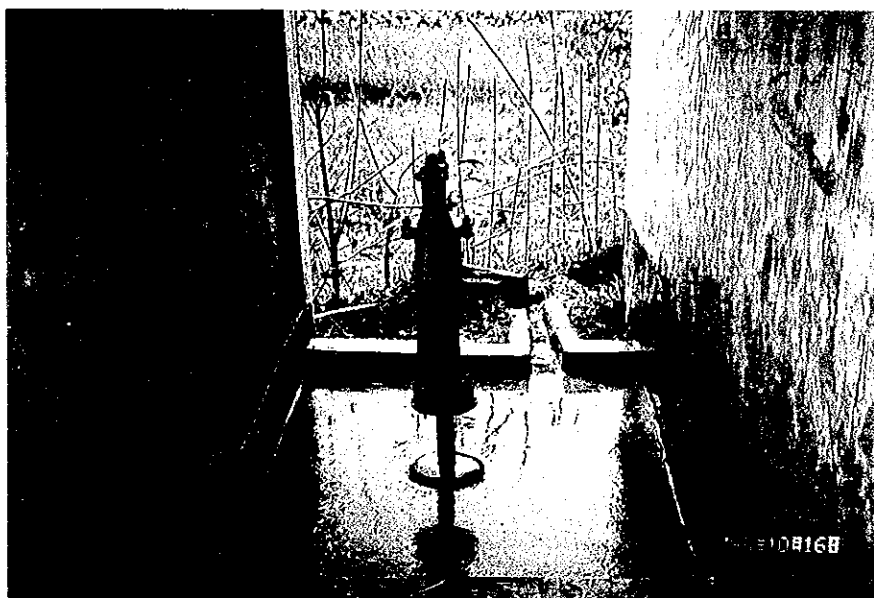
付帯施設の状況

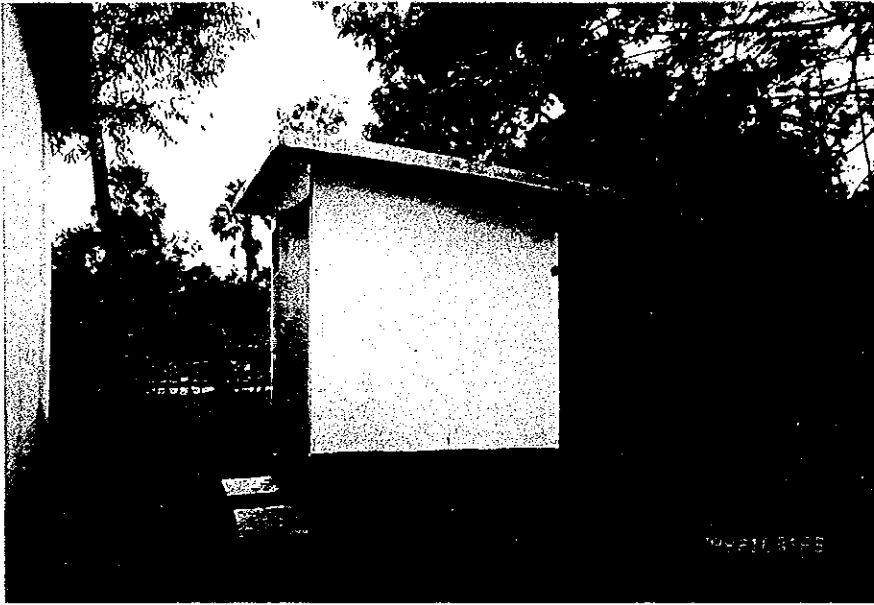
付帯施設の状況

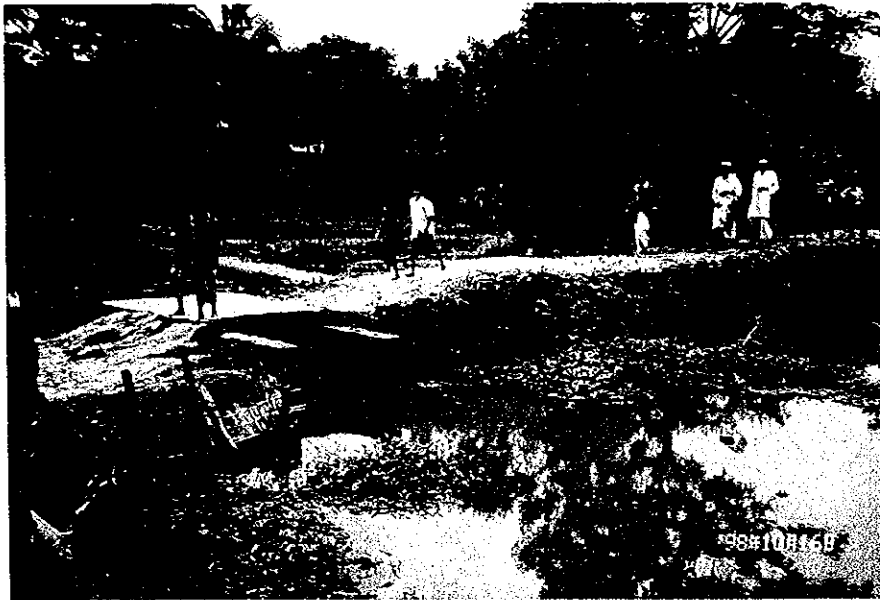
学校周辺の道路状況

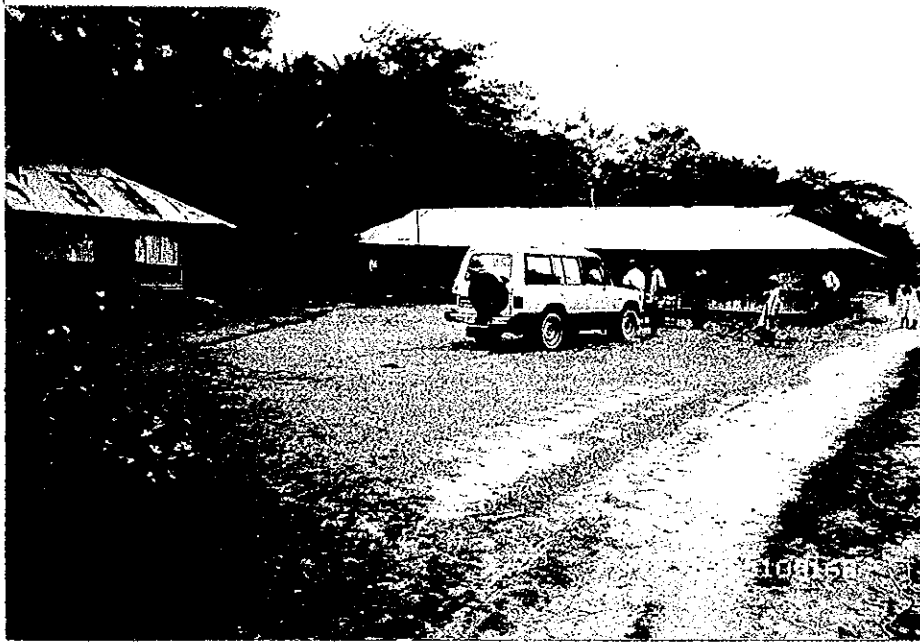
学校敷地全景

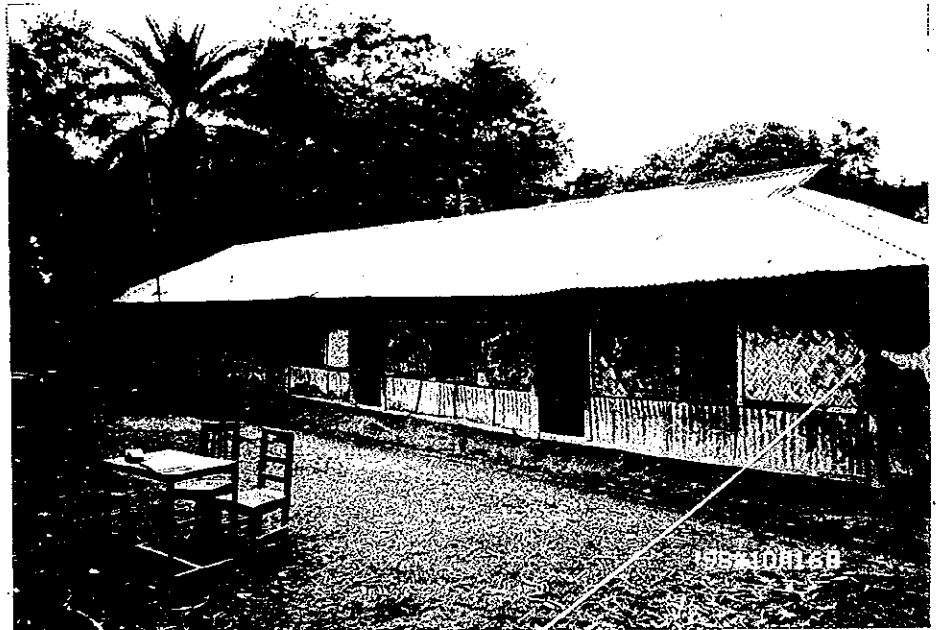
: Place; Roof (Leaking of rain?), rain leaking
Pillar (Exfoliate of concrete?), deteriorated
Wall (Colour painting?), -do-
Window (Window door fitting?) -do-
Method; Name of organisation, T.E.O
Organisational unit for maintenance
(H.Q., District, Thana or school),
Procedure for repair
(Requesting, Patrol by engineer = when)

校舎全景

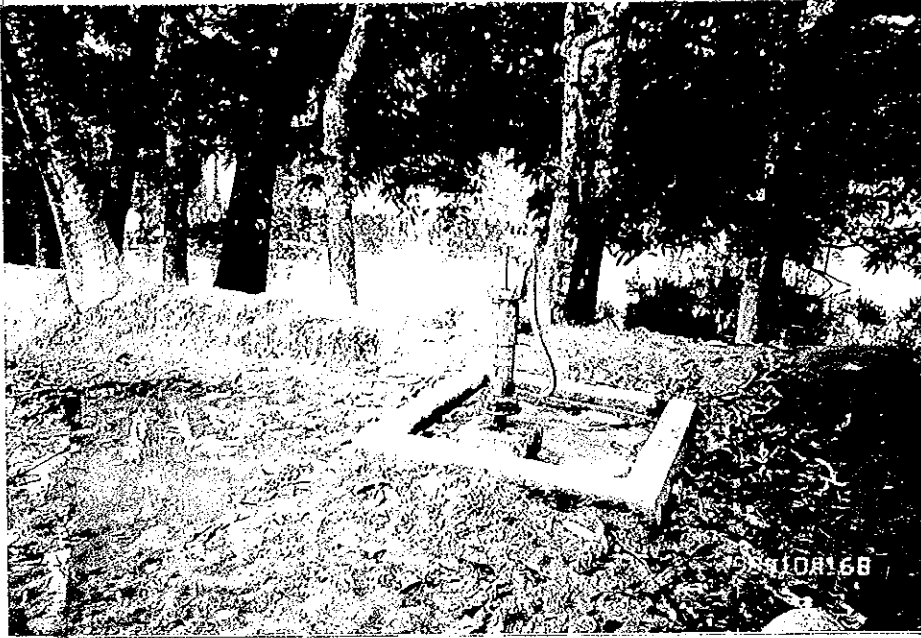
付帯施設の状況

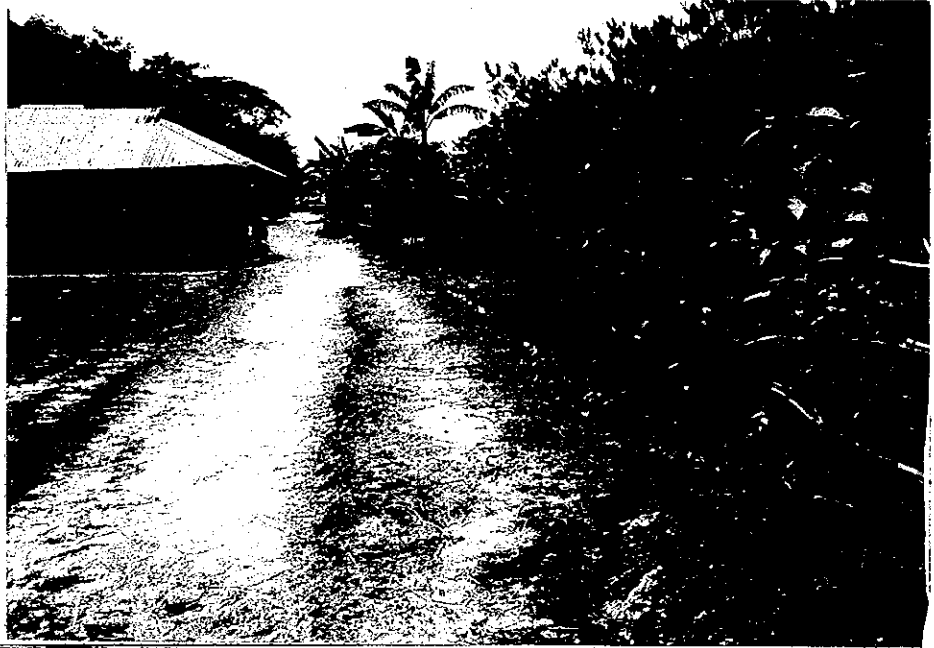
学校周辺の地形状況

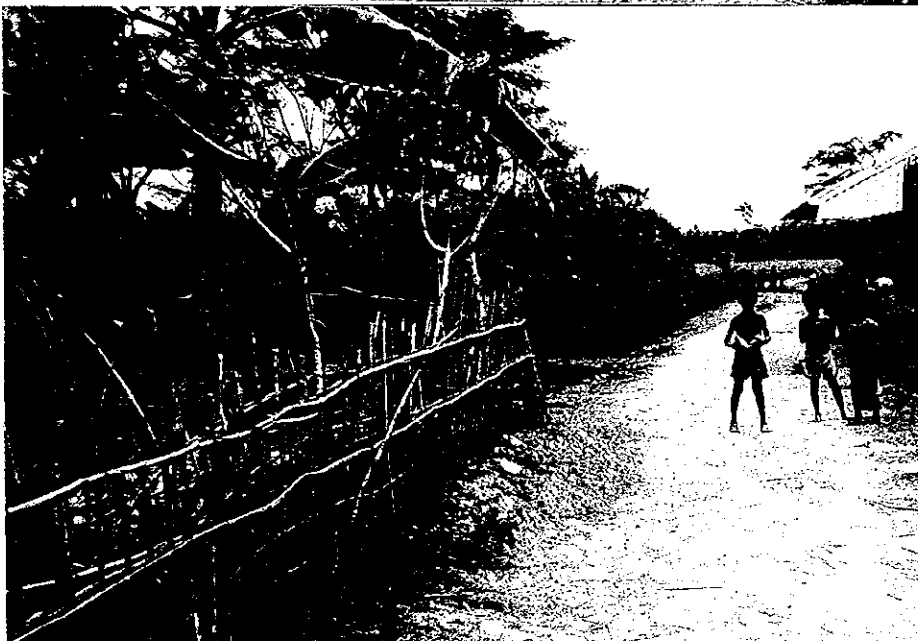
学校周辺の道路状況
