CHAPTER 4. ASSESSMENT OF SARAJEVO WWTP

CHAPTER 4 ASSESSMENT OF SARAJEVO WWTP

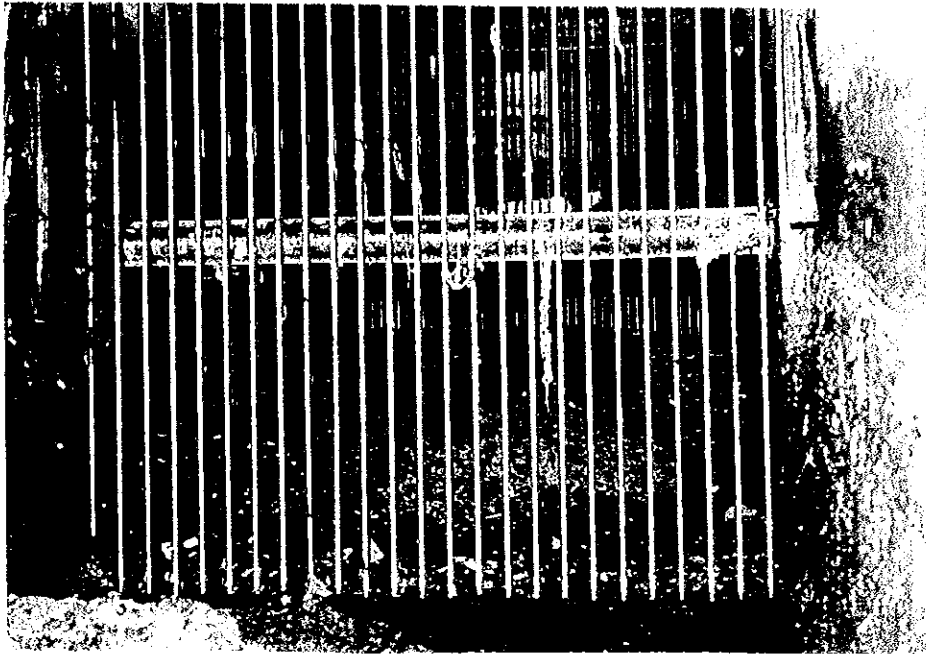
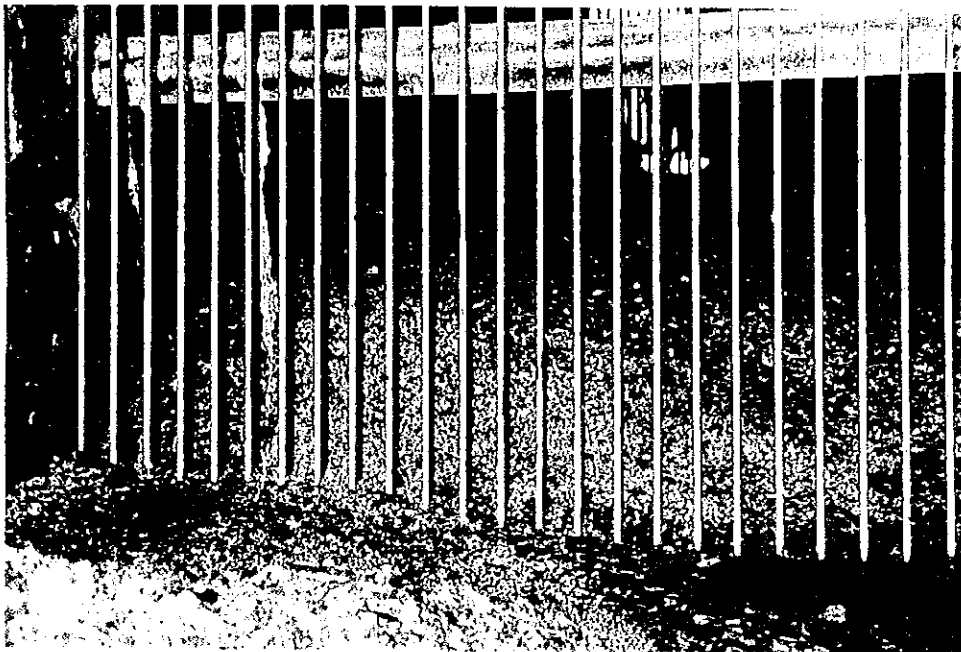
Photo No.4.1

In 1984, during the WWTP commissioning phase, very large amounts of coarse grit were observed in the raw wastewater. Photographs taken at the time are presented in **Photographs 4.1 to 4.5**. The largest part of the grit settled at the inlet to the pump station, in the screenings channels and in the aerated grit chamber. The grit was in such large amounts that it stopped operation of the screens and overwhelmed the capacity of the grit removal system. Large quantities of grit were also observed in the outlet channel leading to the primary sedimentation tanks indicating that the existing grit chamber is unable to deal with the large quantities of sand and gravel that finds its way to the treatment plant particularly during peak wet weather flows.

Facility No:	2	Name:	Screening room
Location	Inlet to screens

Photo documentation of grit removal problems

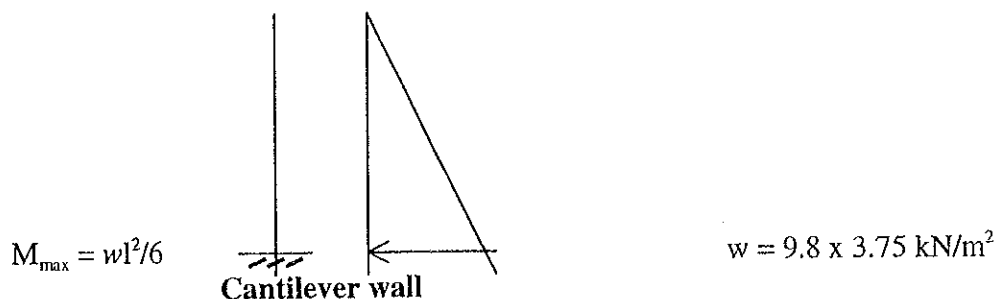
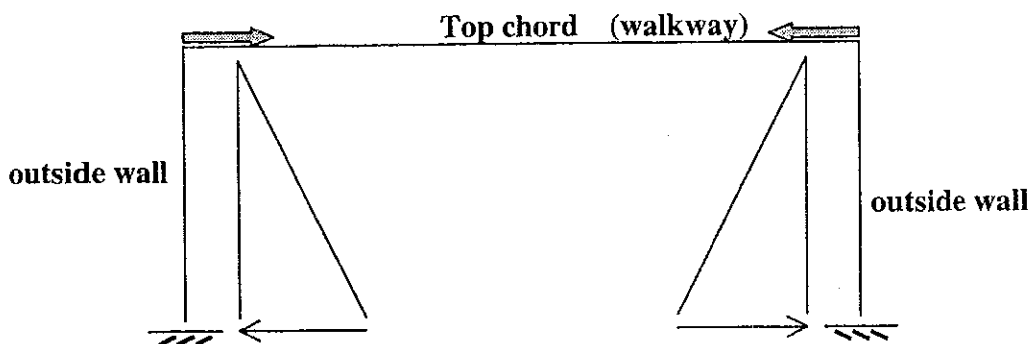
The east wall of the aeration tank exhibits a cracking pattern that indicates a structural deficiency. The pattern is observed at every point where the concrete walkway is connected to the top of the wall. The cracks form a 45-degree angle starting at from the top of the wall extending down towards the centre where they become horizontal. In the middle of the wall span between two access ladders there is a long vertical crack. Understanding the mechanism that causes these cracks is important in order to propose a suitable repair. Simply sealing the cracks would not be effective since the forces that caused them in the first place will still be present and new cracks will form.

A review of design calculations shows that the walls were designed, as is common practice, for cantilever action with primary bending in the vertical plane.

The cantilever model is not valid where the concrete walkway is attached to the top of the wall. The observed cracking can be explained by a simplified model assuming the concrete walkway acts as a top chord tying the two outside walls together as illustrated below.

The top chord prevents the walls from bending out at the top as they were designed for and the rigid connection between wall and walkway induces positive bending moments on the outside face in two locations:

- 1) Bending in the horizontal plane with a maximum in the middle span
- 2) Bending in the vertical plane with negative moments at the top and bottom of the wall and positive moments approximately 2 m from the top.
