**THE FEASIBILITY STUDY  
ON  
THE WASTEWATER TREATMENT PLANT  
OF  
SARAJEVO CITY  
IN  
BOSNIA AND HERZEGOVINA**

**VOLUME III : ASSESSMENT WORK REPORT**

**NOVEMBER 1999**

**TOKYO ENGINEERING CONSULTANTS CO., LTD.  
NIHON SUIDO CONSULTANTS CO., LTD.**

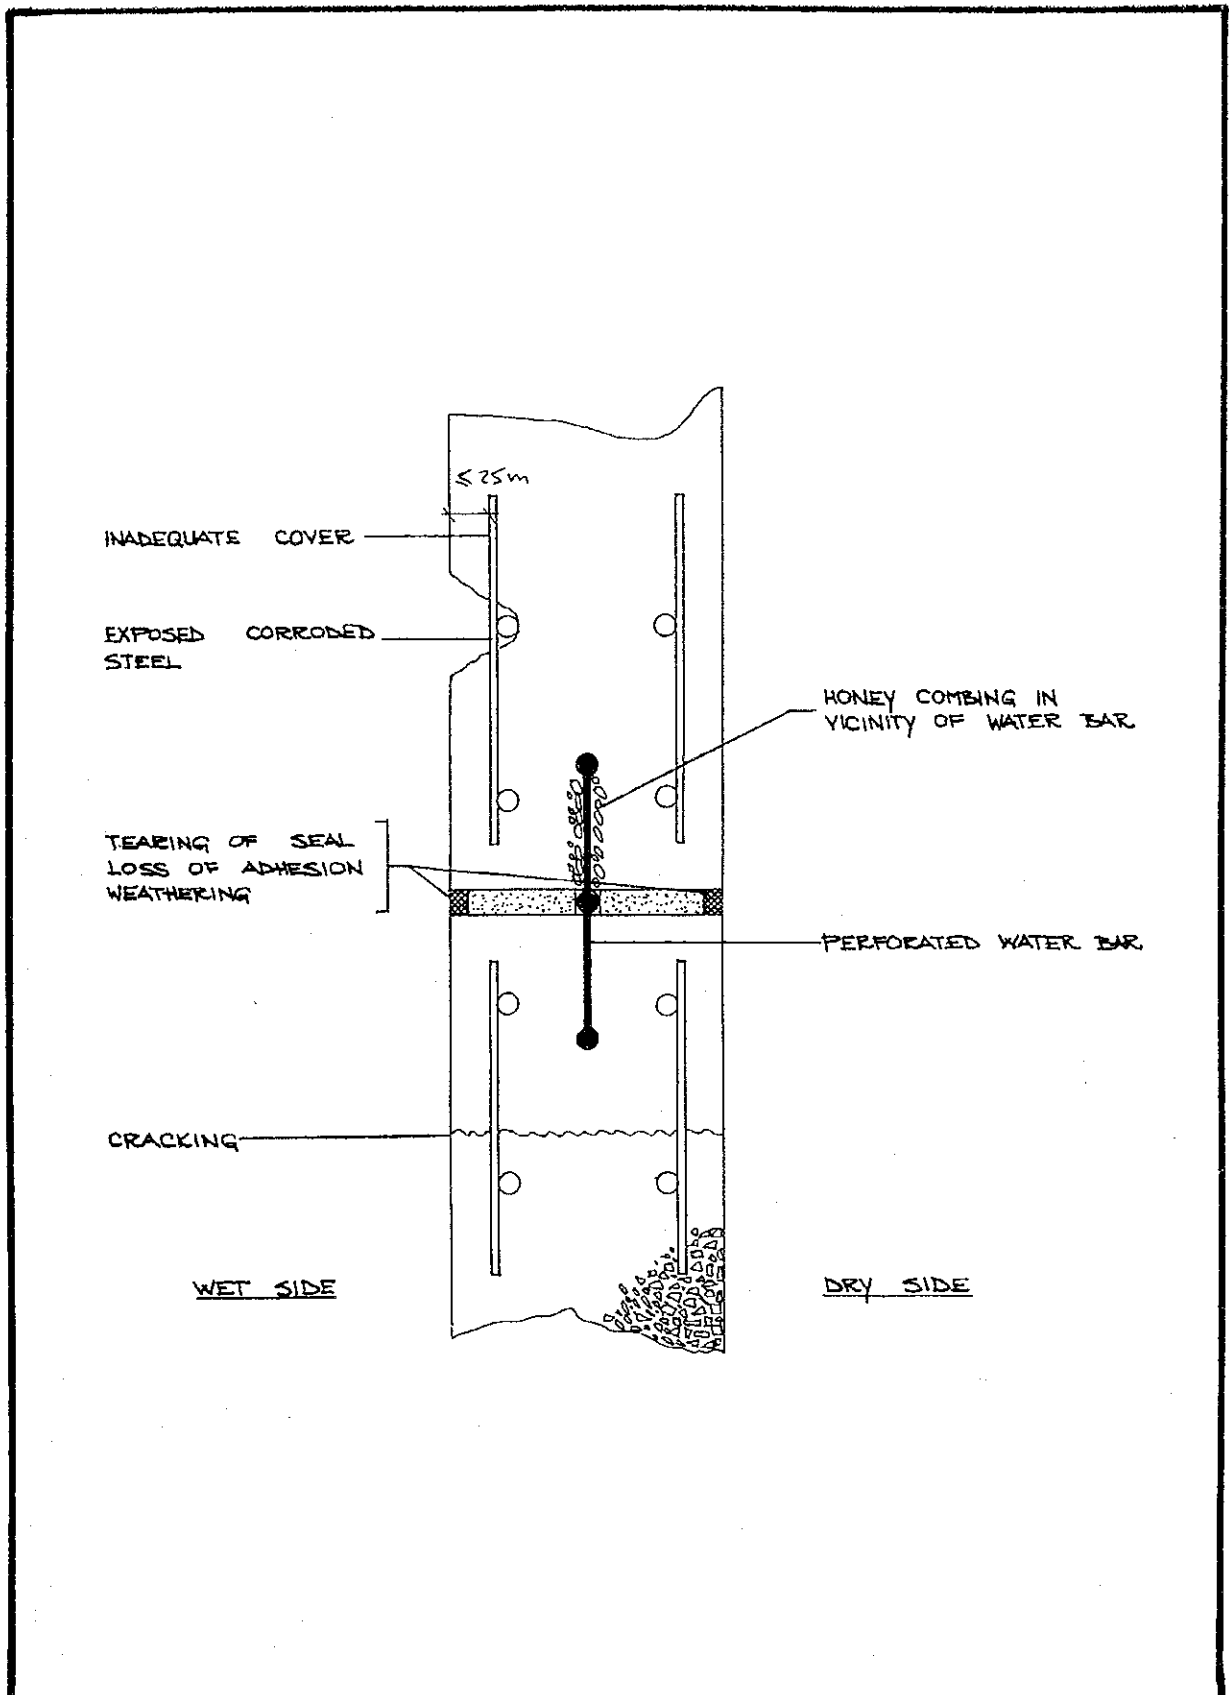
Date : Nov. 99 Scale: Not to scale	THE FEASIBILITY STUDY ON THE WASTEWATER TREATMENT PLANT OF SARAJEVO	Figure 2.5.1
	TYPICAL DEFECTS IN LIQUID RETAINING STRUCTURES

- Rupture of sealant
- Detachment of the sealant from the concrete
- Puncture of the water bar
- Defects in the concrete alongside the joint

These defects, illustrated in **Figure 2.5.1**, are normally the result of poor control during construction and are very difficult and costly to repair.

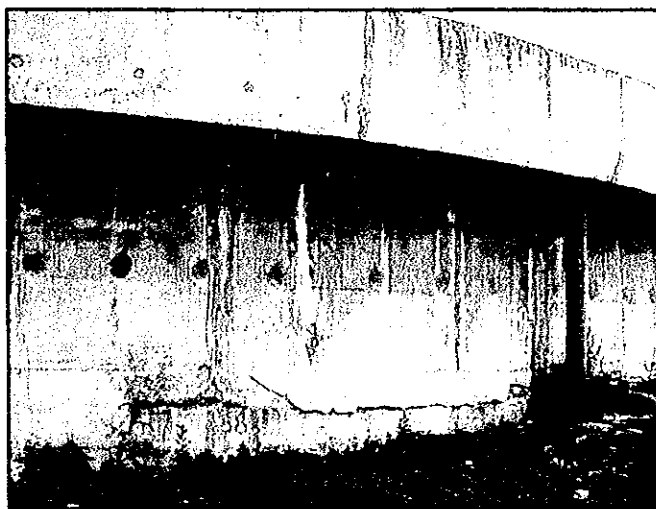
The presence of deep vertical cracks is predominant on all exposed wall surfaces and most numerous on the outside walls of effluent launders in the sedimentation tanks and sludge thickeners.

Vertical cracks in walls and effluent launder

The extent of the cracking indicates that there is insufficient reinforcing steel to control the tensile stresses created by shrinkage and temperature movement.

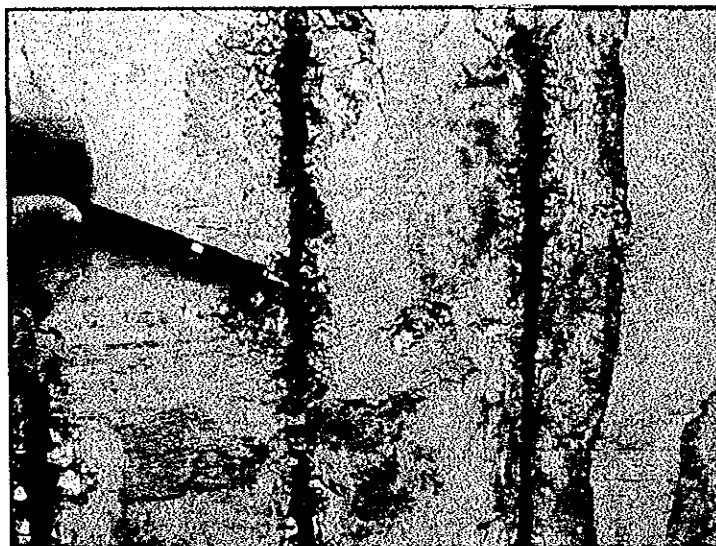
**Inadequate cover and corrosion of reinforcement**

Adequate cover is extremely important in protecting reinforcement. The requirements of modern codes of practice in respect of cover are adequate only if the cover is of dense well-compacted concrete otherwise the concrete will carbonate and so lose its protective capacity. As confirmed by testing, the carbonation front has already advanced to a depth of 20 mm. As observed on site, the cover is inadequate on all interior wall surfaces (usually less than 25 mm and in many cases only a few mm) and the concrete is quite porous. These two factors have contributed to the corrosion observed on site. There is a significant risk of further and severe deterioration.

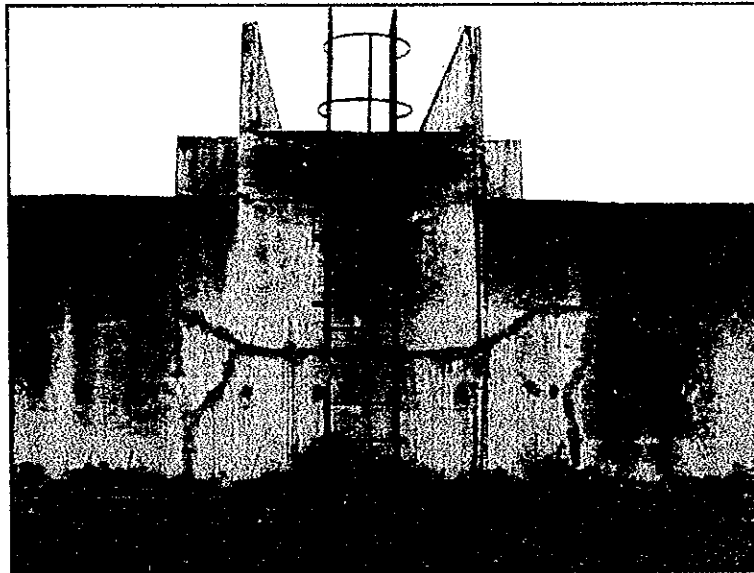
The east wall of the aeration tank exhibits a cracking pattern that indicates a structural deficiency. The pattern is observed at every point where the concrete walkway is connected to the top of the wall. The following photograph depicts the typical condition.

East wall of aeration tank

The cracks form a 45-degree angle starting at from the top of the wall extending down towards the centre where they become horizontal. In the middle of the wall span between two access ladders there is a long vertical crack.

At first it was believed that these cracks might be caused by vibration from the surface aerators. This idea was rejected after testing of the aerators indicated that vibration is insignificant and could not cause this type of cracking pattern. Understanding the failure mechanism is important in order to propose a suitable repair. Simply sealing the cracks would not be effective since the forces that caused them in the first place will still be present and new cracks will form.

These two models are simple assumptions and neither one accurately describes the actual stress and shear patterns in the wall. Precise analysis would require finite element modelling of the walls to determine how the wall plates actually behave under load. Nevertheless, for the purposes of finding an appropriate repair strategy the simplified assumptions are sufficient to confirm that filling these cracks with epoxy grout will not solve the problem. It is important to remove the restraint provided by the walkway and allow the wall to function as it was intended (i.e. as a cantilever wall). The change can easily be made by cutting out the existing slab and replacing it with an open-grate galvanised metal walkway freely supported at the wall.

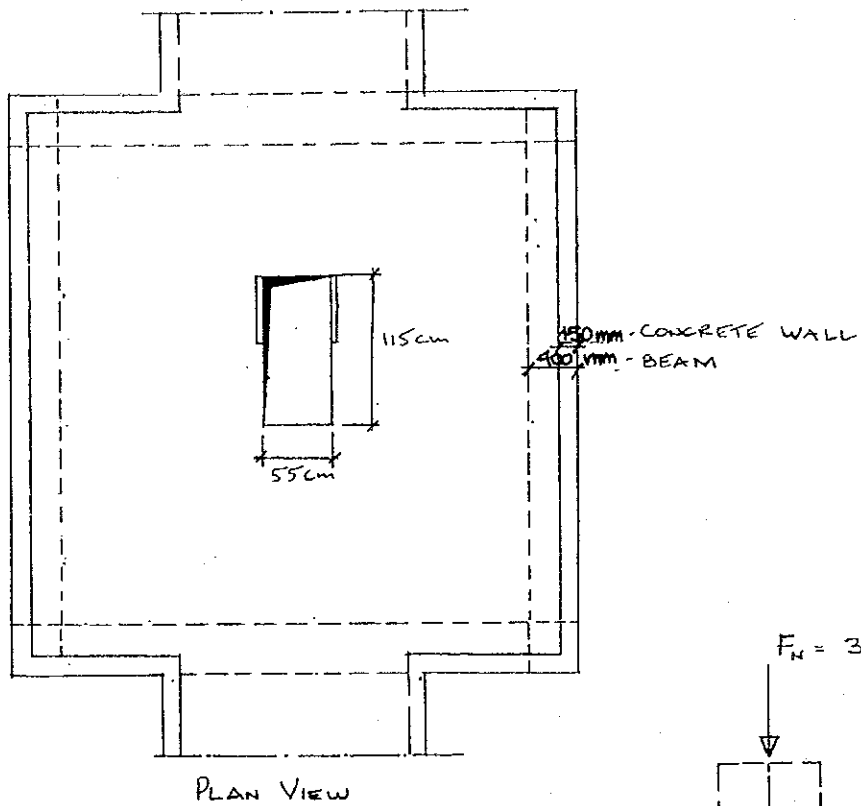
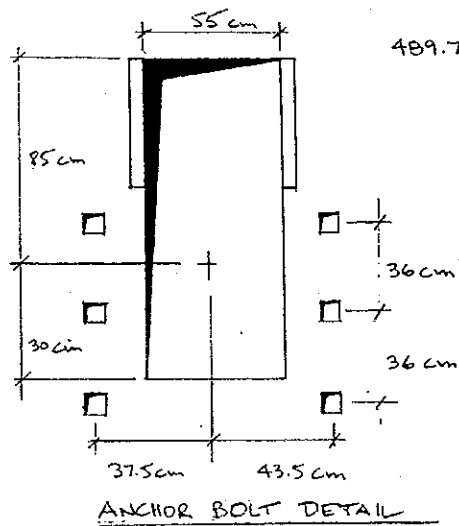
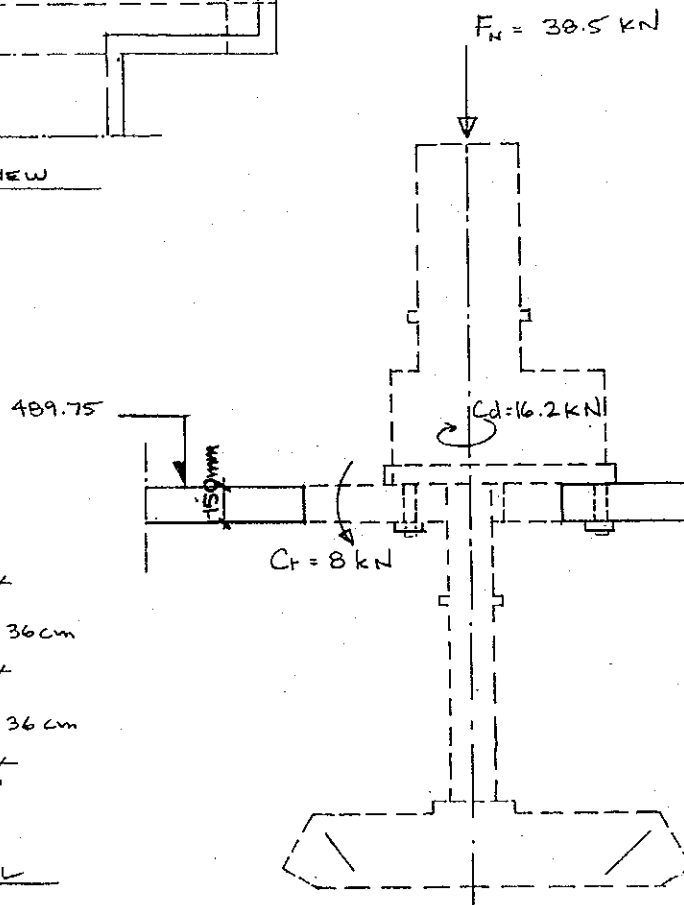
Figure  
2.5.4

Plan and sectional views of the existing aerators are presented in **Figure 2.5.4** and **2.5.5**. Slabs and columns will need extensive reconstruction if the decision is made to keep the present surface aeration system. There are several problems observed:

- installation of aerator anchor bolts through the slab creates stress points that cause cracking
- there is no pad for leveling screws
- There is no vibration isolation pad between the machine and the concrete.
- The concrete slabs and walkways are severely damaged by water and frost as a result of poor drainage. Reinforcement is exposed and corroded
- The concrete fence walls are severely damaged by water and freezing action. The reinforcement at the base of the wall is exposed.
- Columns are damaged at the water line by the action of turbulent water and freezing
- Reinforcement in columns on the south and west faces is corroded.

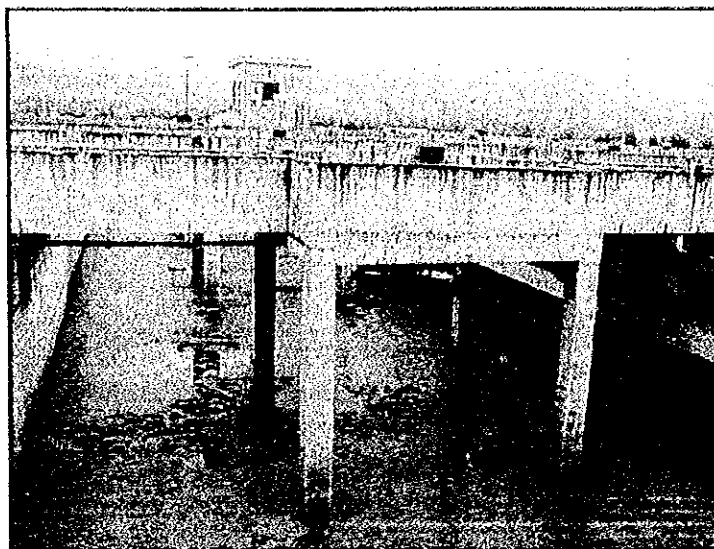
The cover over reinforcing steel in columns is insufficient on the South and West face. Corrosion of the reinforcing steel has produced rust stains on the surface in line with the reinforcement. The same defect is observed at every column, always on the same two faces. Lifting hooks on the North side of every column indicates that the columns were pre-cast then lifted into place. The lack of cover is probably caused by poor form work during the fabrication of the columns.

Typical surface aerator slab & column

Corrosion is not yet severe and has not resulted in the loss of section. Therefore the steel should be exposed, cleaned and treated in the same way that is specified for the walls.
