PHOTODOKUMENTATION

APPENDIX 6

VISUAL SURVEY

Liquid Retaining Structures

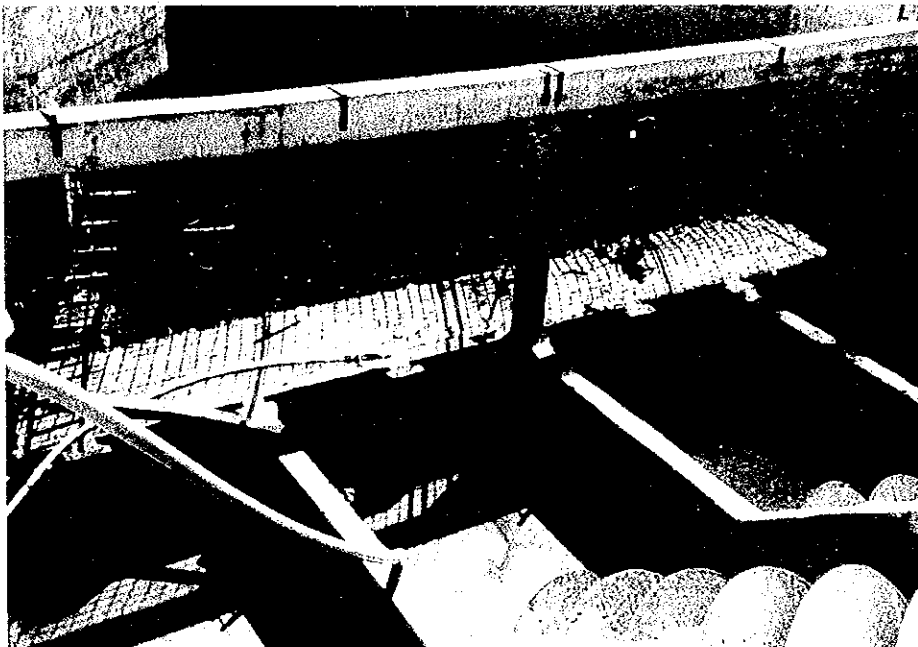
C1-4 Note makeshift screens that trap debris and block flow to pumps
Note concrete pillars behind screens that also trap debris

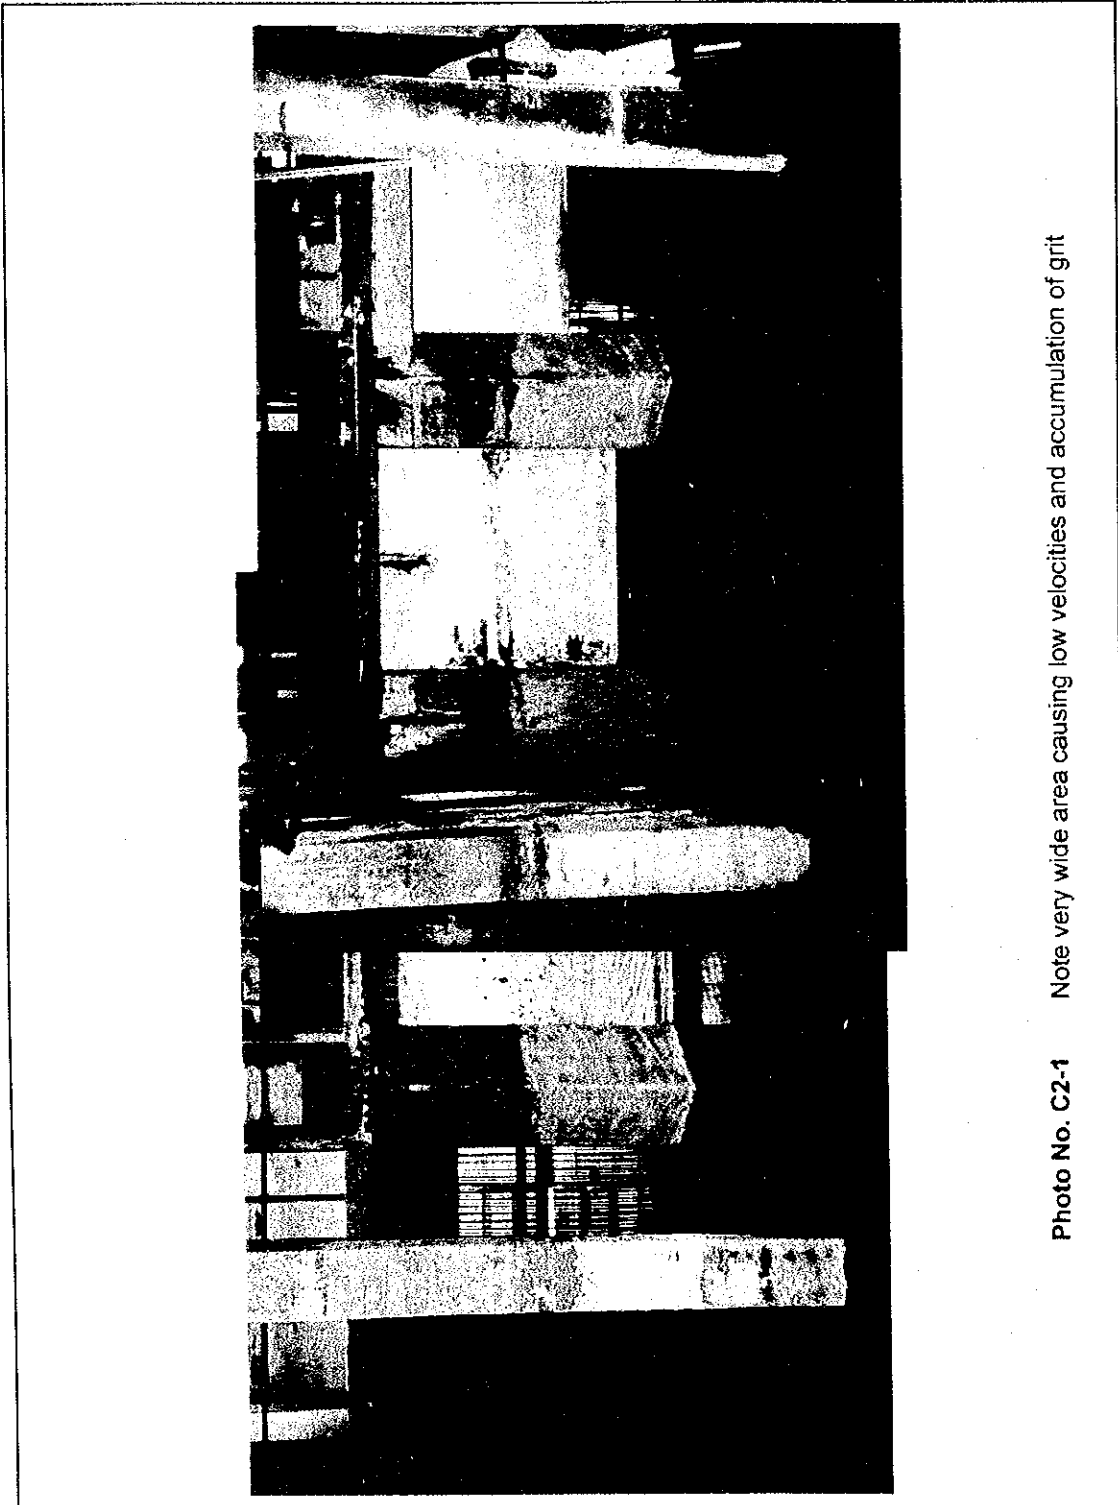
Photo No. C2-1 Note very wide area causing low velocities and accumulation of grit

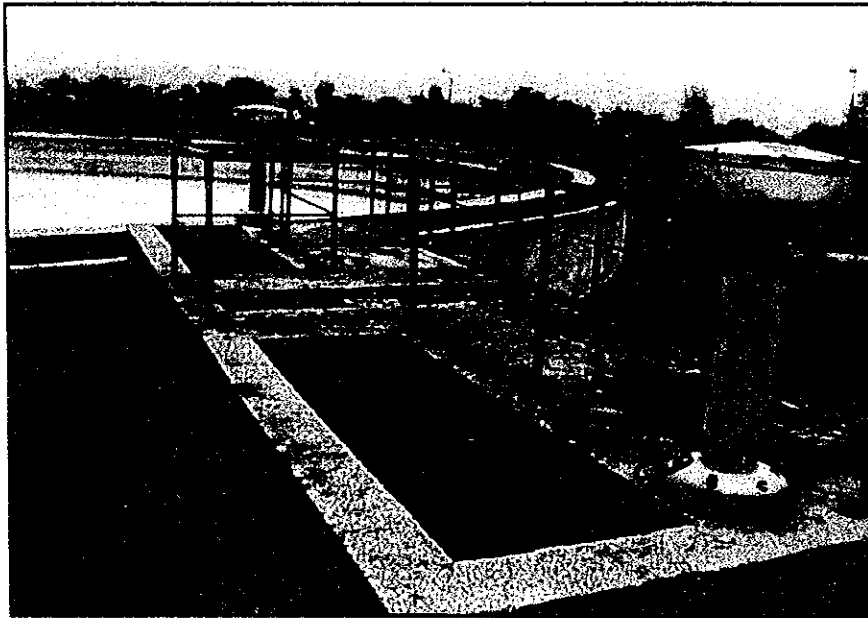
C4-1 Note poor access, lack of operating space and poor condition of railings

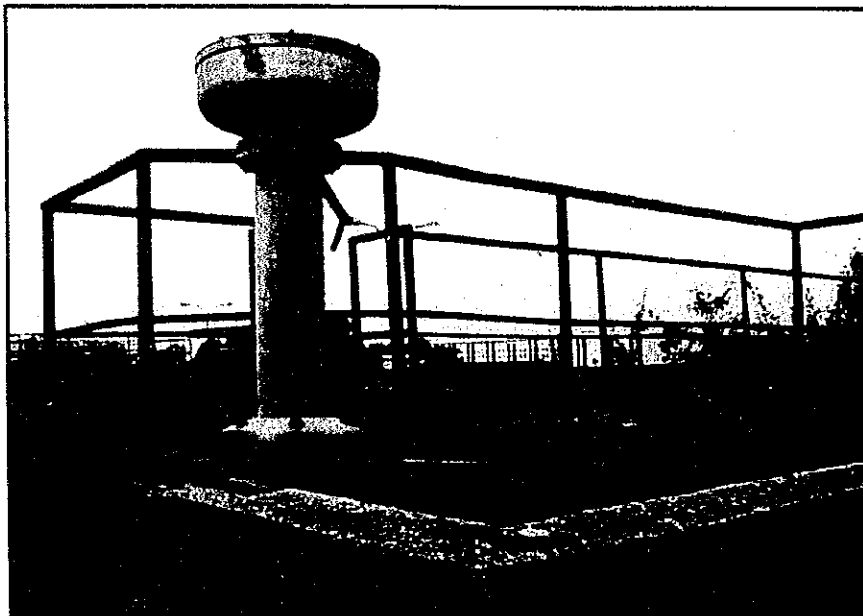
C4-2 Note failure of slab caused by uplift force

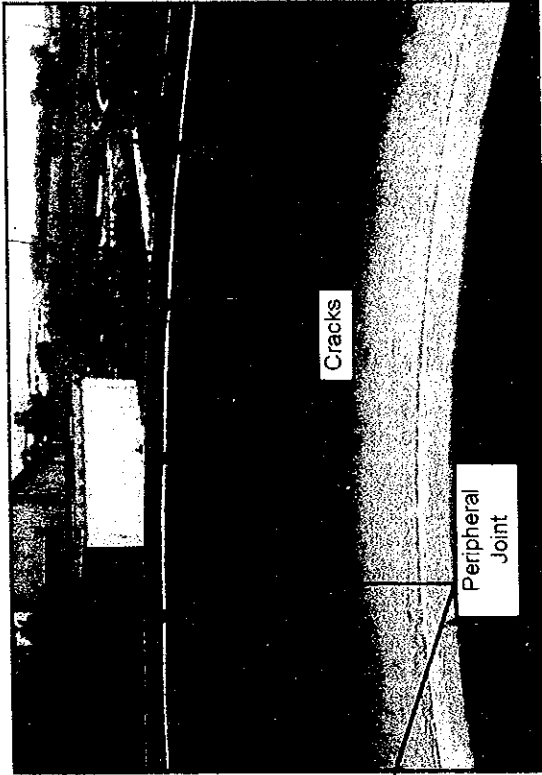
C10-2 Note previously repaired cracks, corroded steel reinforcement and horizontal construction joint

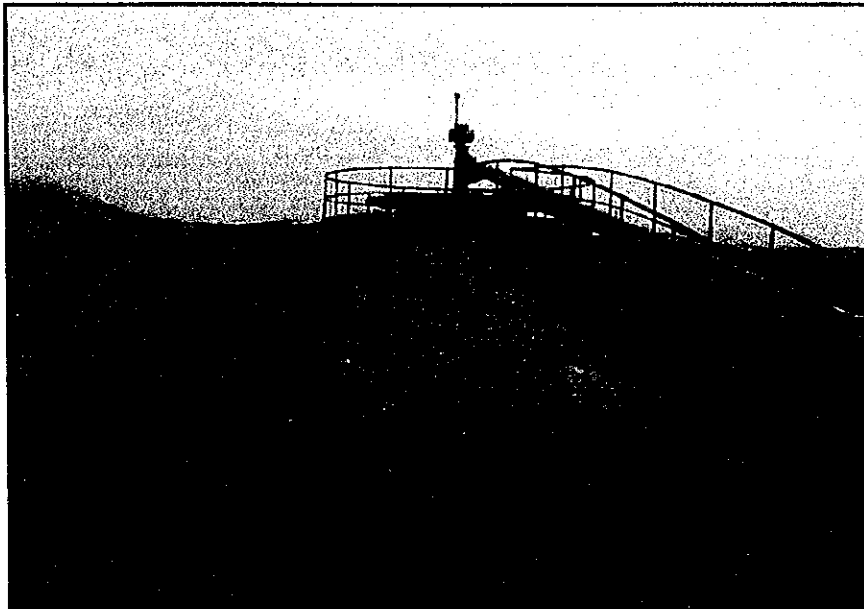
C12-2 Note damage to roofing membrane and corroded access platform

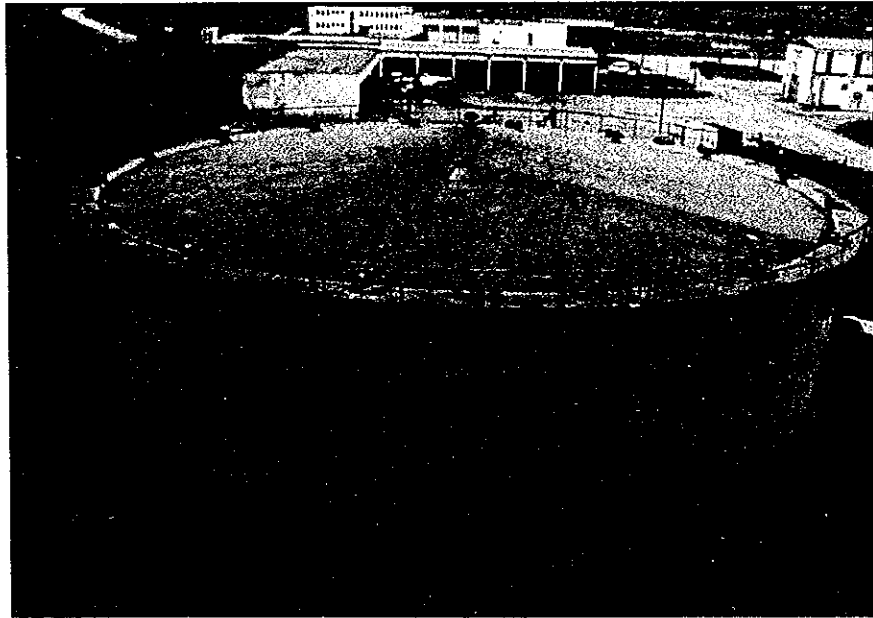
C15-1 Note dampness at construction joints and good condition of roof

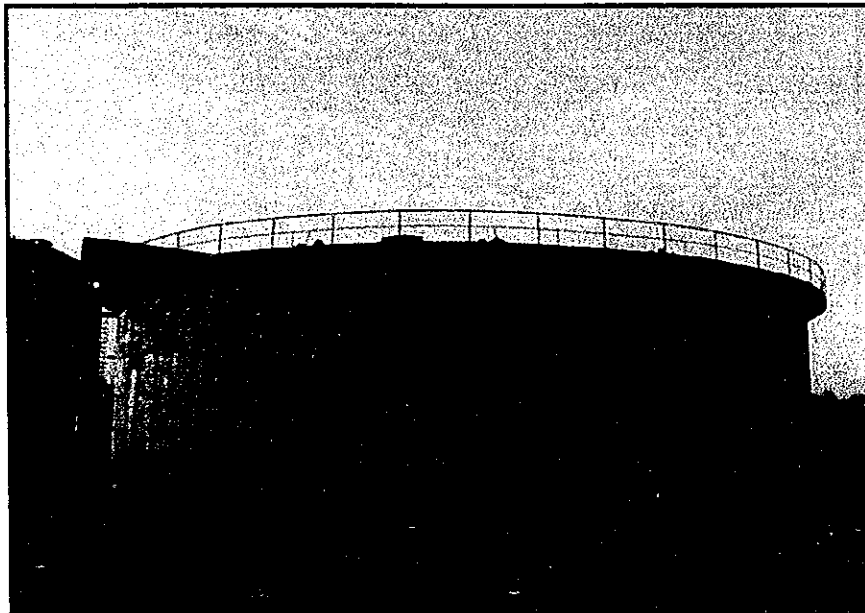
C15-2 Note dampness at construction joints

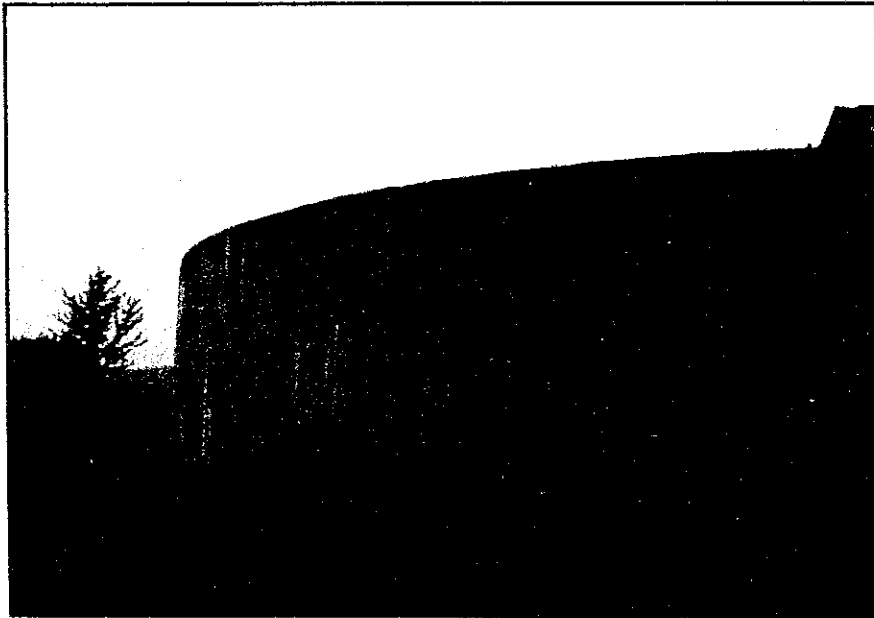
C16-1 View facing West - Note vertical cracks with signs of previous leakage

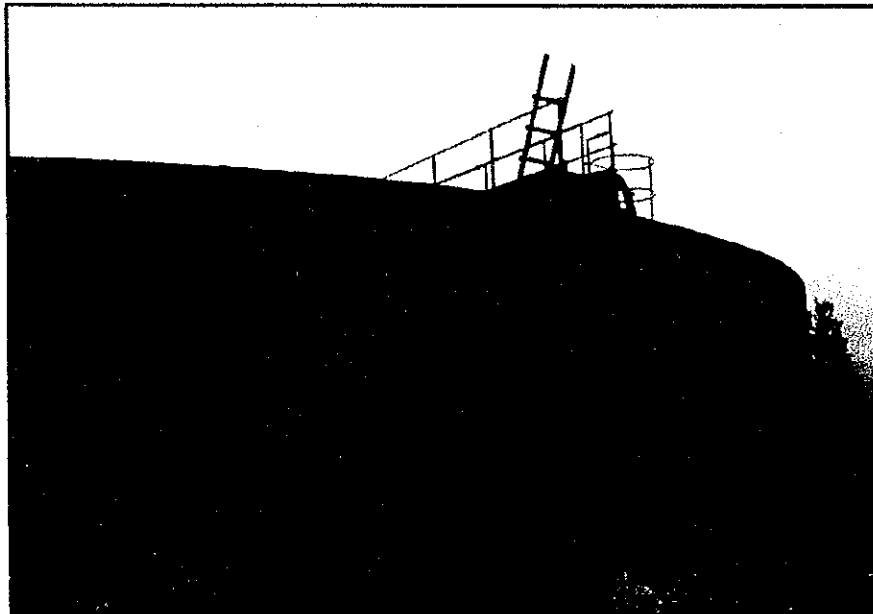
C16-2 View facing South - Note vertical cracks and horizontal construction joint.
