APPENDIX

VISUAL SURVEY ARCHITECTURAL ASPECTS

ARCHITECTURAL
INSPECTION SHEET AND PHOTO

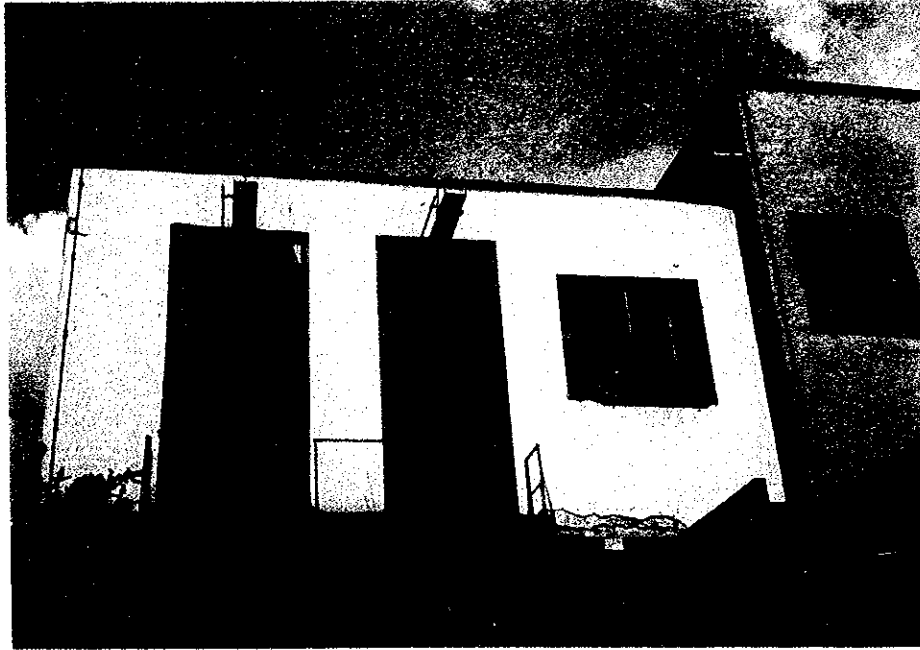
PHOTO NUMBER	1,2-6
--------------	-------

EXTERIOR WEST	COLUMN BEAM	WALL(BRICK)	Δ	DOOR	X WINDOW	METAL	EXTERIOR FINISH	X COPING	X CAULKING
EVALUATION ITEM	NORMAL	NORMAL	✓	NORMAL	NORMAL	NORMAL	NORMAL	NORMAL	NORMAL
	DAMAGE	DAMAGE	✓	RUSTY	RUSTY	RUSTY	DIRTY	RUSTY	BROKEN
		BROKEN		CORROSION	CORROSION	CORROSION	WORN OUT	CORROSION	NONE
		BULLET MARKS		MISSING	MISSING	NONE		NONE	
INVESTIGATION METHOD	VISUAL INSPECTION	VISUAL INSPECTION		VISUAL INSPECTION	VISUAL INSPECTION	VISUAL INSPECTION	VISUAL INSPECTION	VISUAL INSPECTION	VISUAL INSPECTION
PHOTO NUMBERS		1.2-6		1.2-6	1.2-6	1.2-6	1.2-6		
RECOMMENDATION	C	C		A	A	A	A	A	A

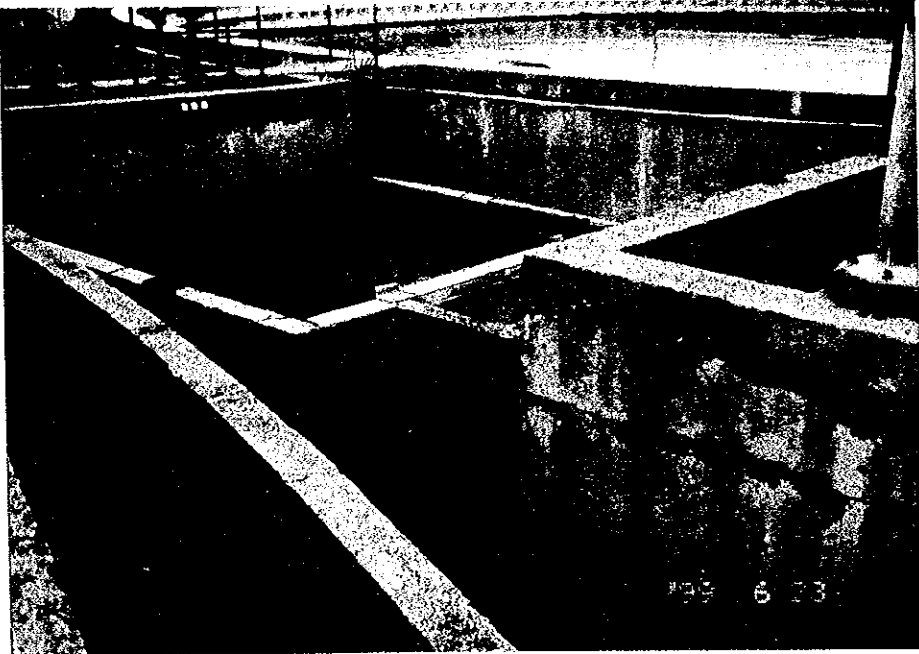
BUILDING NUMBER	9	BUILDING NAME	PRIMARY SLUDGE PUMPING STATION
PHOTO NUMBER	9-2

BUILDING NUMBER	BUILDING NAME	STRUCTURE	COMPLETION YEAR	BUILDING AREA	TOTAL FLOOR AREA	CONCRETE DESIGN COMPRESSIVE STRESS	CONCRETE ACTUAL COMPRESSIVE STRESS	RENEWAL DATA	COPING	CAULKING	OTHERS
9	PRIMARY SLUDGE PUMPING STATION	REINFORCED CONCRETE	1984	30.25m ²	30.25m ²	300X10.6m ²		NOT KNOWN			
EXTERIOR NORTH	COLUMN BEAM	⊙ WALL(CONCRETE)	⊙	DOOR	WINDOW	METAL	EXTERIOR FINISH	X WATER PROOF	X COPING	X CAULKING	X OTHERS
EVALUATION ITEM	NORMAL	DAMAGE	✓	NORMAL	RUSTY	NORMAL	DIRTY	NORMAL	NORMAL	NORMAL	THE SLUDGE PUMPING WELL IN THE NORTH OF THIS BUILDING
	DAMAGE	BROKEN		RUSTY	CORROSION	RUSTY	WORN OUT	LEAKAGE	RUSTY	BROKEN	✓
	BULLET MARKS			CORROSION	MISSING	NONE		DAMAGE	CORROSION	NONE	
INVESTIGATION METHOD	VISUAL INSPECTION	VISUAL INSPECTION		VISUAL INSPECTION	VISUAL INSPECTION	VISUAL INSPECTION	VISUAL INSPECTION	VISUAL INSPECTION	VISUAL INSPECTION	VISUAL INSPECTION	
PHOTO NUMBERS								9-2			
RECOMMENDATION	C	C				A	A	A	A	A

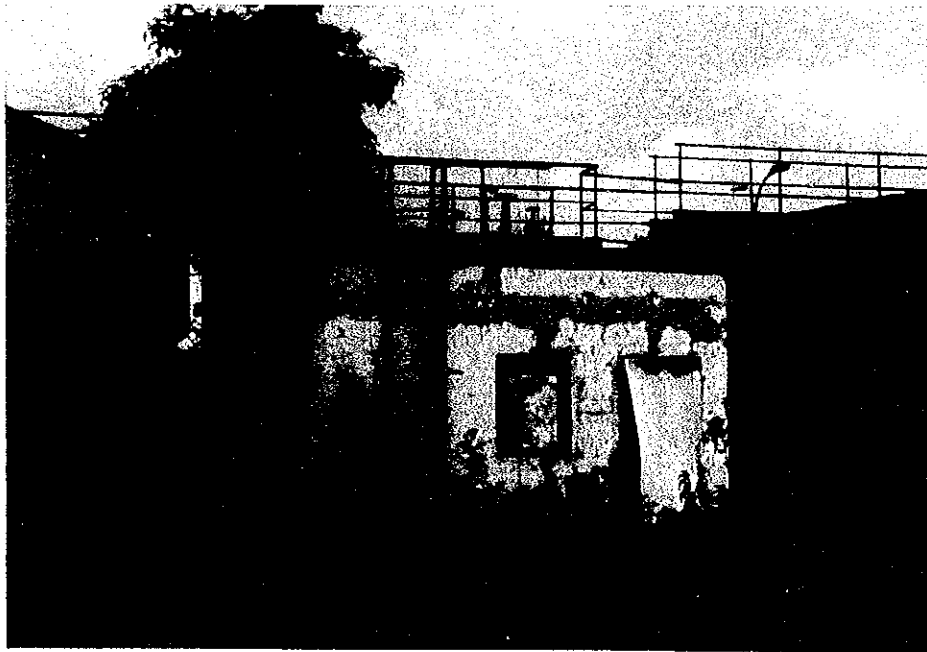
PHOTO NUMBER	11-1
--------------	------

PHOTO NUMBERS									
RECOMMENDATION	C	C				A	A	A	A
EXTERIOR WEST	COLUMN BEAM	⊙ WALL(CONCRETE)	⊙	DOOR	WINDOW	METAL	EXTERIOR FINISH	X WATER PROOF	X CAULKING
EVALUATION ITEM	NORMAL	NORMAL	✓	NORMAL	NORMAL	NORMAL	DIRTY	NORMAL	NORMAL
	DAMAGE	DAMAGE		RUSTY	RUSTY	RUSTY	WORN OUT	LEAKAGE	BROKEN
		BROKEN		CORROSION	CORROSION	CORROSION		DAMAGE	NONE
		BULLET MARKS		MISSING	MISSING	NONE			
INVESTIGATION METHOD	VISUAL INSPECTION	VISUAL INSPECTION		VISUAL INSPECTION	VISUAL INSPECTION	VISUAL INSPECTION	VISUAL INSPECTION	VISUAL INSPECTION	VISUAL INSPECTION
PHOTO NUMBERS	11-1	11-1		11-1	11-1	11-1	11-1		
RECOMMENDATION	C	C		A	A	A	A	A	A

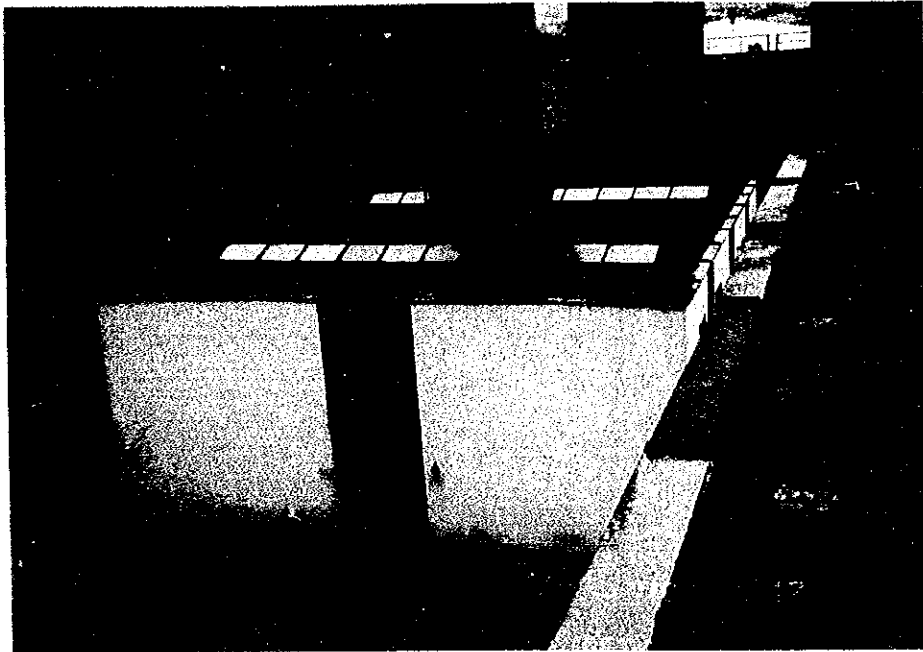
BUILDING NUMBER	13	BUILDING NAME	BOILER HOUSE
PHOTO NUMBER	13-2

PHOTO NUMBERS		13-2		13-2	13-2	13-2	13-2	13-2	13-2		
RECOMMENDATION	C	C		A	A		A	A	A	A	
EXTERIOR WEST	COLUMN BEAM	⊙ WALL(BRICK)	⊙	⊙ DOOR	⊙ WINDOW	METAL	EXTERIOR FINISH	⊙ WATER PROOF	⊙ COPING	⊙ CAULKING	⊙ OTHERS
EVALUATION ITEM	NORMAL	DAMAGE	✓	RUSTY	RUSTY	RUSTY	DIRTY	NORMAL	NORMAL	NORMAL	
	DAMAGE	BROKEN		CORROSION	CORROSION	CORROSION	WORN OUT	LEAKAGE	RUSTY	BROKEN	✓
		BULLET MARKS		MISSING	MISSING	NONE		DAMAGE	CORROSION	NONE	
INVESTIGATION METHOD	VISUAL INSPECTION	VISUAL INSPECTION		VISUAL INSPECTION	VISUAL INSPECTION	VISUAL INSPECTION	VISUAL INSPECTION	VISUAL INSPECTION	VISUAL INSPECTION	VISUAL INSPECTION	
PHOTO NUMBERS											
RECOMMENDATION	C	C		A	A		A	A	A	A

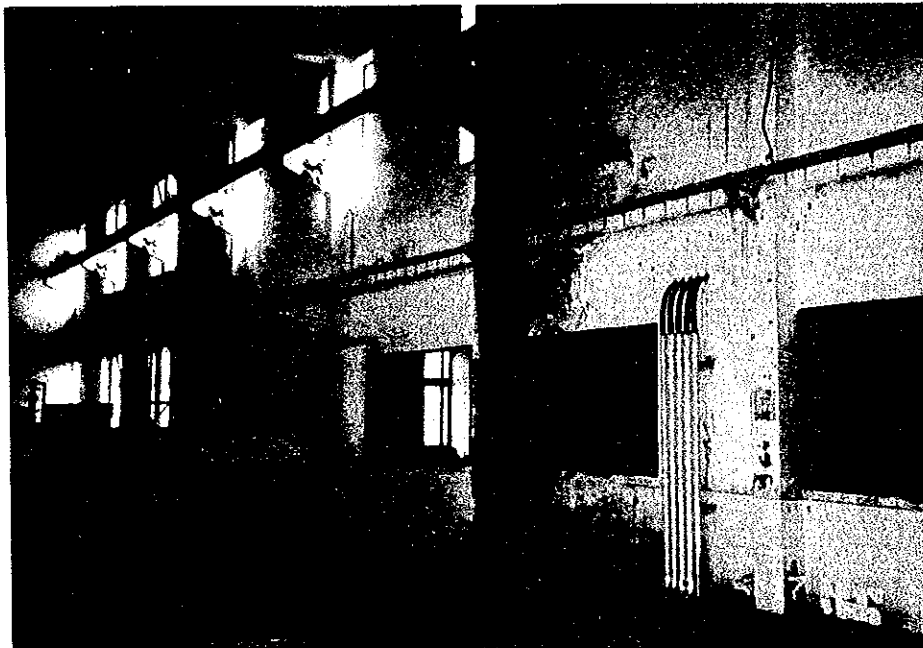
PHOTO NUMBER	17,18-10		
--------------	----------	--	--

SLUDGE FILTER PRESS ROOM	FLOOR	WALL	CEILING	METAL	STAIR	LIGHTING	VENTILATION	HEATING	WATER EQUIPMENT	FIRE EXTINGUISHER	OTHERS
PARTICULAR	NORMAL	NORMAL	NORMAL	NORMAL	NORMAL	NORMAL	NORMAL	NORMAL	NORMAL	NORMAL	THERE ARE SOME HOLES IN THE WALL MADE BY BULLET PENETRATION
EVALUATION ITEM	DIRTY	DIRTY	DIRTY	RUSTY	DIRTY	RUSTY	CORROSION	BROKEN	BROKEN	CORROSION	IT IS NECESSARY TO HAVE A PLAN FOR AVOIDING FLOOD DAMAGE TO FACILITIES.
	SAG	SAG	SAG	CORROSION	UNEVEN	BROKEN	✓	MISSING	MISSING	BROKEN	WE SUGGEST TO SET WATERPROOF EMBANKMENT AT ENTRANCE IN NORTH
	BROKEN	BROKEN	BROKEN	BROKEN	BROKEN	MISSING	MISSING	MISSING	MISSING	MISSING	
INVESTIGATION METHOD	VISUAL INSPECTION	VISUAL INSPECTION	VISUAL INSPECTION	MISSING VISUAL INSPECTION	VISUAL INSPECTION	VISUAL INSPECTION	VISUAL INSPECTION	VISUAL INSPECTION	VISUAL INSPECTION	VISUAL INSPECTION	
PHOTO NUMBERS	17.18-10	17.18-10	17.18-10								
RECOMMENDATION	A	A	A			A	A	A		A
