BUILDING SURVEY DETAILS

BUILDING NUMBER-20 POWER STATION

BUILDING NUMBER-22 RECEPTION

BUILDING ADMINISTRATION BUILDING  
NUMBER-23A (A)BLOCK

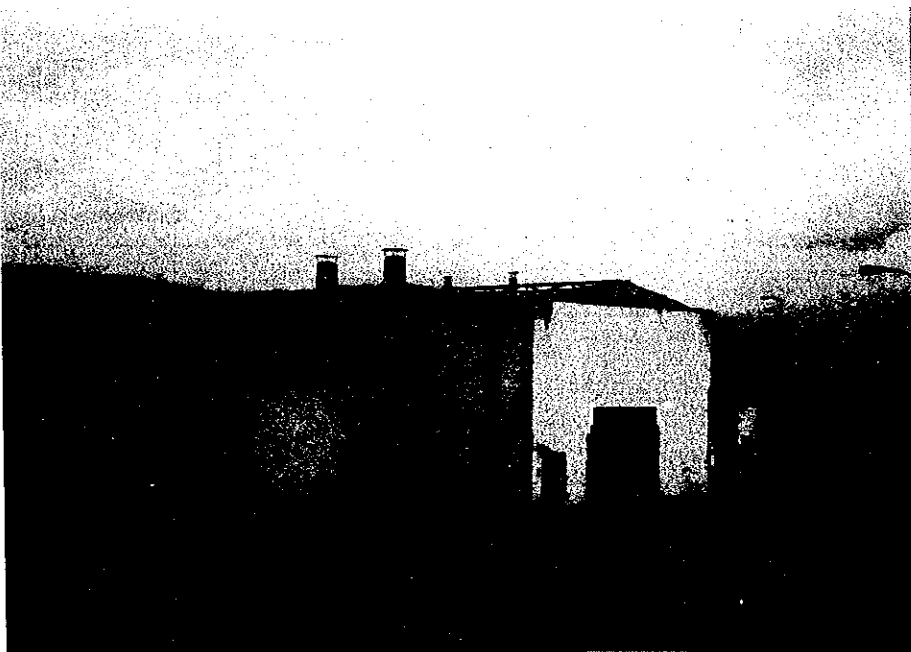
PHOTO NUMBER 20-1

RECOMMENDATION	C	C		A			A		A	A	
EXTERIOR EAST	COLUMN BEAM	⊙ WALL(BRICK)	⊙	DOOR	X	METAL	EXTERIOR FINISH	X	WATER PROOF	X	OTHERS
		NORMAL	✓	NORMAL		NORMAL	NORMAL	NORMAL	NORMAL	NORMAL	
EVALUATION ITEM	DAMAGE	BROKEN		CORROSION	✓	CORROSION	DIRTY	✓	LEAKAGE	BROKEN	✓
		BROKEN		CORROSION	✓	CORROSION	DIRTY	✓	DAMAGE	NONE	
INVESTIGATION METHOD	VISUAL INSPECTION	BULLET MARKS		MISSING	✓	NONE	WORK OUT	✓			
		VISUAL INSPECTION		MISSING	✓	VISUAL INSPECTION	VISUAL INSPECTION	✓	VISUAL INSPECTION	VISUAL INSPECTION	
PHOTO NUMBERS	30-2			20-2			20-2				
RECOMMENDATION	C	C		A			A		A	A	
EXTERIOR SOUTH	COLUMN BEAM	⊙ WALL(BRICK)	X	DOOR	X	METAL	EXTERIOR FINISH	X	WATER PROOF	X	OTHERS
		NORMAL	✓	NORMAL		NORMAL	NORMAL	NORMAL	NORMAL	NORMAL	
EVALUATION ITEM	DAMAGE	BROKEN	✓	CORROSION	✓	CORROSION	DIRTY	✓	LEAKAGE	BROKEN	✓
		BROKEN	✓	CORROSION	✓	CORROSION	DIRTY	✓	DAMAGE	NONE	
INVESTIGATION METHOD	VISUAL INSPECTION	BULLET MARKS		MISSING	✓	NONE	WORK OUT	✓

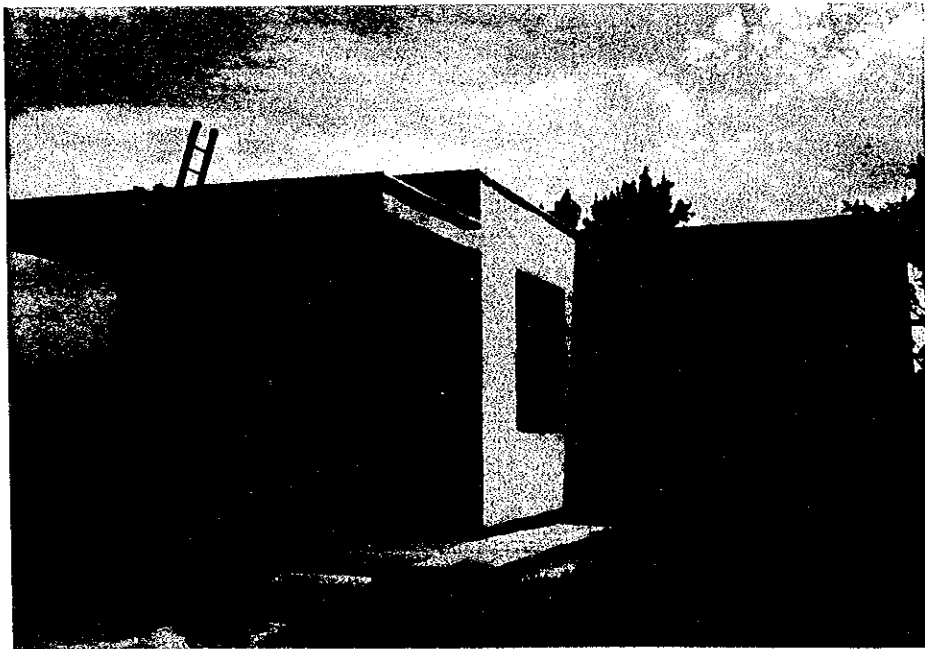
PHOTO NUMBER 22-1

EVALUATION ITEM	NORMAL	NORMAL	✓	NORMAL	NORMAL	NORMAL	NORMAL	✓	✓
	DAMAGE	DAMAGE		RUSTY	RUSTY	RUSTY	DIRTY		
		BROKEN		CORROSION	CORROSION	CORROSION	WORN OUT		
		BULLET MARKS		MISSING	MISSING	NONE			
INVESTIGATION METHOD	VISUAL INSPECTION	VISUAL INSPECTION		VISUAL INSPECTION	VISUAL INSPECTION	VISUAL INSPECTION	VISUAL INSPECTION		
PHOTO NUMBERS	22-1	22-1		22-1	22-1	22-1	22-1	22-4	22-4
RECOMMENDATION	C	C		C	C	C	C	C	C

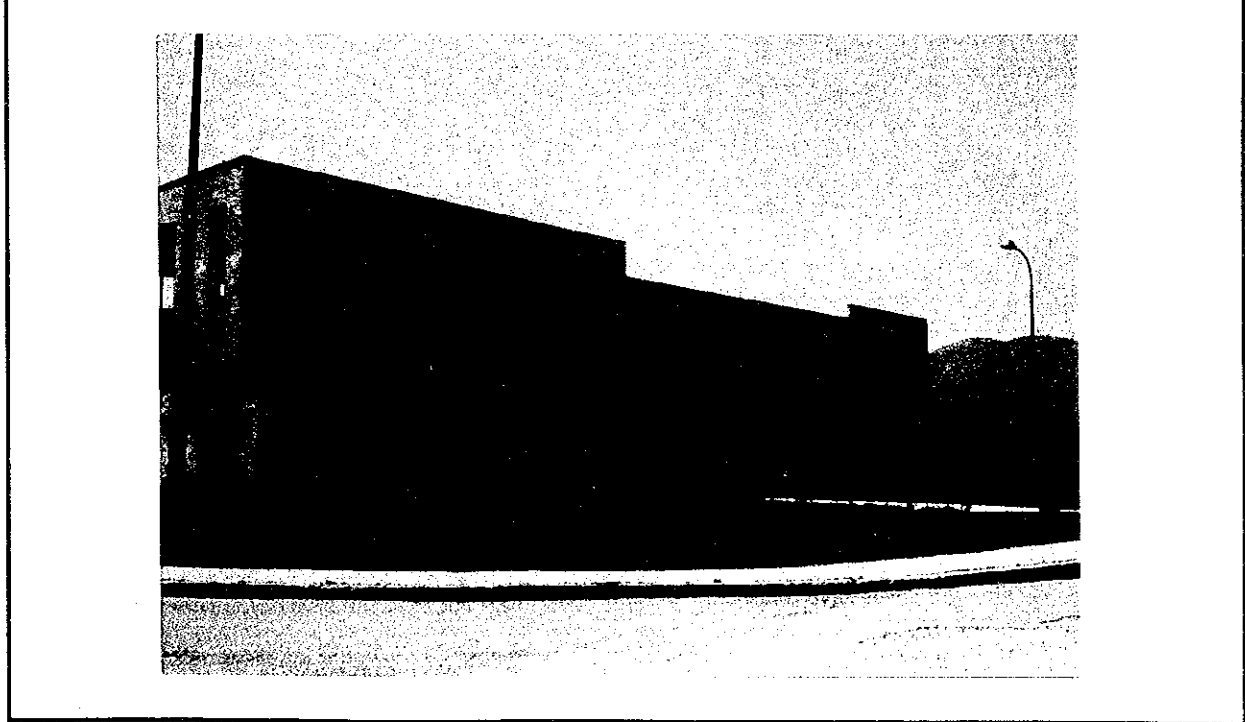
PHOTO NUMBER	23A-1
--------------	-------

BULLET MARKS	BULLET MARKS		MISSING	MISSING	NONE		NONE	
INVESTIGATION METHOD	VISUAL INSPECTION	VISUAL INSPECTION		VISUAL INSPECTION	VISUAL INSPECTION	VISUAL INSPECTION	VISUAL INSPECTION	VISUAL INSPECTION	VISUAL INSPECTION
PHOTO NUMBERS	23A-1	23A-1				23A-8			
RECOMMENDATION	C	C		C	C	C	A	C	C
EXTERIOR WEST	COLUMN BEAM	⊙ WALL(BRICK)	⊙	⊙ DOOR	⊙ WINDOW	⊙ METAL	⊙ EXTERIOR FINISH	⊙ COPING	⊙ CAULKING
EVALUATION ITEM	NORMAL	NORMAL	✓	NORMAL	NORMAL	NORMAL	NORMAL	NORMAL	NORMAL
	DAMAGE	DAMAGE		RUSTY	RUSTY	RUSTY	DIRTY	RUSTY	BROKEN
	BROKEN	BROKEN		CORROSION	CORROSION	CORROSION	WORN OUT	CORROSION	NONE
	BULLET MARKS	BULLET MARKS		MISSING	MISSING	NONE		NONE	
INVESTIGATION METHOD	VISUAL INSPECTION	VISUAL INSPECTION		VISUAL INSPECTION	VISUAL INSPECTION	VISUAL INSPECTION	VISUAL INSPECTION	VISUAL INSPECTION	VISUAL INSPECTION
PHOTO NUMBERS	23A-5,6	23A-5,6		23A-5,6	23A-5,6		23A-5,6		
RECOMMENDATION	C	C		C	C	A	A	C	C
