BUILDING SURVEY DETAILS

BUILDING NUMBER-23B
ADMINISTRATION BUILDING B-BLOCK

INSPECTION SHEETS MECHANICAL ASPECTS

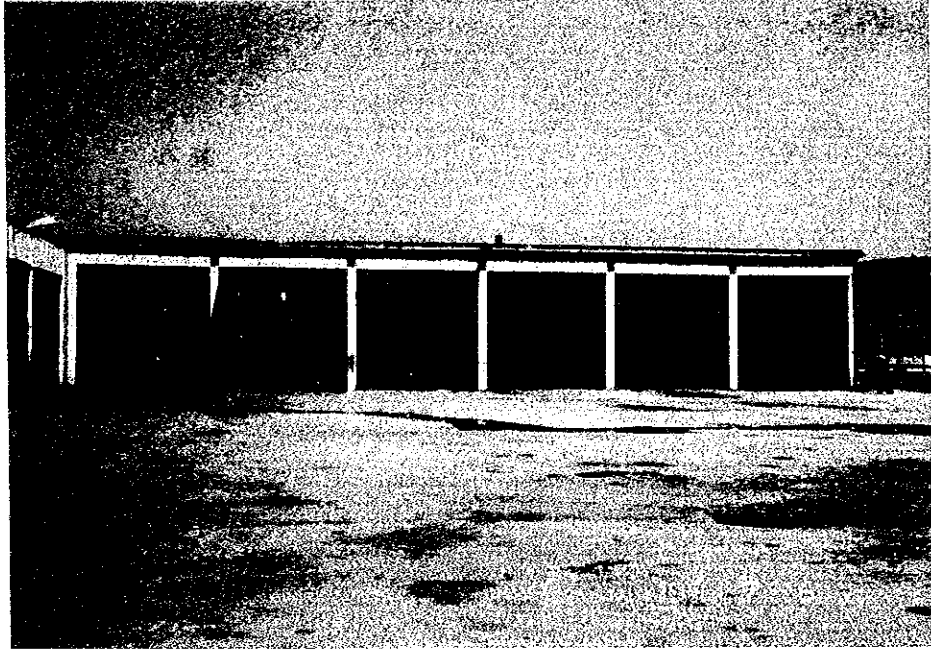
BUILDING NUMBER	23B	BUILDING NAME	ADMINISTRATION
PHOTO NUMBER	23B-2

NORMAL	✓	RUSTY	NORMAL	NORMAL	NORMAL	NORMAL	✓	NORMAL	
		DAMAGE		CORROSION	RUSTY	RUSTY	DIRTY	LEAKAGE		BROKEN	
EVALUATION ITEM		BROKEN		MISSING	CORROSION	CORROSION	WORN OUT	DAMAGE		NONE	
		BULLET MARKS		MISSING	MISSING	NONE					
		VISUAL INSPECTION		VISUAL INSPECTION	VISUAL INSPECTION	VISUAL INSPECTION	VISUAL INSPECTION	VISUAL INSPECTION		VISUAL INSPECTION	
PHOTO NUMBERS	23B-1	23B-1		23B-1	23B-1	23B-1	23B-1				
RECOMMENDATION	C	C		C	C	A	A	C	C	C	
EVALUATION ITEM	EXTERIOR SOUTH	WALL (BRICK)	X	DOOR	WINDOW	METAL	EXTERIOR FINISH X	WATER PROOF	⊙	⊙	
		NORMAL		RUSTY	NORMAL	NORMAL	NORMAL	NORMAL	✓	NORMAL	
		DAMAGE		CORROSION	RUSTY	RUSTY	DIRTY	LEAKAGE		BROKEN	
EVALUATION ITEM		BROKEN		MISSING	CORROSION	CORROSION	WORN OUT	DAMAGE		NONE	
		BULLET MARKS		MISSING	MISSING	NONE					
		VISUAL INSPECTION		VISUAL INSPECTION	VISUAL INSPECTION	VISUAL INSPECTION	VISUAL INSPECTION	VISUAL INSPECTION		VISUAL INSPECTION	
PHOTO NUMBERS	23B-2	23B-2		23B-2	23B-2	23B-2	23B-2

RECOMMENDATION	C	A		A		A	A	C	C	C	
EVALUATION ITEM	EXTERIOR WEST	WALL (BRICK)	⊙	DOOR	WINDOW	METAL	EXTERIOR FINISH X	WATER PROOF	⊙	⊙	
		NORMAL	✓	RUSTY	NORMAL	NORMAL	NORMAL	NORMAL	✓	NORMAL	
		DAMAGE		CORROSION	RUSTY	RUSTY	DIRTY	LEAKAGE		BROKEN	
EVALUATION ITEM		BROKEN		MISSING	CORROSION	CORROSION	WORN OUT	DAMAGE		NONE	
		BULLET MARKS		MISSING	MISSING	NONE					
		VISUAL INSPECTION		VISUAL INSPECTION	VISUAL INSPECTION	VISUAL INSPECTION	VISUAL INSPECTION	VISUAL INSPECTION		VISUAL INSPECTION	
PHOTO NUMBERS	23B-2	23B-2		23B-2	23B-2	23B-2	23B-2				
RECOMMENDATION	C	C		A		A	A	C	C	C

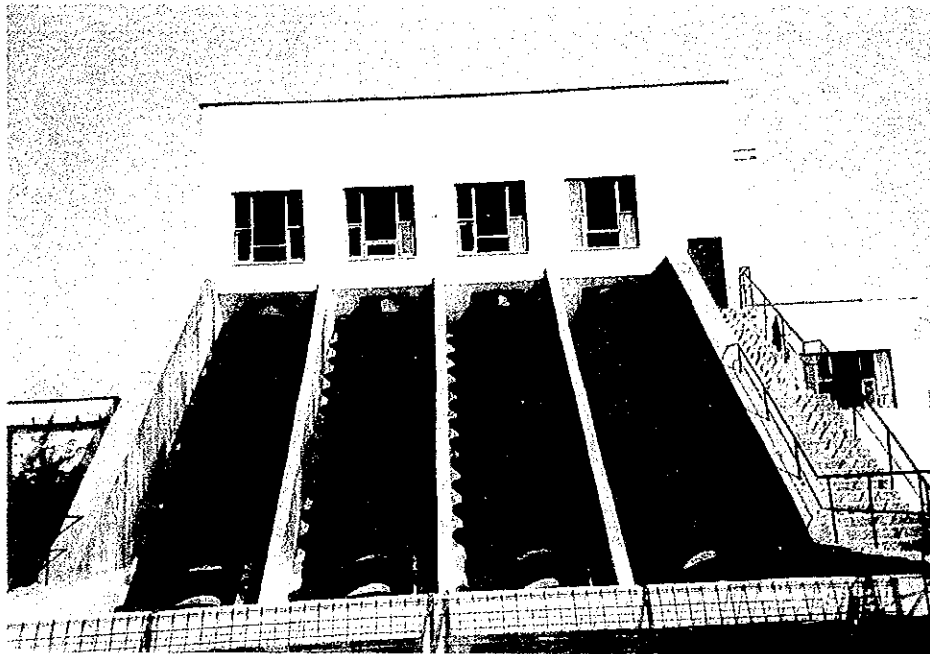
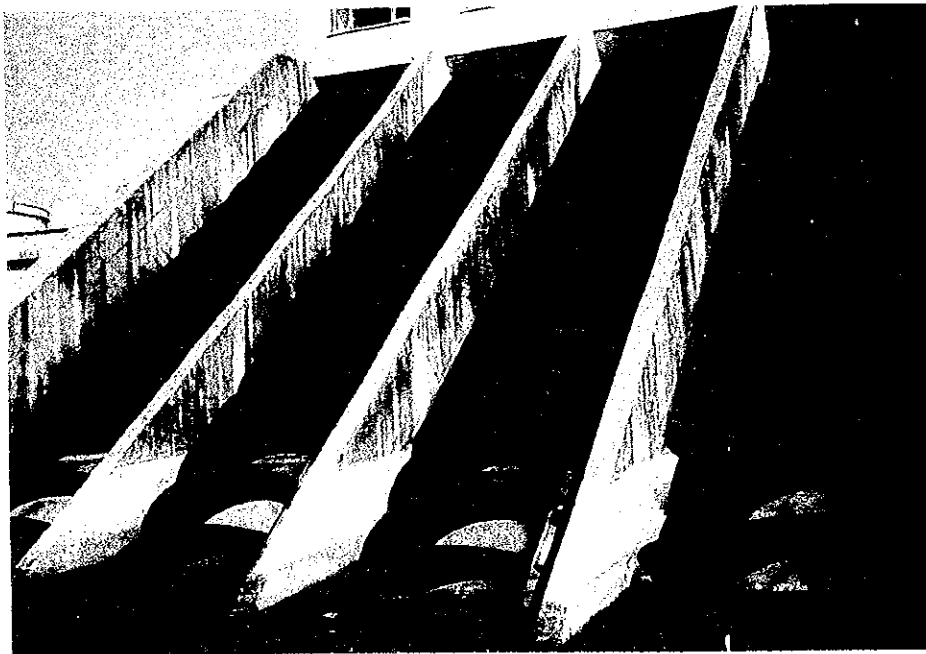
Result of inspection						
Physical inspection				Functional inspection		
Degree of problem	Operating condition	-	※1	Capacity	-	
	Stain/Corrosion	○		Safety measure	△	
	Painting	△	※2	Other	△	※3
	Lubricant	×				
	Deformation/Crack	○				
	Damage	△				
	Abnormal sound	-				
	Overheat	-				
	Wear	○				
Decision	B

※1: Grease lubrication systems for lower bearings of all 4 pumps are damaged or broken, and operation test for this kind of machines need for at least two hours continuous running in order to investigate several bearing's temperature stabilization, vibration, abnormal sound and water pumping up capability etc. In this case all four pumps are lacking of lower bearings' grease lubrication, therefore operation test for two hours should be too dangerous because of probably causing the severe damage of the pumps and not recommendable from the mechanical and safety point of view.

※2: Painting condition of 4 screw pumps are almost same and not so bad. Thickness of painting for each of 4 pumps was tried using Painting thickness measuring equipment at two point for each of 4pumps. However the measurement was too dangerous to be carried out, therefore abandoned finally.

※3: Drive units including reducer and lower bearings (foot bearings) need to be changed and remaining screws and shafts could be utilized, still needs cleaning, protection of corroded parts, painting and adjustment.

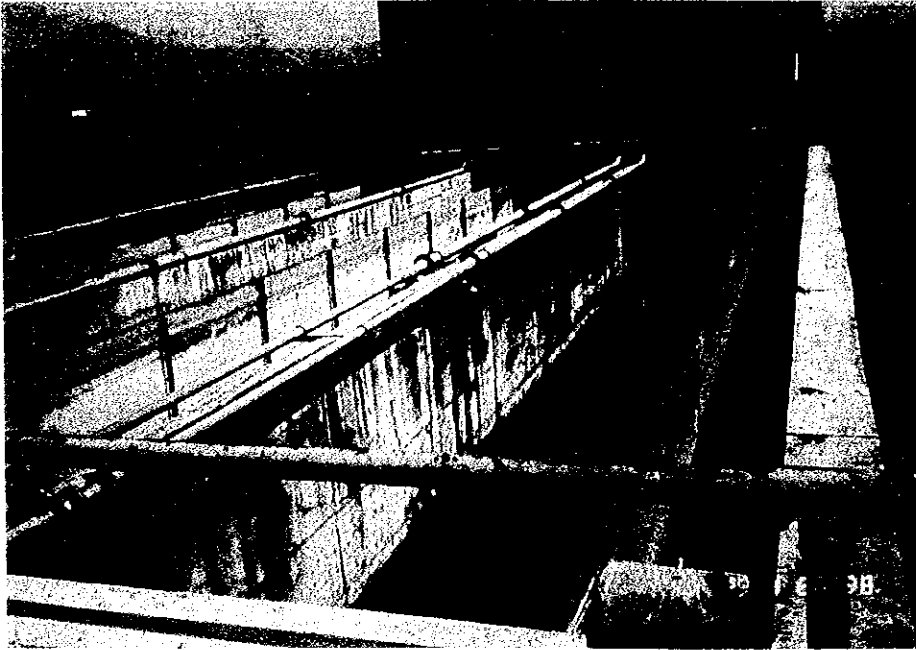
Result of inspection						
Degree of problem	Physical inspection			Functional inspection		
	Operating condition	—		Capacity	--	
	Stain/Corrosion	×		Safety measure	×	
	Painting	×		Other		
	Lubricant	×				
	Deformation/Crack	△				
	Damage	×				
	Abnormal sound	—				
	Overheat	—				
	Wear	×				
Decision	A

Remark : Metal bridge construction is attacked severely by corrosion, bridge drive motor is rusted and flexible cab tire cable is missing thoroughly.

Aeration system, made of galvanized pipe with nozzles for production of air bubbles is damaged heavily.

As a conclusion, whole aeration sand trap mechanism with all necessary auxiliaries except civil structure should be replaced by new one.
