INSPECTION SHEET

Equipment	Primary Sedimentation Tanks No.1~No.2* 380 V 0.75 kw 4 pole	
	*Numbering is from right to left by Arab. rule. Manufacturer: Degremont France	
Location	Primary sedimentation tank	Facilities

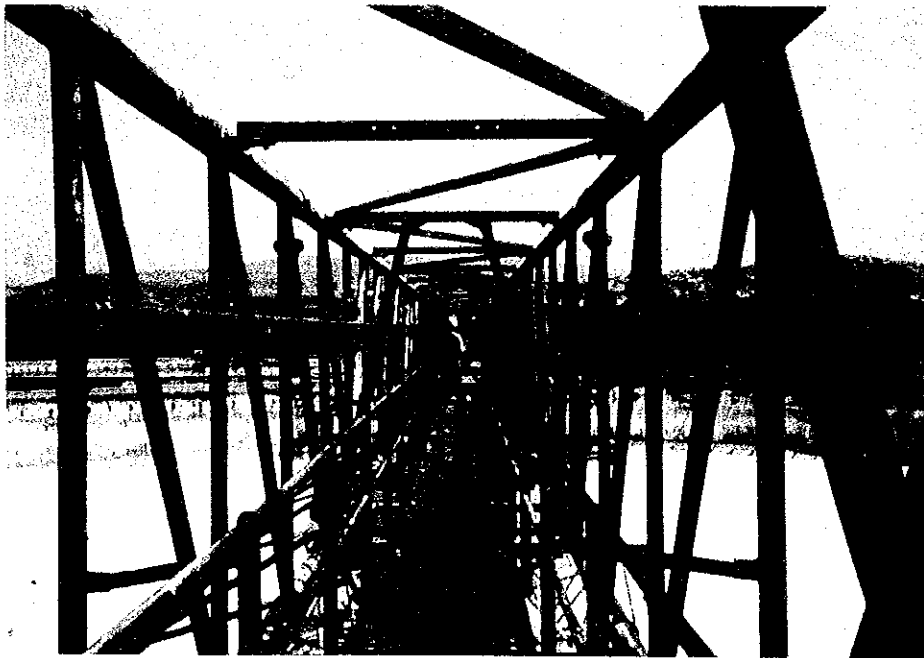
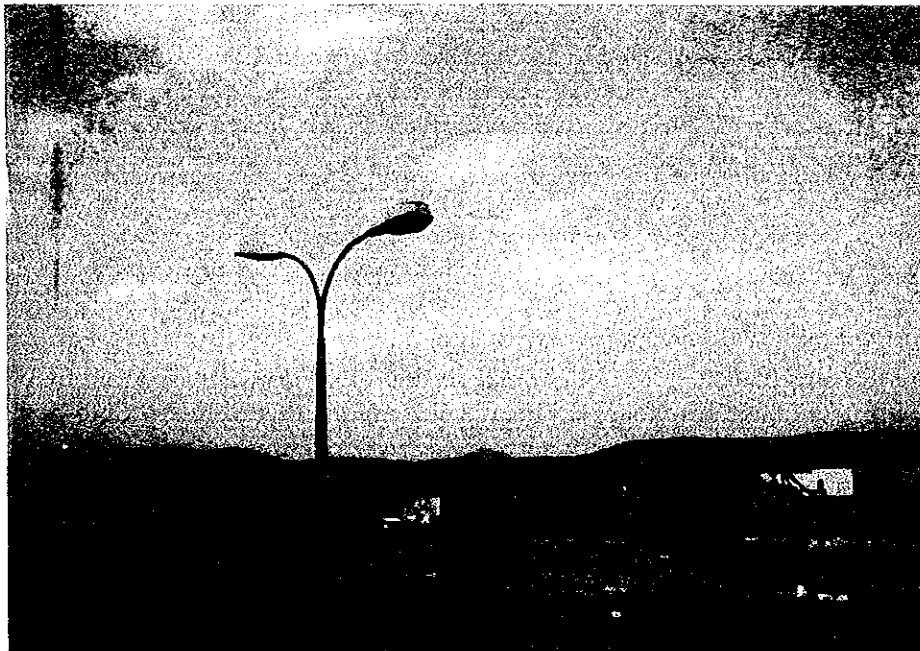
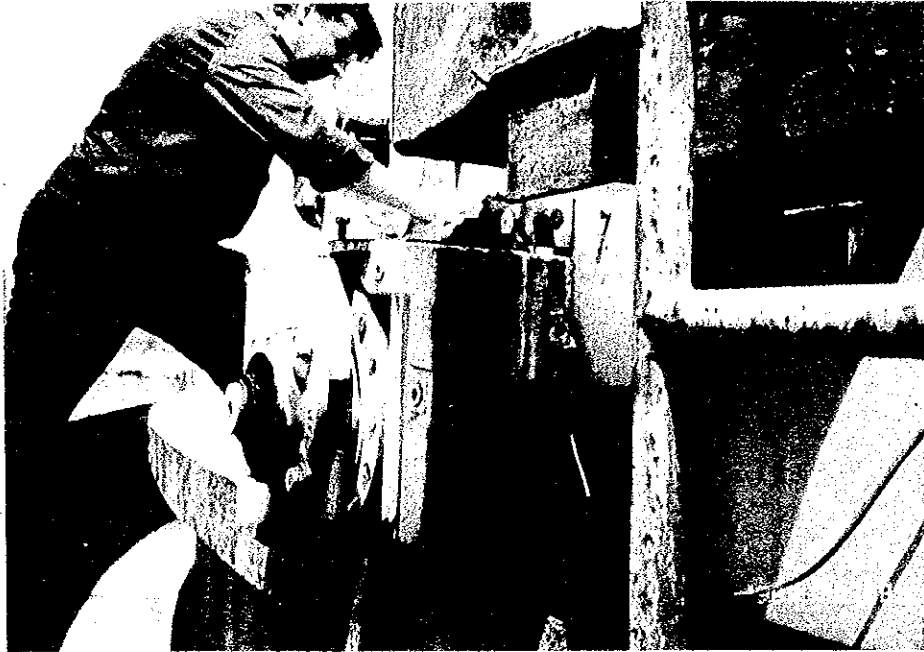
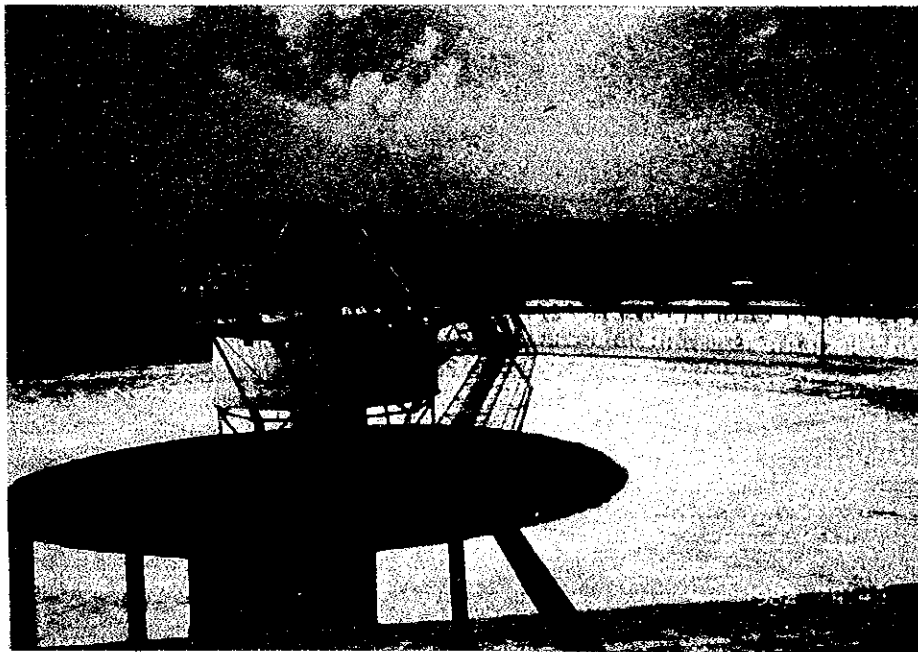
Remark: Drive motors of mechanisms are dismantled and taken away.
 Drive heads for mechanisms are both damaged, therefore drive motors and drive heads should be replaced with new one. Some diagonal beams corroded very severely should be replaced with new one. Certain quantity of bolts and nuts are corroded severely and all the bolts and nuts for mechanisms need to be replaced with stainless steel.
 Blade rakes for all parts should be renewed.

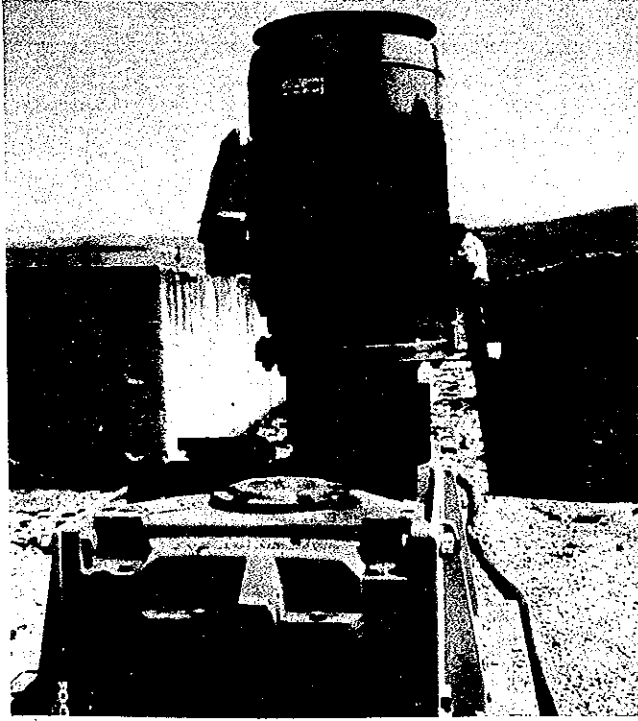
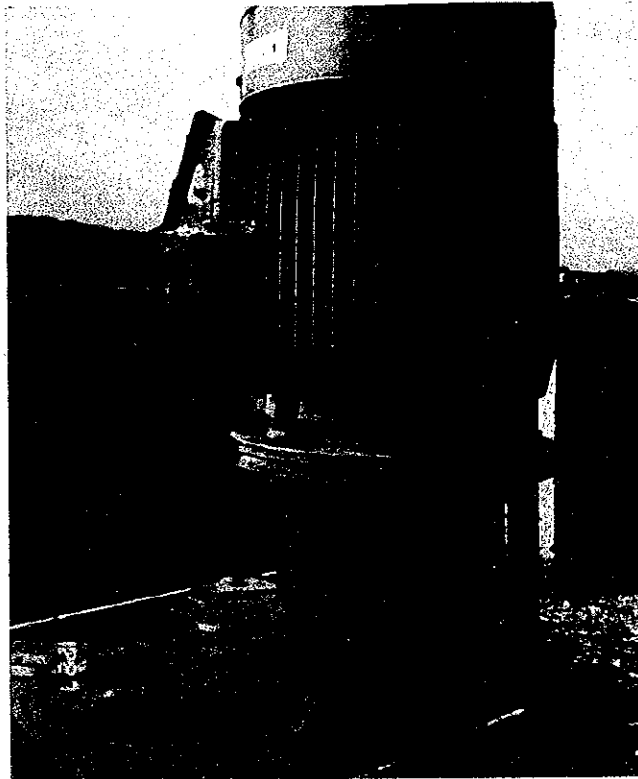
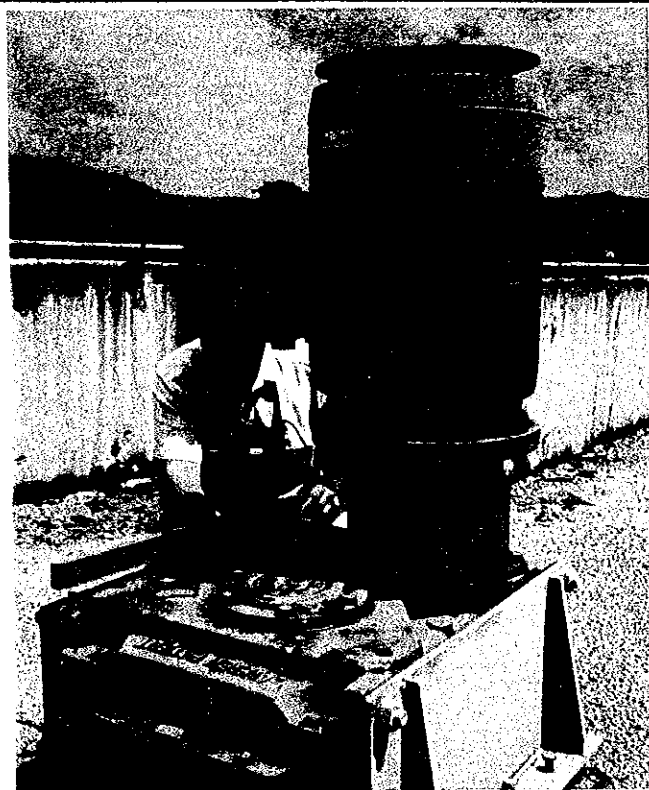
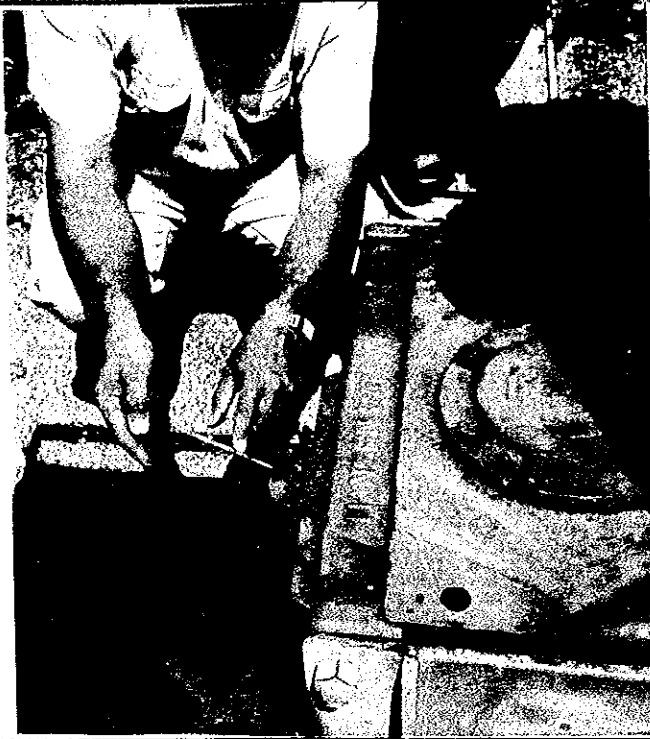
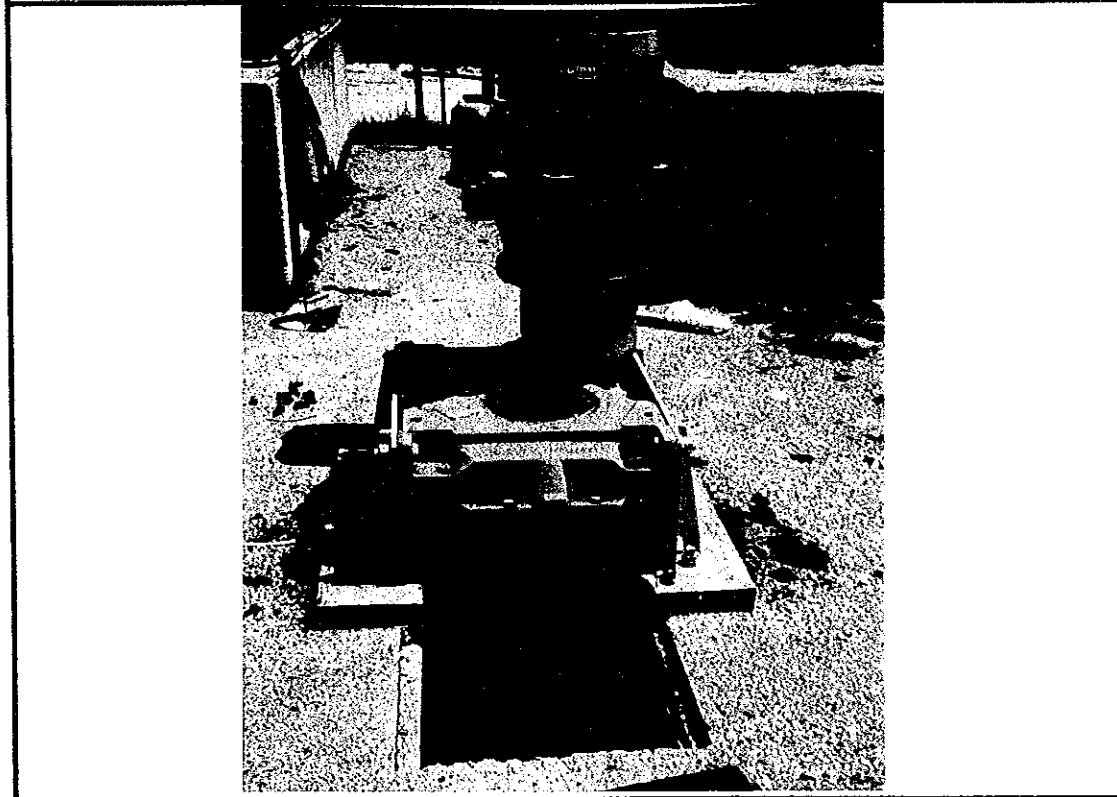
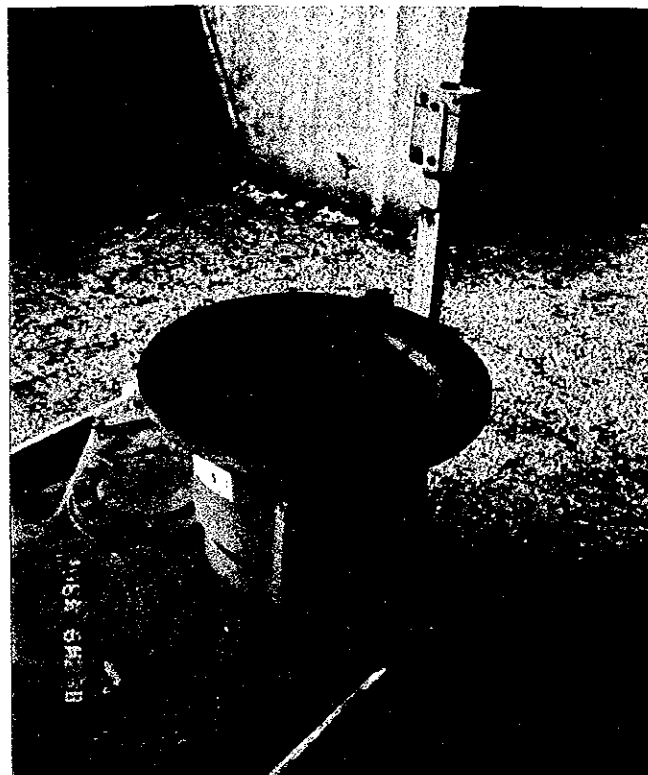
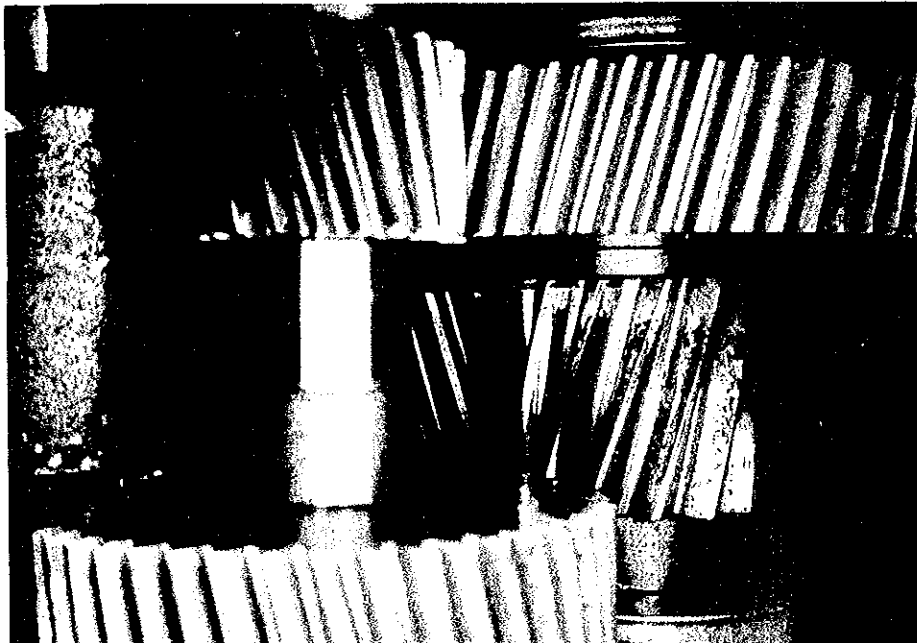
Remark : Almost all the manual drive sluice gate can operate downwards and upwards by turning sluice gate handle by manual, however almost gates need more than 15 kg of man power which figure designated by Japan Sewerage Standard.

All the manual drive sluice gates need to be replaced all of bolts and nuts and retainers with new ones and need to be readjusted.

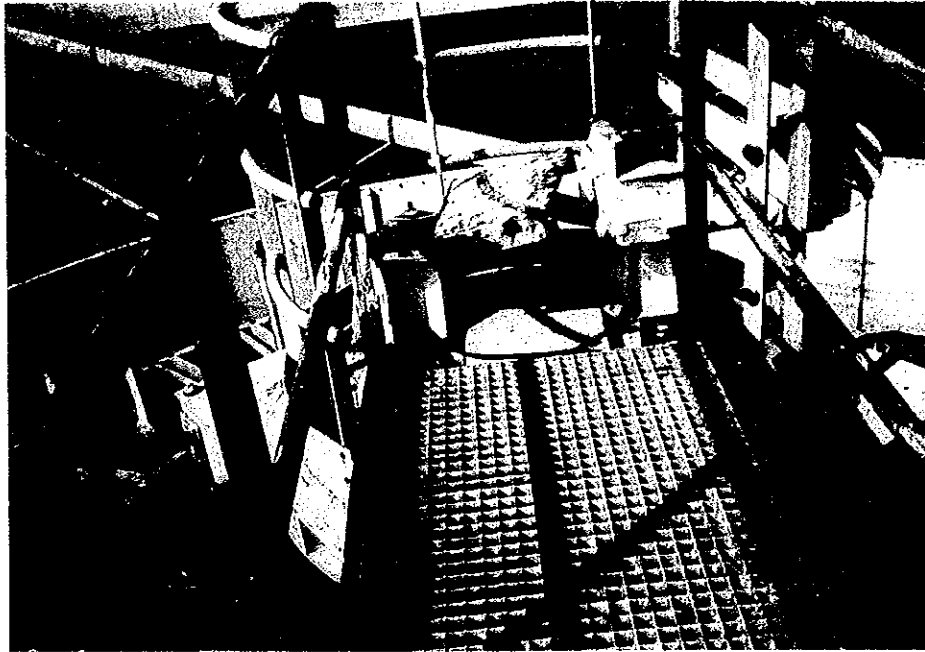
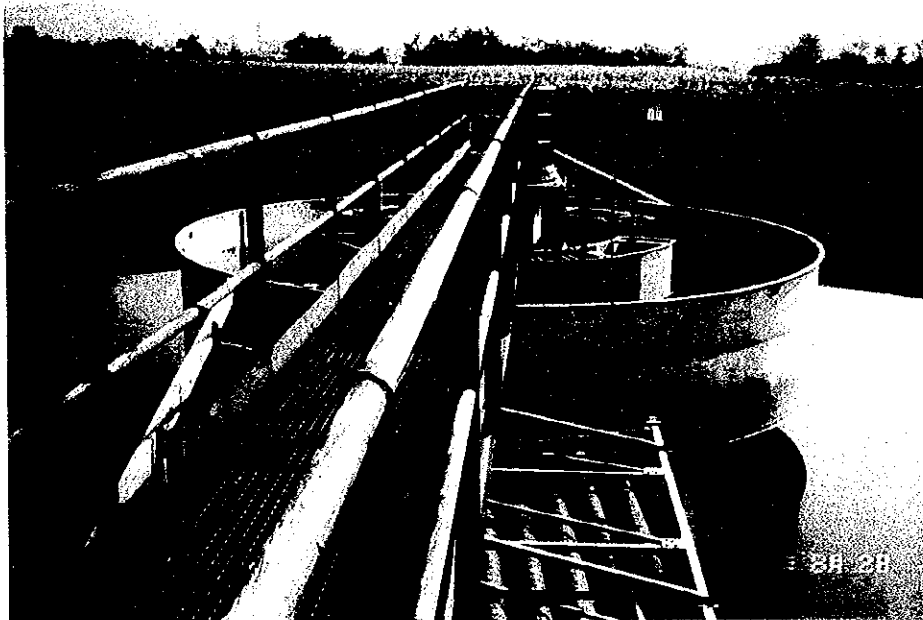
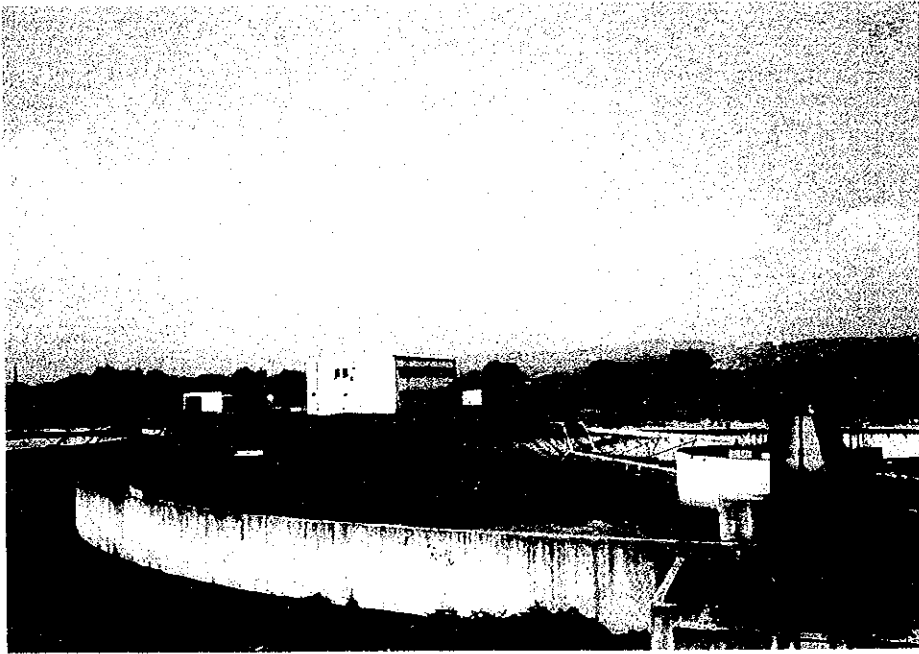
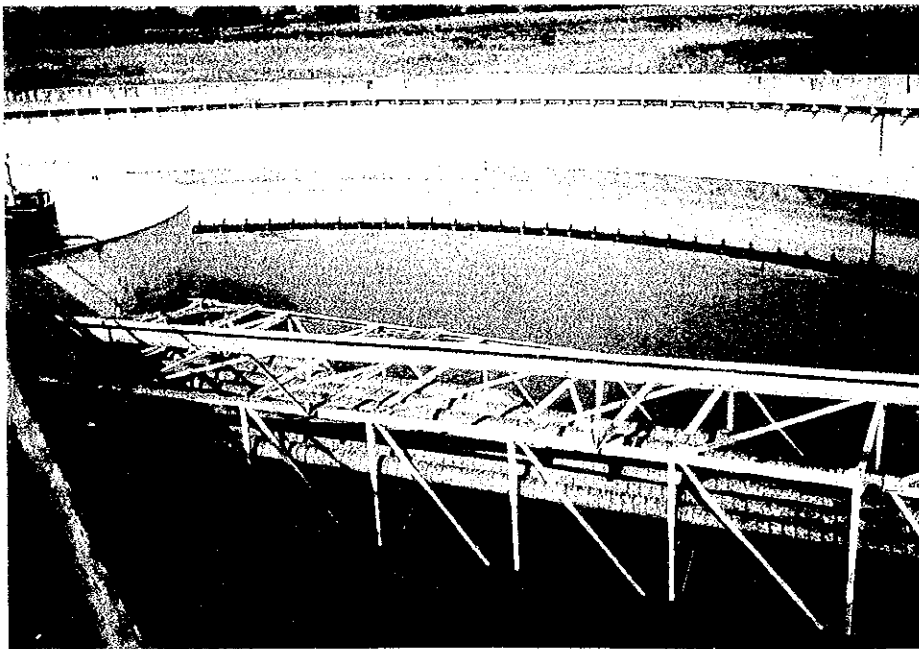
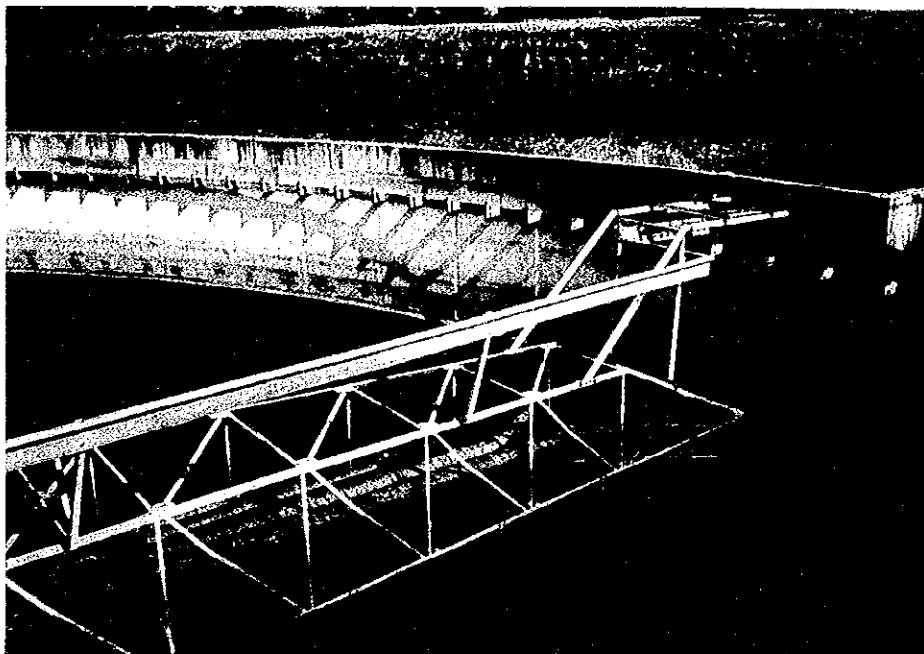
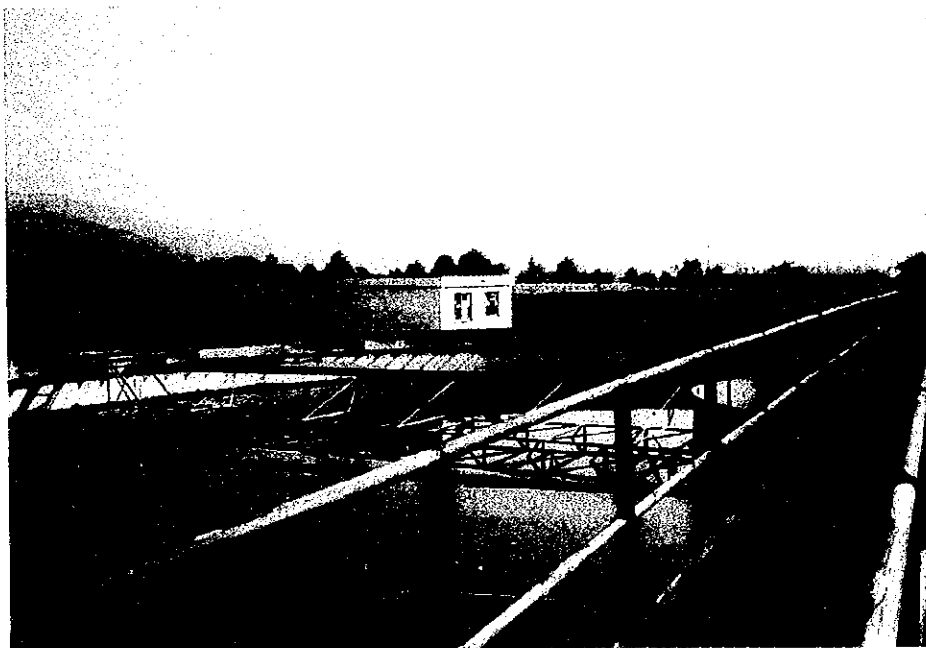
Remark 1: Drive motors of all four final sedimentation tanks are dismantled and taken away and all drive heads are not complete.

The structures of mechanism are partly attacked by rust and almost bolts and nuts are corroded heavily.

The structures of mechanism need to be cleaning, protection of corroded part, replacing of all the bolts and nuts with stainless steel and replacing central sliding sleeves with new ones.

Whole structures of mechanism need repetition of the anti rust protection painting.

The drive units need to be replaced with new ones.

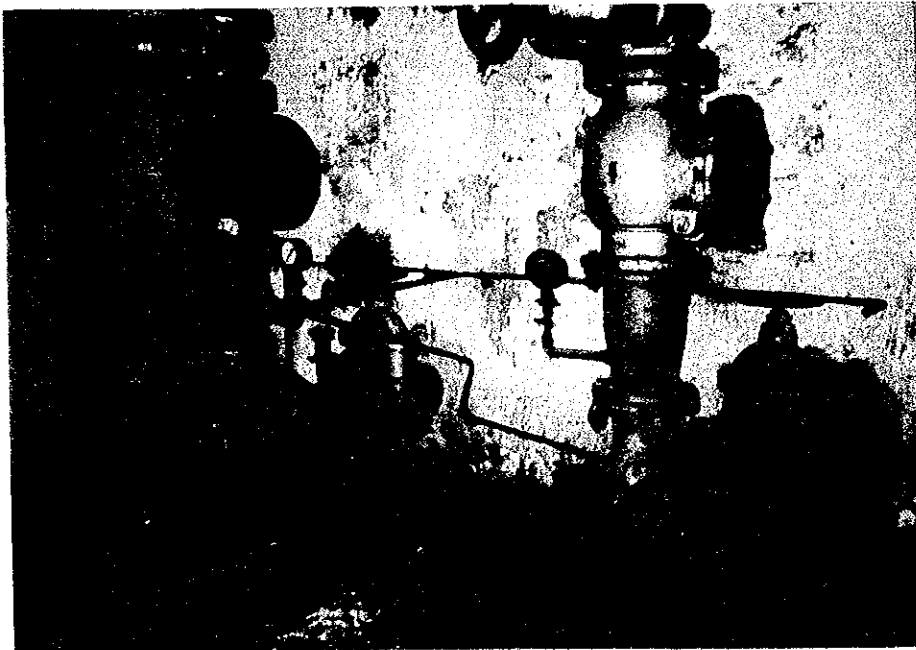
Remark : These pumps are damaged severely and no drive motors exist. Therefore all pumps including necessary auxiliaries with drive motors need to be renewed.

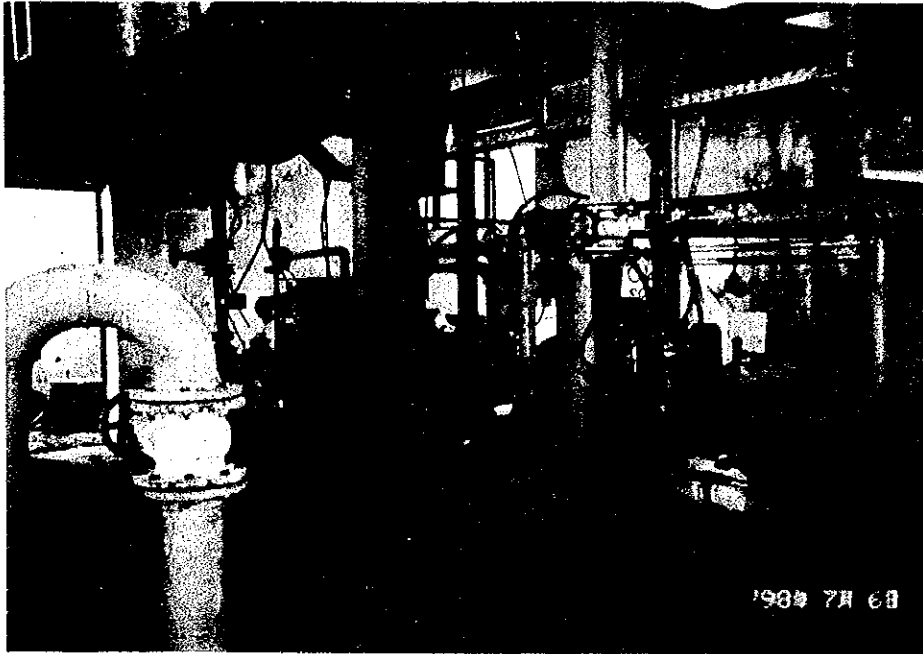
Remark : Digested gas is recirculated for sludge mixing and three compressors of 37 kw were used for that purpose. Digested gas from gas storage tank is transported to power generation and another three compressors of 30 kw were used for that purpose. These six gas compressors are damaged extraordinarily. Because of the complexity of these compressors transporting the very explosive gas, therefore all the compressors with necessary auxiliaries to be replaced with new ones.

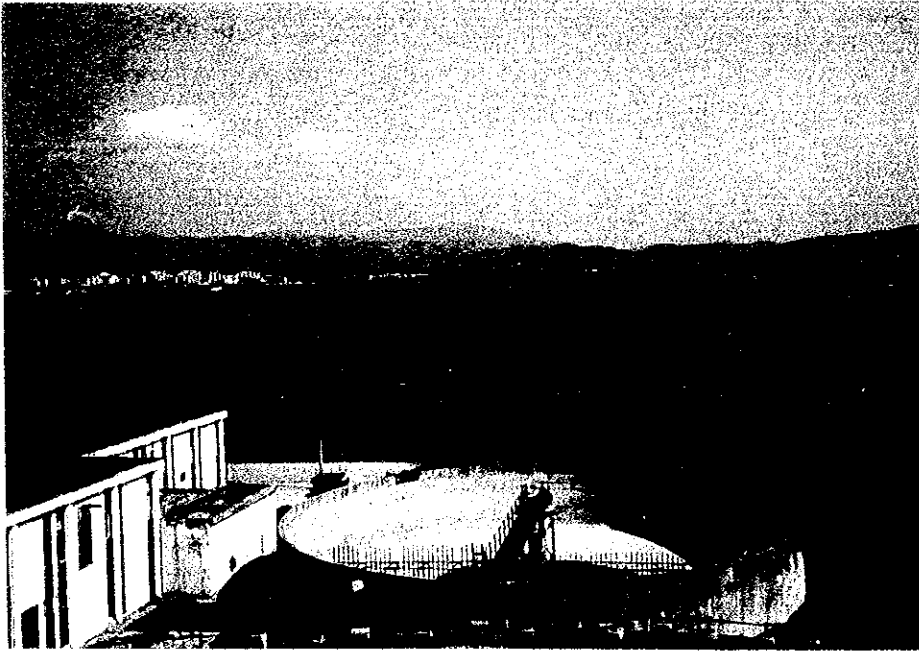
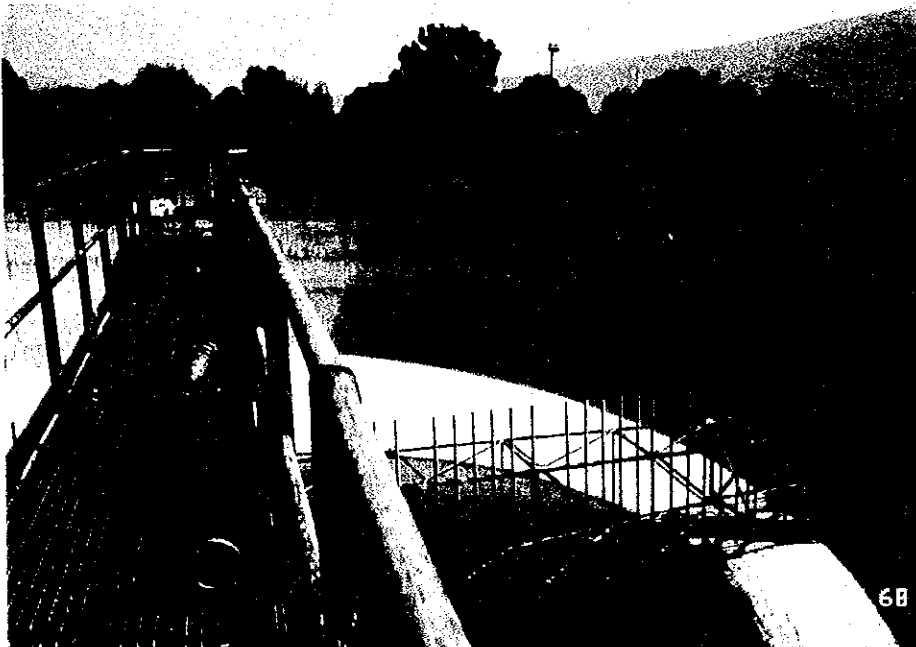
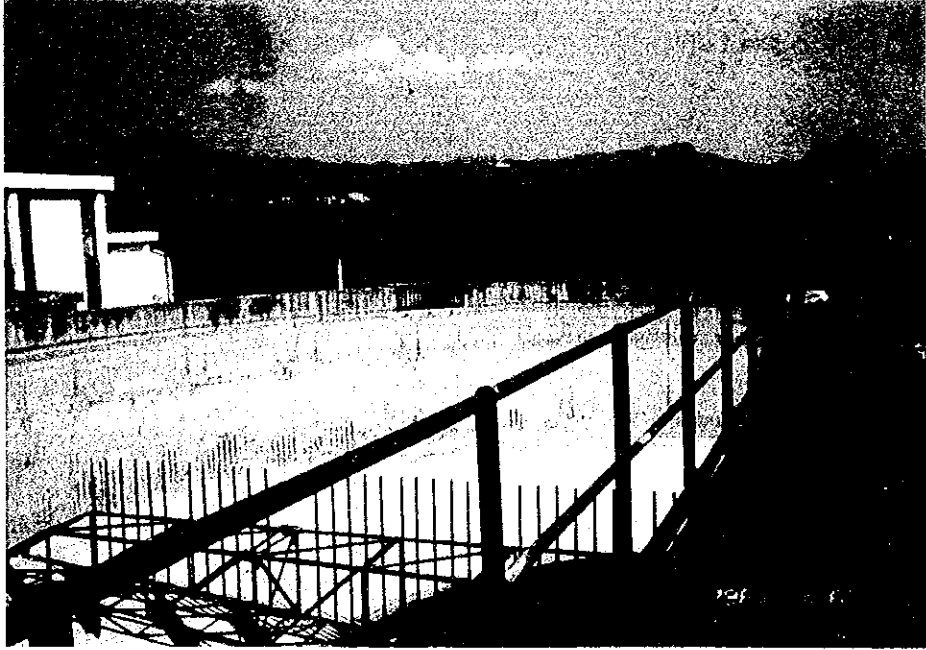
Remark : Drive motor of the thickener is dismantled and taken away and drive head is not complete.

The structure of mechanism is partly attacked by rust , most of bolts and nuts are corroded severely. The structure of mechanism need to be cleaning, protection of corroded parts, replacing of all the bolts and nuts with stainless steel.

The drive head needs to be replaced with new one.

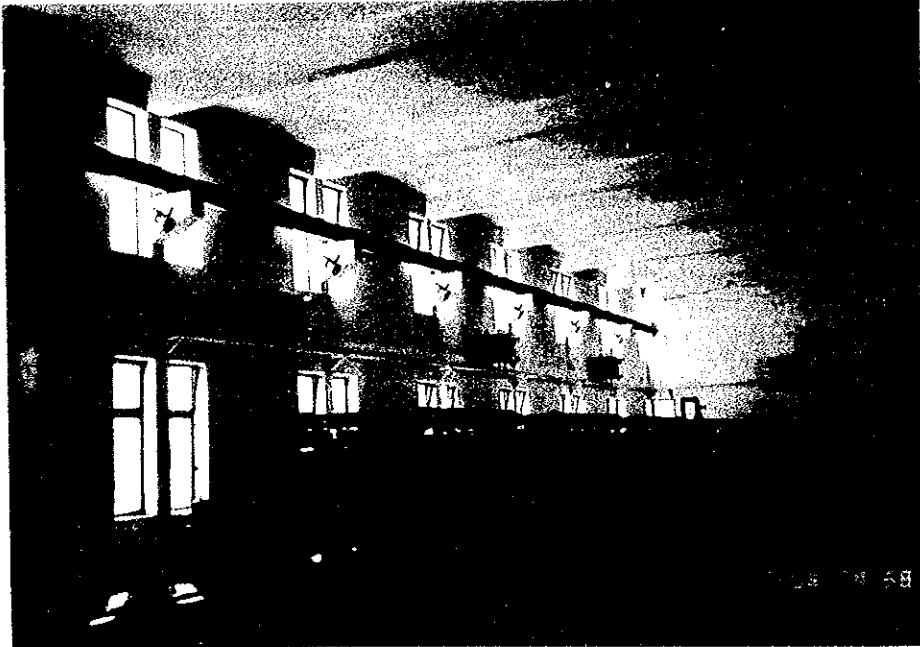
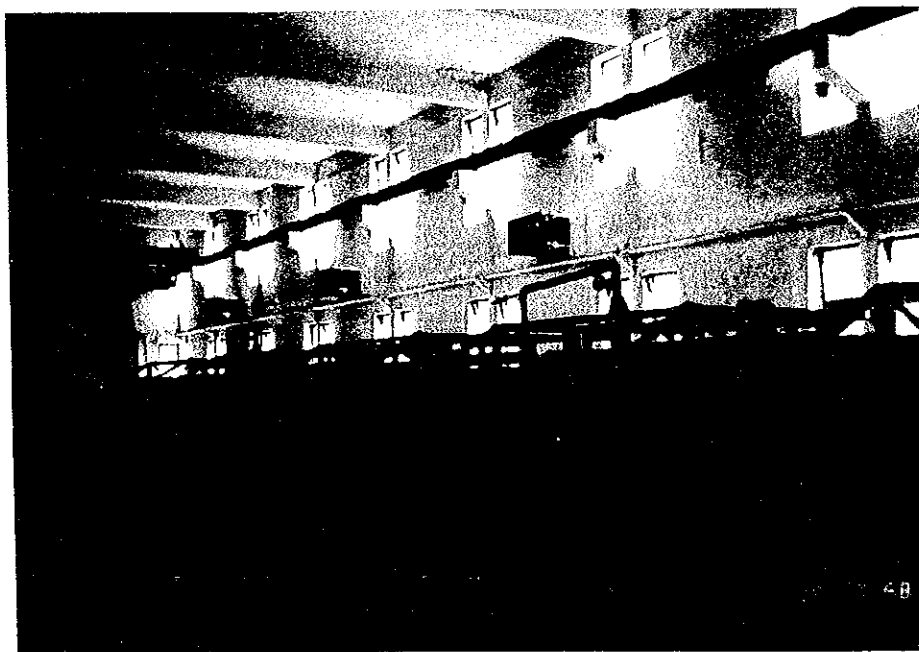
Remark : All five presses are devastated, electrical motors and transmission mechanisms, part of automatics, filter clothes are dismantled. Pipe lines of the air automatics are cut.
Therefore all the five filter presses need to be replaced with new ones.

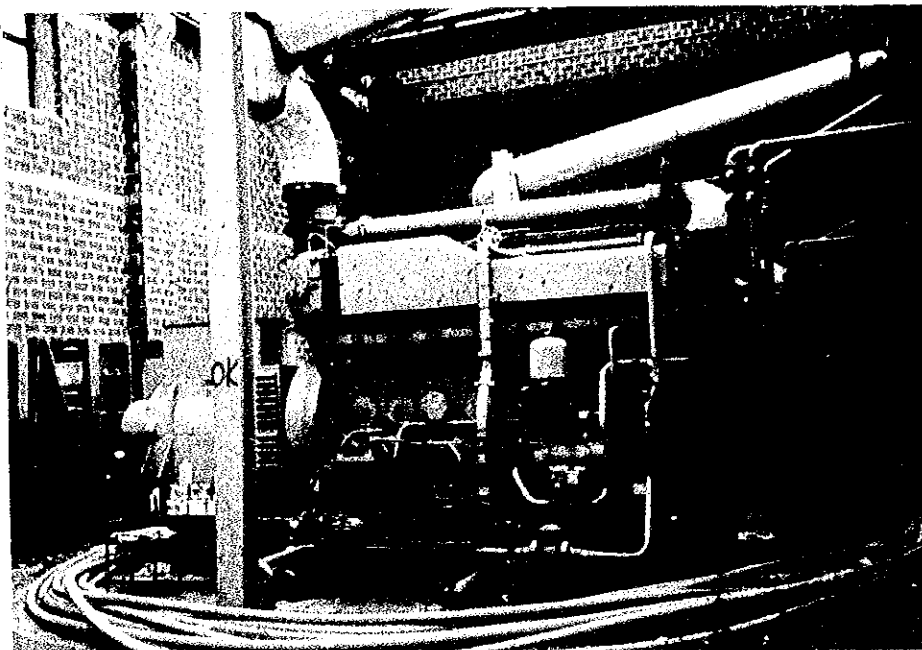
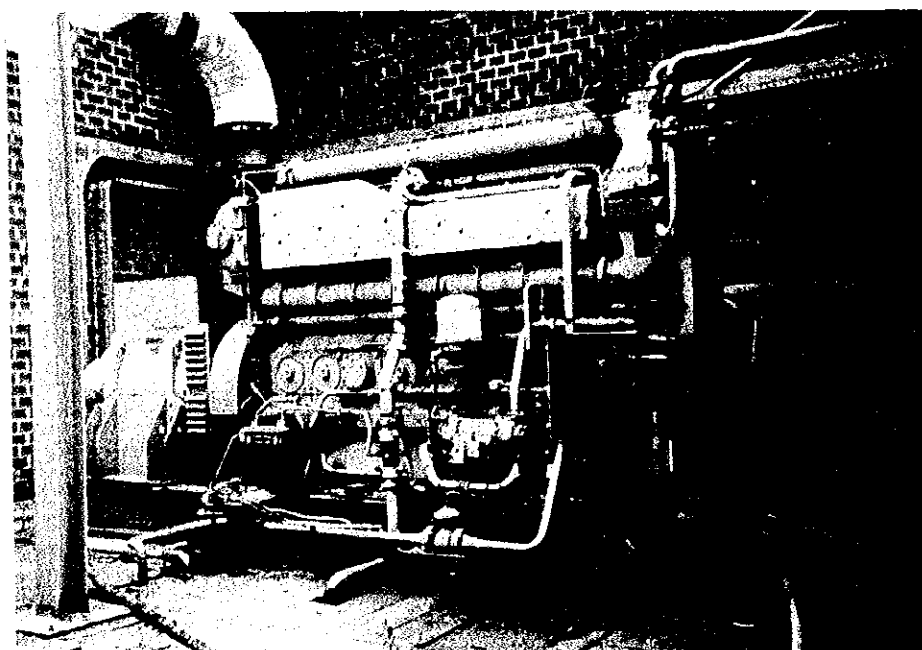
Due to the long stand-still condition and disastrous conservation since April 1992, these machines were found to be suffered extensive damages which make their replacement with new units safer and more cost effective than refurbishment.

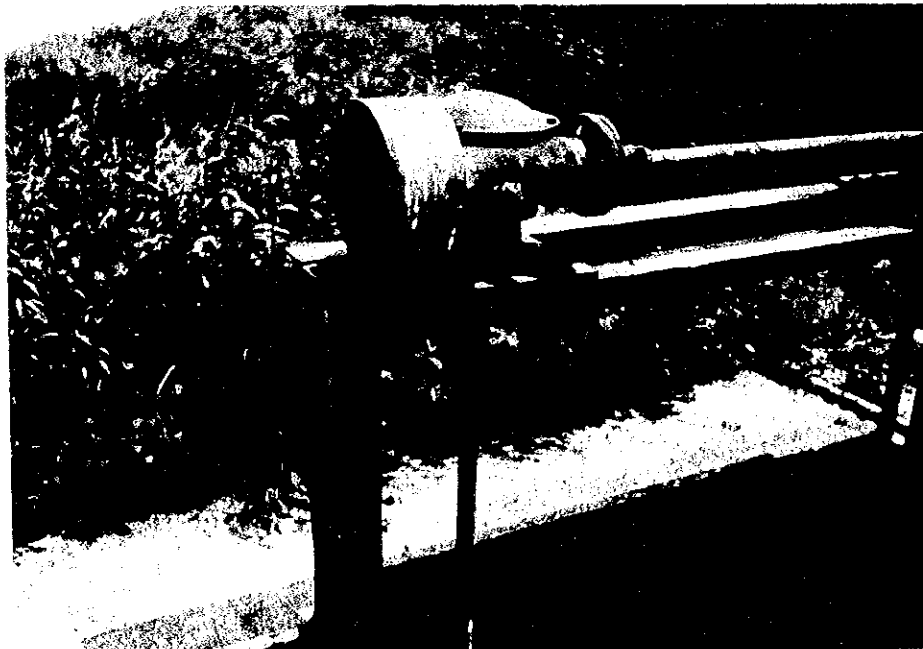
Photo No. 0-E2

Drive reducer

- Motor was removed and taken away.
- Cables were cut and taken away.

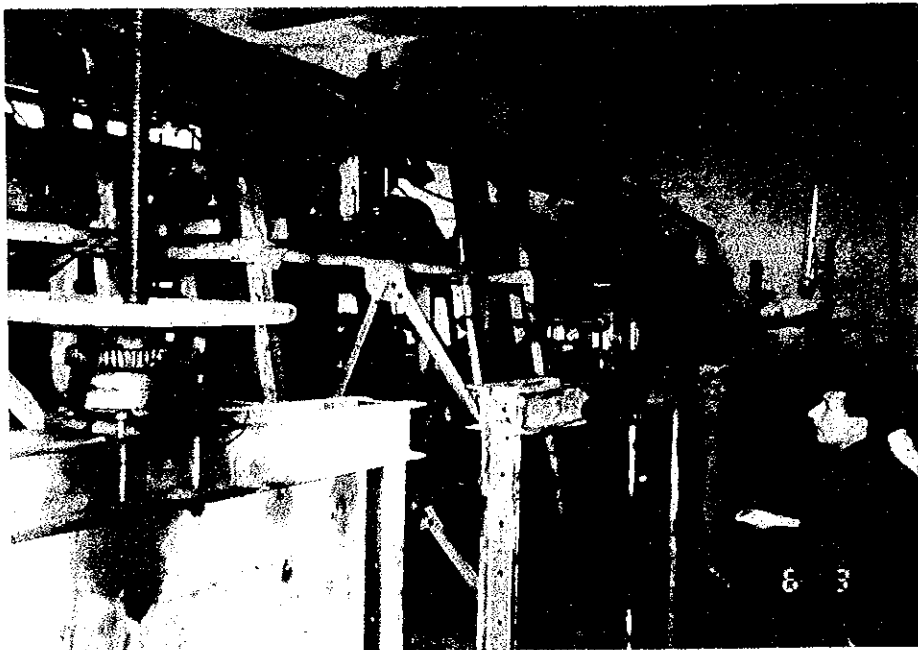
Photo No. 2-E2

- Motors were removed and taken away.
- Cables were cut and taken away.

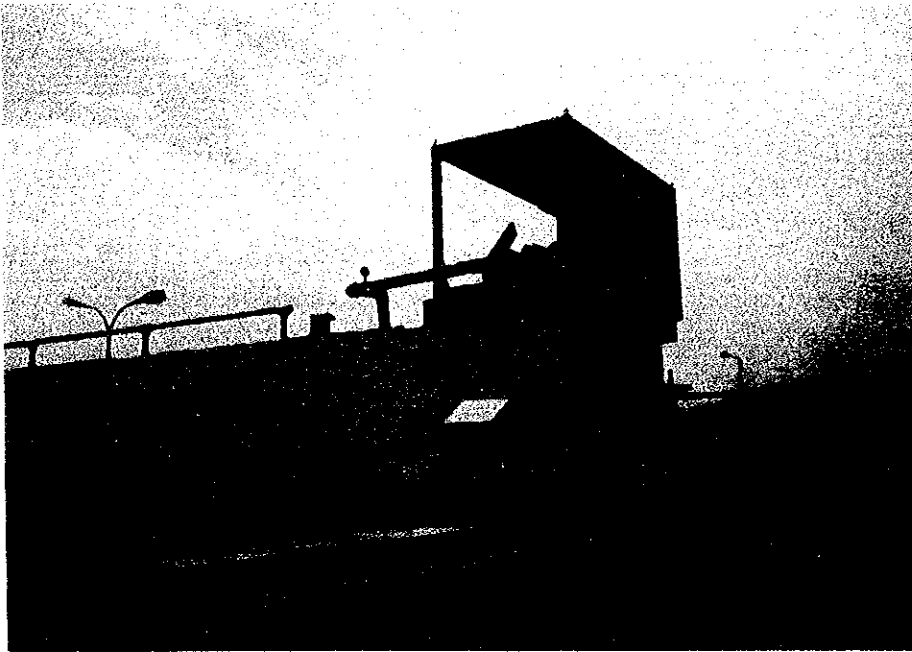
Photo No. 3-E1

- Motors were removed and taken away.
- Cables for all motors were cut and taken away.
