## INSPECTION SHEET

Equipment	Induction motor 256253~88, 1979	380V Manufacturer ;	37kW Electro Mechaniqu	4pole
Location	Aeration tank	Facilities	Aeration turbine

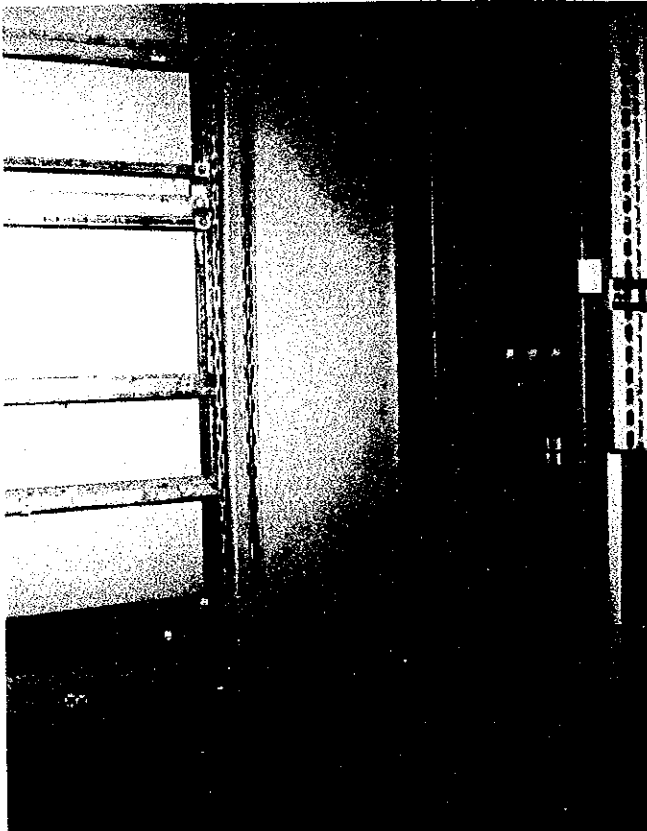
Photo No. 8-E2

-Main instruments/parts were removed and taken away.  
-All wiring and cables were cut and taken away.

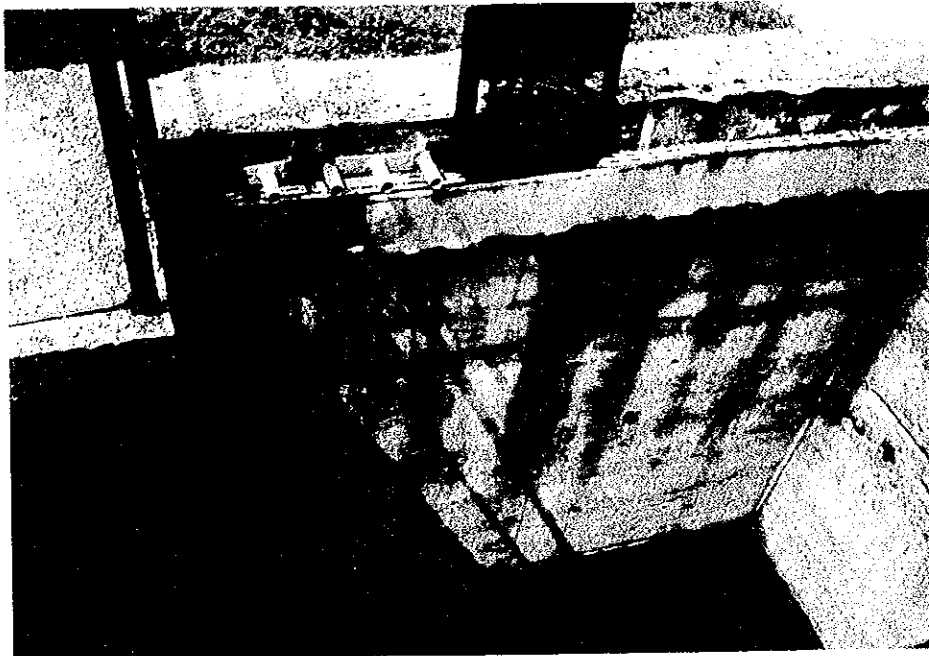
Photo No. 8-E4

- Measuring instrument was destroyed.
- Cables were cut and taken away.

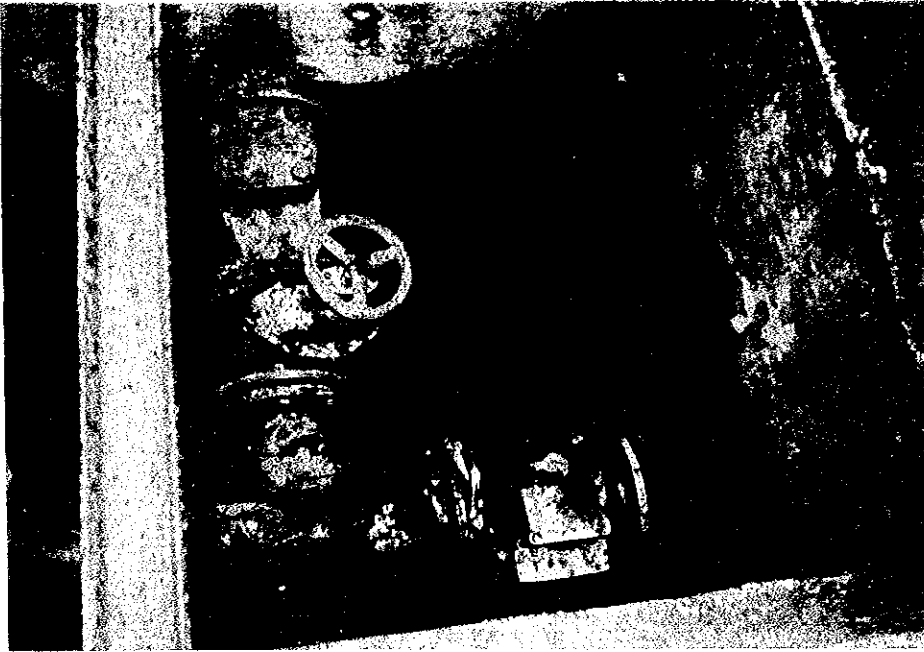
Photo No. 8-E5 | Flow detector for excess sludge

- This detector is corroded and broken.
- Cables were cut and taken away.

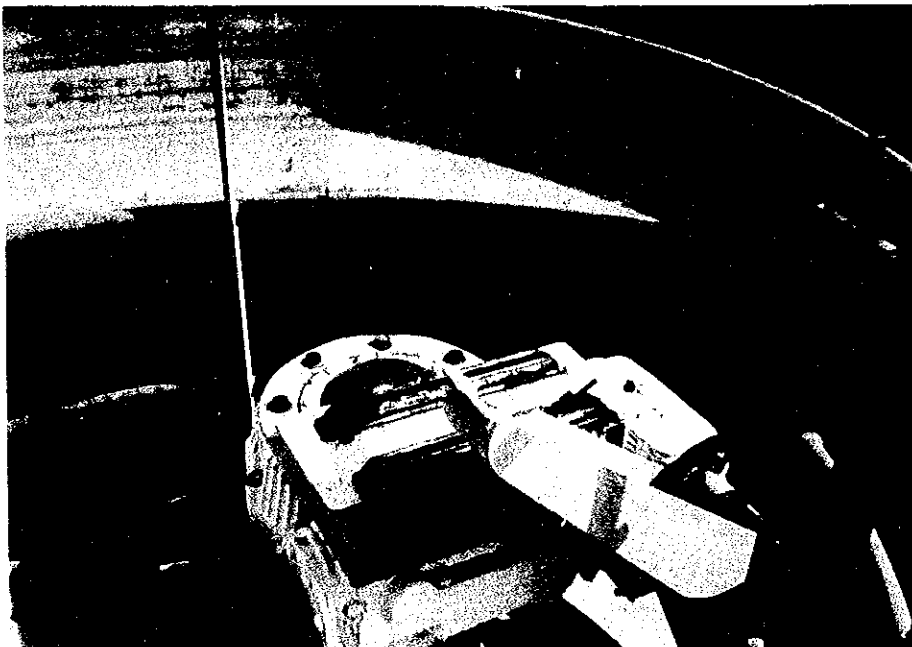
Photo No. 10--E2

- Motor was removed and taken away.
- Cables were cut and taken away.

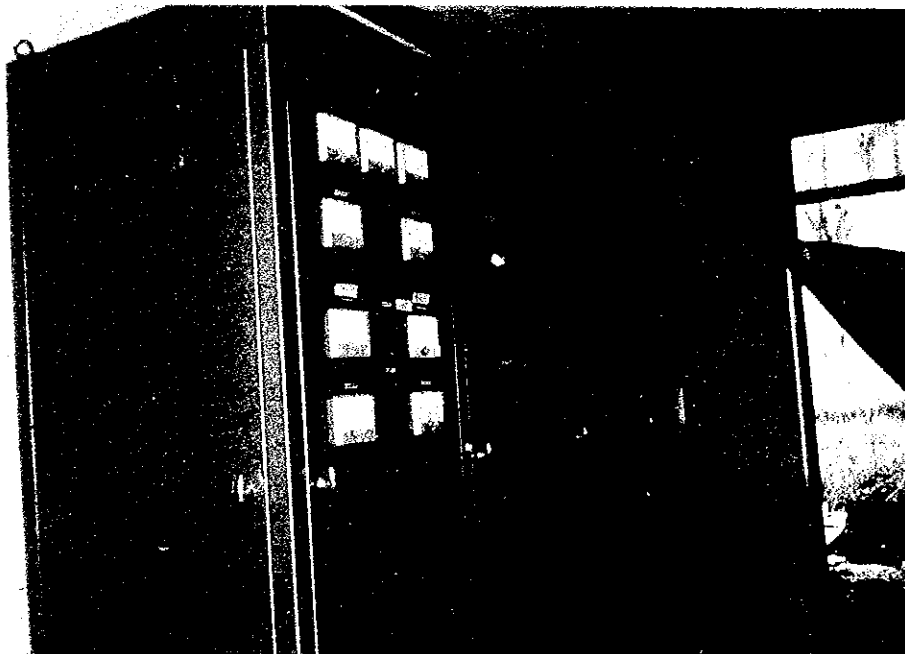
Photo No. 13-E1 | Out look of local control panel

-Stain and corrosion is progressing.

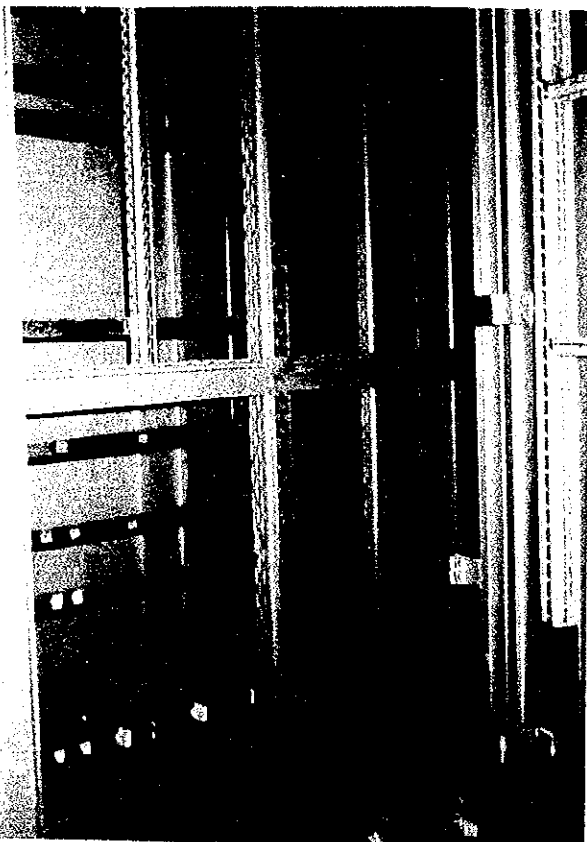
Photo No. 13-E2 | Inside of local control panel

-Main instruments/parts were removed and taken away.  
-All wiring and cables were cut and taken away.

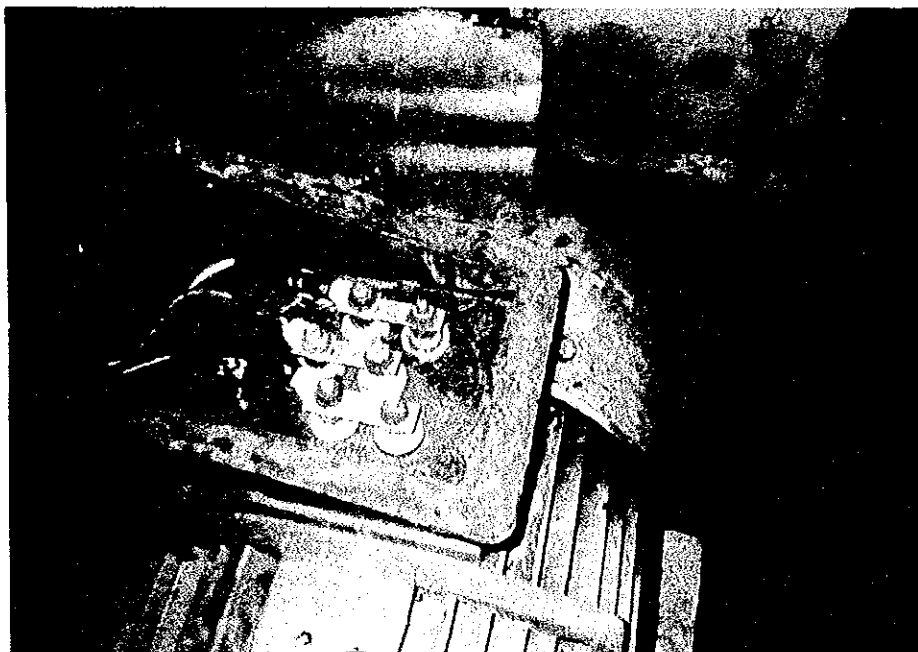
Photo No. 14-E4

(To loosen the terminal bolt is impossible due to corrosion.)

-Rust is much progressing in TERMINAL BOX, and TERMINAL BOLTS are corroded.

\*4 About 20 years passed from the time when this motor was supplied. It is considered that repair of casing and terminal box is difficult. So, renewal is recommendable.

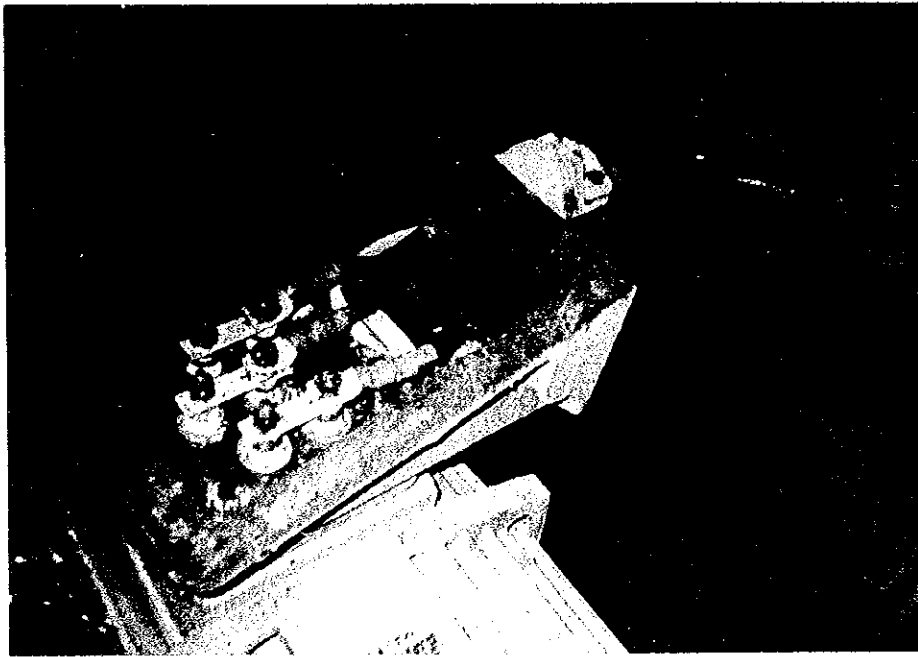
Photo No. 14-E5 | Inside of terminal box(37kW Motor)

-Rust is much progressing in TERMINAL BOX, and TERMINAL BOLTS are corroded.

It is considered that repair of casing and terminal box is difficult. So, renewal is recommendable.

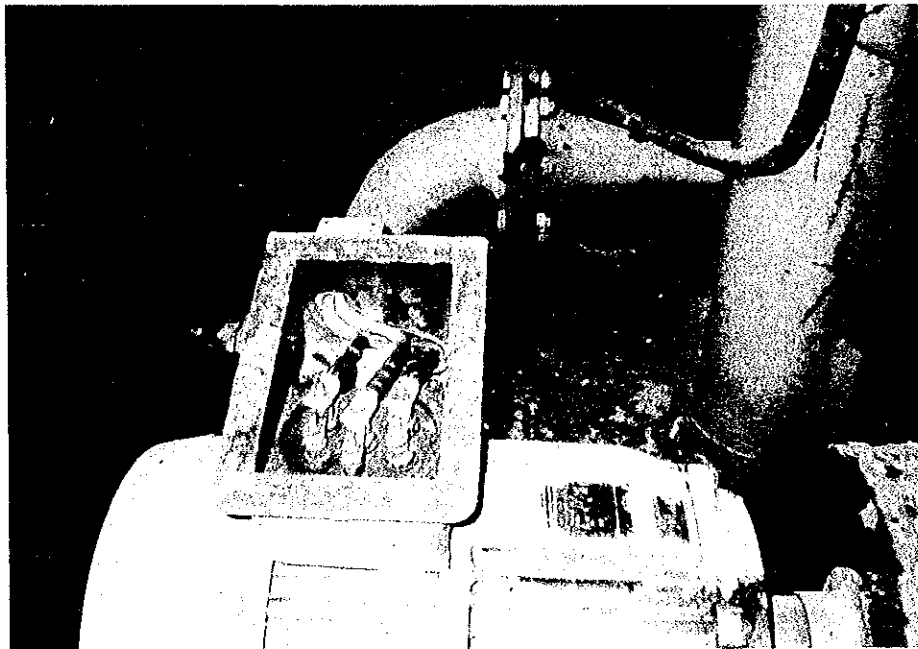
Photo No. 14-E6 | Inside of terminal box(30kW Motor)

-Rust is much progressing in TERMINAL BOX.

\*4 About 20 years passed from the time when this motor was supplied. It is considered that repair of casing and terminal box is difficult. So, renewal is recommendable.

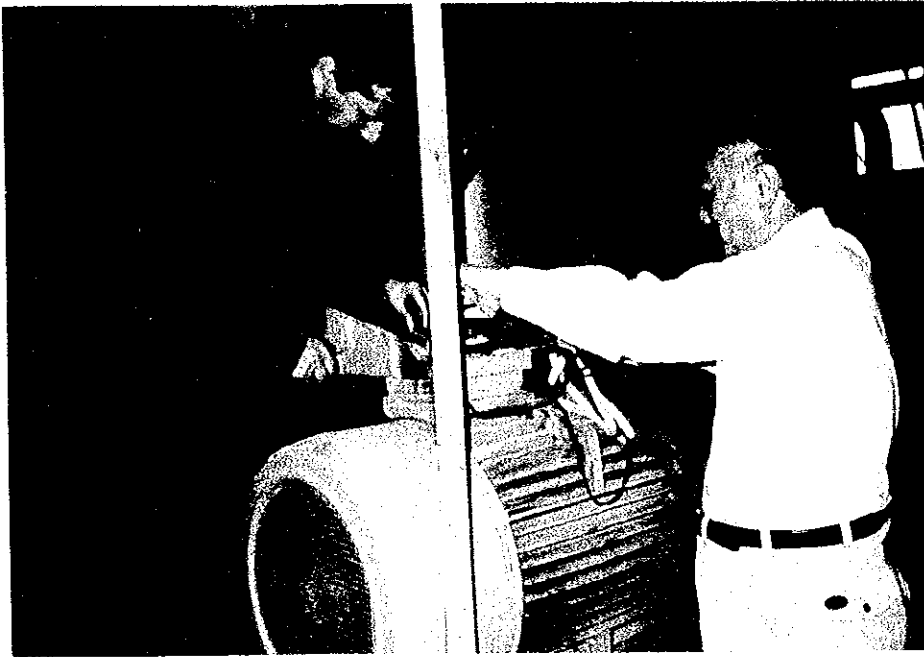
Photo No. 14-E7 | Insuration resistance measuring

-The insulation resistance is reducing for many motors.

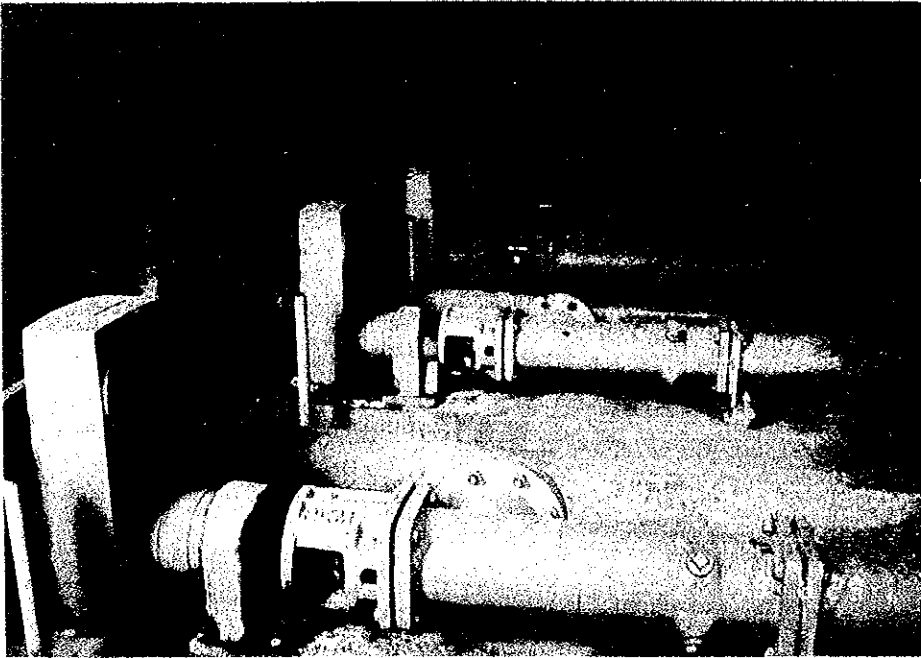
Photo No. 17-E1 | Sludge pump

- Motors were removed and taken away.
- Cables were cut and taken away.

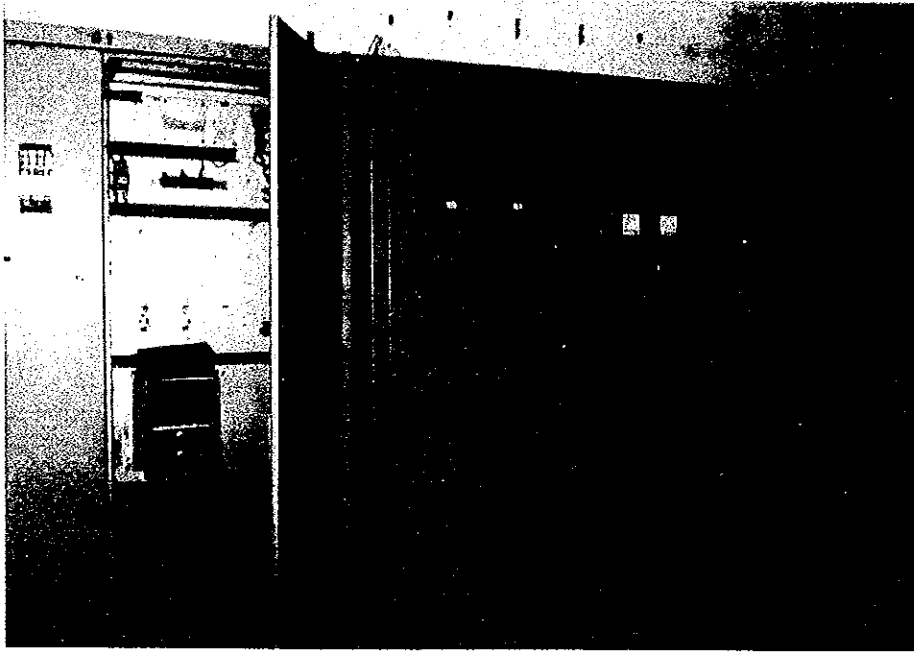
Photo No. 18-E1 | Out lookof local control panel

- Stain and corrosion is progressing.
- Main instruments/parts were removed and taken away.
- All wiring and cables were cut and taken away.

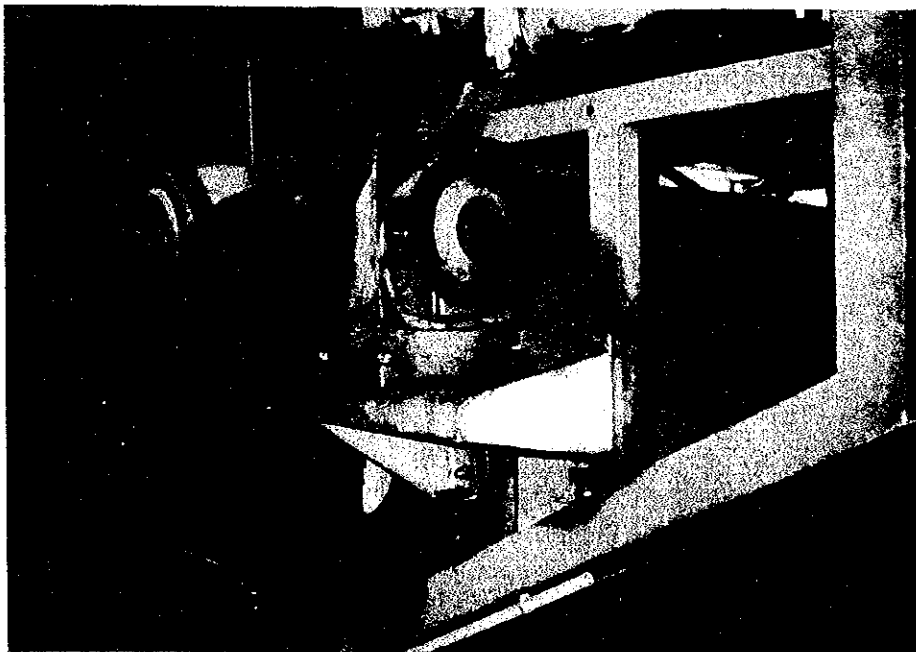
Photo No. 18-E4 | Dehydrater

- Motor was removed and taken away.
- Cables were cut and taken away.

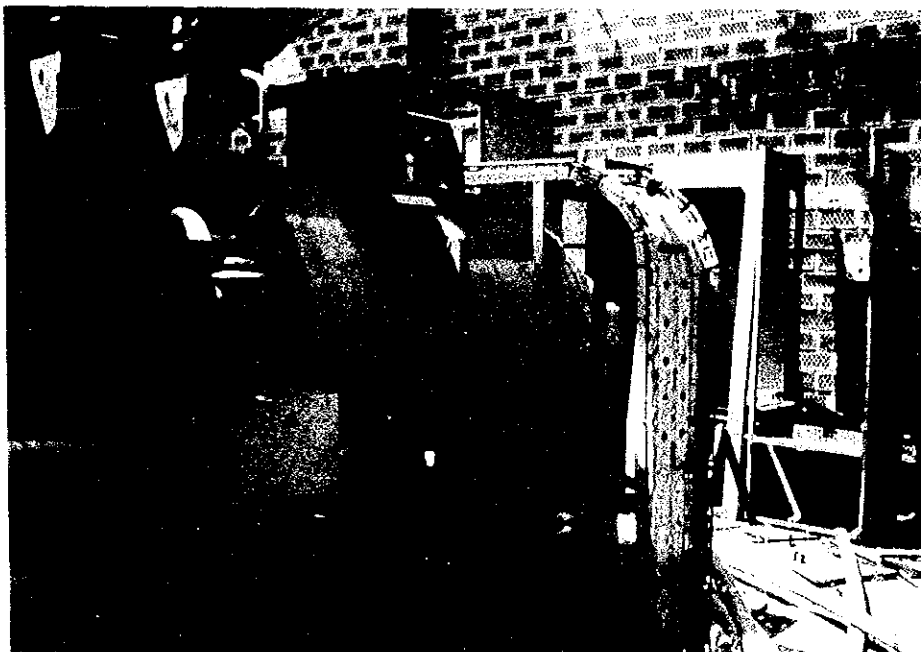
Photo No. 20-E2

-Cables were cut and taken away.

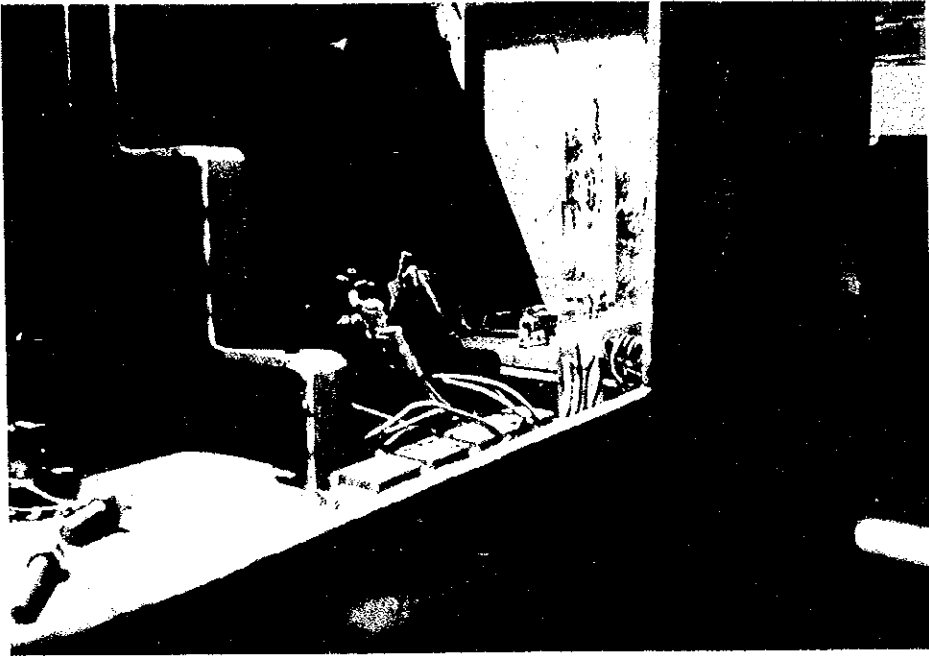
Photo No. 20-E3

- These units of both generators were destroyed.
- Main instruments/parts were removed and taken away.
- All wiring was cut and taken away.

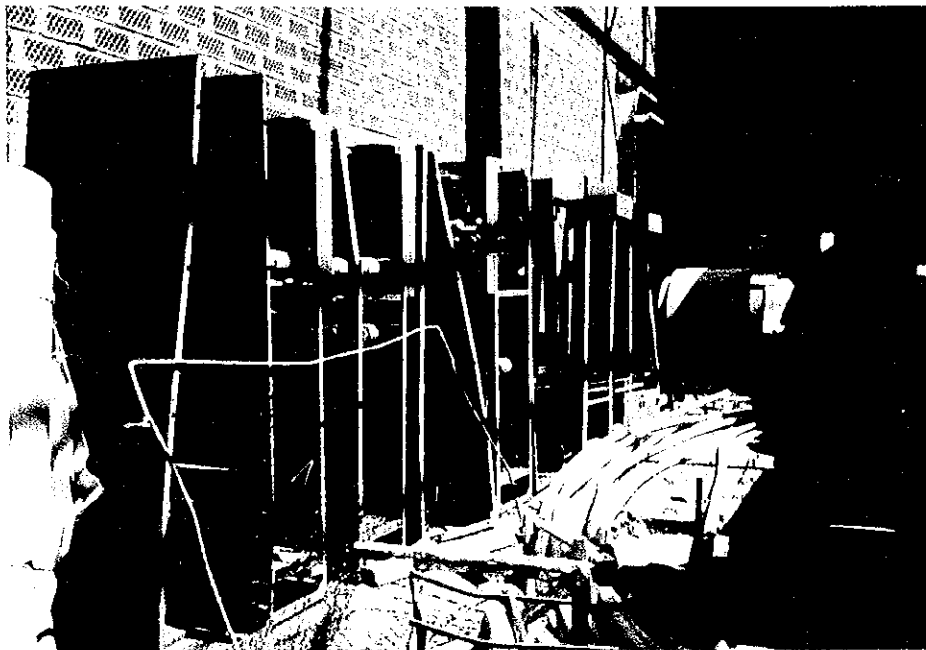
Photo No. 20-E4

- Metal enclosed panels were broken.
- Main instruments/parts were removed and taken away.
- All wiring and cables were cut and taken away.

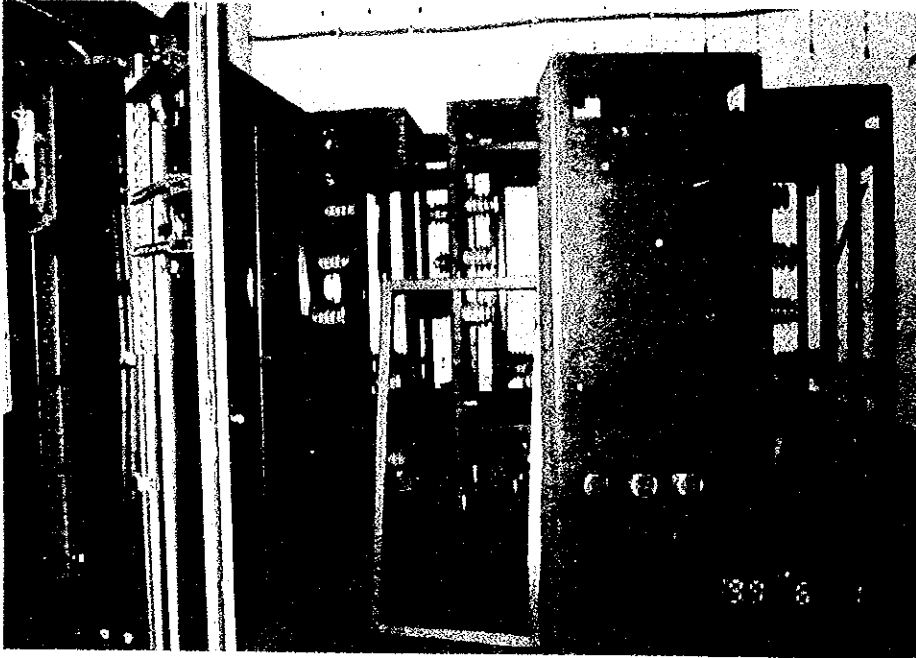
Photo No. 20-E5 | HT switchgear and Local control panel

- Metal enclosed panels were broken.
- Main instruments/parts were removed and taken away.
- All wiring and cables were cut and taken away.

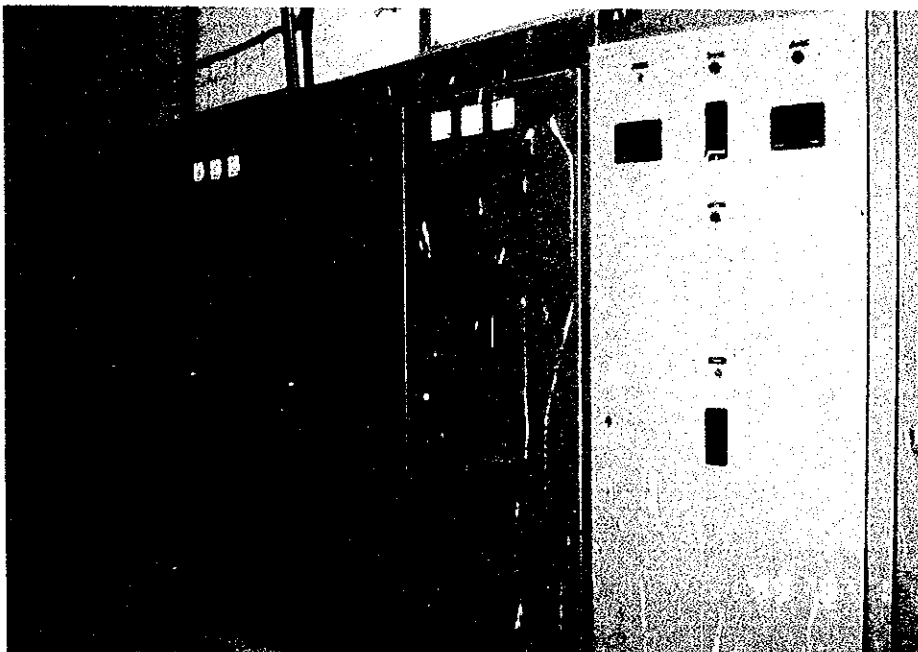
Photo No. 20-E6 | LT power distribution/motot control panel

- Stain and corrosion is progressing.
- Main instruments/parts were removed and taken away.
- All wiring and cables were cut and taken away.

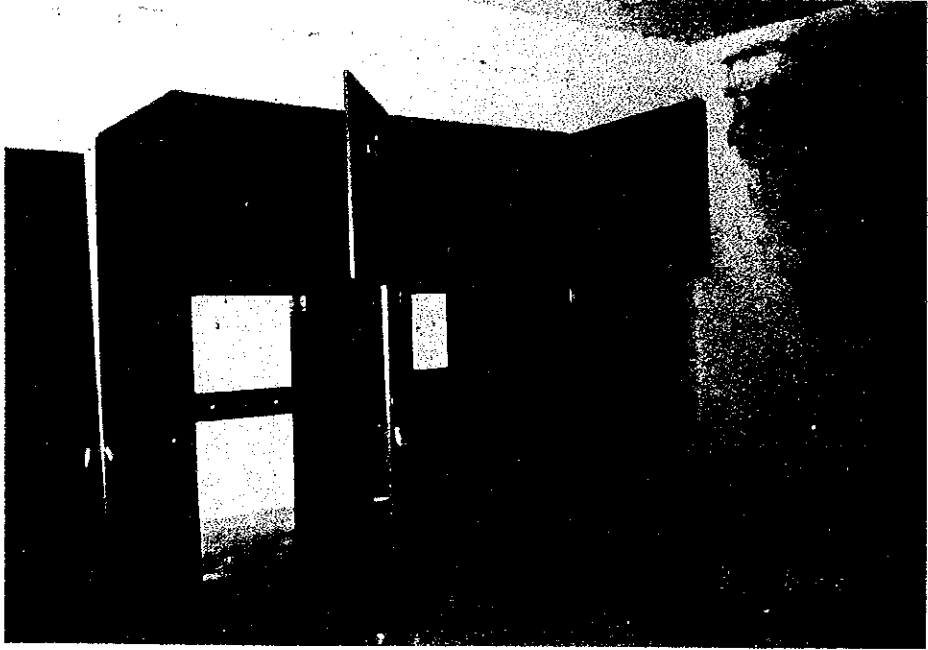
Location ; Substation	
Photo No. 21-E1	HT switch gear

<ul style="list-style-type: none"> <li>-Metal enclosed panels were broken.</li> <li>-Main instruments/parts were removed and taken away.</li> <li>-All wiring and cables were cut and taken away.</li> </ul>

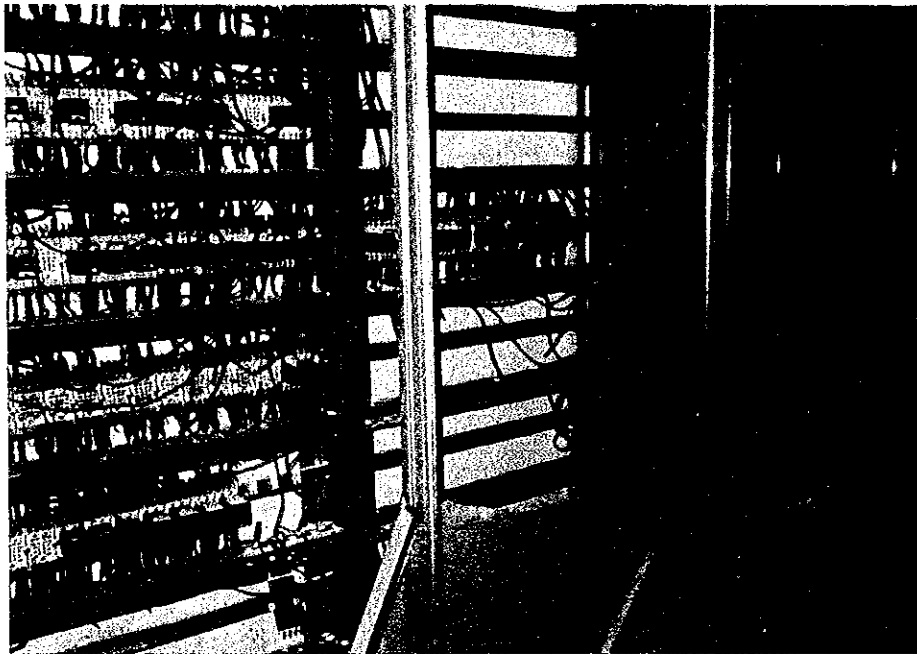
Photo No. 23-E3

- Main instruments/parts were removed and taken away.
- All wiring and cables were cut and taken away.

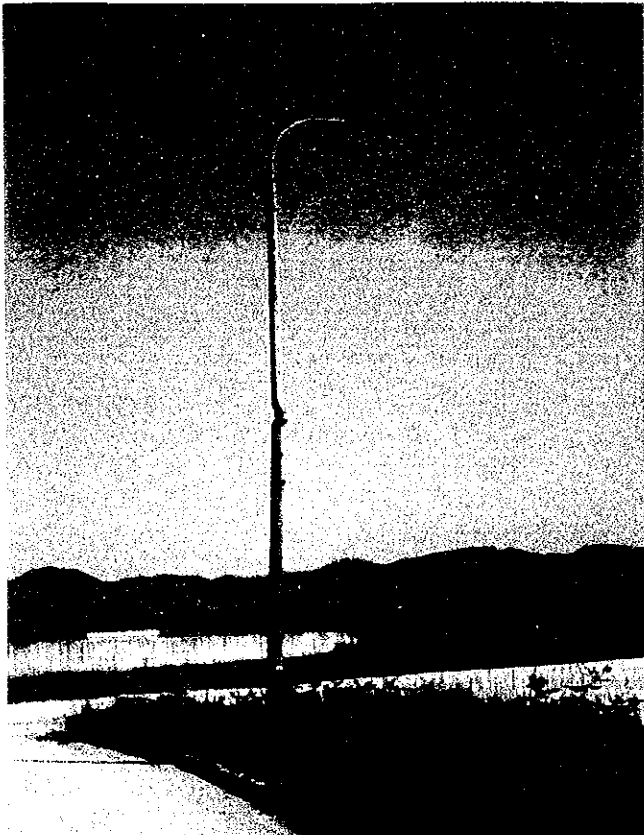
Photo No. 26-E2

-Some fixtures and poles are damaged.  
-Stain and rust are yielded on all poles.
