**THE FEASIBILITY STUDY  
ON  
THE WASTEWATER TREATMENT PLANT  
OF  
SARAJEVO CITY  
IN  
BOSNIA AND HERZEGOVINA**

**FINAL REPORT**

**VOLUME IV : APPENDIX**

**APPENDIX A. PHOTOGRAPHS OF ASSESSMENT OF THE SITE**

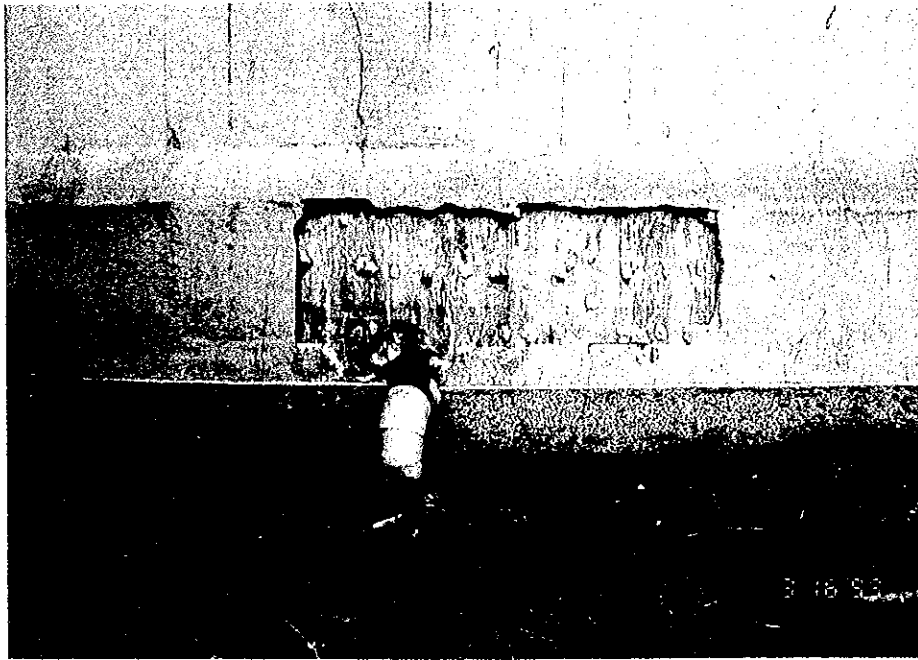
**Deteriorated Insulation Wall at Digestion Tank**

12. Sludge digester	Civil engineering work	External wall heat insulation mortar is peeling of certain section and the reinforcing steel is partially exposed. The roof waterproofing mortar is severely damaged and the safety shelf is partially collapsing.	Detailed inspection on all aspects needs to be performed.
	Construction work	The exterior wall of the stairwell is partially damaged and almost all window panes are destroyed. There are no window glasses. The condition of the interior walls is not good.	As above
	Mechanical work	All mechanical facilities such as humidifier, receiving equipment and removal equipment are inoperable. Moreover, all piping is believed to be blocked.	A detailed inspection needs to be performed.

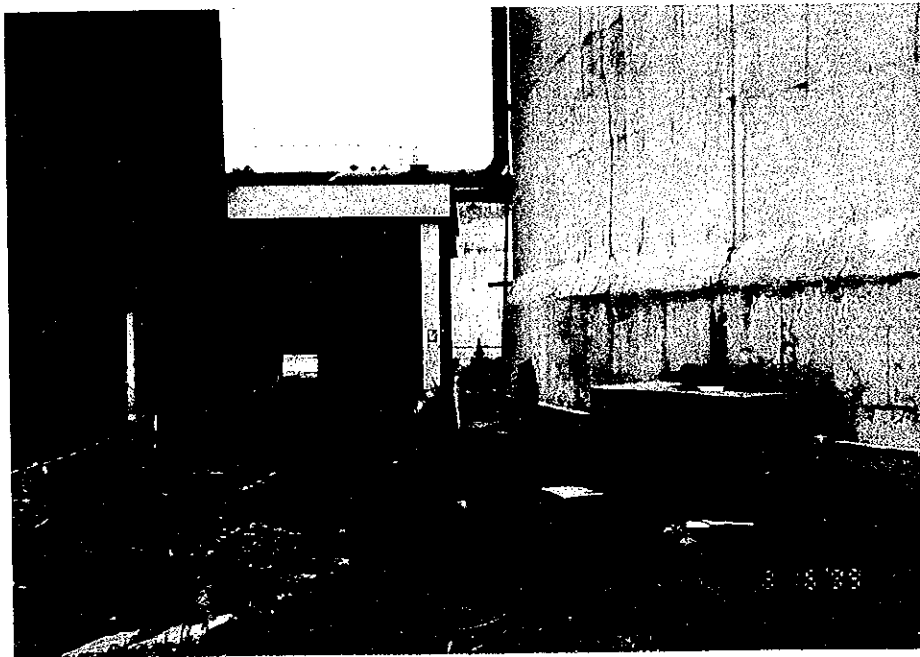
**Current Situation of Mechanical Piping at Digestion Tank**

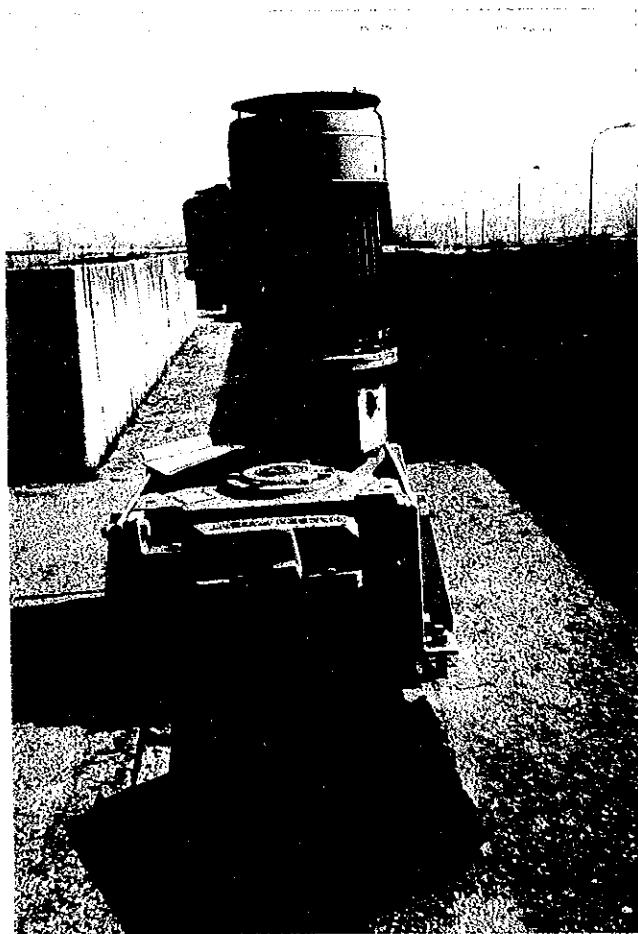
**Deteriorated Slab at Aeration Tank**

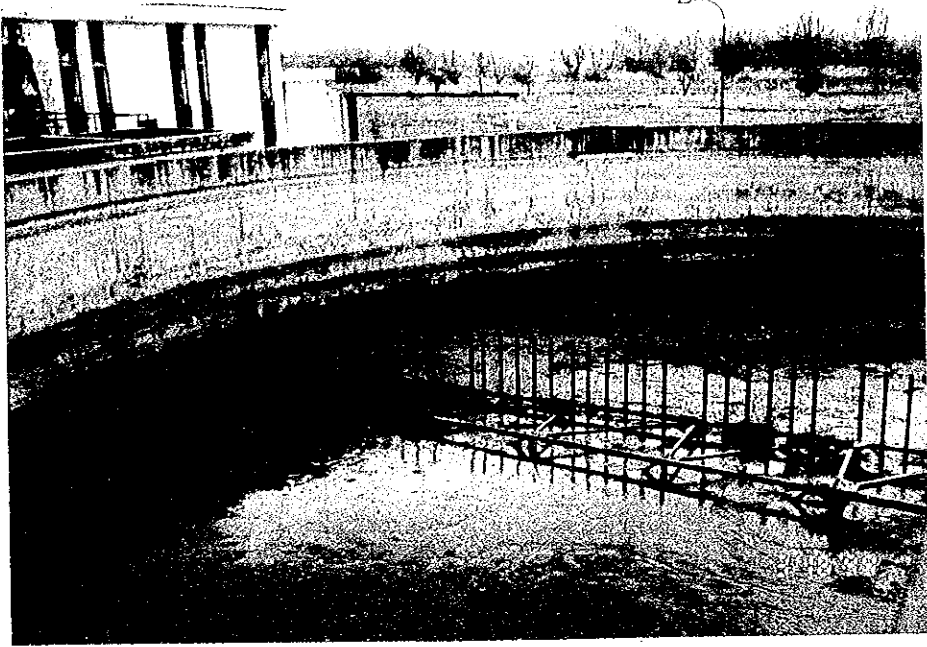
**Accumulation of Digested Sludge in Sludge Holding Tank**

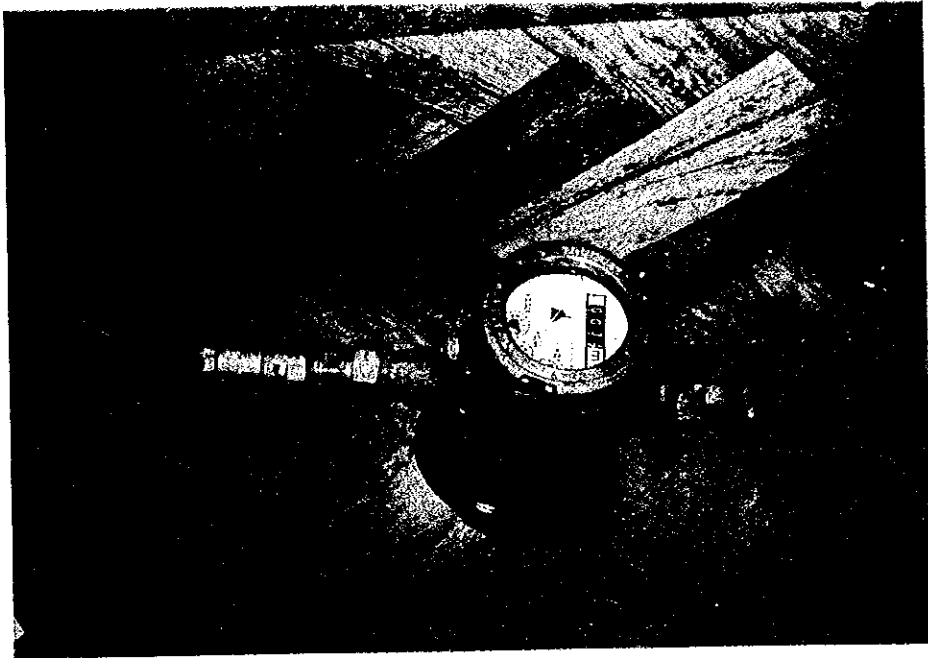
**Damaged Water Meter at Kiosk in Bistrik Area**

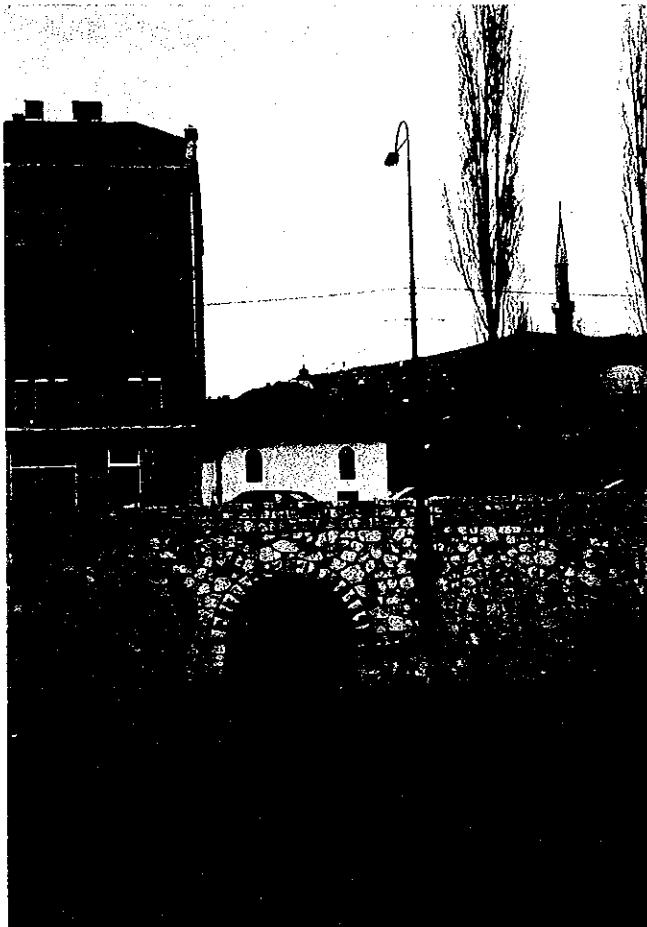
**Discharged Point of Raw Sewage**
