CHAPTER 7 EXISTING ROAD CONDITIONS

7.2.1 Road Inventory Survey

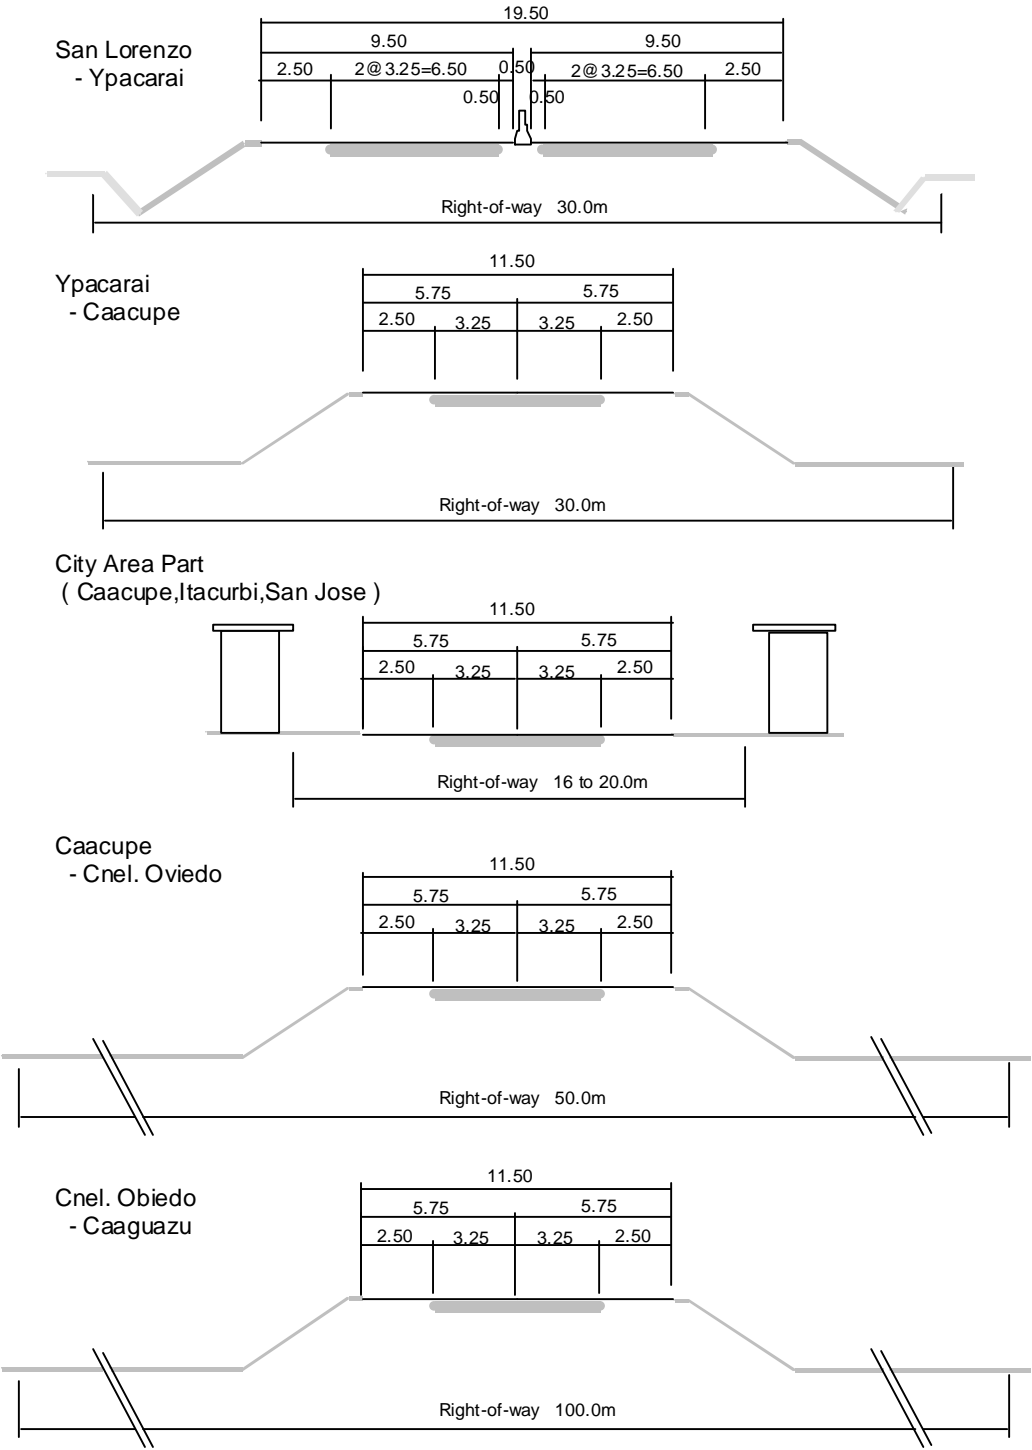
Figure 7.3.1 Existing Cross Section

The surface condition from San Lorenzo to Ypacarai is comparatively good with a 4 lane divided road, the road surface condition from Ypacarai to Caaguazu is almost satisfactory with 2 lanes. The lane width from San Lorenzo to Caaguazu is 3.25m. The lane width required for a principal road is 3.65m. The vehicles are running at a speed exceeding 80km/h on the road. There is the risk that small driving errors result in going off the driveway. For this reason, traffic safety on the road is low.

The existing cross-section from San Lorenzo to Caaguazu is shown below.
