EXISTING WATER SUPPLY SYSTEM

**THE STUDY ON WATER SUPPLY SYSTEM
FOR SIEM REAP REGION IN CAMBODIA**

**FINAL REPORT
Vol. III SUPPORTING REPORT**

ANNEX 4.4.1 EXISTING WATER SUPPLY SYSTEM

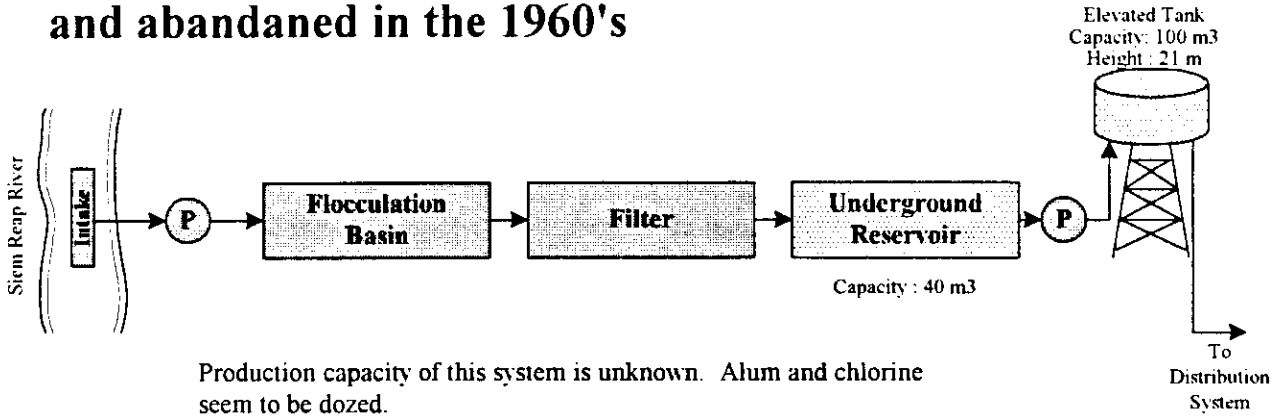
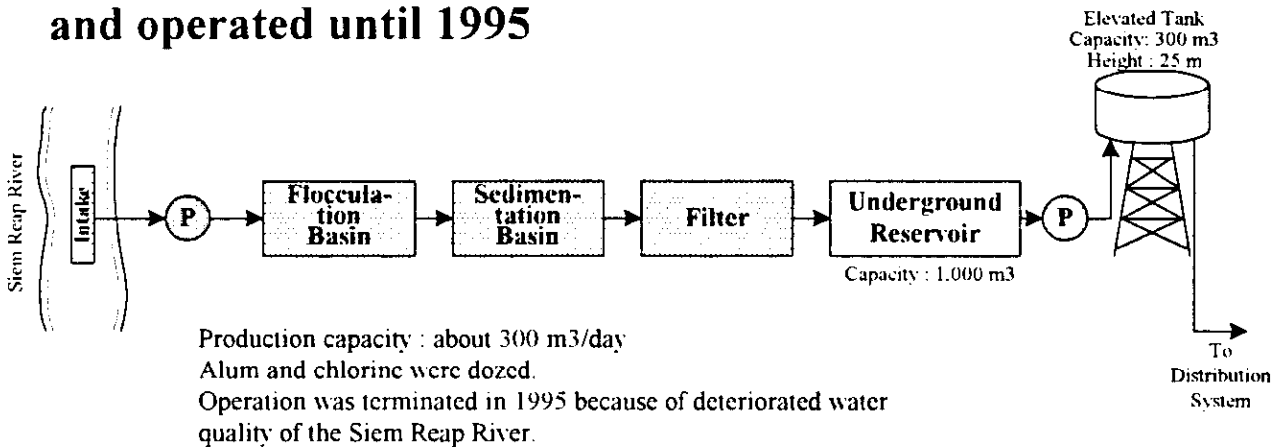
Figure 2.1
Schematic Flow of Treatment System
(Old French System and
Old American System)

All structures except the underground reservoir and the elevated tank were demolished when the Old American System was constructed, therefore details of each facility can not be investigated. The reservoir and the elevated tank still exist but they are not used now.

Concrete structures of flocculation, sedimentation and filtration basins still exist but surface of concrete has been eroded and they can not be used anymore.

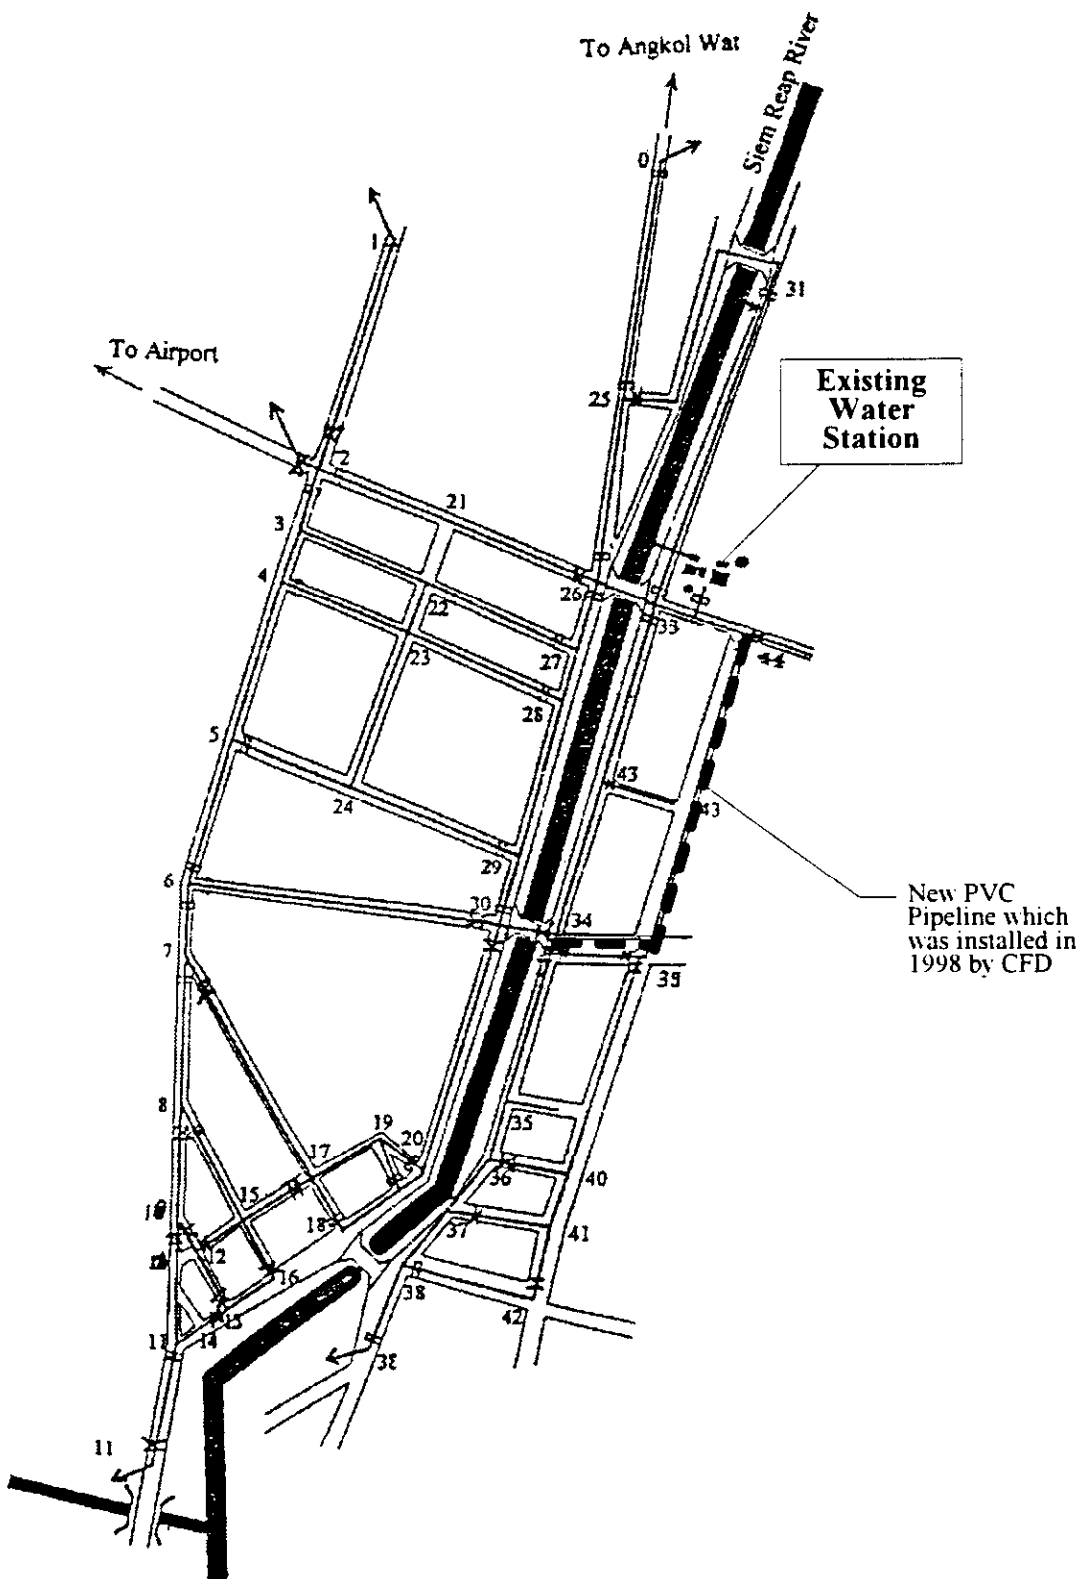
Figure 3.1
Existing Distribution Network

Range of diameter was 100 mm to 250 mm and the material of the distribution pipeline was ACP. Alignment of the distribution network is shown on Figure 3.1.

When the New French System was constructed, CFD checked all distribution network pipeline, and in the case they found broken pipe, they repaired the pipe. There was no expansion works except one pipe additionally installed which is shown on Figure 3.1.

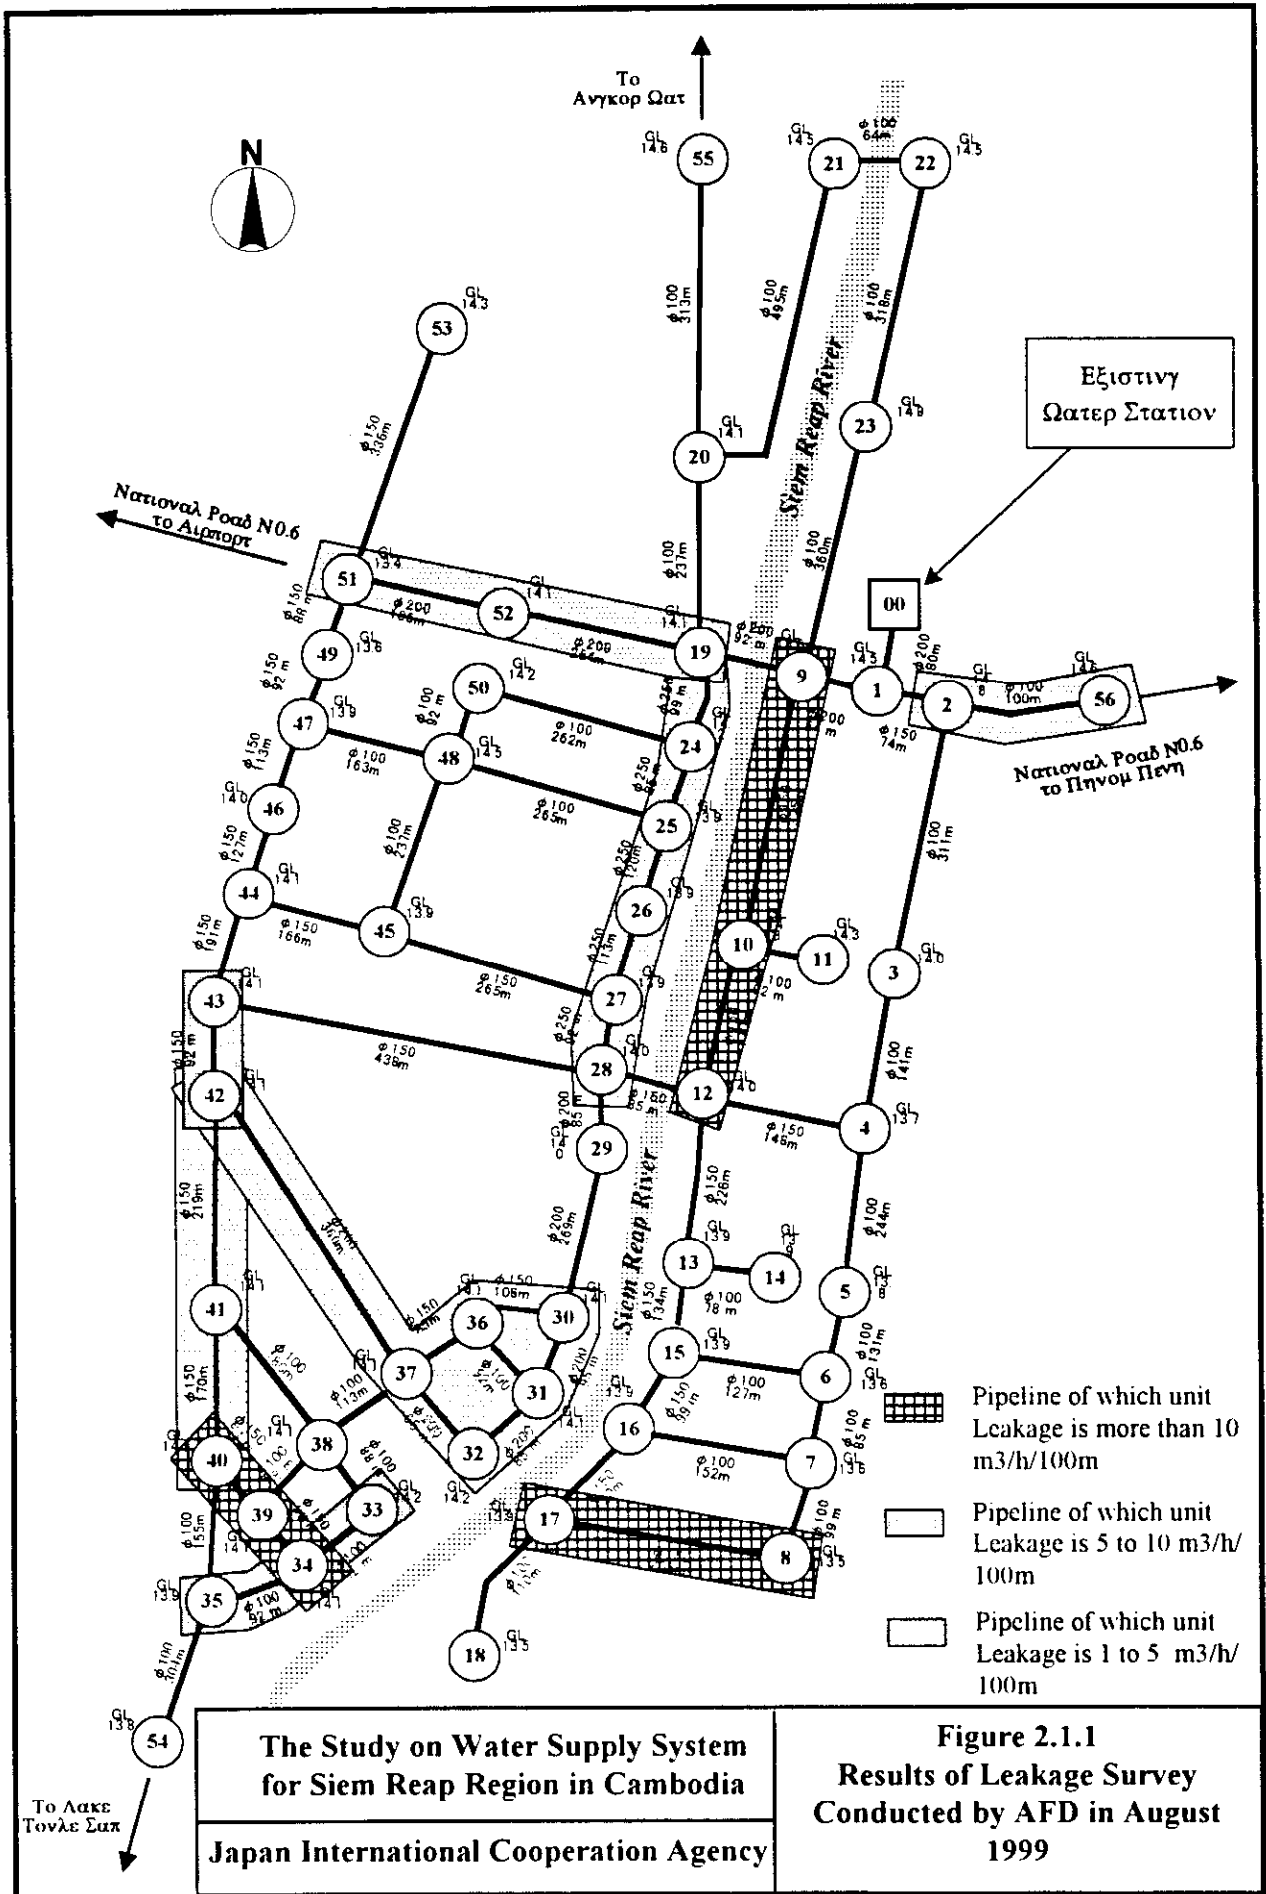
Table 2.1.1 shows the results of the AFD leakage survey. The lower table is sorted by the unit leak amount, m³/hour/100m pipe length. These results are also shown on Figure 2.1.1. This figure shows the pipelines which has high unit leakage in three different level such as pipeline of which unit leakage is more than 10 m³/hr/100m, 5 to 10 m³/hr/100m and 1 to 5 m³/hr/100m.

According to the figure, high leak pipelines exist in southern part of town and along the major roads, National Road No. 6 and trunk road along the Siem Reap River.

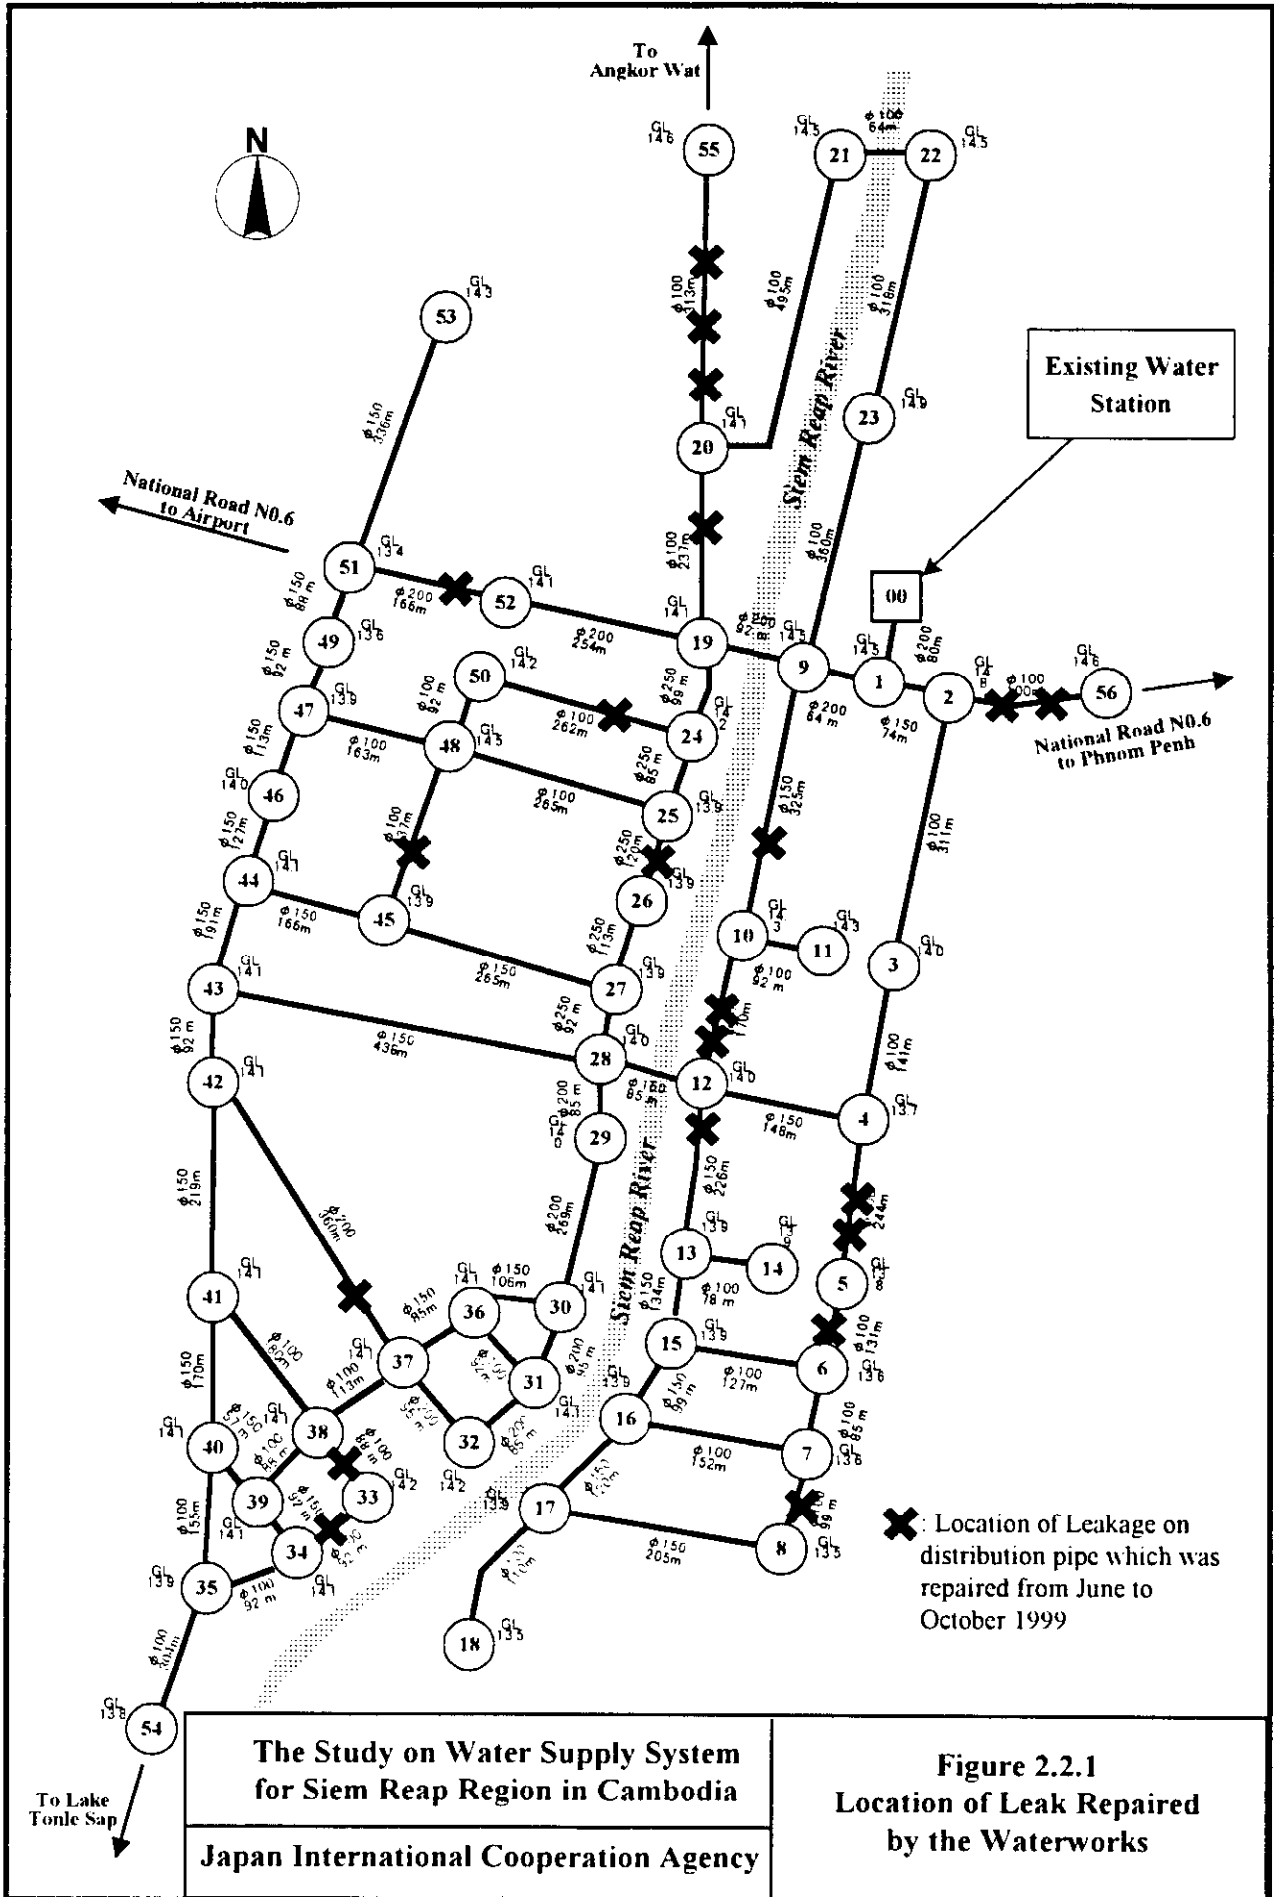
Number of location of leak repair on the distribution pipelines, excluding leakage on house connections, reached 21 as of October 20, 1999. Locations of these leak repairs are shown on Figure 2.2.1.

As shown on the figure, many leakage points are found on pipe Node No. 19 to 55, No. 10 to 13, and No. 4 to 8.

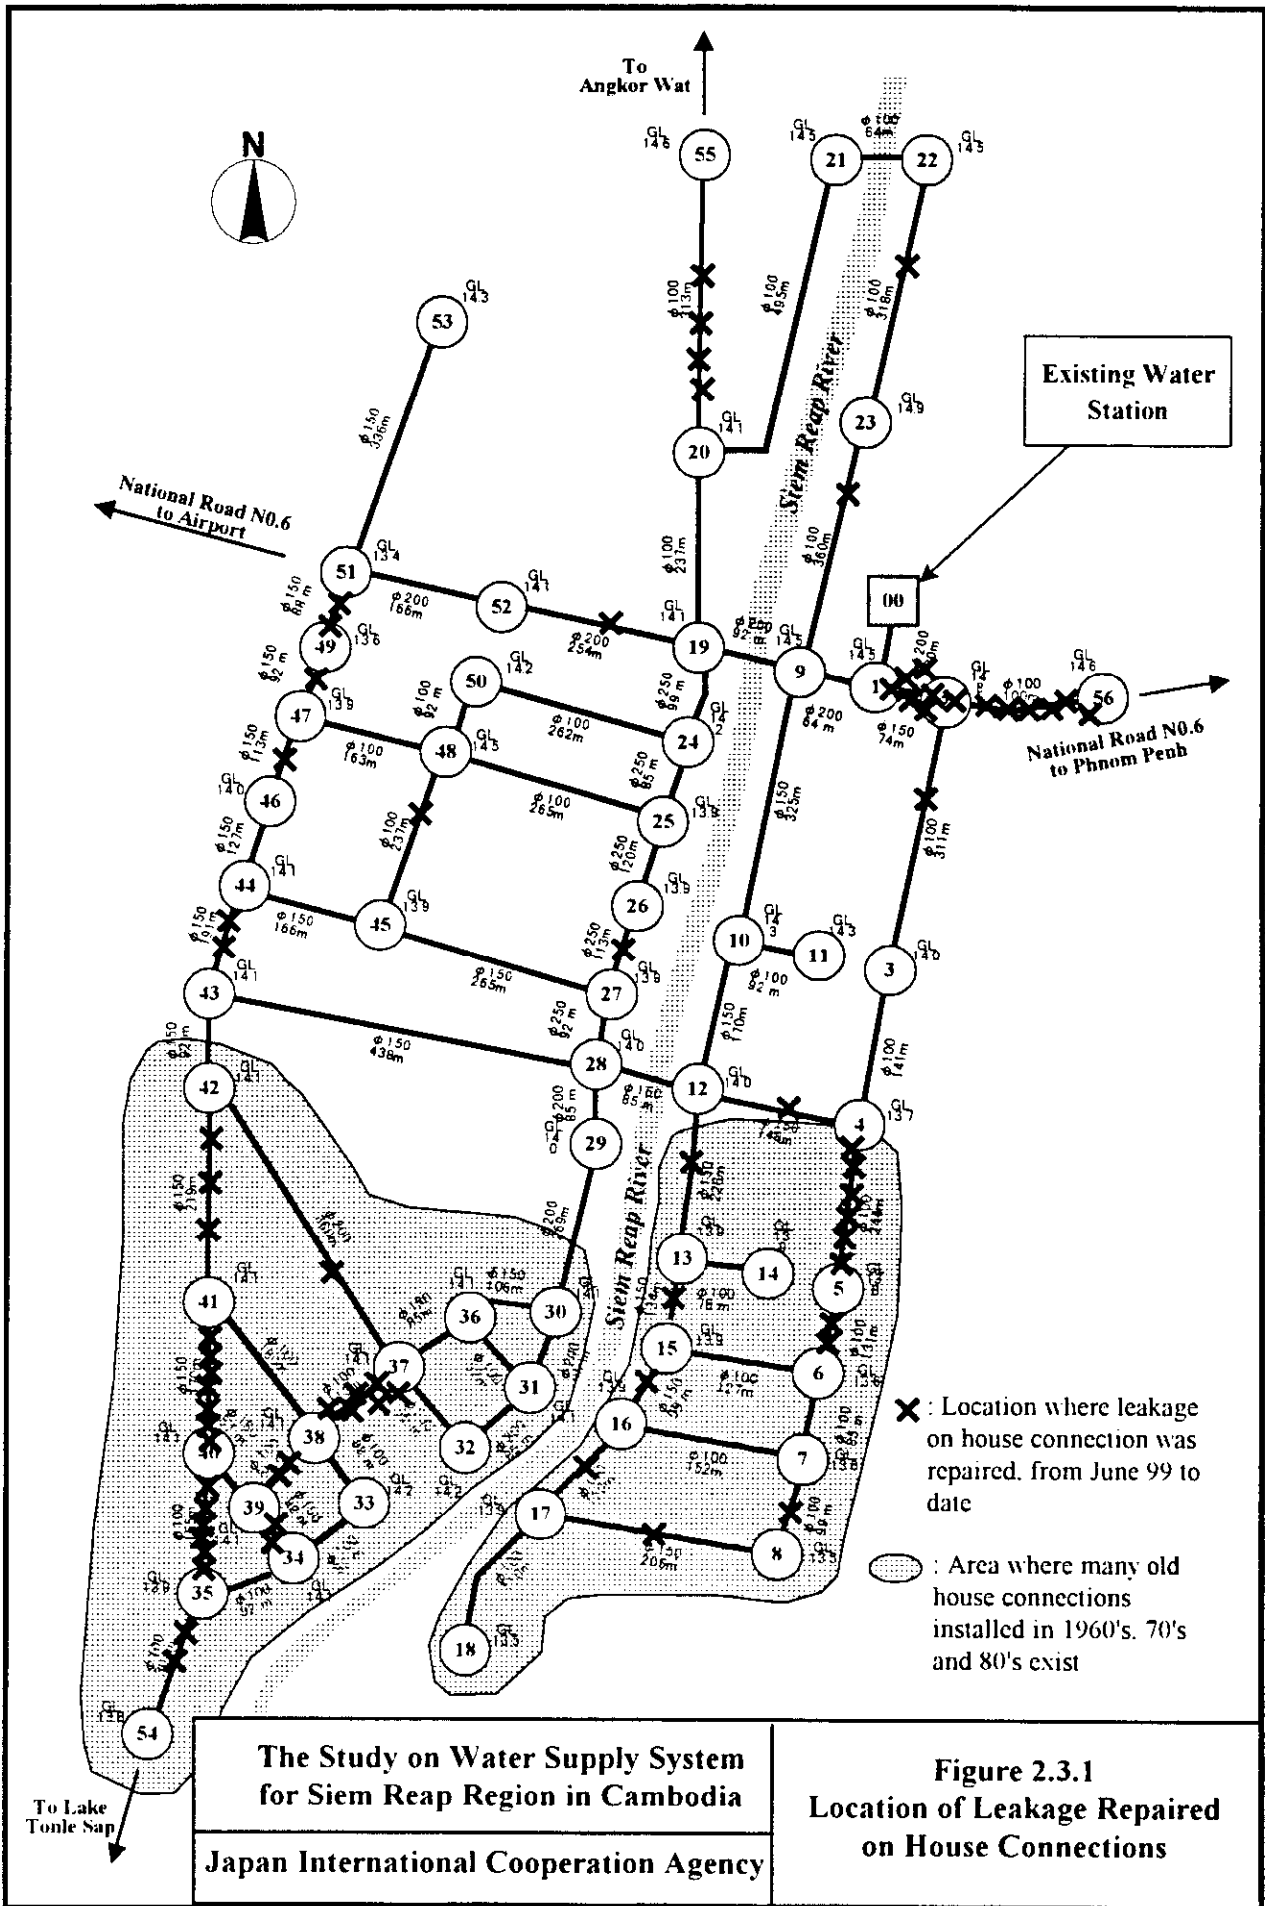
Figure 2.3.1
Location of Leakage Repaired
on House Connections

From June 1999 to October 1999, the Waterworks repaired leakage found on house connections and total number of repair reached about 100 locations. Locations of repaired house connections are shown on Figure 2.3.1. Although the leakage on house connection will not represent the grade of deterioration of a distribution pipeline, repair works of house connection will sometime cause future leakage. For instance, the Waterworks should replace old saddle of the house connection because of leakage and make new drilling on the distribution pipe for a new saddle; old drilled hole will be plugged by bolt. Old drilled hole had been used for long time and the shape of the hole is not accurately circular anymore, therefore, plugging the old hole to complete watertight is very difficult.

Such old house connections are found in southern area of the town as shown on Figure 2.3.1.

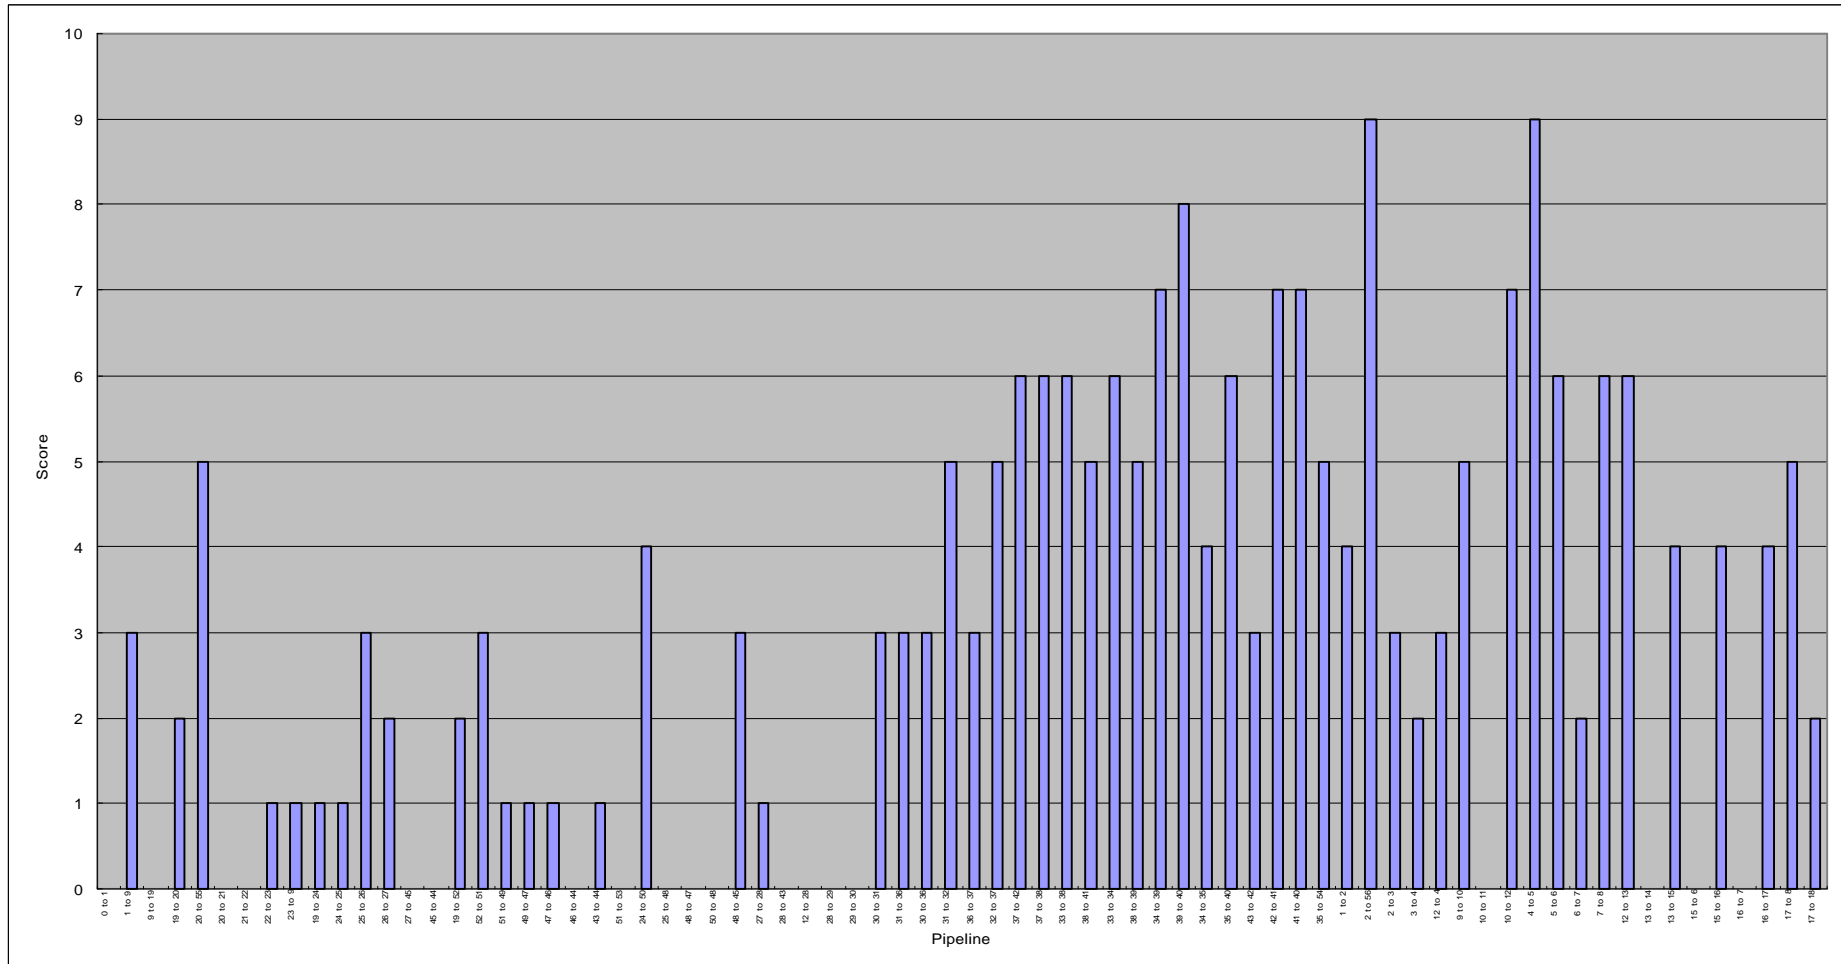
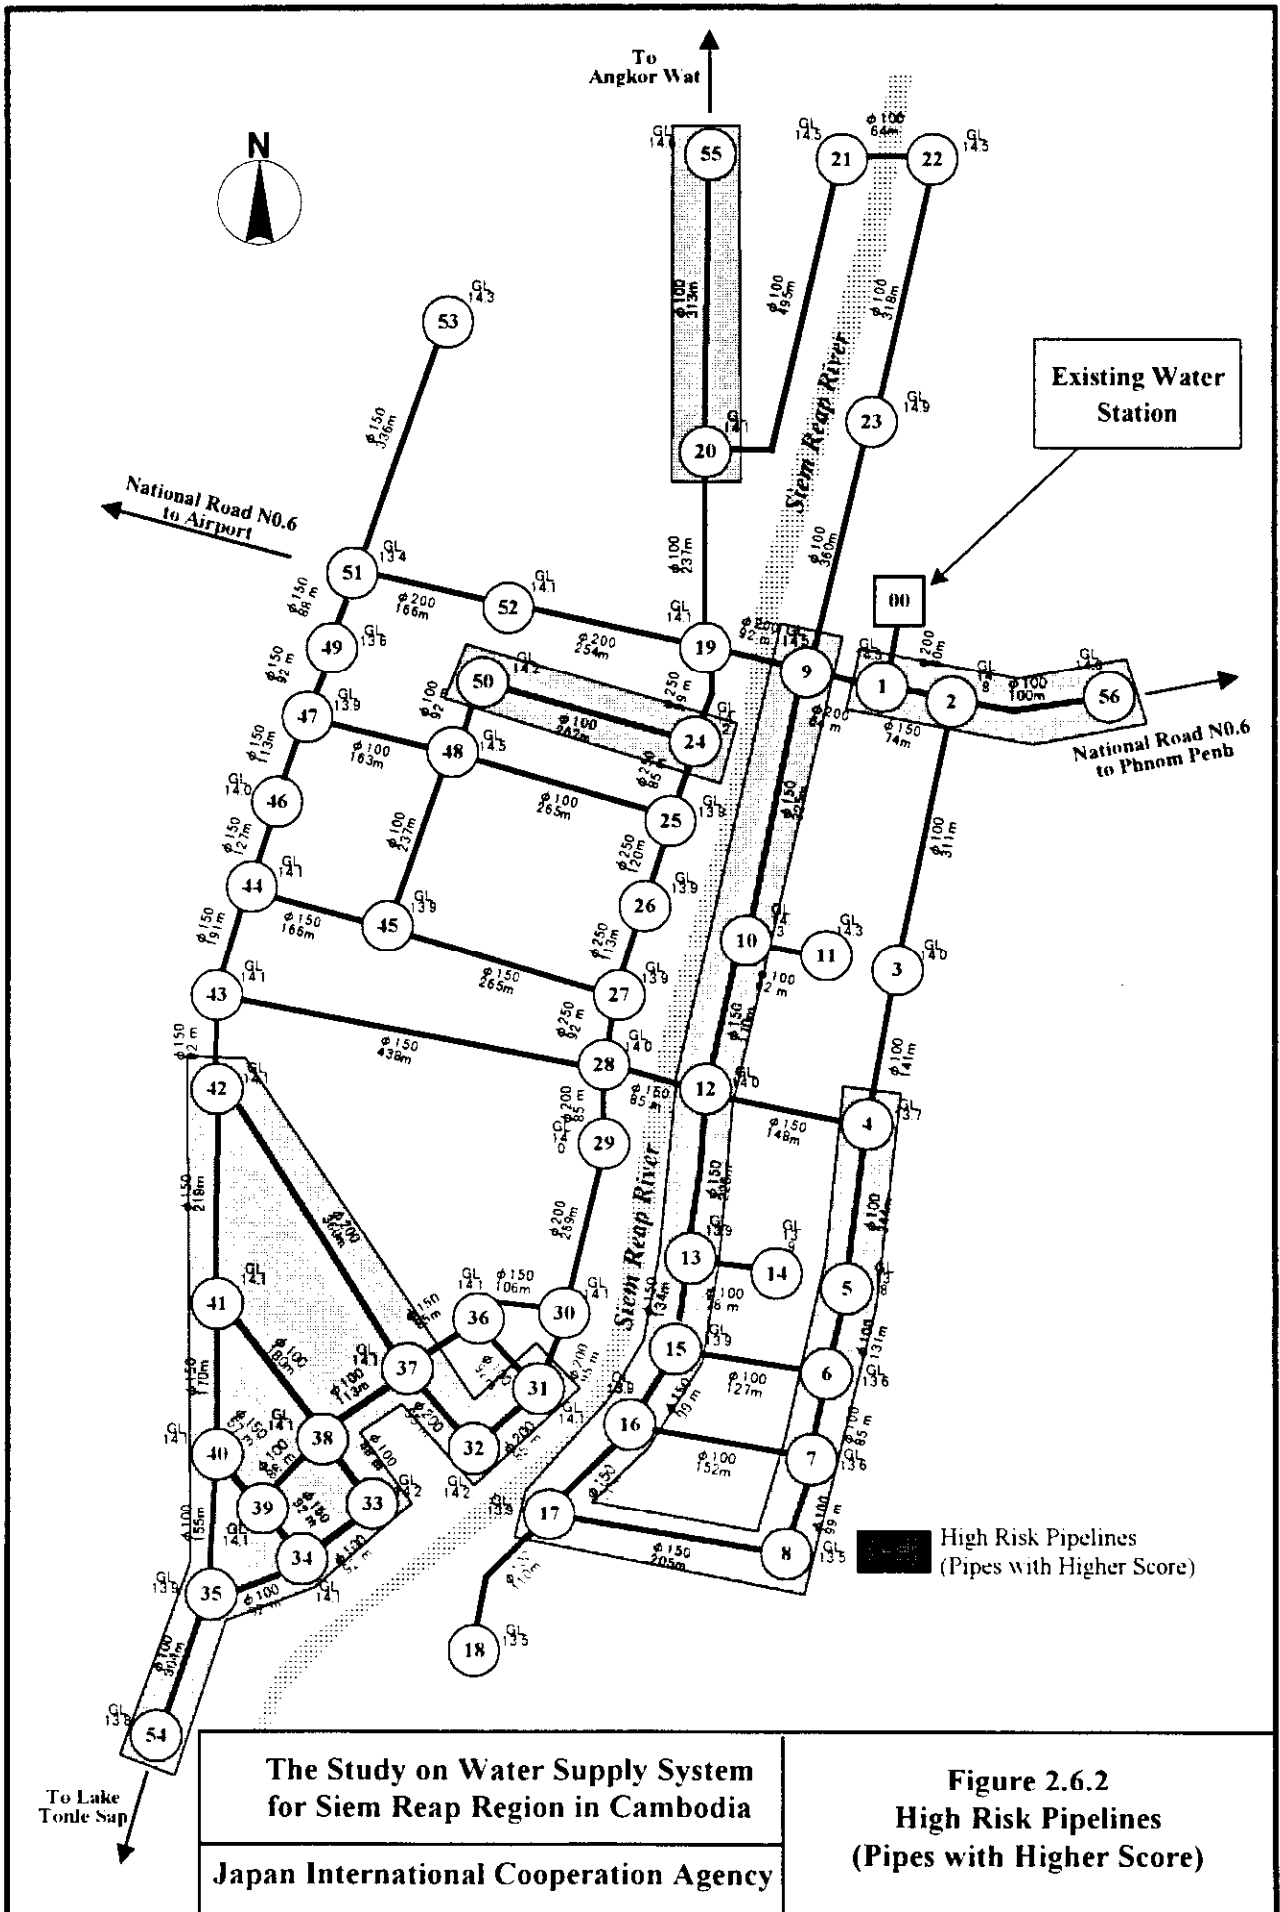
Figure 2.6.1 Results of Scoring

Table 2.6.1 is the scoring sheet of each pipeline scored by the scoring method mentioned above and results are shown on Figure 2.6.1. High-risk pipelines scored more than 4, which are highly recommended to be replaced, obtained from the scoring are shown on Figure 2.6.2.

High-risk pipelines are selected and these pipelines are recommended to be replaced. It should be noted that this does not mean the remaining pipelines are in good condition. Remaining pipelines were also installed from 1960s and they should also be replaced gradually after the replacement of the high-risk pipeline by the Siem Reap Waterworks using own funds or donor's assistance.
