***CHAPTER 3***  
***ROADS AND BRIDGES SECTORS***

## CHAPTER 3 ROAD AND BRIDGE SECTORS

### 3.1 Present Situation of Roads and Bridges

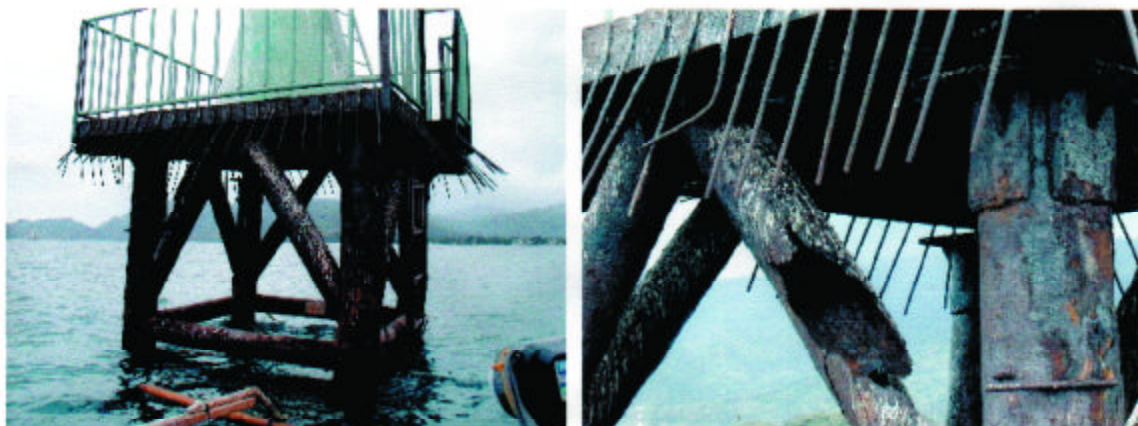
**Figure 4.3**      **Typical photographs of pile structure**

The stages and foundation piles are extremely poor and dangerous.

The typical photographs of the structure are shown in Figure 4.3.
