***CHAPTER 4***  
***PORTS SECTOR***

### 4.1 Present Situation of Ports

#### 4.1.1 Dili Port

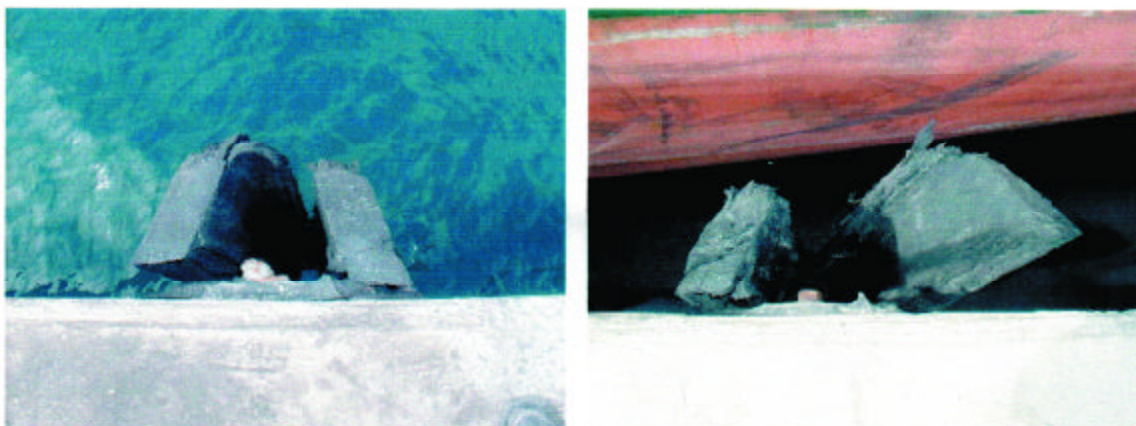
Presently most rubber fenders are in unsatisfactory condition. They are split, miss a portion and are hanging as pieces. In addition that some of them are completely missing.

Therefore, the called vessels are difficult to berth without any damages to their hull.

**Photo 4.1.1 Typical photograph of the fender**

- Unsuitable rubber materials
- Unsatisfied manufacturing of fenders
- Berthing velocity is more than the designed (caused by unavailable situation of pilot and tugboat services)
- Berthing of vessels with more than permissible size
- Poor maintenance
- Improper installation

Therefore, the fender size and quality shall be reconsidered prior to replacement, also the installation method should be properly specified.

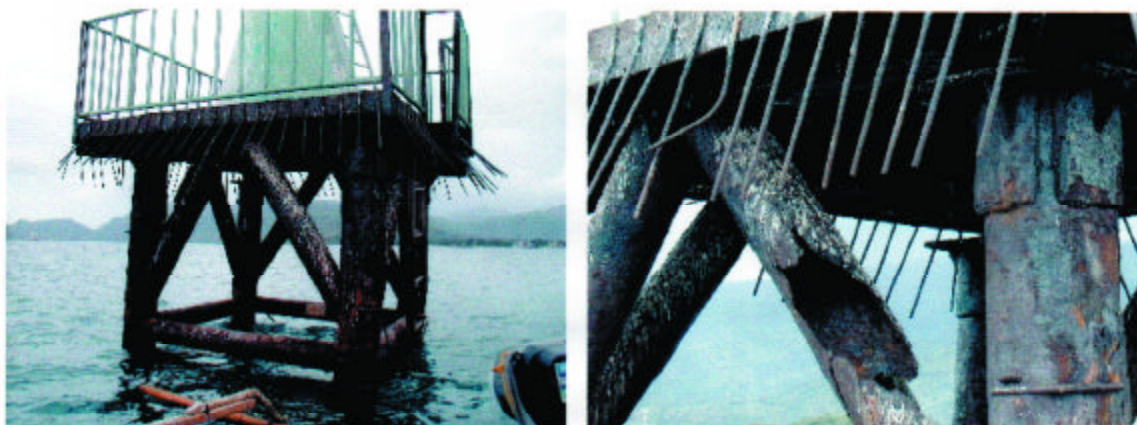
- The light beacons are installed in fiber grassed made container on the platform supported by steel foundation piles.
- Equipment is still in a reasonable condition.
- The platforms and foundation piles are in a extremely poor and dangerous condition caused by totally corroded steel material without corrosion prevention and maintenance. For instance, corroded portions have been laminated in total.

- These structures are forecasted to collapse at any time if the abnormal waves appear or if a small rowboat collides with it.

**Photo 4.1.2 Typical photograph of the pile structure**

Therefore, it is recommended to reconstruct the entrance light beacons immediately to obtain a safe navigable port. On the other hand, the above equipment is still in a reasonable condition. This equipment can be reinstalled on the new platforms. Thus the platforms and foundation piles should be reconstructed immediately in order to utilize the equipment.

It is important that the platforms and foundation piles shall be reconstructed immediately so that the port can be operated as a navigable port.

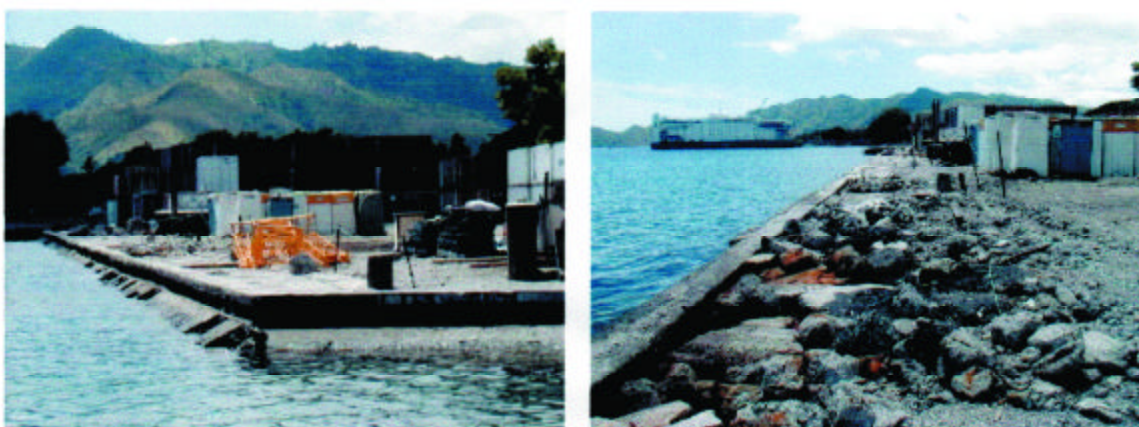
The condition of the revetment is very poor since many portions have collapsed. The revetment was constructed during Portugal rule (in the early 1950<sup>th</sup>), and is a so

**Photo 4.1.3 Typical photograph of East Container Stacking Yard**

Storm water pipes and culverts are observed at front of the revetment. However, all of those are collapsed together with the revetment, so that once heavy rainfall begins the storm water will wash away these collapse wastes. Therefore it is forecasted that in the near future, the storm water will cover the container-stacking yard. Such water would directly flow to the ocean together with the surfaced soil/gravel and sand. This natural phenomenon would cause heavy damages to the container-stacking yard.

Recent observation shows that the degree of damaged revetment has become greater, caused by heavy rains of Tuesday April 4 and Saturday April 8 in 2,000.

Recently, containers are leaning from a vertical position. This phenomenon of the leaning is becoming bigger day by day. This leaning is caused by unstable ground. The ground must be paved with the stable materials such as asphalt or concrete as soon as possible to prevent from fall of these containers.

Therefore, it is recommended to reconstruct immediately the east container stocking yards in accordance with good engineering design to prevent collapse of the container stacking yard.

Also, the container stacking yard should be paved with asphalt or interlocking concrete blocks to prevent serious damages to the reconstructed revetment. The Asian Development Bank is considering to do this pavement work, so that reconstruction of the revetment and pavement works will be well organized prior to the commencement of the works.

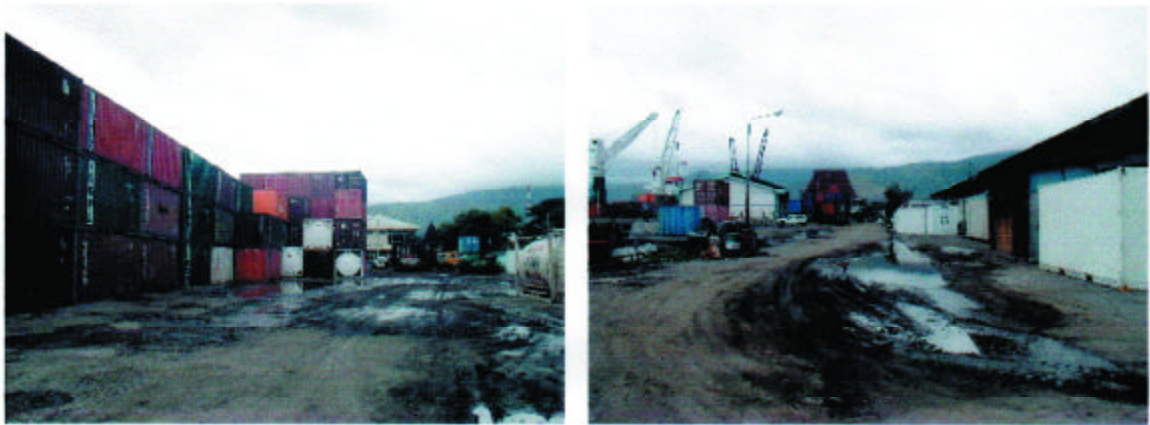
In addition, that according to the collapsed condition that it is conjectured that the revetment has been damaged by earthquake.

Presently, the stacking containers in the yard are exposed itself to the waves during high tide. On the other hand, valuable land is eroding every days caused by said waves. One can recognize erosion by the limited area's muddy seawater during high tide. Therefore, it is important that:

**Photo 4.1.4** Typical photograph of West Container Stacking Yard

- The revetment should be constructed as soon as possible so that the valuable land can be saved.
- The ground must be paved with the stable materials as soon as the revetment has reconstructed.

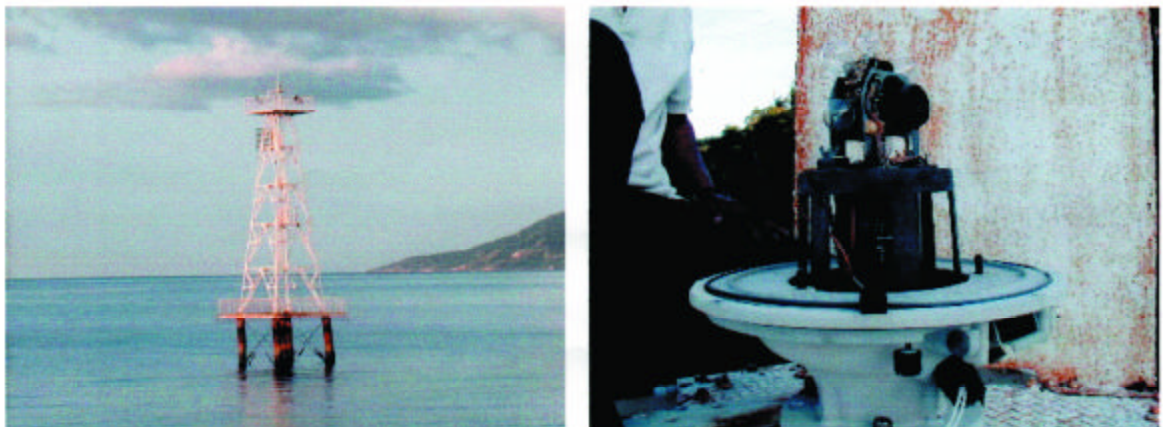
The approach to the harbor is marked by two (2) navigation aids on top of steel erected tower. These occur at the entrance together with the navigation aids (beacon) marking the approach. And two- (2) leading lights are existing on the splash zone and inland. The distance between two- (2) lights is horizontally 180m. The height of inland tower is measured approximately 15m. The condition of those navigation aids is structurally good, however all of the power supply system had been destroyed during the post-consultation destruction. Therefore, the port is unavailable to night calling vessels. The photographs of leading light tower and lamps is shown in Photo 4.1.5 hereinafter.

**Photo 4.1.5 Leading light tower and lamp**

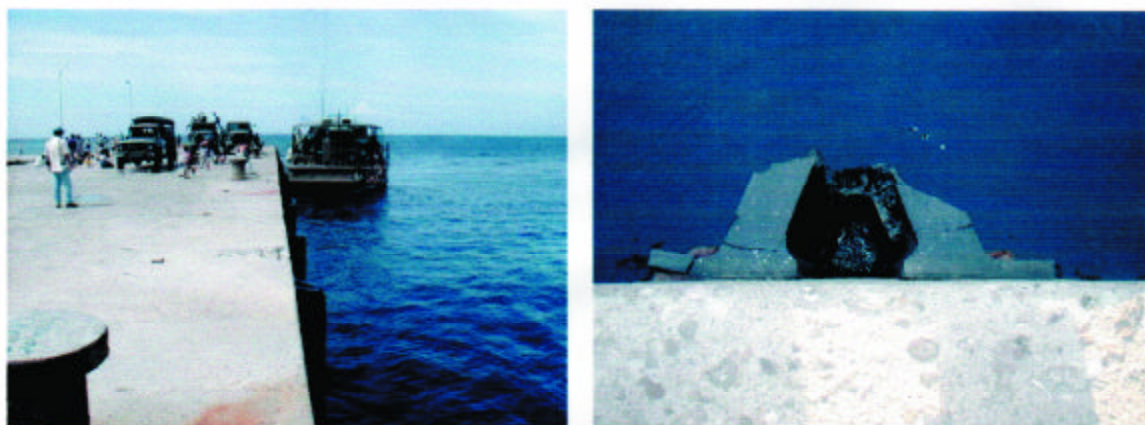
The wharf is a T-shaped quay with a pier of 80m in length and 15m in width and available draft alongside of 8.6m. Originally twenty- (20) V-1600 x 500-type rubber fenders are installed with spacing approximately 4.5m spacing. Most of the fenders are in poor condition and two- (2) are missing. Five- (5) concrete moving bits are located along the pier with spacing approximately 20m. The condition of the wharf is generally good, only a few spots need to be rehabilitated. The typical photographs of the fender are shown in Photo 4.1.6 hereinafter.

**Photo 4.1.6 Typical photograph of Wharf and Fender**

The most of fenders are damaged seriously due to too large vessels, quality of the fenders and installation. In addition, two (2) fenders are missing as of May 3<sup>rd</sup>, 2000.
