Retention Ponds in Sungai Petani No. 7

| Name of Development | Taman Sutera | | |

Retention Ponds in Sungai Petani No. 8

| Name of Development | Taman Arked | | |

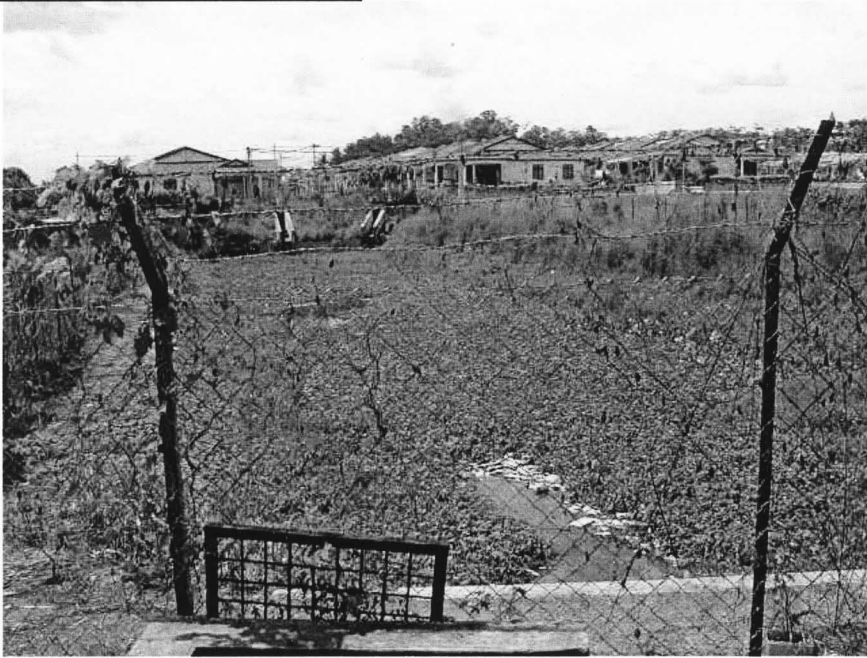
| Overview of Pond | | | |

| Environmental Condition | <ul style="list-style-type: none"> •growth of kangkung, floating rubbish and offensive odor | | |

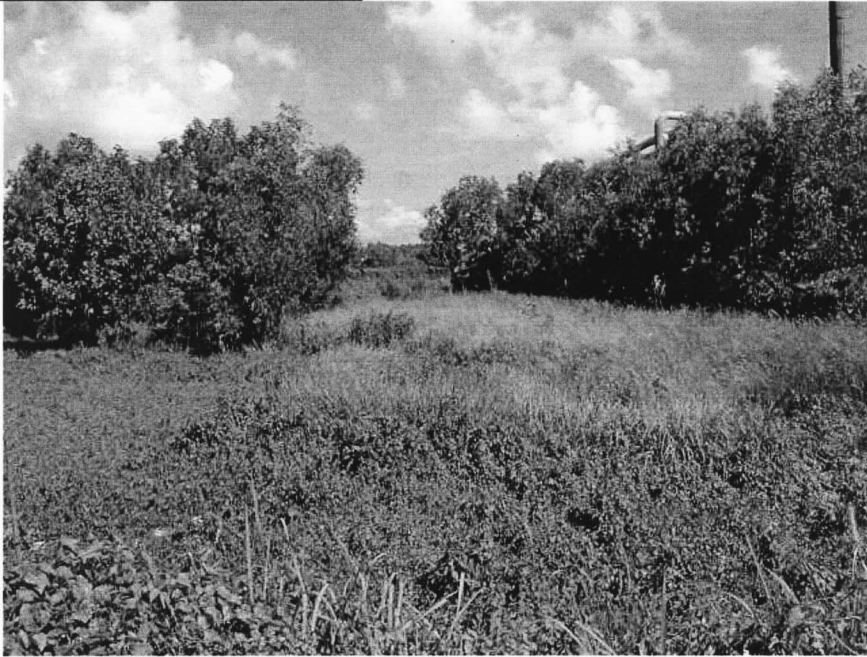
| Overview of Pond | | | |

| Environmental Condition | <ul style="list-style-type: none"> •difficult to enter and evaluate due to thick growth of weeds | | |
