BASIC DESIGN STUDY REPORT

THE NEW NYALI BRIDGE AND THE NEW MTWAPA BRIDGE

THE REPUBLIC OF KENYA

August 2000

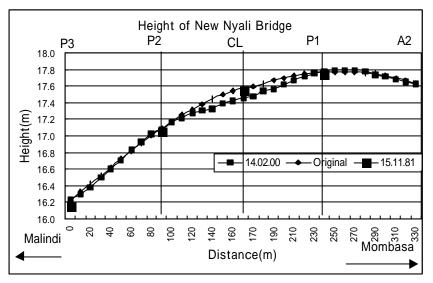
Fig. 2.3.1 Deflection of span central girder

<Prestressed concrete superstructure, Deflection of main girder >

original design is observed, resulting in 11 cm lowering from the original design in the middle of center span. The survey result of H.B GAUFF in December, 1981 showed 2.5 cm lowering from the original design. Though the camber is not clear, the present condition evidently indicates lowering from the original design. As crack occurrence is extremely limited, such lowering is not attributable to structural defects, but to the effect of creep. Since the longitudinal design is based on the up grade or forward and backward longitudinal grades are extremely gentle, 0.4% and 1.0% respectively, it is thought that calculated camber could not be provided during construction. The values on the side spans are approximately as designed.

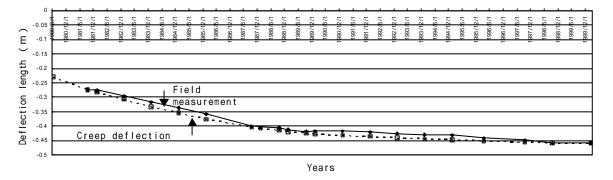
Fig. 2.3.3 Girder deflection along the time-course

As is known from Figs. 2.3.2 and 2.3.3, 22 cm lowering from the original design was observed in the middle of span. The survey result of H.B. GAUFF in November, 1981 shows 4.4 cm lowering from the original design. For this bridge, surveys were conducted once or twice a year from 1987 to January 1990, then every year since January 1996. The results in September 1987 indicate already 17 cm lowering from the longitudinal alignment of original design, followed by further 5 cm or so in the subsequent 12 years. Namely, 77% of the total deflection occurred in seven years. The longitudinal alignment of the road is of a concave shape in the middle of the span, and creep unique to concrete caused longitudinal lowering of the main girder. In addition, measurement of the deflection under static loading during this survey resulted in approximate agreement with the calculation result. Therefore, decrease in rigidity of the girder cannot be considered. Moreover, the result of this survey is almost the same as the values obtained two years ago, so deflection is thought to have converged and will not proceed any more in the future.

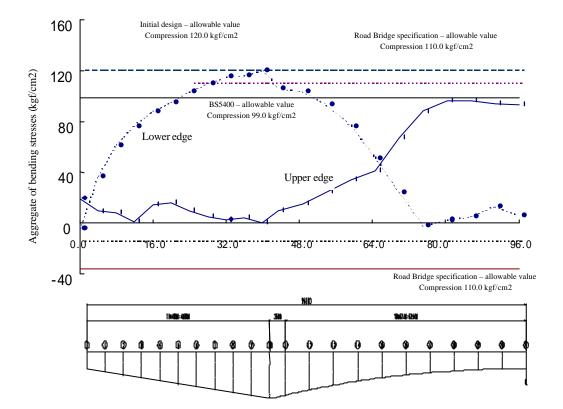
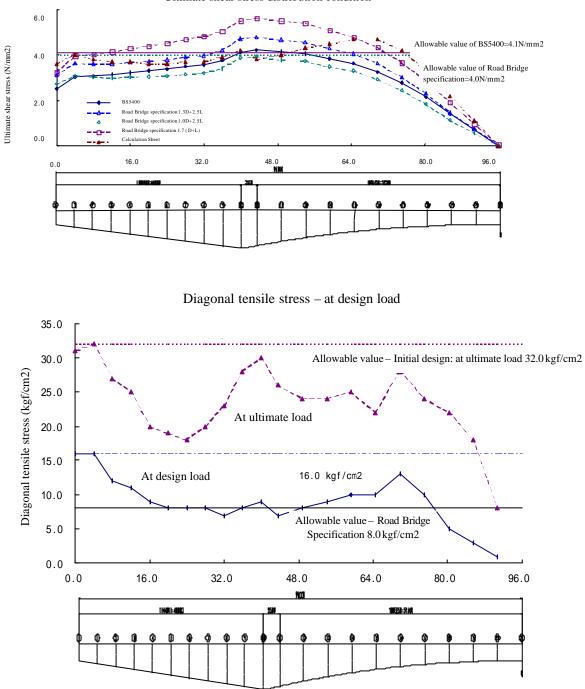
Fig. 2.3.7 The Stress and Allowable Value

Initially, the New Nyali Bridge was planned and constructed under loan assistance. Then, the New Mtwapa Bridge was hurriedly added. Accordingly, there are slight differences in concepts used for concrete strength and live load between these bridges. The original design was implemented during a period from May 1976 to March 1977. At the time, the design method according to the British Standard (hereinafter called "BS") was not required to specify allowance for shear stress. Therefore, shear stress occurring specifically in the New Mtwapa Bridge, which is substantially higher than currently specified allowable values, is the cause of many cracks of this bridge. On the other hand, bending and diagonal tensile stresses meet allowable values, so that there was no problem in the design in those days (Fig. 2-3-7). When compared with the Japanese standard, the bridge according to the existing BS standard (BS5400:1978) has shear, bending, and diagonal tensile stresses exceeding allowable values in several points. These points will require reinforcement in the future.

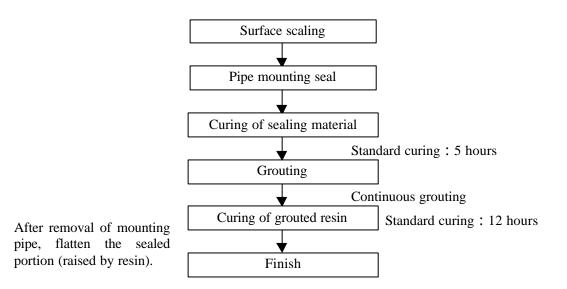
Fig. 3.1.5 Resin grouting procedure

<Crack width 0.2mm or more >

As shown in Fig. 3.1.5, the special epoxy resin will be grouted deep inside the crack under low pressure and at low speed over a long period of time, integrating the bridge body.

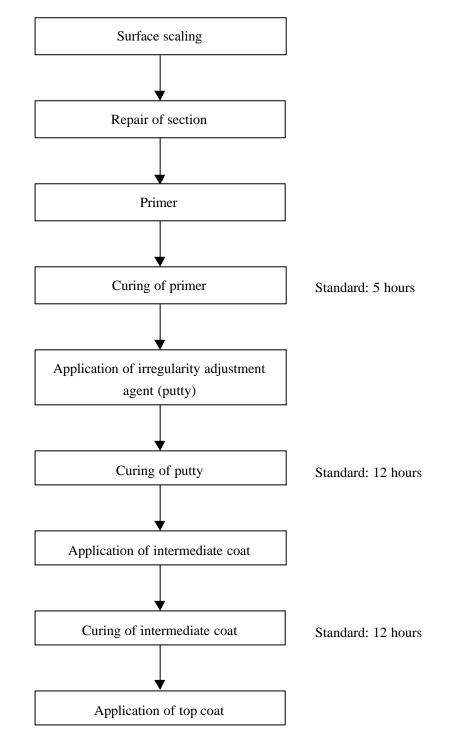
Fig. 3.1.6 Corrosion-resistant coating procedure

<Crack width less than 0.2mm >

For cracks less than 0.2mm, the concrete surface will be protected as shown in Fig.3.1.6 to prevent deterioration of concrete. (corrosion-resitant coat)
